Ratool Apparels Ltd. (Extension 2)

Anser Road, Vagnahati, Sreepur, Gazipur

6 November 2023

Building-05 (Main Production Building): Five storied RC building.

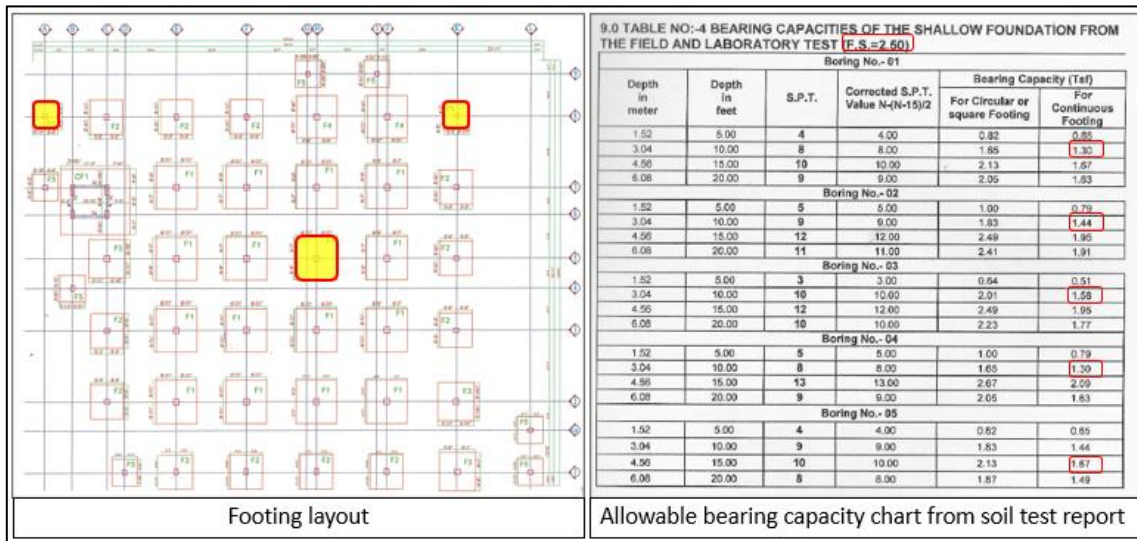
Observation-1: Foundation found to be stressed considering 5 storied building.

Description: Cursory calculation indicates the highlighted foundations are inadequate for both bearing & punching considering minimum concrete strength. Also, the loading is considered 4 kPa as per prepared floor load plan and allowable bearing capacity of soil is **3 tsf (FS: 2.5)** at 2.13 m depth. Building engineer is required to verify in-situ material strength as frequency of material strength test does not meet the minimum requirement and review the design load and foundation stresses.

Observation	Action Plan	Timeline
Foundation found to be stressed considering 5 storied building (Building-05; Main Production Building).	Verify in-situ material strength.	within 6 weeks
	Building engineer is required to review the design load and foundations stresses.	within 6 weeks
	Produce and actively manage a loading plan for all floor plates within the factory, considering floor, column and foundation capacity.	within 6 weeks
	Prior to commencement of further extension work above 3 stories, the factory is required to carry out the suggested remedial works if required.	within 6 months
Discrepancy in as-built drawing (Building-05; Main Production Building).	Building engineer is required to update the as-built drawing as per actual site condition.	within 6 weeks
Corrosion on exposed rebar (Building-05; Main Production Building).	Building engineer is required to take proper measures to protect the rebar from corrosion.	within 6 months

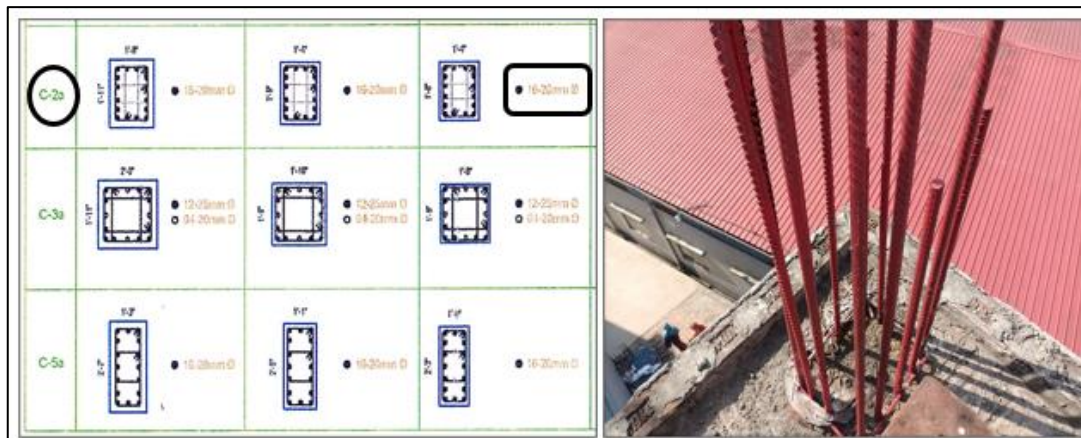
Observation-2: Discrepancy in as-built drawing (Building-05; Main Production Building).

Description: During inspection, 14 rebar were found in column-2a whereas 16 rebar were mentioned in as-built drawing.

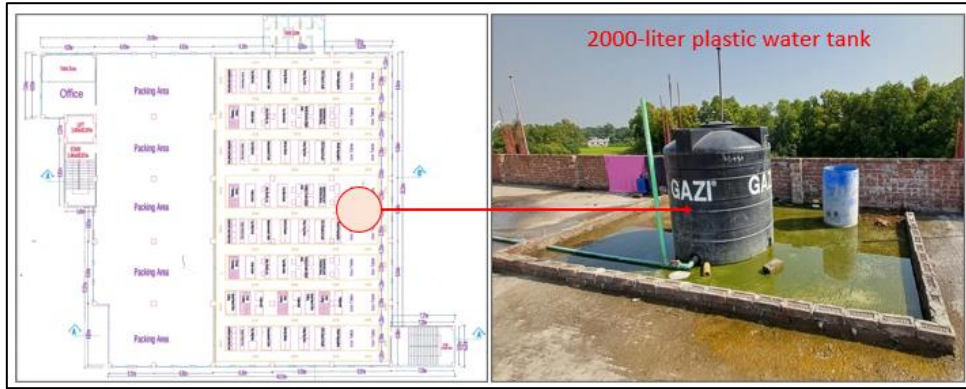
Description: A 2000-liter capacity plastic water tank was found on the existing roof (proposed 3rd floor) but in as-built drawing it was not mentioned.

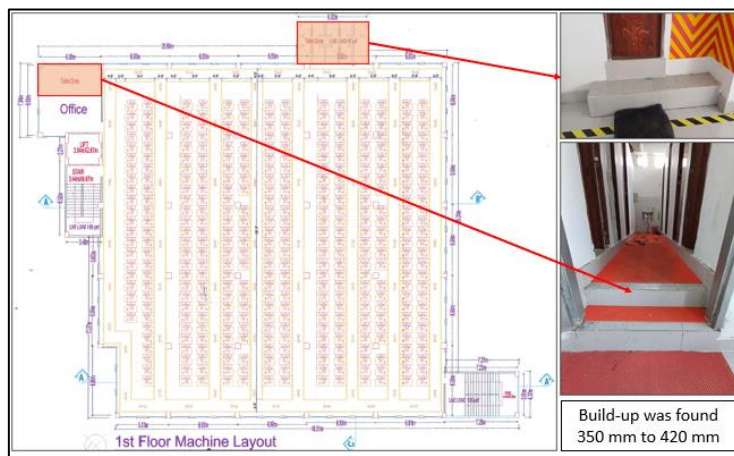
Description: 1st floor toilet zone build-up was found 350 mm to 420 mm but in as built it was not mentioned. Building engineer is required to revise the as-built drawing as per actual site condition.

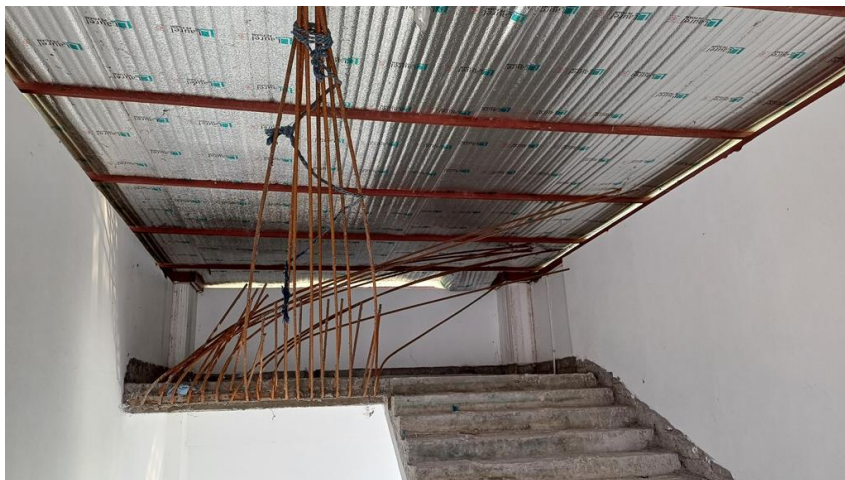
Observation-3: Corrosion on exposed rebar (Building-05; Main Production Building).

Description: During inspection, some rebar was found corroded. Building engineer is required to take proper measures to protect the rebar from corrosion.

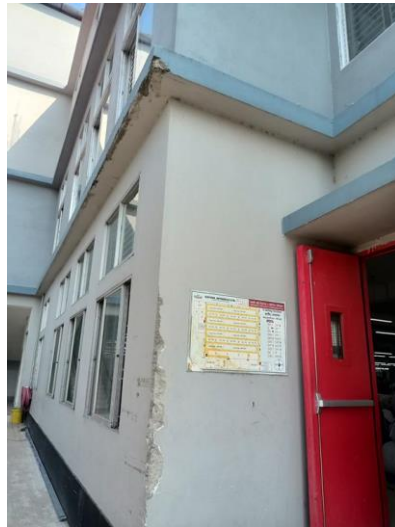
Observation-4: Column susceptible to vehicle impact (Building-05; Main Production Building).

Description: Some columns on the ground floor had the sign of vehicle impact. Building engineer is required to provide barriers around the column to avoid vehicle impact.

Column susceptible to vehicle impact (Building-05; Main Production Building).	Building engineer is required to provide barriers around the column to avoid vehicle impact.	within 6 months
Racks and plastic water tanks are not anchored or braced (Building-05; Main Production Building).	The building is required to adequately anchor/brace all non-structural elements to resist earthquake forces to comply with the BNBC.	within 6 months

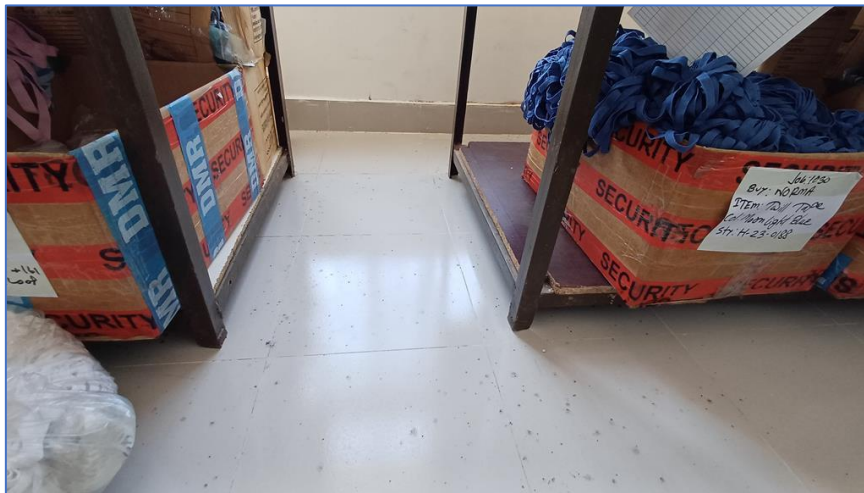
Observation-5: Racks and plastic water tanks are not anchored or braced (Building-05; Main Production Building).

Description: Some racks on floors are not anchored or braced to resist lateral (earthquake) forces. The building is required to adequately anchor/brace all non-structural elements to resist earthquake forces to comply with the BNBC.
