# AKH Knitting & Dyeing Limited (Extension)

92, Phulbaria, Tetuljhora, Saver, Dhaka-1347

1 November 2023

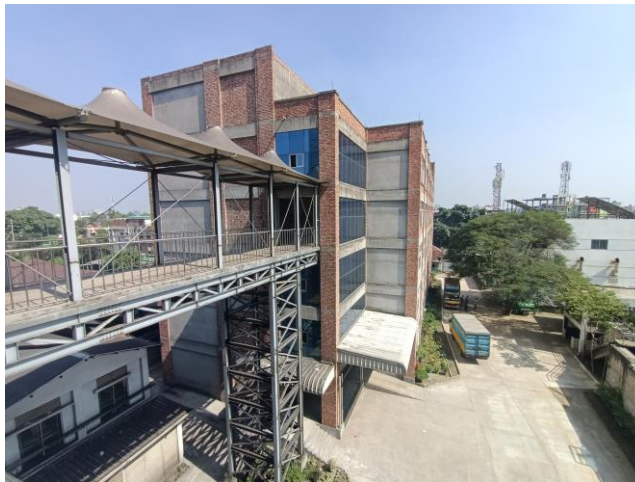
### Observation-01: Absence of design report (Store & Dinning Building)

**Description:** As per BNBC, every building or structure designed shall have its design documents prepared in accordance with the provision of Section 1.9.1. The design document shall include a design report, and a set of structural drawings, which shall be prepared in compliance with section 1.9.1.1 and section 1.9.1.2, part-6 of BNBC. At the time of inspection, only as-built drawing and geotechnical report were available, but no design report & load plan were available which are required to be prepared in compliance with section 1.9.1.1 (part-6, BNBC).

| Observation | Action Plan | Timeline |
|---|---|---|
| Absence of design report (Store & Dinning Building) | Building engineer is required to prepare the design documents including a design report, and a set of structural drawings in compliance with section 1.9.1.1 and section 1.9.1.2, part-6 of BNBC and submit it to RSC for review. | within 6 weeks |
| Absence of design report (Store & Dinning Building) | Carry out remedial works (if any) after review by RSC. | within 6 months |
| Absence of design report (Store & Dinning Building) | Implement floor load plan. | within 6 months |

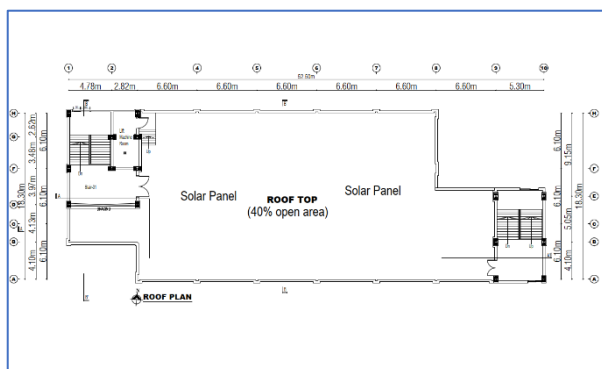
Roof layout

### Observation-02: Floor layout mismatch (Store & Dinning Building)

**Description:** Plastic water tank on the roof not shown in the drawings. Also, partition walls on the second floor not shown in the floor layout. Building engineer is required to update the as built drawings as per on site condition.

| Observation | Action Plan | Timeline |
|---|---|---|
| Floor layout mismatch (Store & Dinning Building) | Building engineer is to survey the whole structure and update as-built drawings representing accurate site condition. | within 6 weeks |

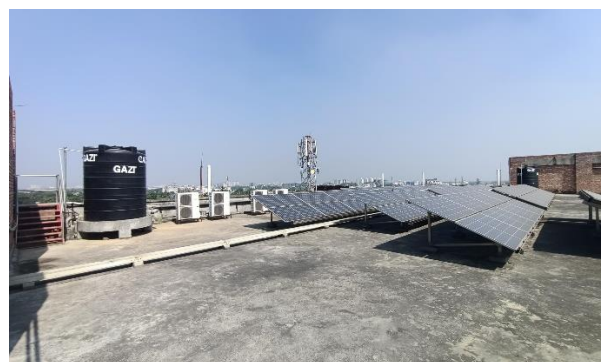
Plastic water tank 2 X 5000 L

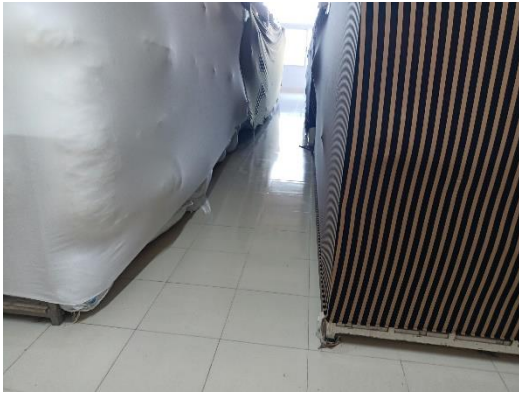
**Observation-03:** Non-structural elements not anchored or braced. (Store & Dinning Building)

Racks on floor

**Description:** Some racks on floors are not anchored and plastic water tank not braced to resist lateral (earthquake) forces. Building is required to anchor/brace all non-structural elements adequately to resist earthquake forces.

| Observation | Action Plan | Timeline |
|---|---|---|
| Non-structural elements not anchored or braced. (Store & Dinning Building) | Building is required to anchor/brace all non-structural elements adequately to resist earthquake forces. | within 6 months |

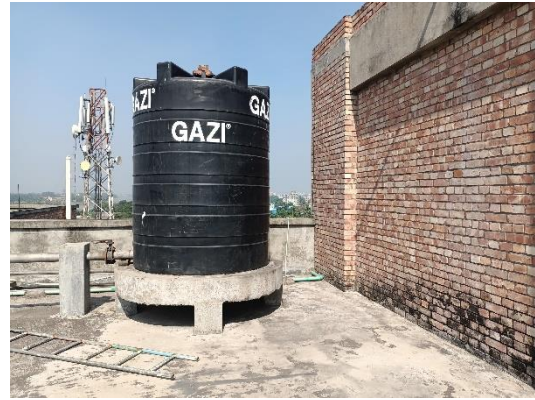
Plastic water tank on roof

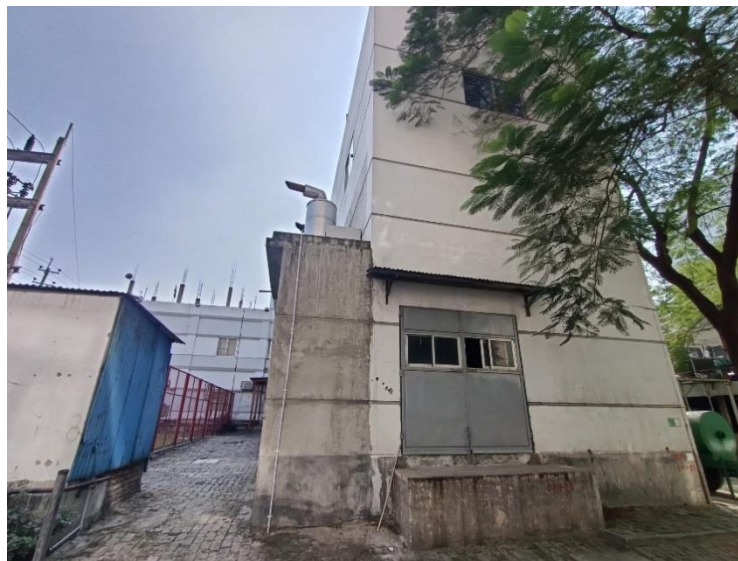
**Observation-04:** Absence of design report (Utility Building-2).

**Description:** As per BNBC, every building or structure designed shall have its design documents prepared in accordance with the provision of Section 1.9.1. The design document shall include a design report, and a set of structural drawings, which shall be prepared in compliance with section 1.9.1.1 and section 1.9.1.2, part-6 of BNBC. At the time of inspection, only as-built drawing and geotechnical report were available, but no design report & load plan were available which are required to be prepared in compliance with section 1.9.1.1 (part-6, BNBC).

| Observation | Action Plan | Timeline |
|---|---|---|
| Absence of design report (Utility Building-2). | Building engineer is required to prepare the design documents including a design report, and a set of structural drawings in compliance with section 1.9.1.1 and section 1.9.1.2, part-6 of BNBC and submit it to RSC for review. | within 6 weeks |
| Absence of design report (Utility Building-2). | Carry out remedial works (if any) after review by RSC. | within 6 months |
| Absence of design report (Utility Building-2). | Implement floor load plan. | within 6 months |

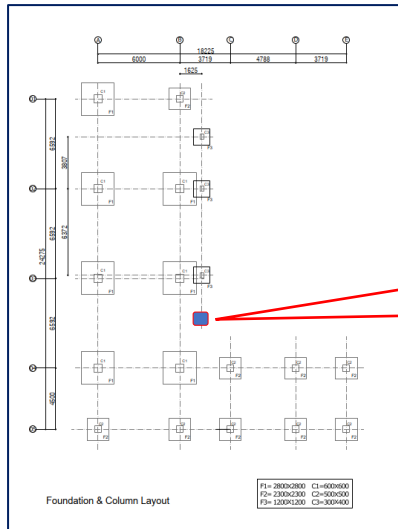
Column layout of GF

**Observation-05:** Lack of information in drawings. (Utility Building-2)

**Description:** A newly constructed column on GF not shown in the column and footing layout. Also roof beam layout was not found in the provided as-built drawings. Building engineer is required to update the as built drawings as per on site condition. Also, vertical load path needs to be confirmed for that column.

| Observation | Action Plan | Timeline |
|---|---|---|
| Lack of information in drawings. (Utility Building-2) | Building engineer is to survey the whole structure and update as-built drawings representing accurate site condition. | within 6 weeks |
| Lack of information in drawings. (Utility Building-2) | Vertical load path needs to be confirmed for the additional column. | within 6 weeks |

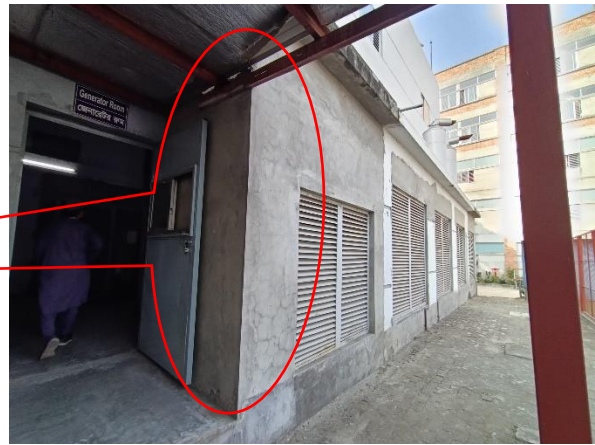
Undocumented column on GF

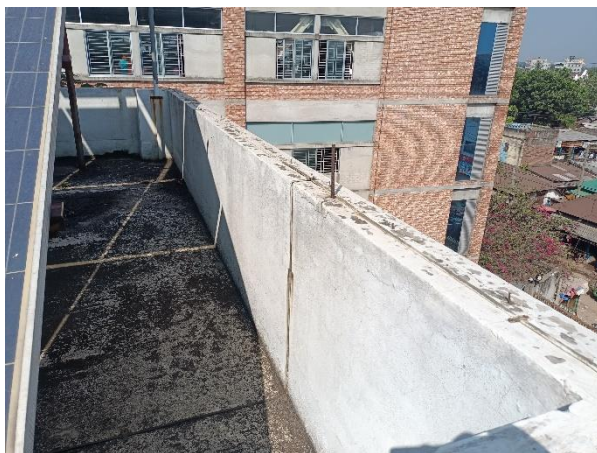
Insufficient discharge point

**Description:** Sign of water clogging, and insufficient discharge point was observed on the roof. Building engineer is required to provide adequate discharge point on the roof for drain out rainwater.

| Observation | Action Plan | Timeline |
|---|---|---|
| Insufficient discharge point on the roof. (Utility Building-2) | Building engineer is required to provide adequate discharge point on the roof for drain out rainwater. | within 6 months |

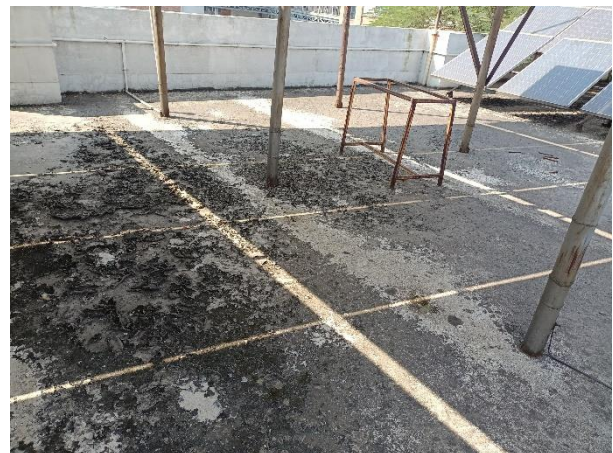
Sign of water clogging

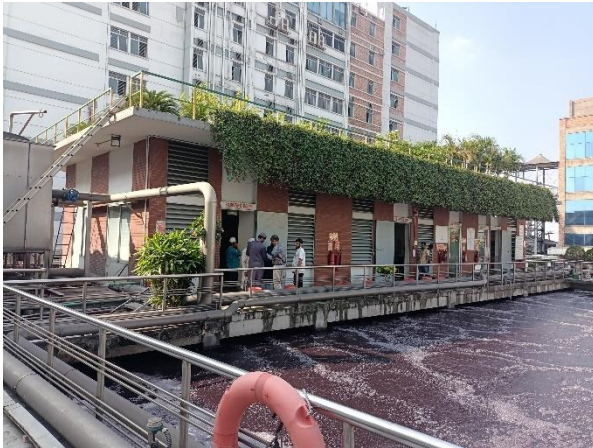
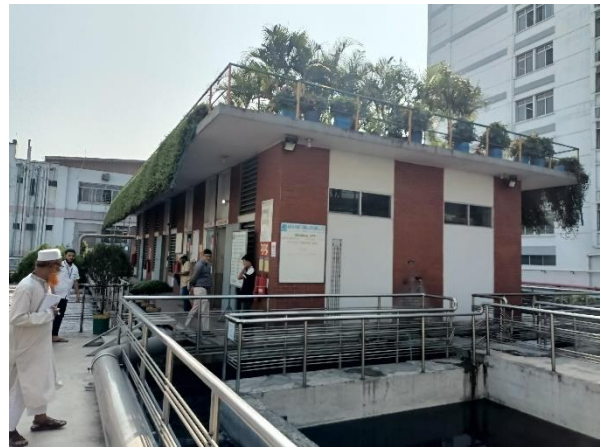
ETP Building

**Observation-07:** Absence of design report (ETP Building).

**Description:** As per BNBC, every building or structure designed shall have its design documents prepared in accordance with the provision of Section 1.9.1. The design document shall include a design report, and a set of structural drawings, which shall be prepared in compliance with section 1.9.1.1 and section 1.9.1.2, part-6 of BNBC. At the time of inspection, only as-built drawing and geotechnical report were available, but no design report & load plan were available which are required to be prepared in compliance with section 1.9.1.1 (part-6, BNBC).

| Absence of design report (ETP Building). | Building engineer is required to prepare the design documents including a design report, and a set of structural drawings in compliance with section 1.9.1.1 and section 1.9.1.2, part-6 of BNBC and submit it to RSC for review. | within 6 weeks |
| Absence of design report (ETP Building). | Carry out remedial works (if any) after review by RSC. | within 6 months |
| Absence of design report (ETP Building). | Implement floor load plan. | within 6 months |

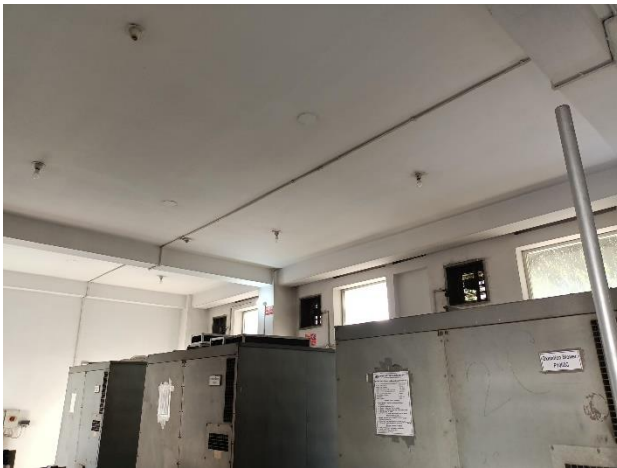
Roof Slab

**Observation-08:** Information missing in structural drawings. (ETP Building)

**Description:** Roof slab details were found missing in provided as-built drawings. The building engineer is required to incorporate all the missing information in the as-built drawing and submit it to RSC.

| Information missing in structural drawings. (ETP Building) | Building engineer is to survey the whole structure and update as-built drawings representing accurate site condition. | within 6 weeks |

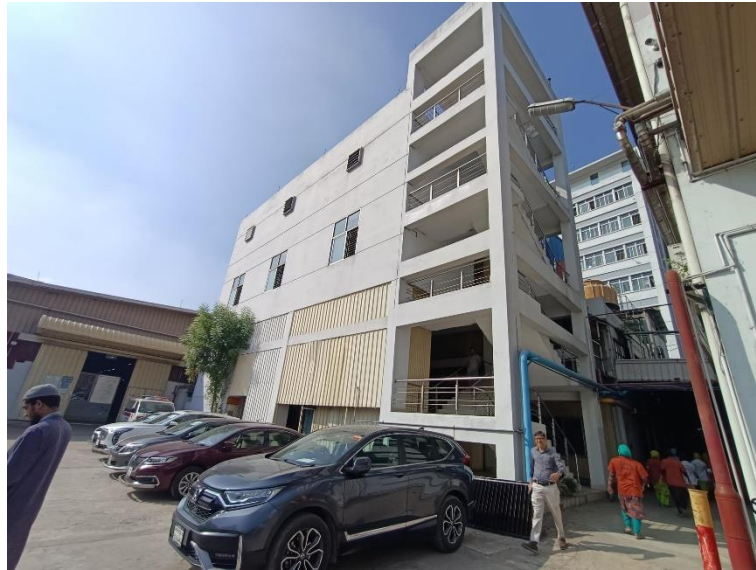
**Observation-09:** Absence of design report (Wast Heat Boiler & Compressor Room).

**Description:** As per BNBC, every building or structure designed shall have its design documents prepared in accordance with the provision of Section 1.9.1. The design document shall include a design report, and a set of structural drawings, which shall be prepared in compliance with section 1.9.1.1 and section 1.9.1.2, part-6 of BNBC. At the time of inspection, only as-built drawing and geotechnical report were available, but no design report & load plan were available which are required to be prepared in compliance with section 1.9.1.1 (part-6, BNBC).

| Absence of design report (Wast Heat Boiler & Compressor Room). | Building engineer is required to prepare the design documents including a design report, and a set of structural drawings in compliance with section 1.9.1.1 and section 1.9.1.2, part-6 of BNBC and submit it to RSC for review. | within 6 weeks |
| Absence of design report (Wast Heat Boiler & Compressor Room). | Carry out remedial works (if any) after review by RSC. | within 6 months |
| Absence of design report (Wast Heat Boiler & Compressor Room). | Implement floor load plan. | within 6 months |

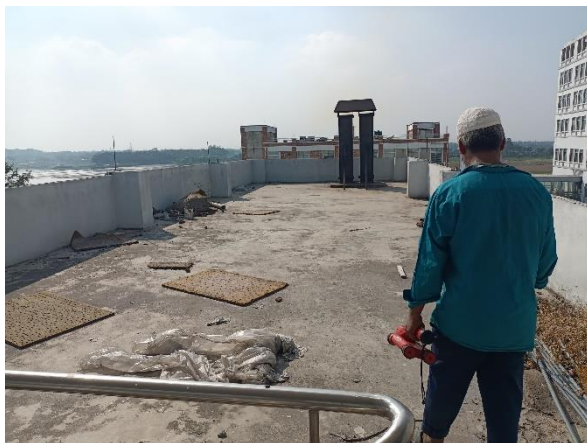
Insufficient discharge point

**Description:** Sign of water clogging, and insufficient discharge point was observed on the roof. Building engineer is required to provide adequate discharge point on the roof for drain out rainwater.

| In sufficient discharge point on the roof. (Wast Heat Boiler & Compressor Room) | Building engineer is required to provide adequate discharge point on the roof for drain out rainwater. | within 6 months |

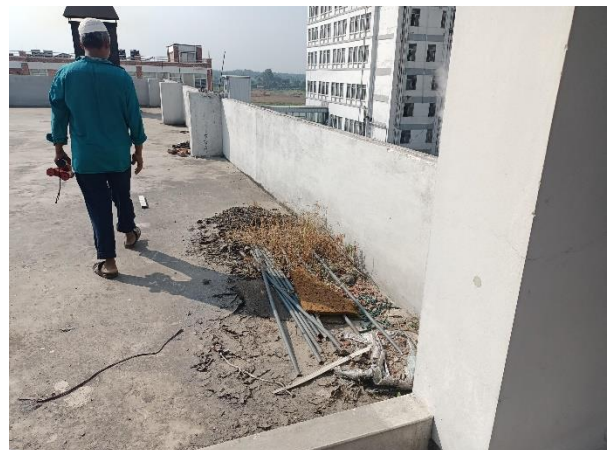
Sign of water clogging

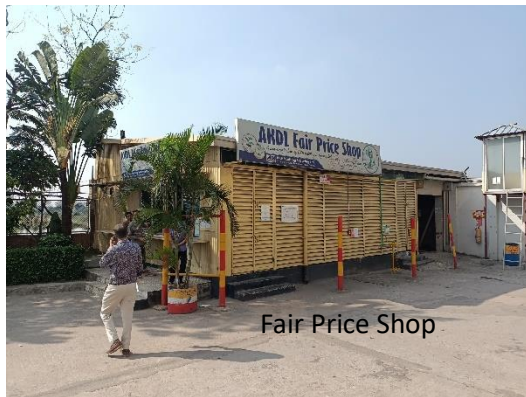
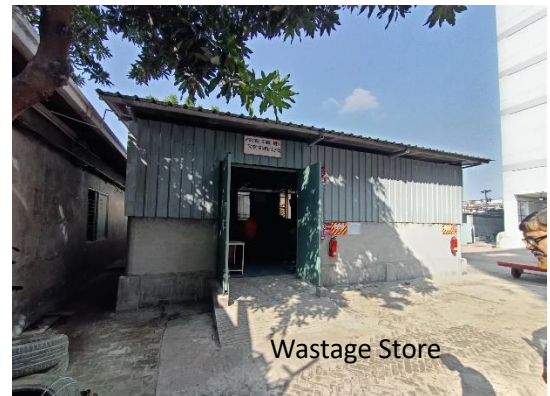
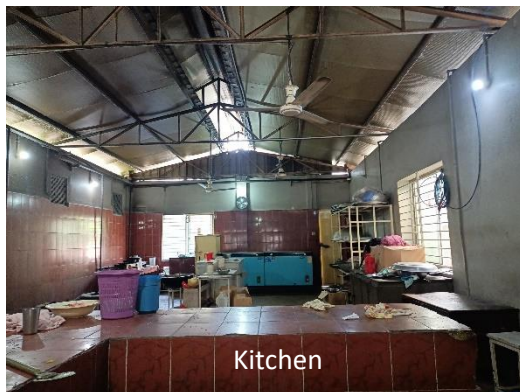
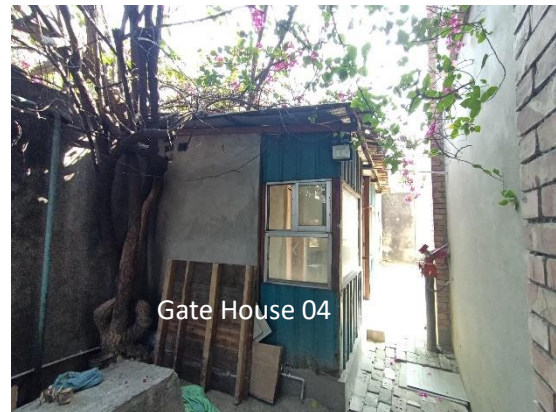
**Observation-11:** Lack of as-built drawings (Fair Price Shop; Kitchen; Wastage Store; Gate House 04).

**Description:** As-built drawings were not available for the mentioned structures. Building engineer is required to prepare full set of as-built drawings and submit to RSC.

| Lack of as-built drawings (Fair Price Shop; Kitchen; Wastage Store; Gate House 04). | Building engineer is to survey the whole structure and update as-built drawings representing accurate site condition. | within 6 weeks |
