# Masihata Sweaters Ltd. (Extension)

South Panishail, Kashimpur, BKSP, Gazipur.

15 November 2023

## 2. Observations

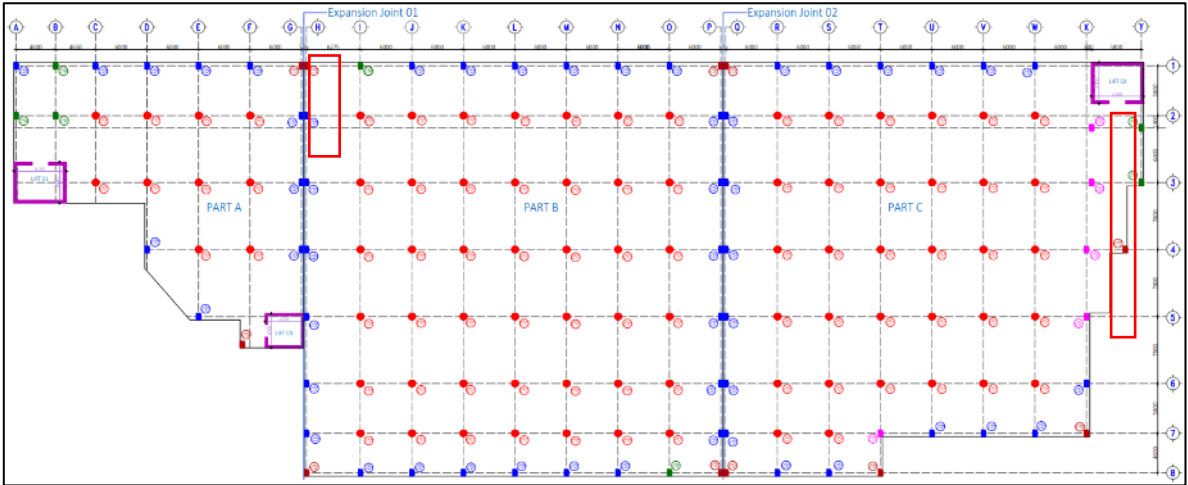
Column Schedule

**Description:** During inspection, mismatches were found between onsite condition and as-built drawing. Rebar numbers of C2, C5 and C6 column found different from column schedule. The building engineer is required to survey the full structure and produce accurate as-built drawings.

| Serial | Observation | Action Plan | Timeline |
|---|---|---|---|
| 3 | Discrepancies in as built drawings. (Building-2) | The building engineer is required to survey the full structure and produce accurate as-built drawings. | within 6 weeks |

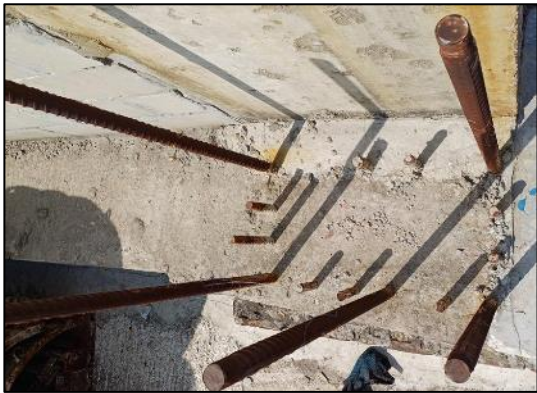
C2 column-16 nos of rebar found instead of 18 nos rebar.

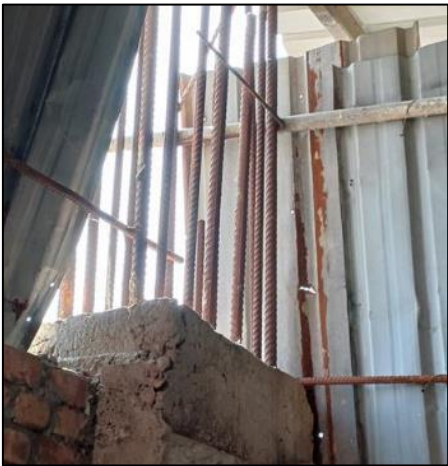
C5 column-18 nos of rebar found instead of 24 nos rebar.

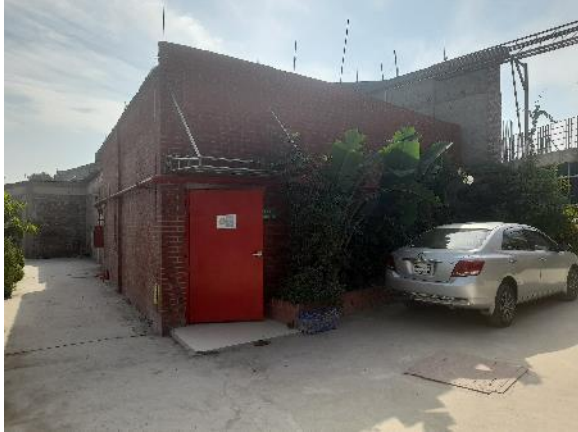
Daycare building

**Description:** During inspection, mismatches observed in as-built drawings. As per drawings, member size of steel truss was provided 2L-50X50X6, where member size was found L-38X38X5 on site. The building engineer is required to prepare accurate as built drawings and revise the design report.

| Serial | Observation | Action Plan | Timeline |
|---|---|---|---|
| 4 | Mismatches in as-built drawings (Building-3) | The building engineer is required to prepare accurate as built drawings and revise the design report. | within 6 weeks |

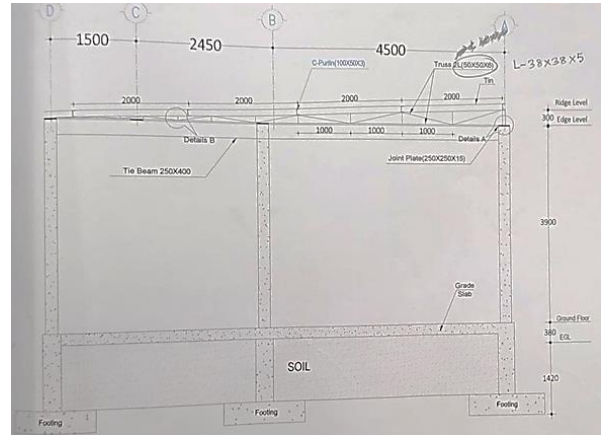
Truss Section (L-38X38X5)

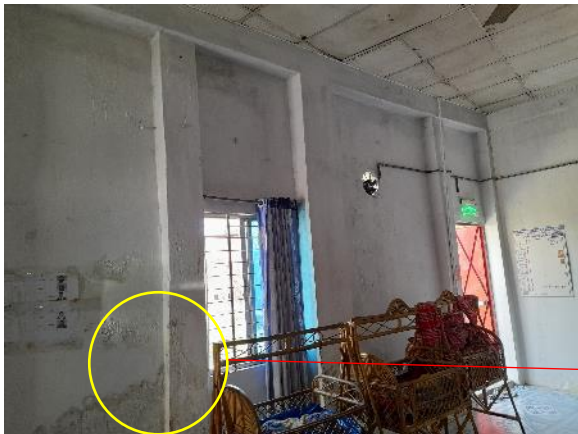
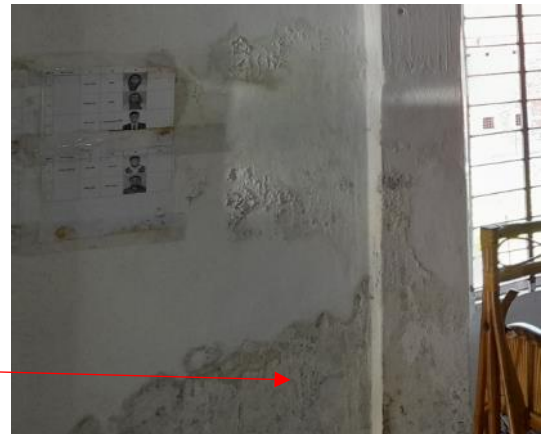
**Observation-4: Dampness on brick wall (Building-3).**

**Description:** Dampness observed on brick wall. Building engineer is required to repair the dampness.

| Serial | Observation | Action Plan | Timeline |
|---|---|---|---|
| 6 | Dampness at brick wall (Building-3). | Building engineer is required to repair the dampness. | within 6 weeks |

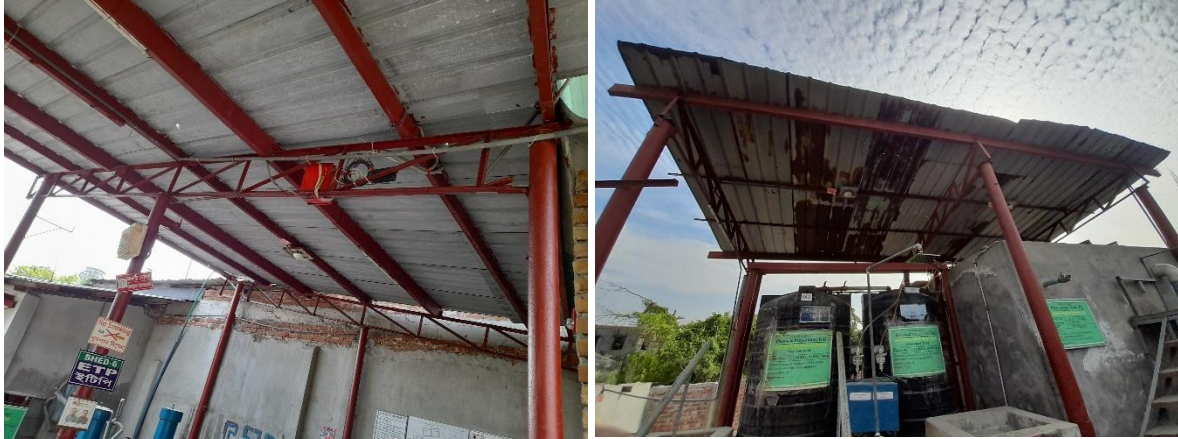
ETP steel shed

**Observation-5: Lack of lateral stability (Building-6).**

**Description:** During inspection, a built drawing was not available for the structure. Also, lateral load transfer media was not available. The existing truss may be inadequate against the lateral loading. The building engineer is required to prepare accurate as built drawings and perform the Engineering Assessment (EA) for the ETP shed.

| Serial | Observation | Action Plan | Timeline |
|---|---|---|---|
| 7 | Lack of lateral stability (Building-6) | Survey the whole structure and prepare the as-built drawings. | within 6 weeks |
| 8 | Lack of lateral stability (Building-6) | Building engineer is required to verify the lateral stability of the ETP shed | within 6 weeks |

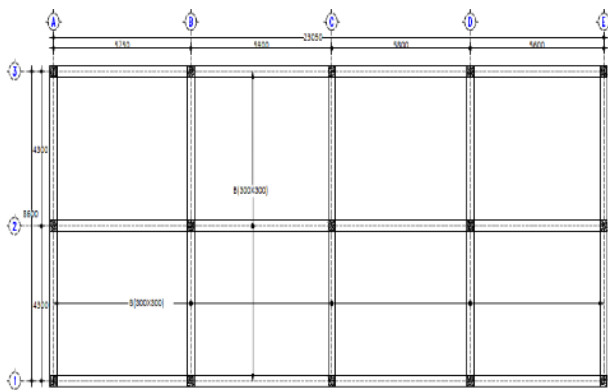
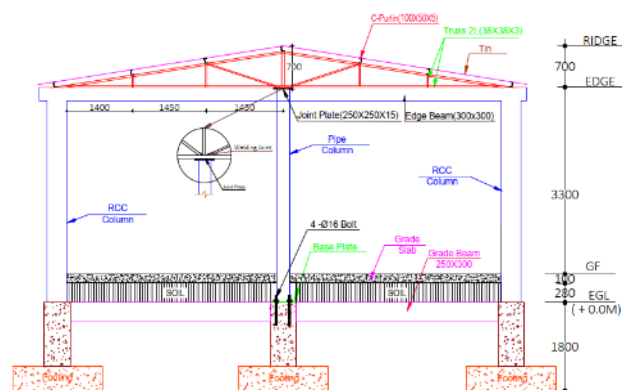
Edge Beam Layout and frame section

**Description:** During inspection, no edge beams were observed at the eave height level. In as-built drawings, edge beams are provided at eave height. The building engineer is required to prepare accurate as built drawings and revise the design report.

| Serial | Observation | Action Plan | Timeline |
|---|---|---|---|
| 10 | Mismatches in as-built drawings (Building-7). | The building engineer is required to prepare accurate as built drawings and revise the design report. | within 6 weeks |

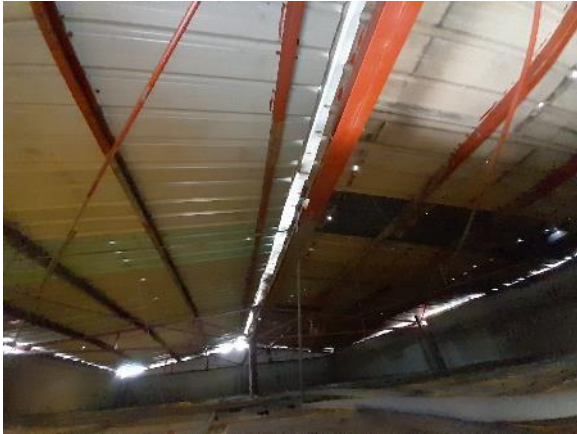
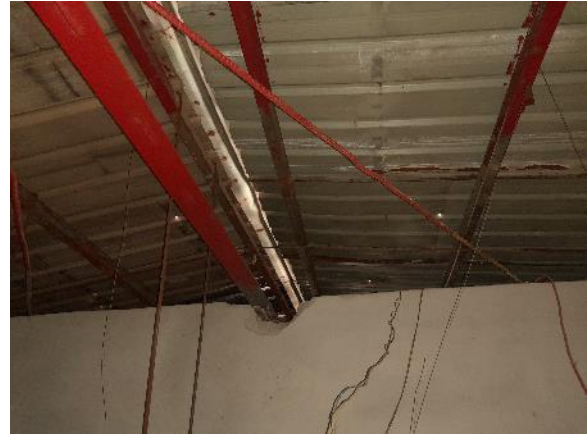
**Observation-7:** Loose and bent horizontal bracing (Building-7).

**Description:** Horizontal bracing (16mmØ bar) was found bent and loose. Factory is required to take remedial actions as per the suggestion of building engineer.

| Serial | Observation | Action Plan | Timeline |
|---|---|---|---|
| 12 | Loose and bent horizontal bracing (Building-7). | Factory is required to take remedial actions as per the suggestion of building engineer. | within 6 weeks |

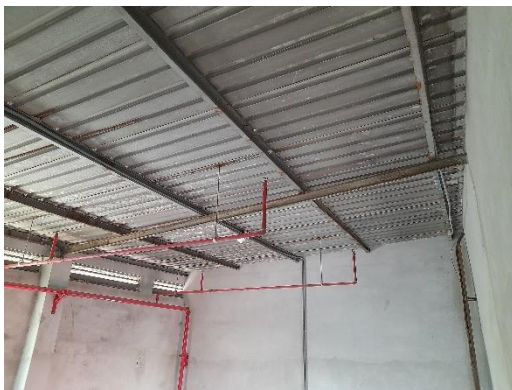
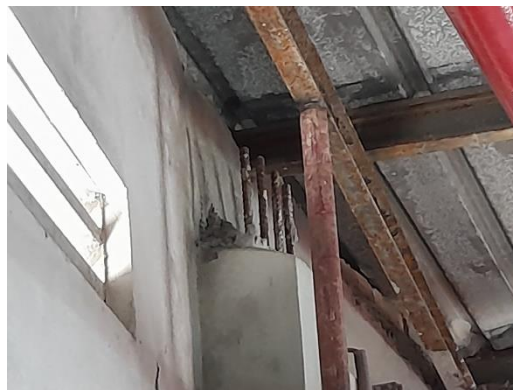
Steel Roof shed over the Fire pump room and control room

**Description:** Light weight steel roof shed was found over the Fire pump room and control room. The size of the steel members connections seems to be inadequate against the lateral loading.

| Serial | Observation | Action Plan | Timeline |
|---|---|---|---|
| 13 | Verify the connection adequacy of the roof shed.<br>(Building-8) | Building engineer is required to verify the adequacy of connection against uplift force. | within 6 weeks |

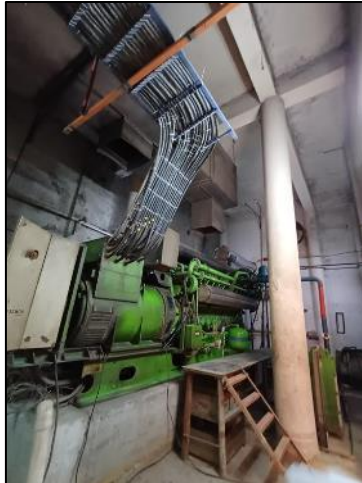
Building-9 (Generator Building)

**Observation-9:** Lack of design report. (Building-9)

During inspection, the design report was not available on site. The building engineer is required to prepare a design report based on in-situ material strength & software-based analysis and submit it to RSC for review.

| Serial | Observation | Action Plan | Timeline |
|---|---|---|---|
| 15 | Lack of design report.<br>(Building-9) | The building engineer is required to prepare a design report based on in-situ material | within 6 weeks |

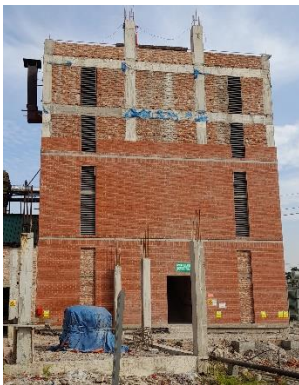
Utility Building

During inspection, total eight sets of the cylinder test of the report was available but only two sets (one set from Column and one set from footing) of the cylinder test report having average strength. The frequency of test for the cylinder test report does not comply with BNBC.

The provided design documents does not contains any FEA model. Building engineer is required to update the design documents based on in-situ strenth and submit to RSC.

| 17 | Design documents needs to be revised (Building-10) | The building engineer is required to update design documents based on in-situ material strength & software-based analysis and submit it to RSC for review. | within 6 weeks |

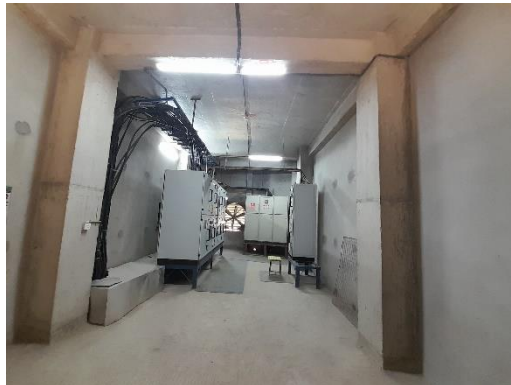
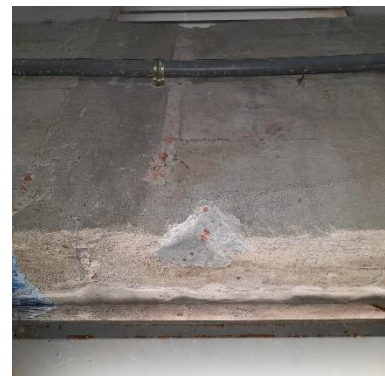
Beam aggregate-Brick chips

**Observations:** Stone chips aggregate has been used for the construction of the utility building but one of the beam was found made of brick chips. Building engineer is required to identify all the locations where brick chips has been used.

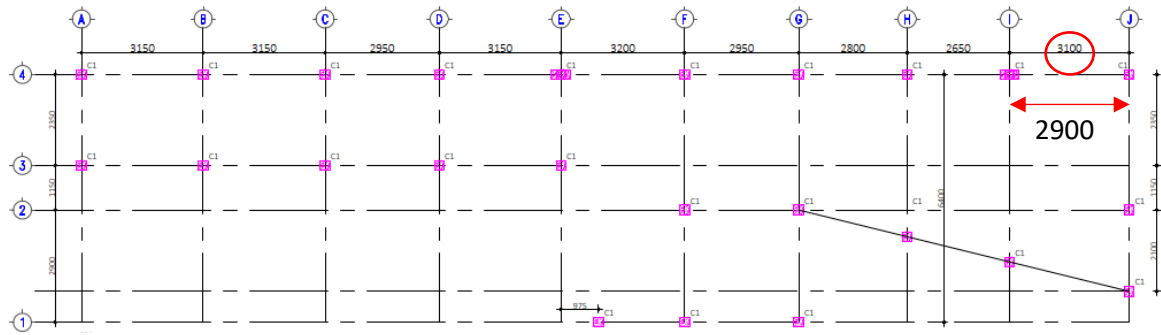
Grid distance mismatch

**Observations:** During inspection, discrepancy observed in as-built drawings. Grid distance mismatch was found at some locations. As per drawing, purlin size is 2C-100X50X3 but purlin size was found C-100X50X3 on-site. The building engineer is required to prepare accurate as built drawings and revise the design report.

| 19 | Mismatches in as-built drawings (Building-11). | The building engineer is required to prepare accurate as built drawings and revise the design report. | within 6 weeks |

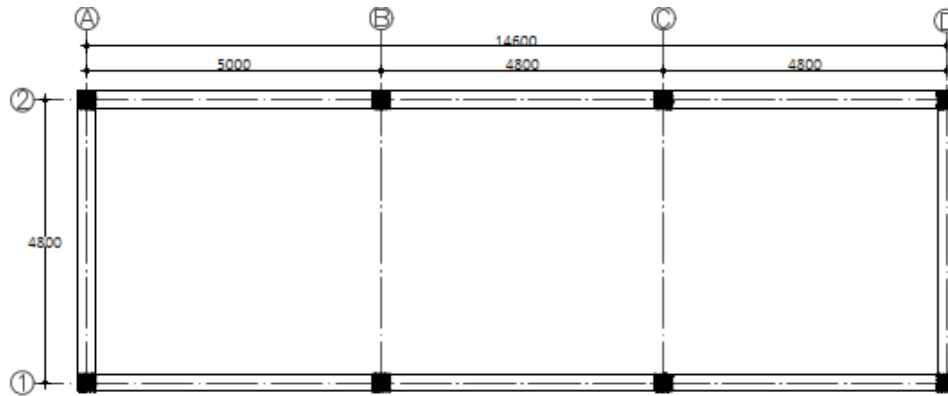
Edge beam layout (as per structural drawing)

**Description:** According to the on-site condition, there is no edge beam at eave height level. Building engineer is required to prepare accurate as built drawings and revise the design report.

| 21 | Discrepancies in as built drawings (Building-12). | Building engineer is required to prepare accurate as built drawings and revise the design report based on in-situ material strength. | within 6 weeks |

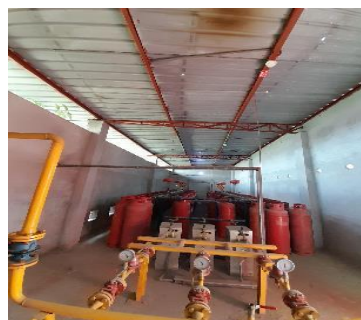
Missing edge beams at on-site condition

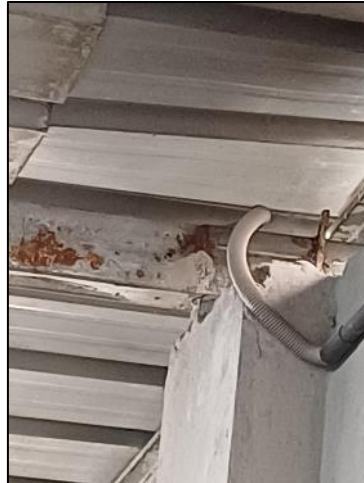
**Observation-14:** Apparently inadequate connection. (Building-16)

**Description:** Apparently inadequate structural connection details were found in steel roof shed. Building engineer is required to check the adequacy of the steel connection for uplift forces.

| 25 | Apparently inadequate connection. (Building-16) | Building engineer is required to check the adequacy of the steel connection for uplift forces. | within 6 weeks |

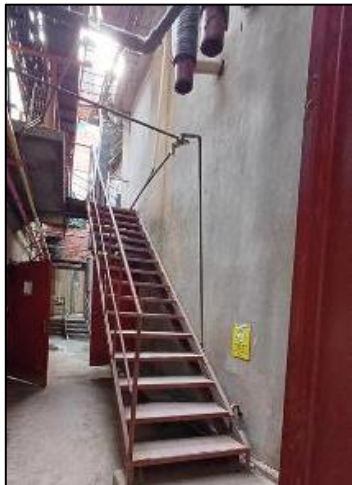
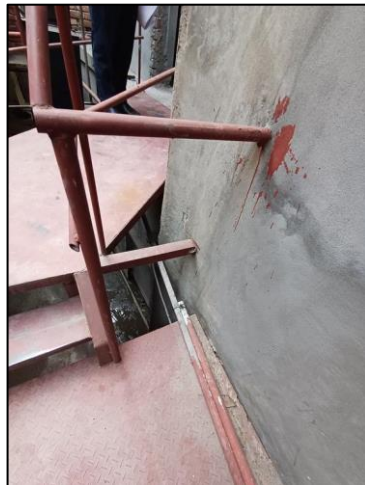
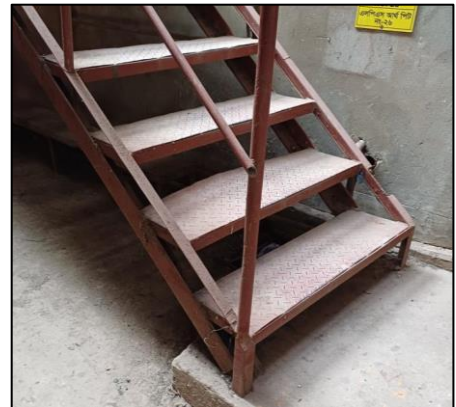
**Observation-15:** Adequacy of steel stairs needs to be checked. (Building-16)

**Description:** Inadequate structural connections were found in steel stair. Building engineer is required to check the structural adequacy of the steel stair.

| 27 | Adequacy of steel stair need to be checked. (Building-16) | Building engineer is required to check the adequacy of the steel stair. | within 6 weeks |

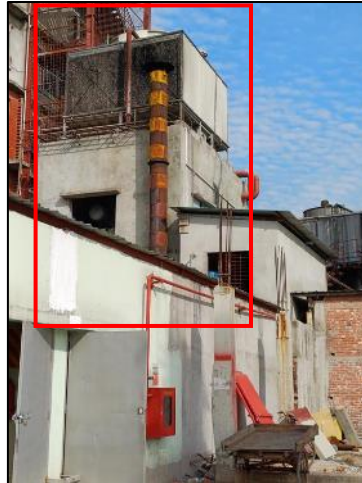
**Observation-16:** Lack of design report. (Building-18)

During inspection, the design report was not available on site. The building engineer is required to prepare a design report.

| 29 | Lack of design report. (Building-18) | The building engineer is required to prepare a design report based on in-situ material strength & software-based analysis and submit it to RSC for review. | within 6 weeks |

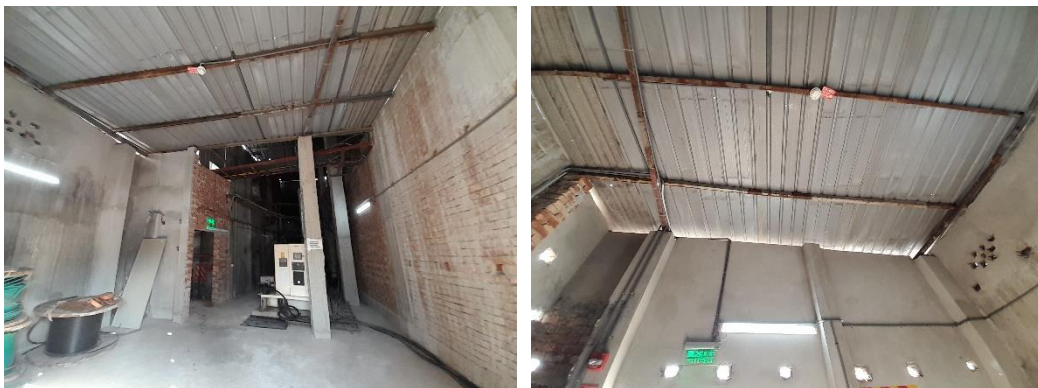
Roof shed

**Observation-17:** Verify the connection adequacy of the roof shed. (Diesel Generator)

**Description:** Light weight steel roof shed is supported by the RC column. During inspection, the as-built drawing was not available for the Diesel Generator. The roof shed is apparently non-engineered. Also, connection seems to be inadequate to carry the uplift force.

| 31 | Verify the connection adequacy of the roof shed. (Diesel Generator) | Building engineer is required to verify the adequacy of connection against uplift force. | within 6 weeks |
