# PLUMMY FASHIONS Ltd

North Norshingpur, kashipur, Fatullah, Narayangonj  
(23.616667 N, 90.469167 E)

21<sup>st</sup> October 2015

# Observations

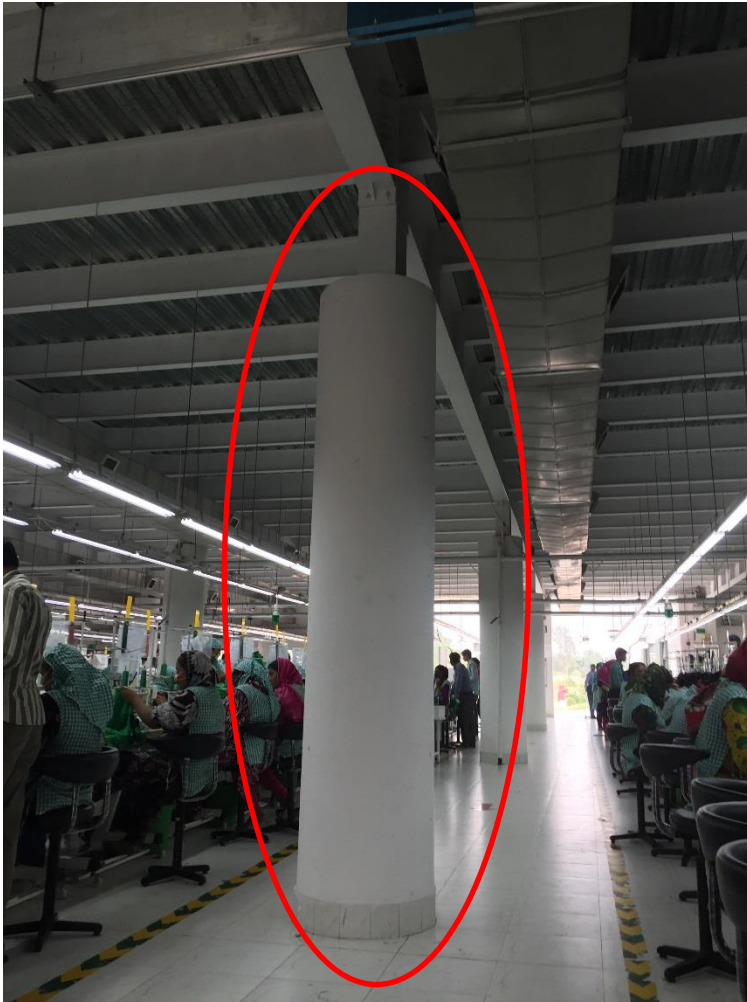
Steel posts supported on the RC columns from original design

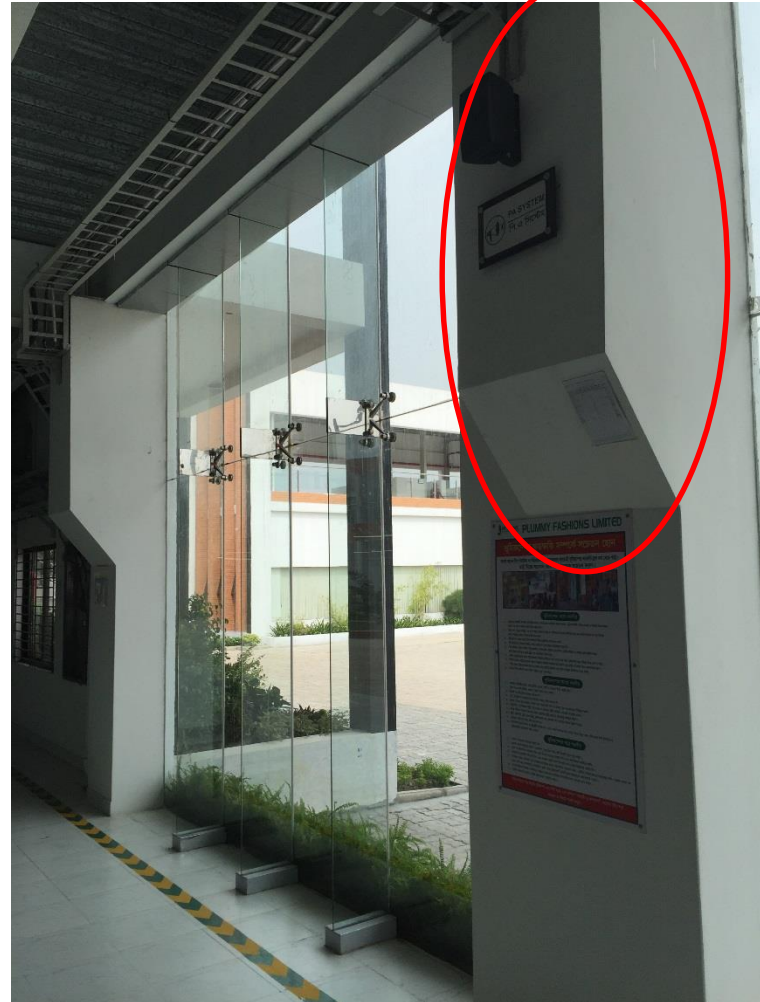
RC columns with corbels to support steel structure

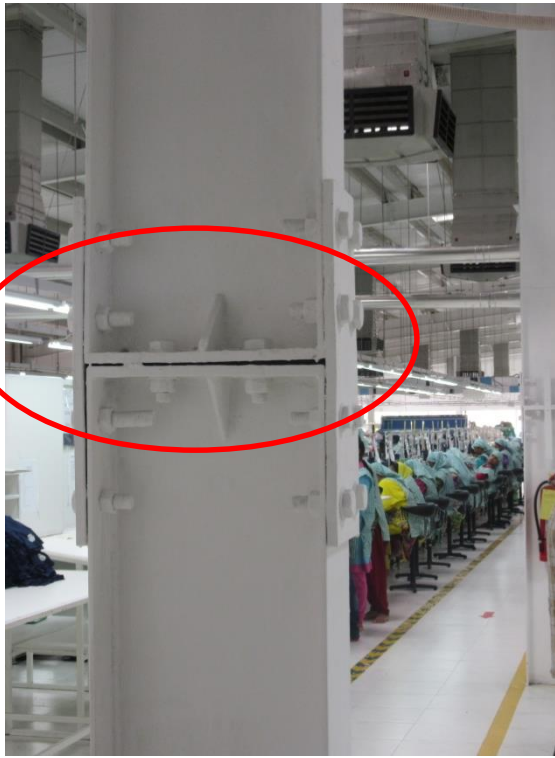
Poor connection in Production and Dining shed almost every column

| Item No. | Observation | Recommended Action Plan | Recommended Timeline |
|---|---|---|---|
| 1 | Poor construction of steel structural connections in Production, Dyeing and Dining buildings | Building Engineer to verify stability and design of frame taking into account the current state of the connections. Engineer to review the connections and the lack of stiffeners provided | 6-weeks |
| 2 | Poor construction of steel structural connections in Production, Dyeing and Dining buildings | All gaps in the steel structure connections should be repaired and missing stiffeners welded in where required. | 6-months |

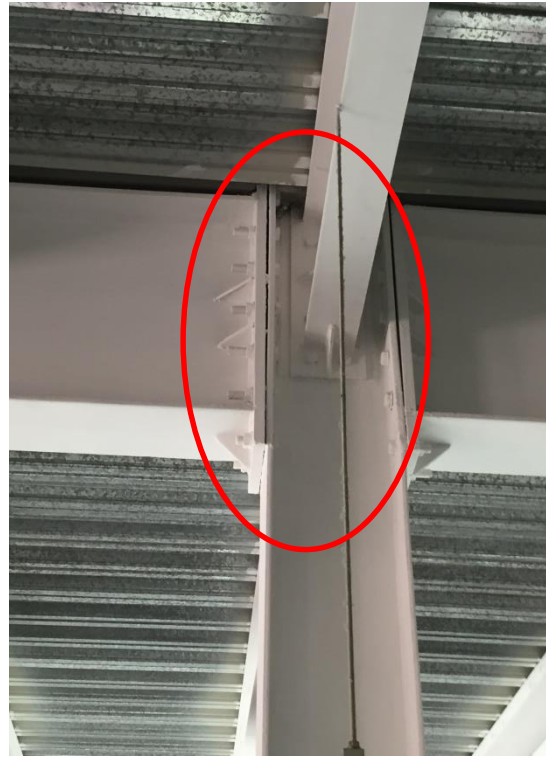
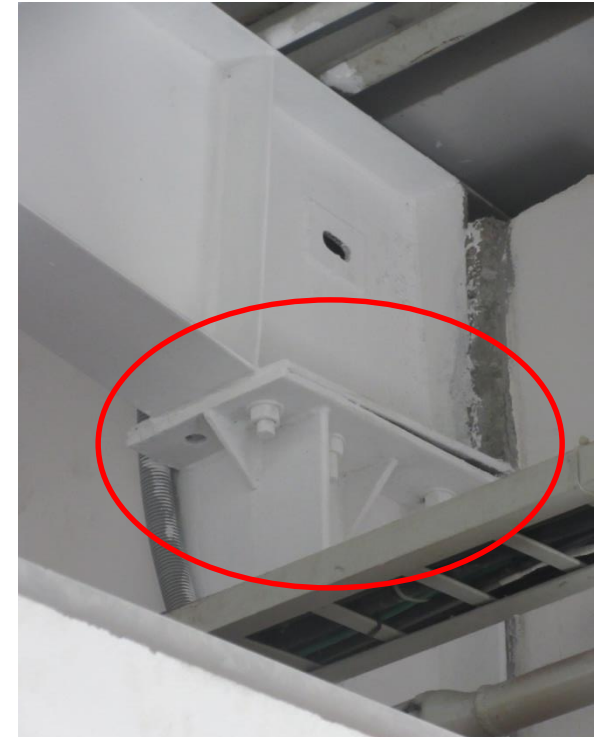
Bolt missing of connection on North side in production building also in stair side of dining building

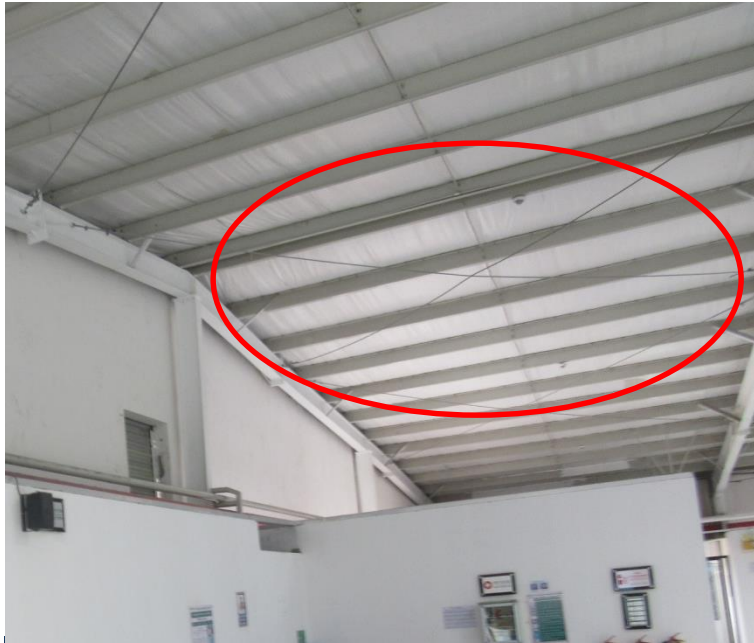
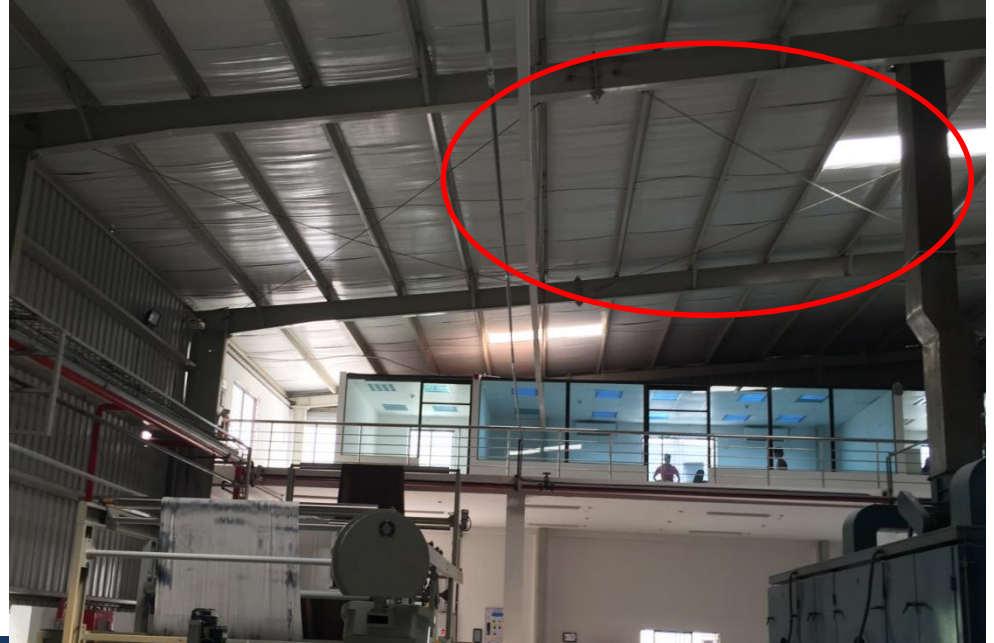
Cable bracing sagging in Production & Dyeing shed

| Item No. | Observation | Recommended Action Plan | Recommended Timeline |
|---|---|---|---|
| 3 | Loosely tightened cable bracing | All loosely tightened cable bracing should be tensioned | 6-weeks |

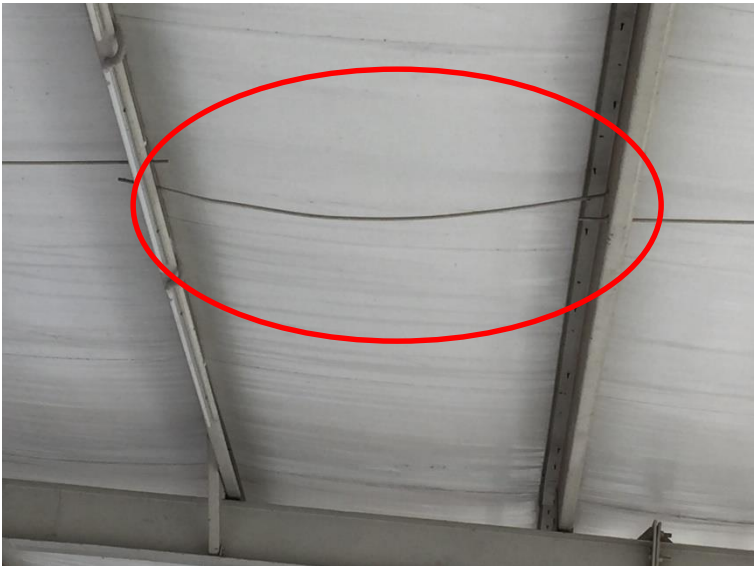
Loose  
bracing in  
Dining  
shed

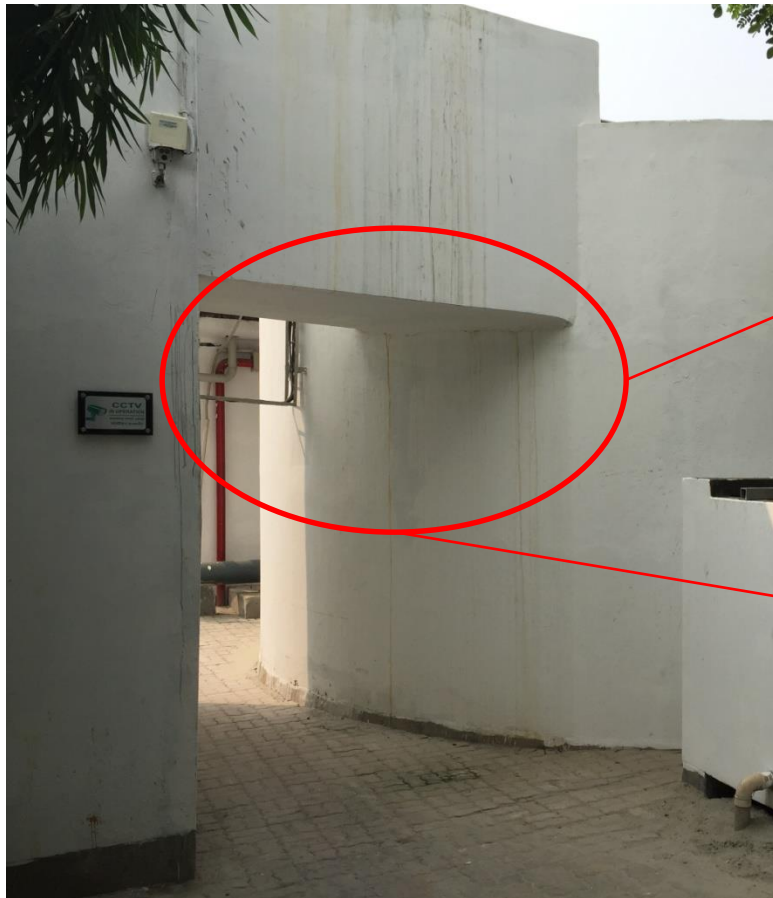
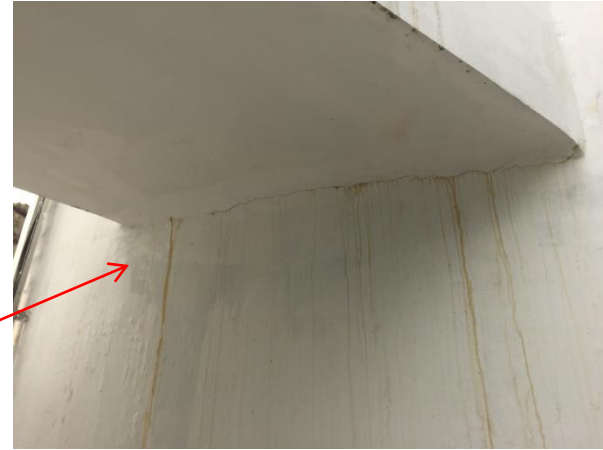
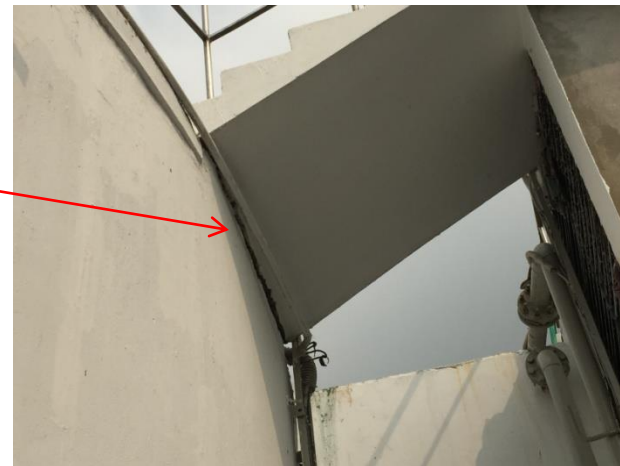
Outer side wall has water leakage

| Item No. | Observation | Recommended Action Plan | Recommended Timeline |
|---|---|---|---|
| 4 | Leakage of water from treatment plant outer wall and stairs | Building Engineer to check the cause of the water leak and repair as required. | 6-months |
