# Cosmopolitan Industries PVT Ltd (Epic) (Extension)

Khejurbagan, Baro Ashulia, Ashulia.  
(23.891528, 90.323389)  
03 September 2023

# Observations

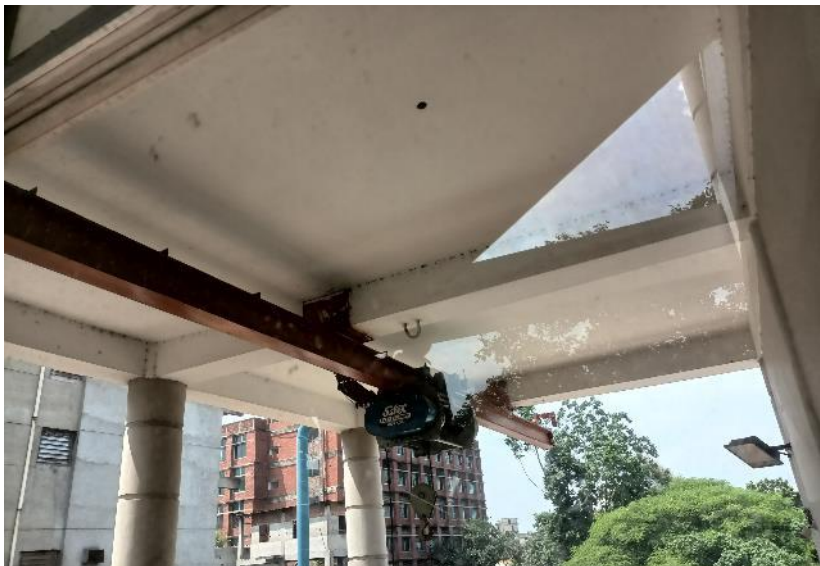
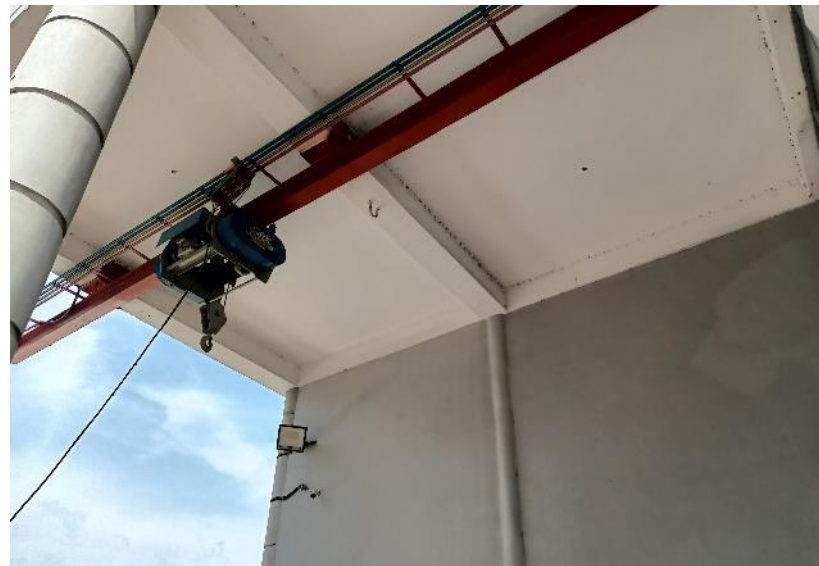
**Crane at the beam**

Overhang crane suspended from beam

Crane beam suspended from beam at 2<sup>nd</sup> floor level. Missing bot was observed in the connection. Building engineer is required to calculate the imposed loading and check the adequacy of floor/column/foundation and connection of the crane support. Also, install the missing bolt.

| Item No. | Observation | Recommended Action Plan | Recommended Timeline |
|---|---|---|---|
| 04 | Crane at the beam. (ETP Expansion) | Building engineer is required to calculate the imposed loading and check the adequacy of floor/column/foundation and connection of the crane support. | 6-weeks |

| Item No. | Observation | Recommended Action Plan | Recommended Timeline |
|---|---|---|---|
| 06 | Crane at the beam. (ETP Expansion) | Carry out strengthening work if required. | 6-months |
| 07 | Crane at the beam. (ETP Expansion) | Limit crane safe working load as required. | 6-months |

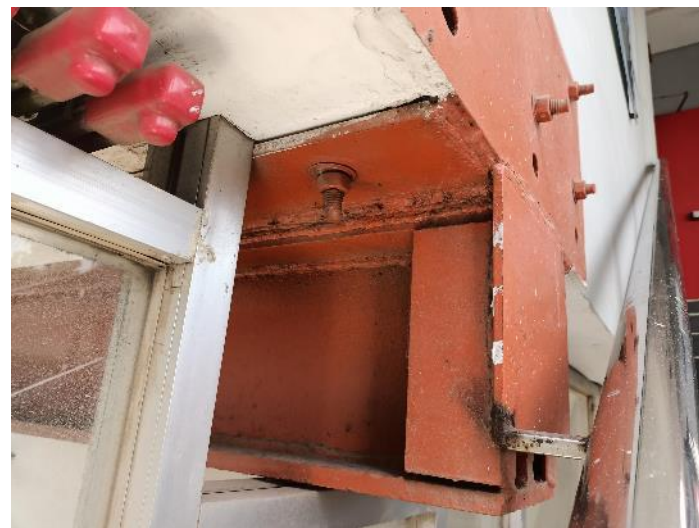
Bolt missing at connection

| Item No. | Observation | Recommended Action Plan | Recommended Timeline |
|---|---|---|---|
| 05 | Crane at the beam. (ETP Expansion) | Install the missing bolt. | 6-weeks |

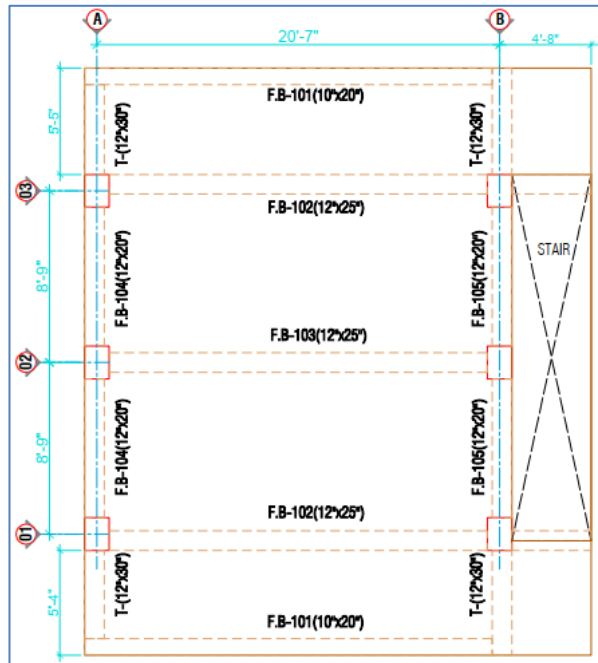
## 2-way slab consideration in Design Report

Beam Layout in as-built drawing

| Item No. | Observation | Recommended Action Plan | Recommended Timeline |
|---|---|---|---|
| 08 | Mismatch in Design Report. (Utility Storage) | Building engineer is required revise the design report as-built beam & column layout of the structure. | 6-weeks |

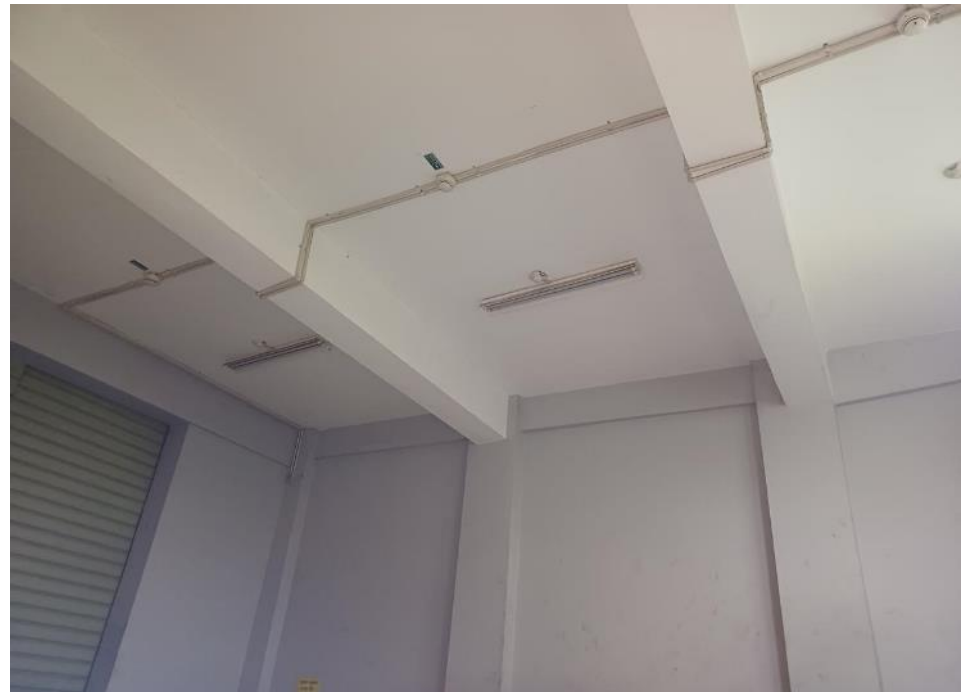
One way slab was found on-site

| Item No. | Observation | Recommended Action Plan | Recommended Timeline |
|---|---|---|---|
| 09 | Mismatch in Design Report. (Utility Storage) | Carry out remedial works if required. | 6-months |

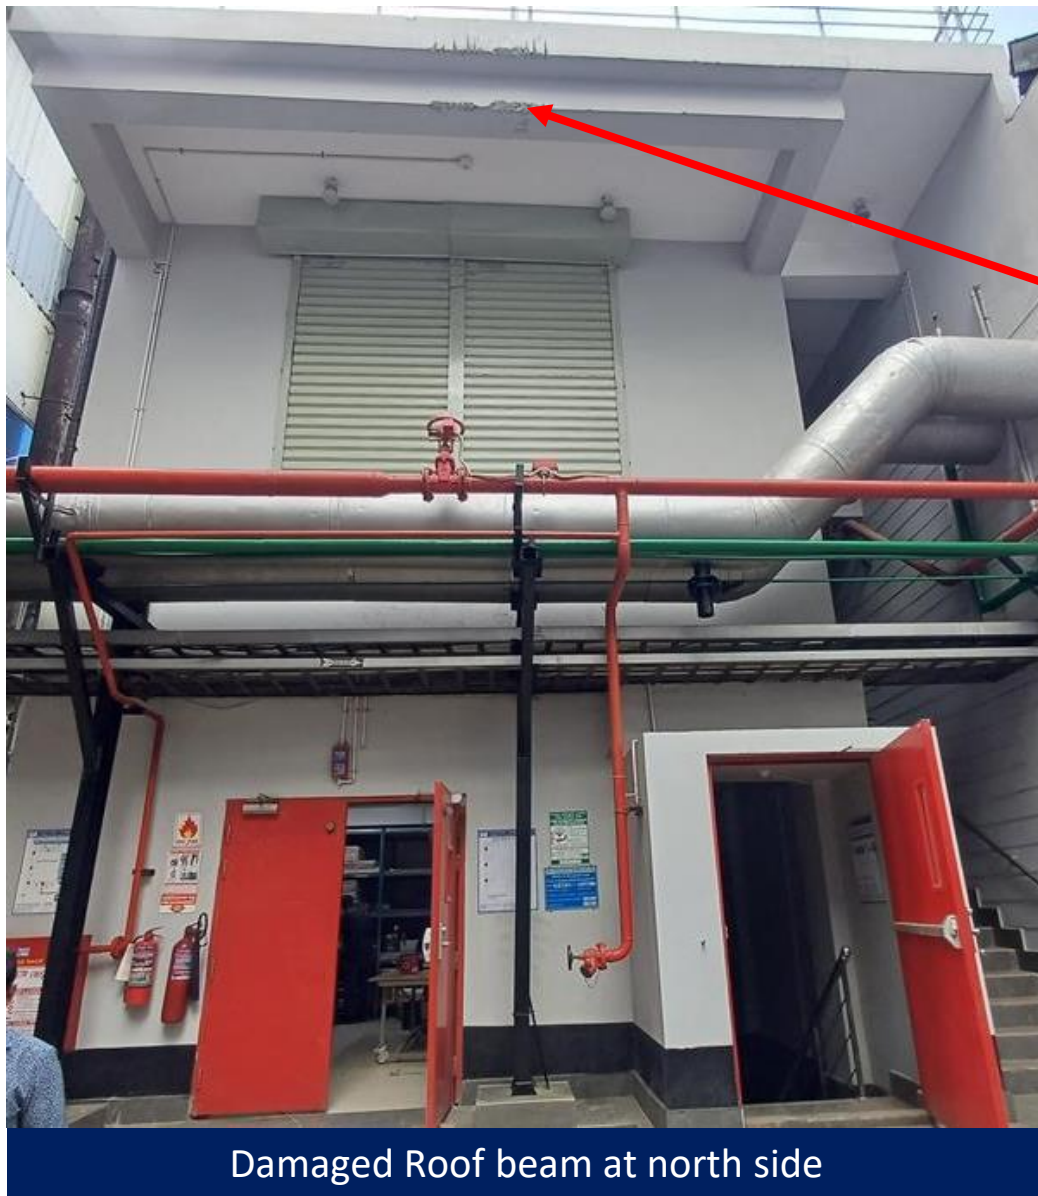
## **Damages in roof beam**

Damaged Roof beam at north side

Building Engineer is required to repair the damage area with a suitable method.

| Item No. | Observation | Recommended Action Plan | Recommended Timeline |
|---|---|---|---|
| 10 | Damages in roof beam. (Utility Storage) | Building engineer is required to repair the damage beam with a suitable method. | 6-months |

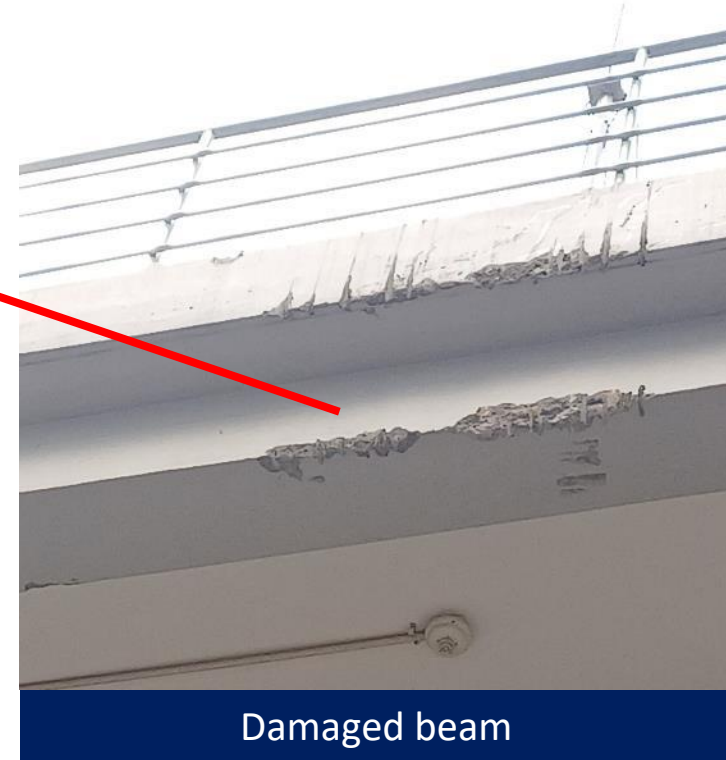
Damaged beam
