# Aleya Apparels Ltd.

6 November 2023

## 1. Building Information

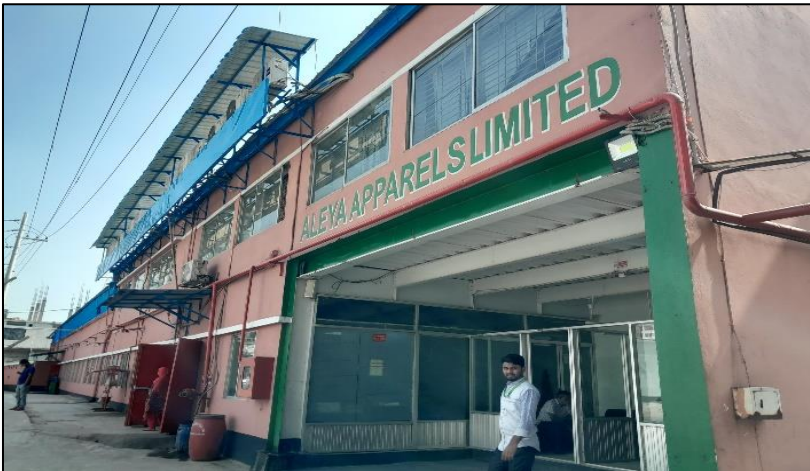
Building -1

Observation-1: Design report needs to be revised.

**Description:** A set of design reports have been prepared for Building-1 where detailed calculations were not provided for adequacy of foundation and connections. Moreover, the foundation system for 3 storied masonry structure is not clear as it is adjacent to steel column. A qualified building engineer is required to investigate the foundation system of the load bearing wall adjacent to the main building and prepare accurate as-built documents. The building engineer is required to incorporate detailed calculations in the design report. Submit the revised design report to the RSC for review.

SL No.	Observation	Action Plan	Timeline
01.	Design report needs to be revised (Building-1)	The building engineer is required to incorporate all necessary calculations in the design report and add foundation adequacy for the masonry structures. Submit the revised design report to the RSC for review.	within 6 weeks

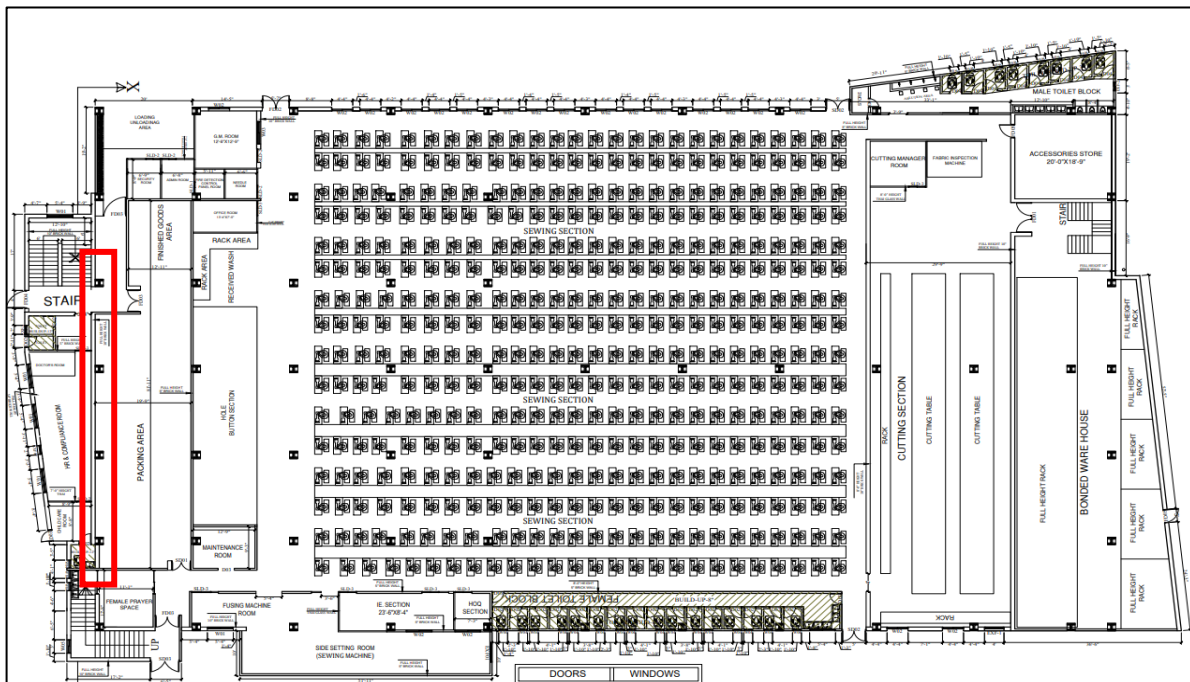
250 mm thick load bearing wall adjacent to steel column of main Building-1

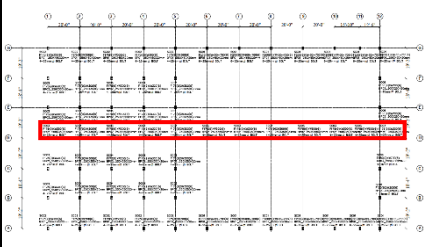
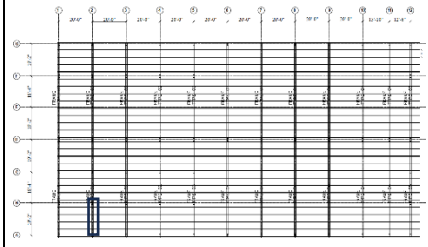
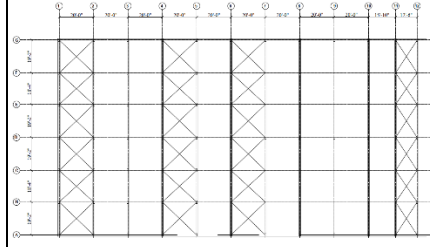
<p>Column layout plan</p>	<p>Rafter &amp; purlin Layout</p>	<p>Bracing layout</p>

**Observation-2: Mismatch in between as-built drawing and on-site condition.**

**Description:** During inspection some mismatches were found between structural drawing & on-site condition.

02.	Design report needs to be revised (Building-1)	Carry out remediation work if required.	within 6 months
03.	Mismatch in between as-built drawing and on-site condition. (Building-1)	The building engineer is required to survey the structure and produce accurate as-built structural drawings.	within 6 weeks
04	Lack of design documents for extended masonry structures. (Building-1)	The building engineer is required to prepared design report and as-built drawing for masonry structure and submit to RSC for review.	within 6 weeks

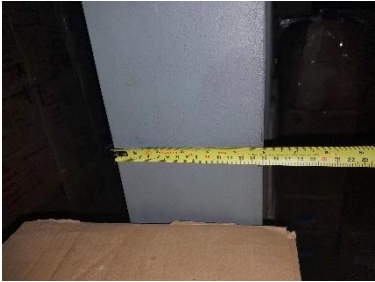
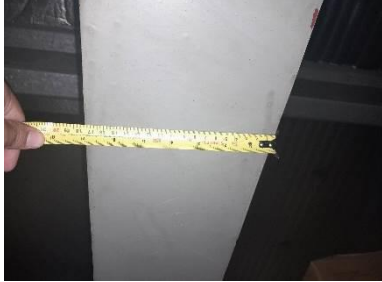
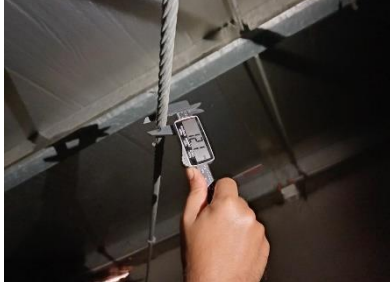
<p>On site SC3 column flange width</p>	<p>On site R1 rafter flange width</p>	<p>On site 12mm cable bracing</p>

1. The flange of SC3 steel column was found 150 instead of 175.
2. The flange of R1 steel rafter was found 175 instead of 200.
3. Cable bracing diameter was found 12 mm instead of 16 mm.

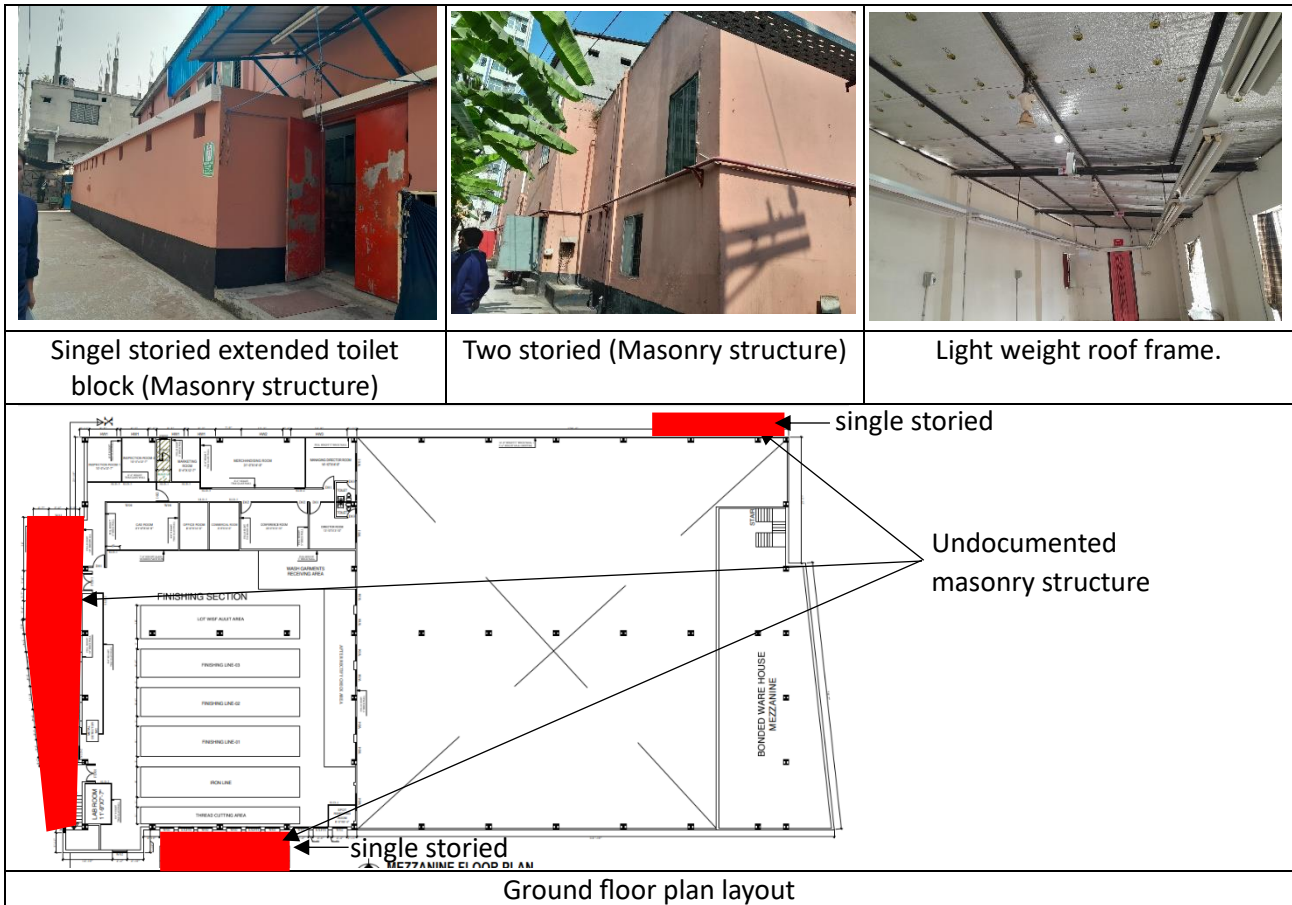
**Observation-3: Lack of design documents for extended masonry structures.**

**Description:** During inspection, undocumented extended masonry structure was found beside Building-3. No design documents were found for masonry structure. The building engineer is required to prepared design report and as-built drawing for masonry structure and submit to RSC for review.

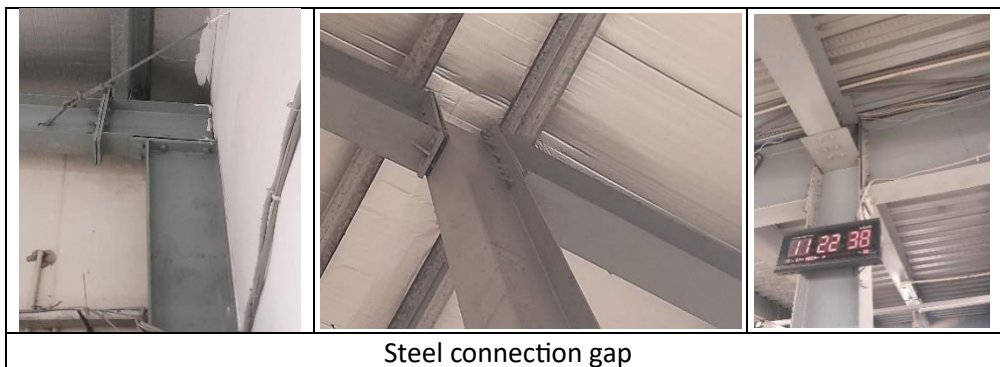
**Observation-4: Significant connection gap between steel plate.**

**Description:** Connection gap found between steel connection plates of rafter. Building engineer is required to fill all the steel connection gap with suitable method.

05.	Lack of design documents for extended masonry structures. (Building-1)	Carry out remediation work if required.	within 6 months
06.	Significant connection gap between steel plates. (Building-1)	Building engineer is required to fill all the steel connection gap with suitable method.	within 6 weeks

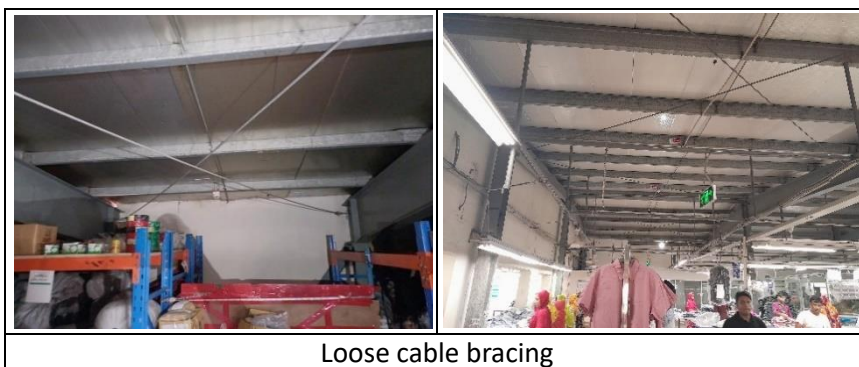
**Observation-5: Loose cable bracing.**

**Description:** During inspection, loose cable bracing was observed on the roof. Building engineer is required to identify all the loose bracing and tighten accordingly.

07.	Loose cable bracing (Building-1)	Building engineer is required to identify all the loose bracing and tighten accordingly.	within 6 months
08.	Inconsistencies in design report. (Building-3)	The building engineer is required to revise the report for actual framing system with proper justification and incorporate structural & geotechnical foundation adequacy check in the design based on soil investigation report. Submit the revised design report to the RSC for review.	within 6 weeks

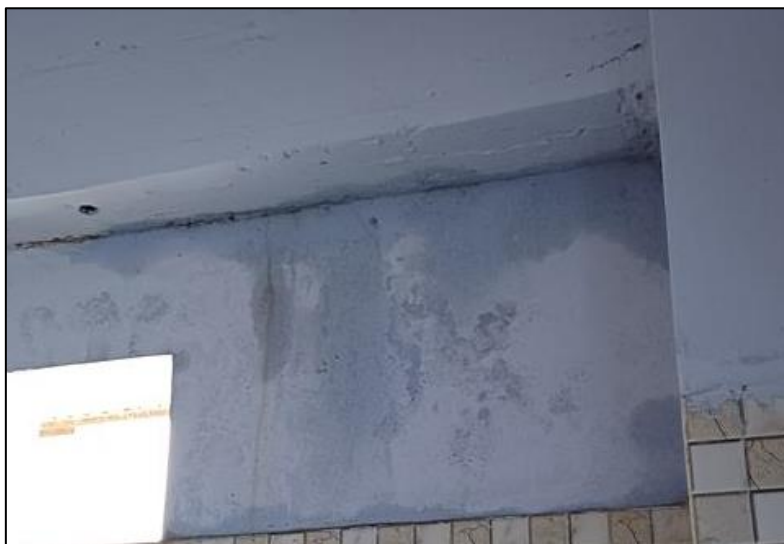
Dampness in periphery wall

**Description:** During inspection, dampness was observed on the periphery wall. Building engineer is required to repair dampness with suitable method.

10.	Inconsistencies in design report. (Building-3)	Carry out remediation work if required.	within 6 months
11.	Dampness in periphery wall. (Building-3)	Building engineer is required to repair dampness with suitable method.	within 6 weeks

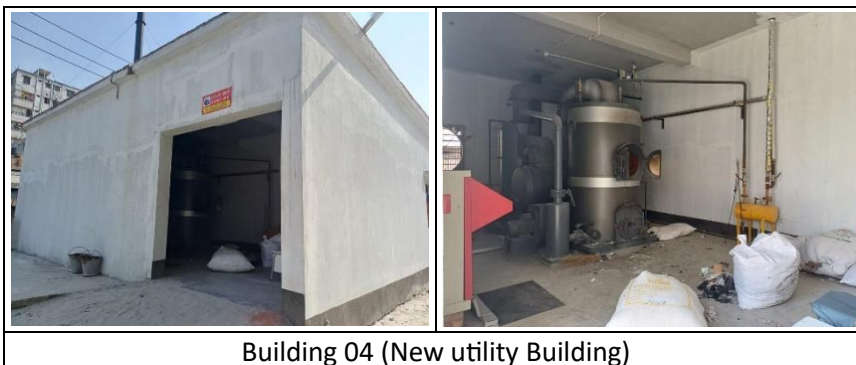
Building 04 (New utility Building)

**Observation-8: Lack of design documents for Building-4 (New utility Building).**

**Description:** Building-4 (New Utility Building) is a single storied masonry structure with large span. No design documents were found for this building. The building engineer is required to prepared design documents including as-built drawing & design report for masonry structure. Submit the design documents to the RSC for review.

12.	Lack of design documents for Building-4 (New Utility Building).	The building engineer is required to prepared design report and as-built drawing for masonry structure and submit to RSC for review.	within 6 weeks
