# Designer Washing & Dyeing Limited

Gohailbari, Shimulia, Ashulia, Saver, Dhaka-1345.

19 November 2023

## 1. Building Information

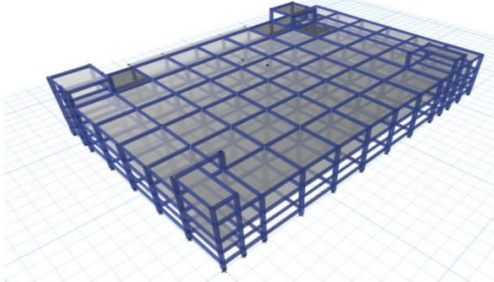
Figure 2.3D OF THE ETABS MODEL

### Observation-1: Inconsistencies in design report. (Washing building).

**Description:** A Design Report was provided for this structure where the intermediate moment resisting frame (IMRF, R=8) was considered without any justification. Also, the consideration of soil bearing capacity doesn't match with the soil test report. Moreover, the number of concrete cylinder test reports found on site doesn't comply with the frequency of testing requirements as per BNBC (Part VI, Chapter 5, 5.12.2), but in the design report, design strength 4500 psi considered for column and 3000 psi consider for beam & slab. The building engineer is required to revise the design report for the actual framing system with proper justification and confirm the design strength of in situ concrete by taking 100 mm diameter core (min 4 nos) from lower tier columns and revise foundation adequacy calculation. Submit the revised design report to the RSC for review.

| SL No. | Observation | Action Plan | Timeline |
|---|---|---|---|
| 01. | Inconsistencies in design report. (Washing building). | The building engineer is required to revise the design report based on in-situ material strength, actual soil bearing capacity & software-based analysis model and submit the documents to the RSC for review. | within 6 weeks |
| 02. | Inconsistencies in design report. (Washing building). | Building engineer is required to take 4 nos of concrete core from the lower-tier columns to confirm the design strength of the concrete. | within 6 weeks |
| 03. | Inconsistencies in design report. (Washing building). | Carry out suggested remedial works if required. | within 6 months |

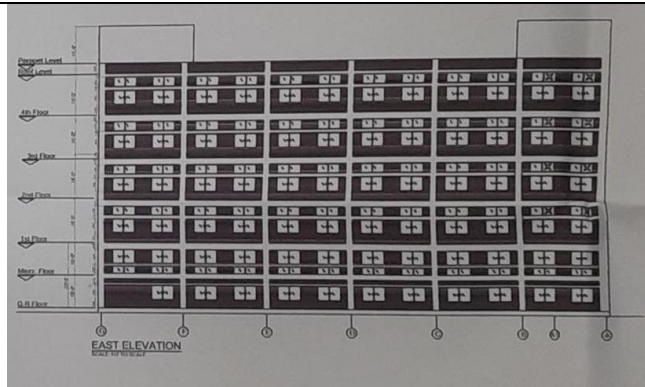
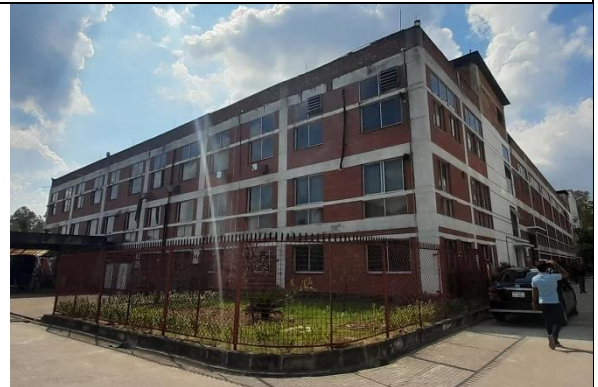
**Observation 2:** Column and foundation stress above normal for possible vertical extension.  
(Washing Building)

**Description:** This building is permitted for 5 (G+M+4) storied from PWD, Dhaka (Local Authority). Currently, the building is two storied. Proposed drawings were available during the inspection. Considering the proposed Five-storied building and minimum concrete strength, the stress in the column exceeds the normal design limit. However, the building engineer is required to carry out a Detailed Engineering Assessment (DEA) considering the BNBC provision and complete necessary remedial works prior to the commencement of further construction.

| SL No. | Observation | Action Plan | Timeline |
|---|---|---|---|
| 04. | Possible vertical extension. (Washing Building) | In case of extension, the building engineer is required to carry out a Detailed Engineering Assessment (DEA) considering the BNBC provision and complete necessary remedial works prior to the commencement of any further construction. | within 6 months |

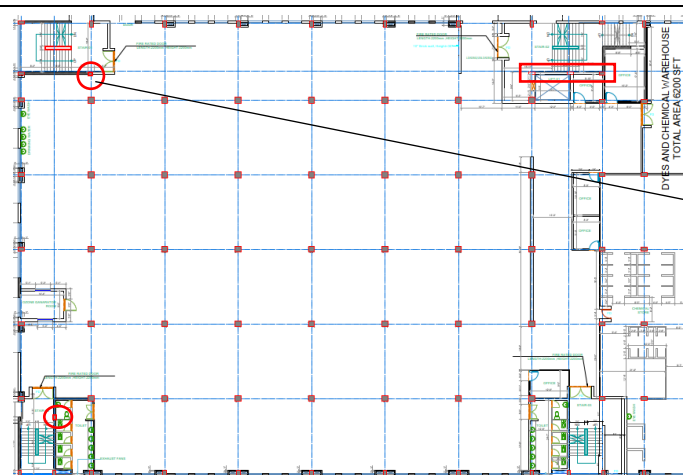
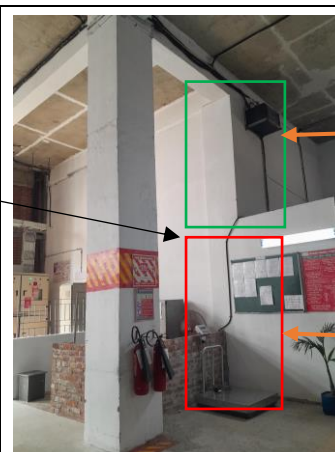
**Observation-3:** Mismatch in as-built drawing. (Washing Building)

Brick column

RC column up to 1<sup>st</sup> landing of stair.

Marked ground-floor columns were found up to 1<sup>st</sup> landing of stairs.

Onsite condition.

**Description:** During the inspection, some mismatch was found in the as-built drawing. Individual column layout was missing in the as-built drawing. There is a variation in column layout between the ground floor and the rest of the floors. The building engineer is required to survey the full structure and prepare accurate as-built drawings including floor wise column layout.

| SL No. | Observation | Action Plan | Timeline |
|---|---|---|---|
| 05. | Mismatch in the as-built drawing. (Washing Building) | The building engineer is required to survey the full structure and prepare accurate as-built drawings. | within 6 weeks |

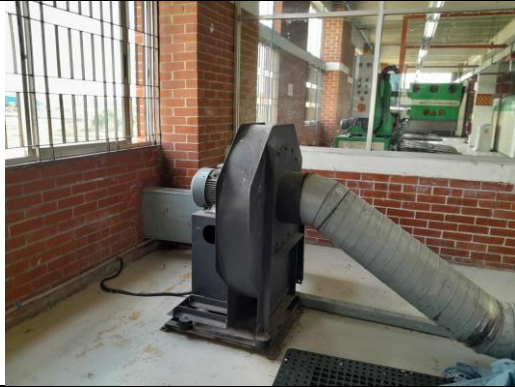
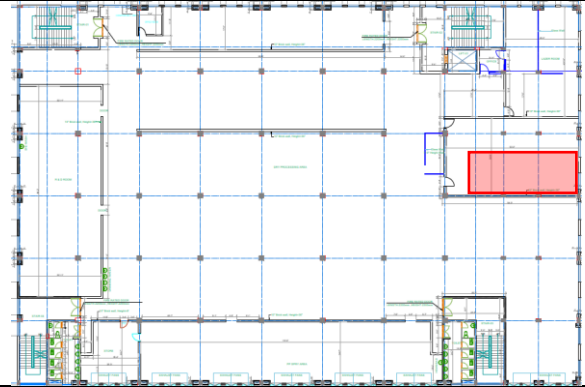
**Observation-4:** Vibration observed on the floor. (Washing Building).

**Description:** During the inspection, significant vibration was observed on the 1st floor marked in the architectural layout. The building engineer is required to investigate the reason for the vibration and apply suitable damper material to reduce the vibration.

| SL No. | Observation | Action Plan | Timeline |
|---|---|---|---|
| 06. | Vibration observed on the floor. (Washing Building). | The building engineer is required to investigate the reason for the vibration and apply suitable damper material to reduce the vibration. | within 6 months |

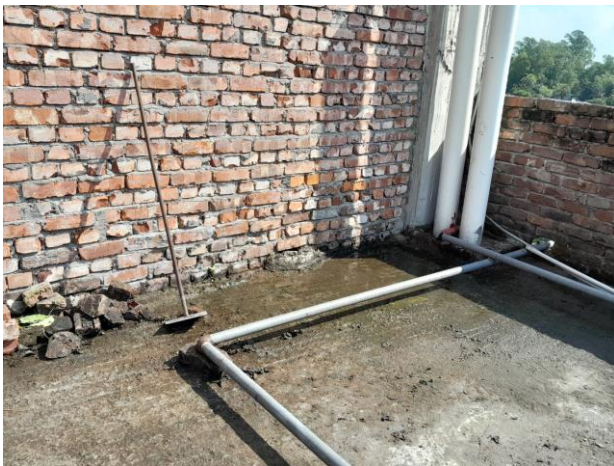
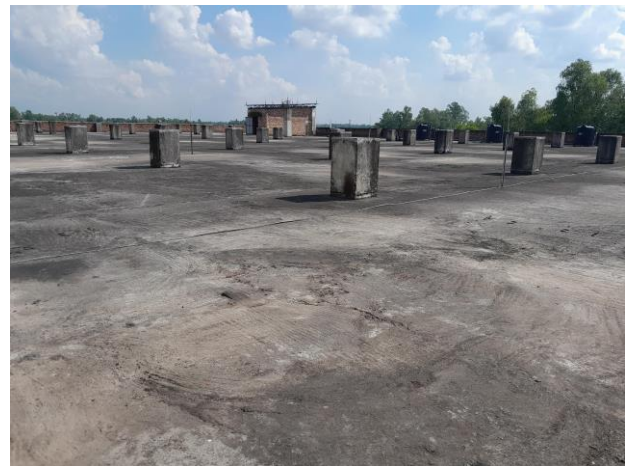
**Observation-5:** Water stagnant and lack of drainage system on the roof. (Washing Building)

**Description:** During the inspection, water stagnant was found on the roof, also no drainage system was provided on the roof. The building engineer is required to improve the water drainage system at the roof.

| SL No. | Observation | Action Plan | Timeline |
|---|---|---|---|
| 07. | Water stagnant and lack of drainage system on the roof. (Washing Building). | The building engineer is required to improve the water drainage system on the roof. | within 6 months |

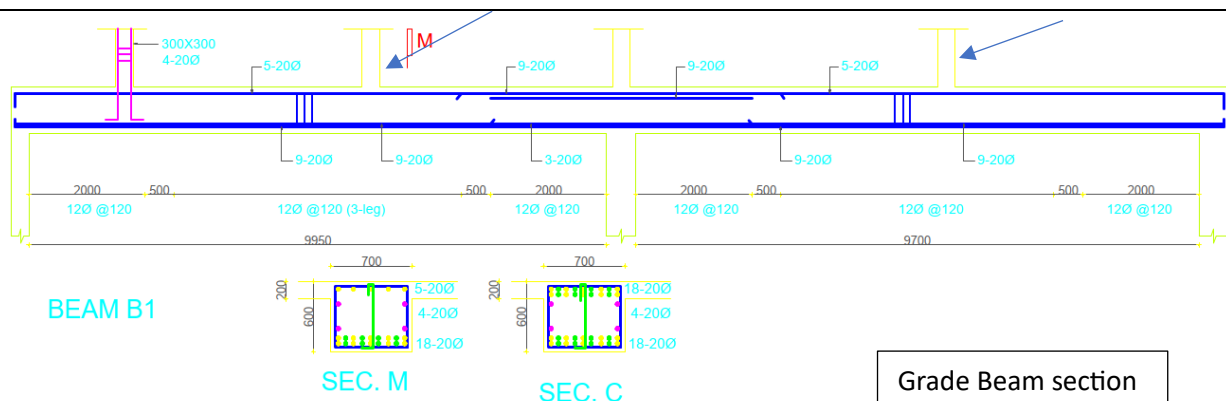
**Observation-6:** Shear & bending capacity check required for grade beams. (ETP)

**Description:** Columns are constructed from the grade beam. Building engineer is required to check the shear & bending capacity of the grade beams for the additional load from columns.

| SL No. | Observation | Action Plan | Timeline |
|---|---|---|---|
| 08. | Shear & bending check is required for grade beams. (ETP) | The building engineer is required to check the shear & bending capacity of the grade beams for the additional load from columns. | within 6 weeks |
| 09. | Shear & bending check is required for grade beams. (ETP) | Carry out remedial works if necessary. | within 6 months |

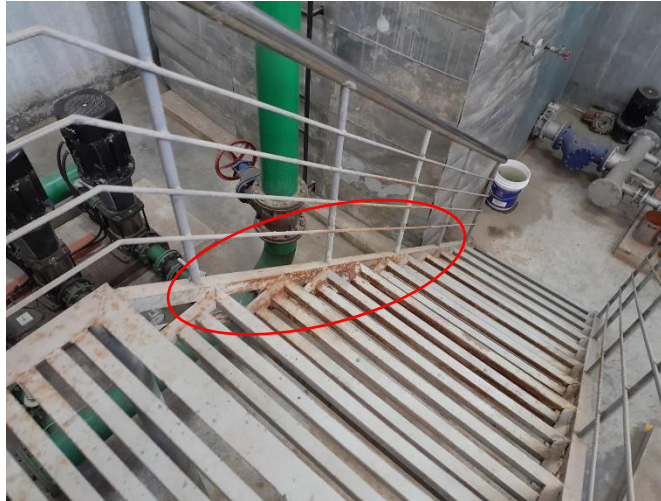
**Observation-6:** Corrosion in steel member at steel stair. (WTP)

**Description:** During inspection, corrosion was observed on the steel stair. The building engineer is required to remove corrosion and provide anti-corrosive coating.

| SL No. | Observation | Action Plan | Timeline |
|---|---|---|---|
| 10. | Corrosion in steel member at steel stair. (WTP) | The building engineer is required to remove corrosion and provide anti-corrosive coating. | within 6 months |
