# Viyellatex Limited (Extension)

297 khairtul, Tongi, Gazipur.  
(23.9198555441, 90.387490388)  
7 November 2023

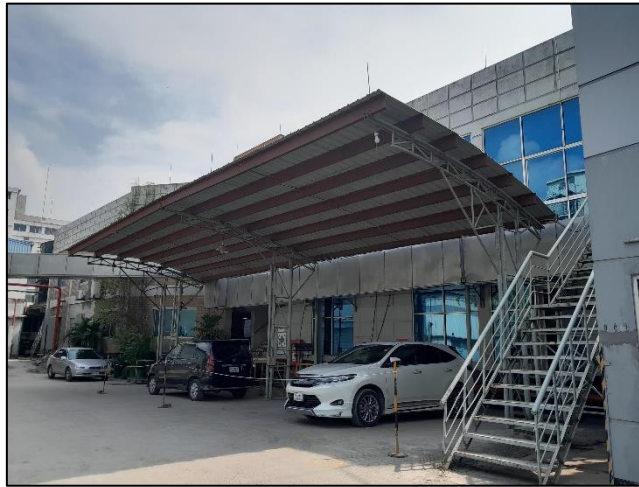
**Observation-1:** Lack of design report. (Building 3 (HR Building)).

**Description:** As per BNBC, every building or structure designed shall have its design documents prepared in accordance with the provision of Section 1.9.1. The design documents shall include as built drawings and a design report which shall be prepared in compliance with section 1.9.1, part-6 of BNBC.

During inspection, the design report was not available on site. The building engineer is required to prepare a design report based on in-situ material strength & software-based analysis and submit it to RSC for review.

| Observation | Action Plan | Timeline |
|---|---|---|
| Lack of design report. (Building 3 (HR Building)). | The building engineer is required to prepare a design report based on in-situ material strength & software-based analysis and submit it to RSC for review. | within 6 weeks |

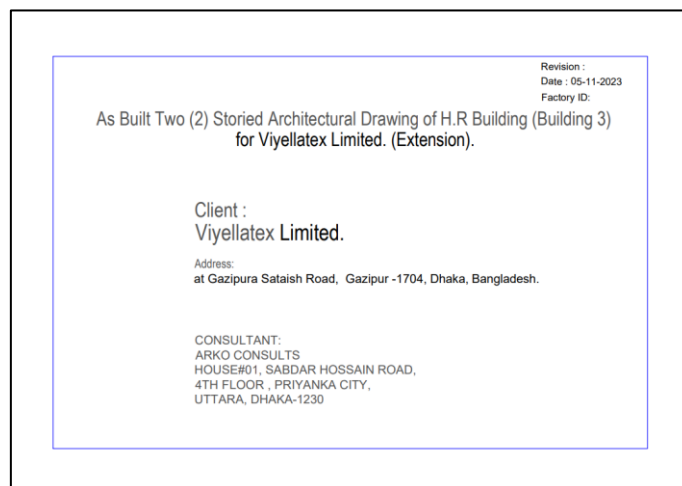
**Observation-2:** Lack of geotechnical investigation report. (Building-3 (HR Building)).

**Description:** The geotechnical investigation report is not available for building 3 (HR Building). A geotechnical engineer is required to prepare a Geotechnical investigation report.

| Observation | Action Plan | Timeline |
|---|---|---|
| Lack of geotechnical investigation report. (Building-3 (HR Building)). | A geotechnical engineer is required to prepare a Geotechnical investigation report. | within 6 months |

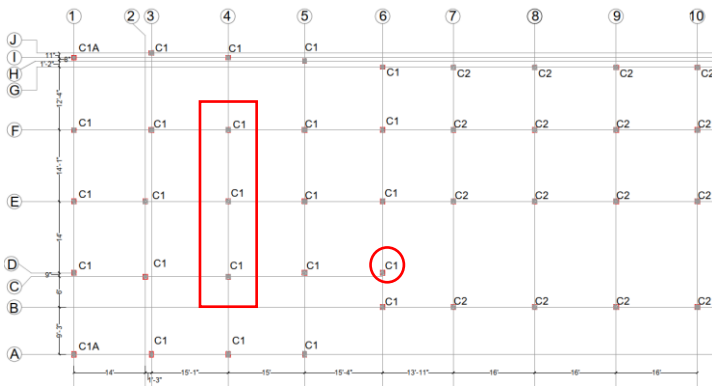
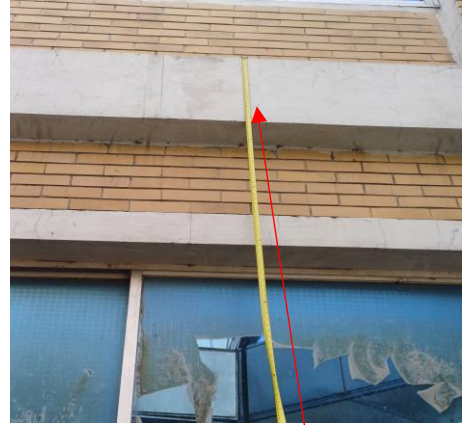
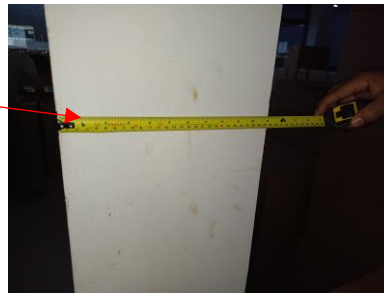
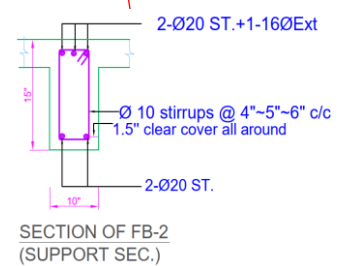
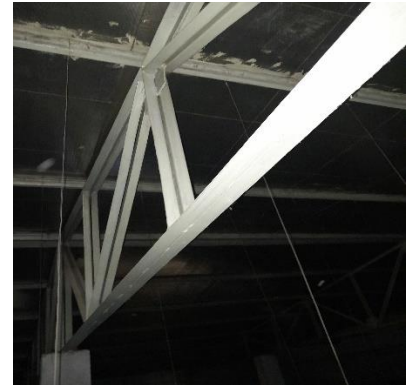
**Observation-3: Discrepancies in as-built drawings (Building-3 (HR Building)).**

**Description:** During the inspection, mismatches were found between the onsite condition and the as-built drawing.

- Marked C1 column size was found 250x300 mm instead of 300x300 mm.
- FB2 was found 250x450 mm instead of 250x375 mm.
- Diagonal truss member was found double angle L-50x50x4 instead of single angle.

However, the building engineer is required to survey the full structure and produce accurate as-built drawings.

| Observation | Action Plan | Timeline |
|---|---|---|
| Discrepancies in as-built drawings (Building-3 (HR Building)). | The building engineer is required to survey the full structure and produce accurate as-built drawings. | within 6 weeks |

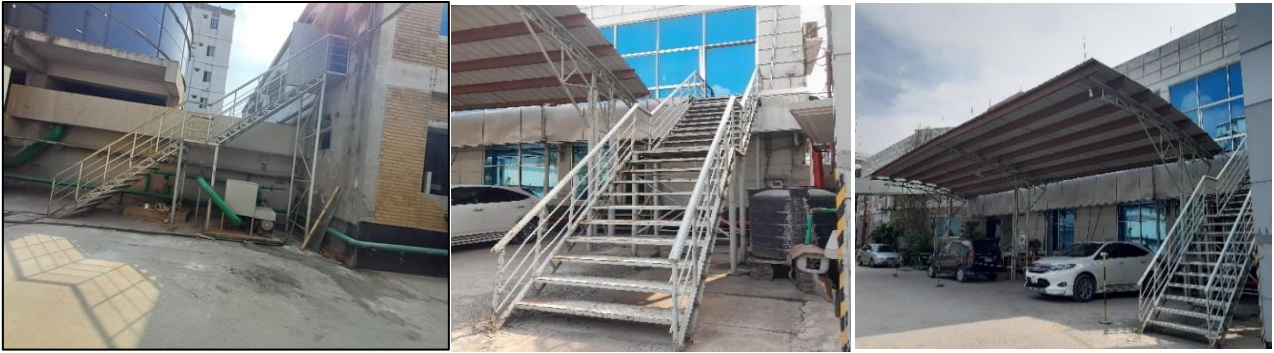
**Observation 4:** Undocumented structures. (Building-3 (HR Building)).

**Description:** During the inspection, an undocumented canopy, and external steel stairs were found adjacent to Building 3. Design documents were not available for the canopy and stair. The building engineer is required to prepare design documents with as-built drawings reflecting the as-constructed condition.

| Observation | Action Plan | Timeline |
|---|---|---|
| Undocumented structures. (Building-3 (HR Building)). | The building engineer is required to prepare design documents with as-built drawings reflecting the as-constructed condition. | within 6 weeks |

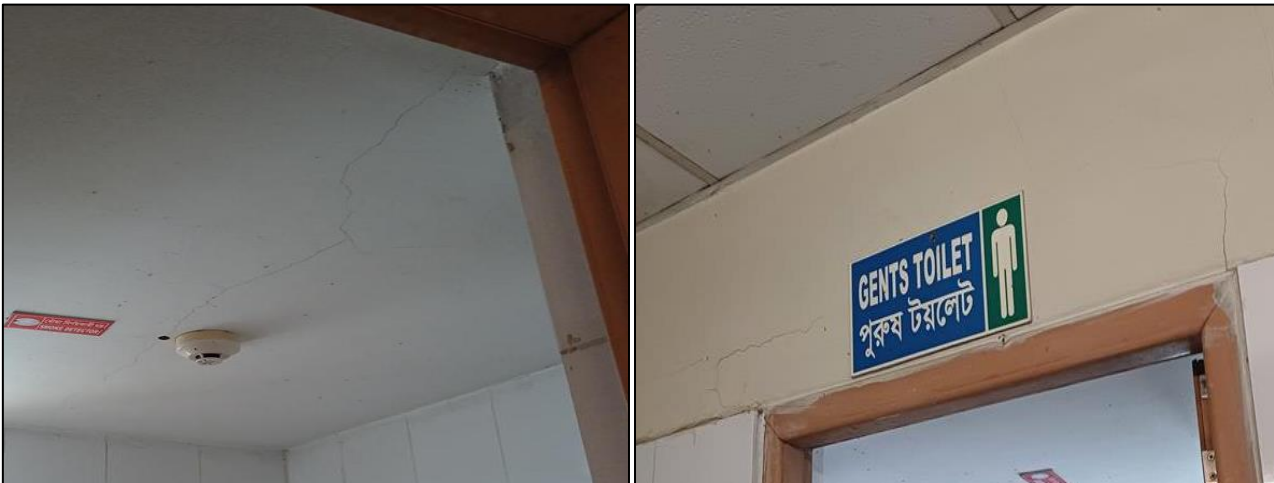
**Observation 5:** Crack found on false slab and wall in the toilet area. (Building-3 (HR Building)).

**Description:** Crack was found on false slab and wall in the toilet area. The building engineer is required to repair the crack as per the suggestion of the building engineer.

| Observation | Action Plan | Timeline |
|---|---|---|
| Crack was found on the false slab and wall in the toilet area. (Building-3 (HR Building)). | The factory is required to repair the crack as per the suggestion of the building engineer. | within 6 weeks |

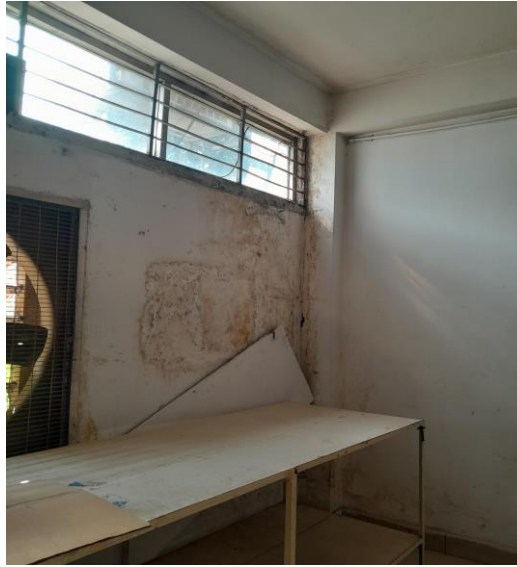
**Observation-6:** Dampness of brick wall (Building-3 (HR Building)).

**Description:** Dampness found on brick wall of building 3. The building engineer is required to identify the source of dampness, and take remedial measures to repair the wall accordingly.

| Observation | Action Plan | Timeline |
|---|---|---|
| Dampness of brick wall (Building-3 (HR Building)). | The building engineer is required to identify the source of dampness and take remedial measures to repair the wall accordingly. | within 6 weeks |

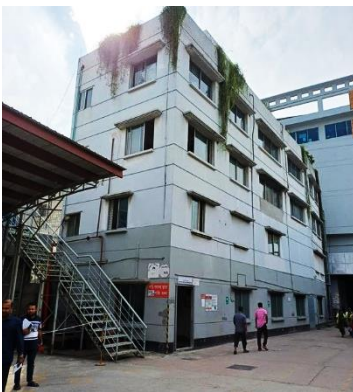
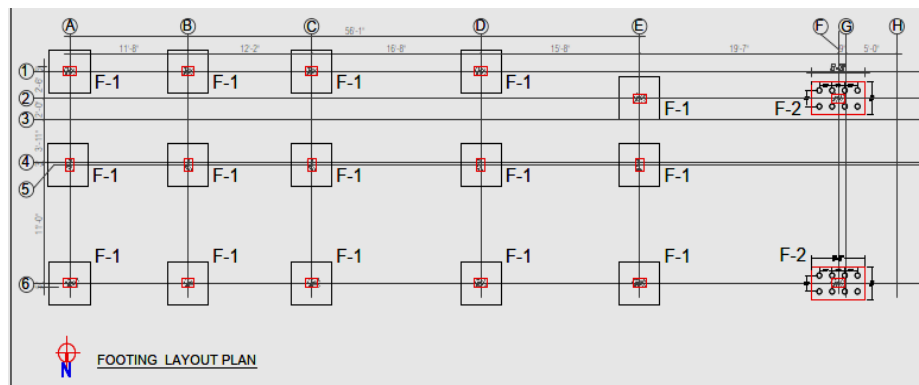
**Observation-7:** Lack of design documents (Building 04 – Lab Building).

**Description:** Sub-soil investigation report, material strength test report, and details of footing (No dimension was mentioned in the footing layout) were not available on site. The building engineer is required to carry out an Engineering Assessment (EA) based on in-situ material strength and submit it to RSC for review.

| Observation | Action Plan | Timeline |
|---|---|---|
| Lack of design documents (Building 04 – Lab Building). | The building engineer is required to carry out an Engineering Assessment (EA) based on in-situ material strength and submit it to RSC for review. | within 6 weeks |

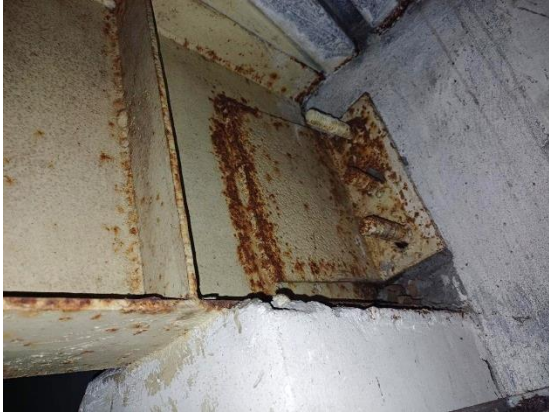
Corrosion on the steel beam

**Description:** Corrosion was found on several steel members. The building engineer is required to apply rust-proof paint on the corroded member.

| Observation | Action Plan | Timeline |
|---|---|---|
| Corrosion on steel member (Building 04 – Lab Building). | The building engineer is required to apply rust-proof paint on the corroded member. | within 6 weeks |

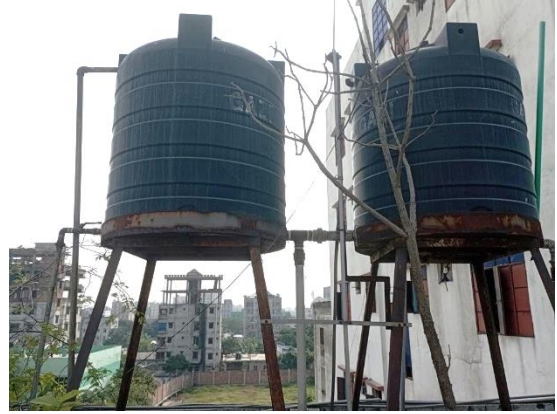
Corrosion on the water tank supporting structure

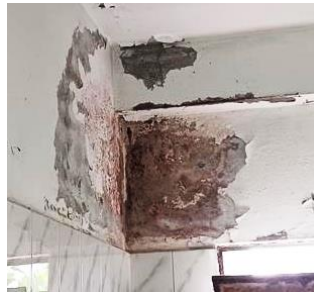
**Observation-9:** Dampness of brick wall (Building 04 – Lab Building).

**Description:** Dampness found on the brick wall of the store building. The factory is required to identify the source of dampness, and take remedial measures to repair the wall accordingly.

| Observation | Action Plan | Timeline |
|---|---|---|
| Dampness of brick wall (Building 04 – Lab Building). | The building engineer is required to identify the source of dampness and take remedial measures to repair the wall accordingly. | within 6 weeks |

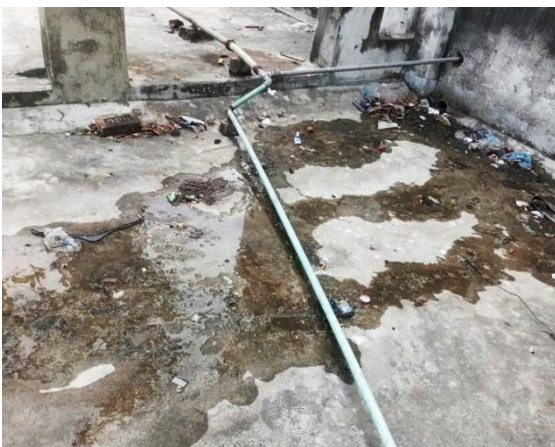
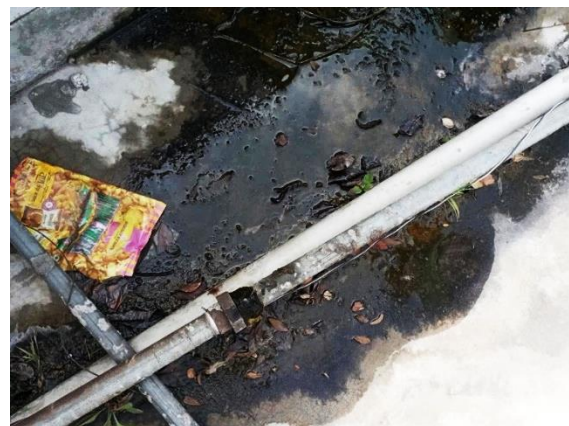
**Observation-10:** Water clogging on the roof. (Building 04 – Lab Building).

**Description:** Water clogging was observed on the roof of the building. The building engineer is required to develop a proper drainage system on the roof with an adequate slope to resist water ingress.

| Observation | Action Plan | Timeline |
|---|---|---|
| Water clogging the roof. (Building 04 – Lab Building). | The building engineer is required to develop a proper drainage system on the roof with an adequate slope to resist water ingress. | within 6 weeks |

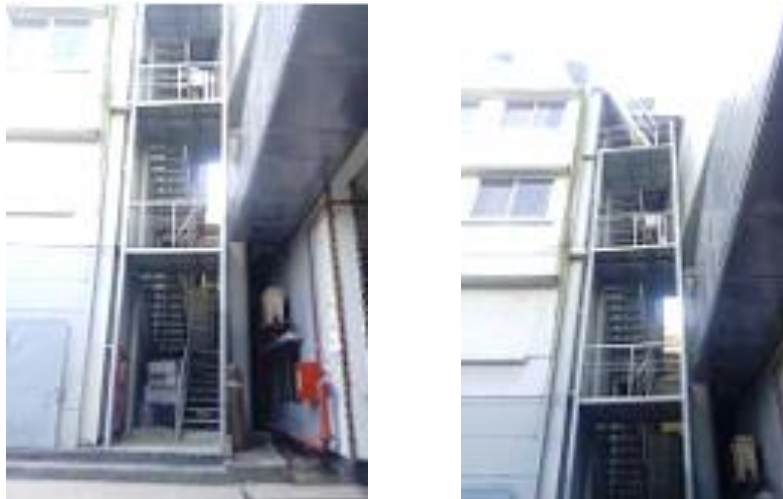
**Observation-11:** Lack of lateral stability of steel stair (Building 04 – Lab Building).

**Description:** No bracing was observed. The building engineer is required to check lateral stability as part of EA and submit it to RSC for review.

| Lack of lateral stability of steel stair (Building 04 – Lab Building). | The building engineer is required to check lateral stability as part of EA and submit it to RSC for review. | within 6 weeks |

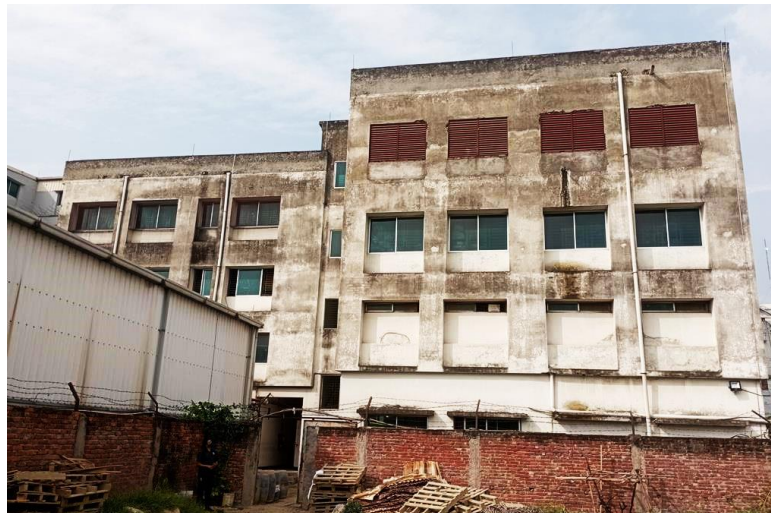
**Observation-12:** Lack of design report (Building 05 - Chemical Building).

**Description:** As per BNBC, every building or structure designed shall have its design documents prepared by the provision of Section 1.9.1. During the inspection, the design report and soil test report were not available on site.

The building engineer is required to prepare a set of design documents including as-built drawings, live load plan and a design report based on in-situ material strength and software-based analysis which shall be prepared in compliance with section 1.9.1, part-6 of BNBC.

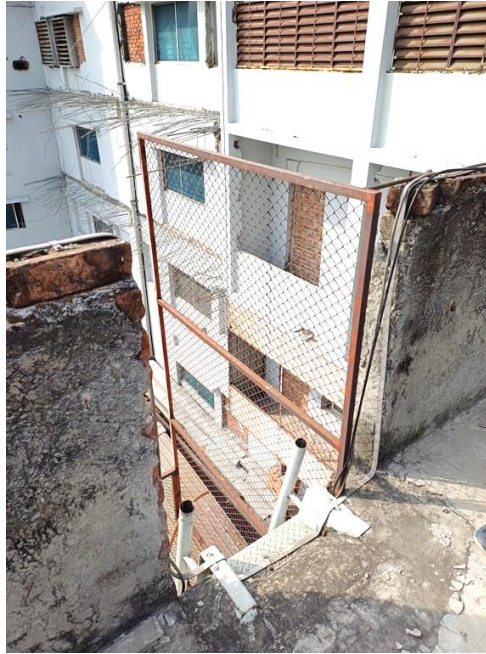
**Observation 13:** Falling hazard at roof level (Building 05 – Chemical Building).

**Description:** Falling hazard was observed on the roof. The building engineer is required to provide a barrier to avoid falling hazards.

| Falling hazard at roof level (Building 05 – Chemical Building). | The building engineer is required to provide a barrier to avoid falling hazards. | within 6 weeks |

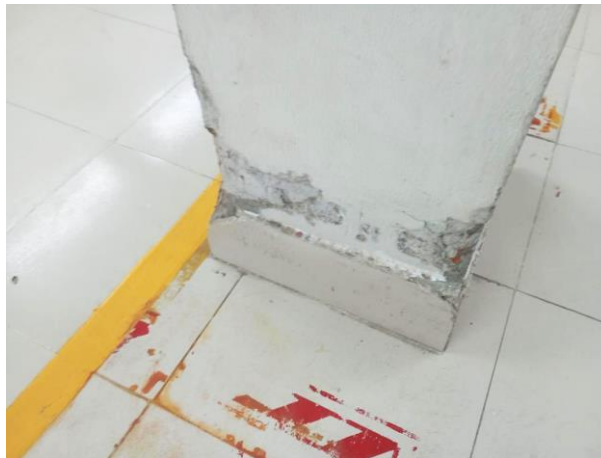
**Observation-14:** Damage column due to trolley impact (Building 05 – Chemical Building).

**Description:** Damage column was found due to trolley impact. The building engineer is required to repair the damaged column and provide a barrier to avoid trolley impact.

| Damage column due to trolley impact (Building 05 – Chemical Building). | The building engineer is required to repair the damaged column and provide a barrier to avoid trolley impact. | within 6 weeks |

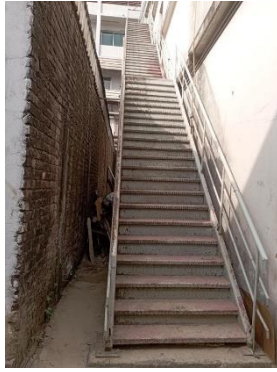
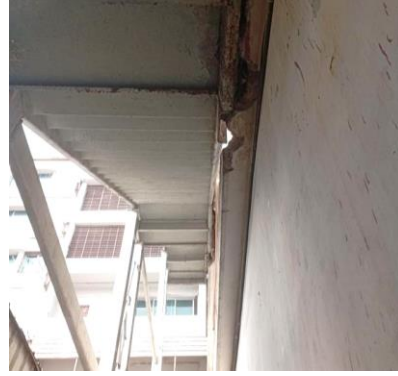
**Observation-15:** Non-engineered steel stair (Building 05 – Chemical Building).

**Description:** Non-engineered steel stair was found on the west side of the building. The building engineer is required to check the member, connection & stability system of the structure and suggest proper remediation accordingly.

| Non-engineered steel stair (Building 05 – Chemical Building). | The building engineer is required to check the member, connection & stability system of the structure and suggest proper remediation accordingly. | within 6 weeks |

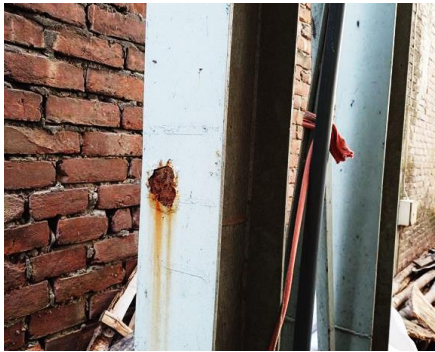
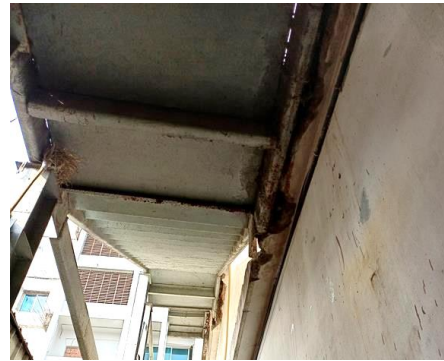
**Observation-16:** Corrosion on steel stair (Building 05 – Chemical Building).

**Description:** Corrosion was found in several steel members. The building engineer is required to apply rust-proof paint on the corroded member.

| Corrosion on steel stair (Building 05 – Chemical Building). | The building engineer is required to apply rust-proof paint on the corroded member. | within 6 weeks |

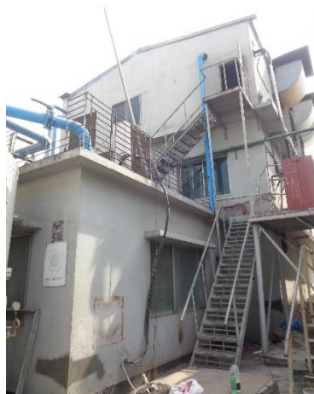
**Observation-17:** Absence of design report (Building-6: Utility-3).

**Description:** As per BNBC, every building or structure designed shall have its design documents prepared by the provision of Section 1.9.1. The design documents shall include as-built drawings and a design report which shall be prepared in compliance with section 1.9.1, part 6 of BNBC.

During inspection, the design report was not available on site. The building engineer is required to prepare a design report in compliance with section 1.9.1, part 6 of BNBC.

| Absence of design report (Building-6: Utility-3) | The building engineer is required to prepare a design report in compliance with section 1.9.1, part 6 of BNBC. | within 6 weeks |

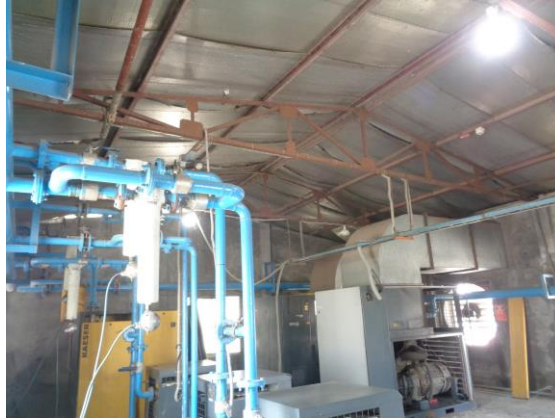
**Observation-18:** Lack of lateral stability (Building-6: Utility-3).

**Description:** Lateral stability is provided through truss frame action only, but no roof/wall bracing/compression member is provided therefore there is no obvious lateral stability system in this shed. The building engineer is required to check the lateral stability of the shed.

| Lack of lateral stability (Building-6: Utility-3). | The building engineer is required to check the lateral stability of the shed. | within 6 weeks |

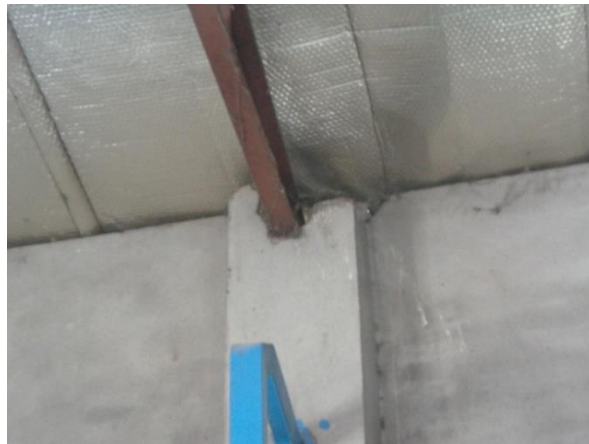
**Observation-19:** Apparently inadequate connection (Building-6: Utility-3).

**Description:** The steel truss frame is inserted into the brick wall poorly without any proper connection. The building engineer is required to check the connection adequacy of the steel members.

| Apparently inadequate connection (Building-6: Utility-3). | The building engineer is required to check the connection adequacy of the steel members. | within 6 weeks |

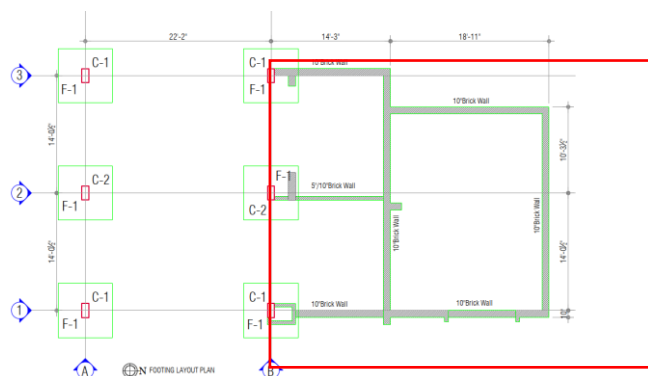
**Observation-20:** Missing information in as-built drawing (Building-6: Utility-3).

Foundation details not provided for masonry part.

**Description:** Foundation information and details are only provided for the RC part. No foundation details were provided for the masonry part. The building engineer is required to update the as-built drawing.

| Missing information in as-built drawing (Building-6: Utility-3). | The building engineer is required to update as-built drawings. | within 6 weeks |

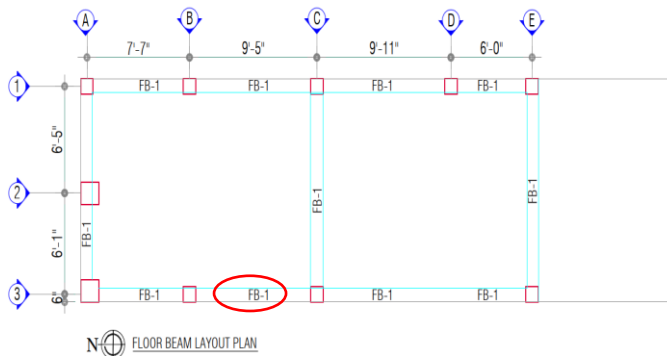
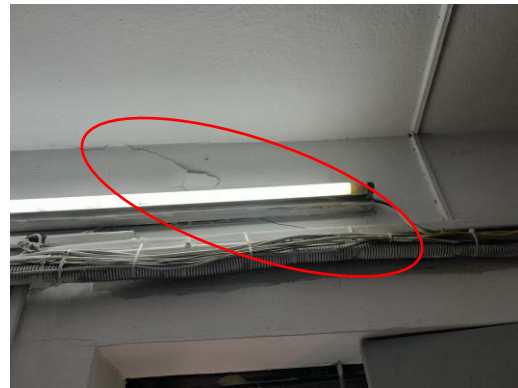
**Observation-22:** Beam crack observed at ground floor roof beam. (Building 7 (Security Building))

| Beam crack observed at ground floor roof beam. (Building 7 (Security Building)) | The building engineer is required to produce an investigation report regarding the extent of the crack and provide remedial measures accordingly. | Immediate |

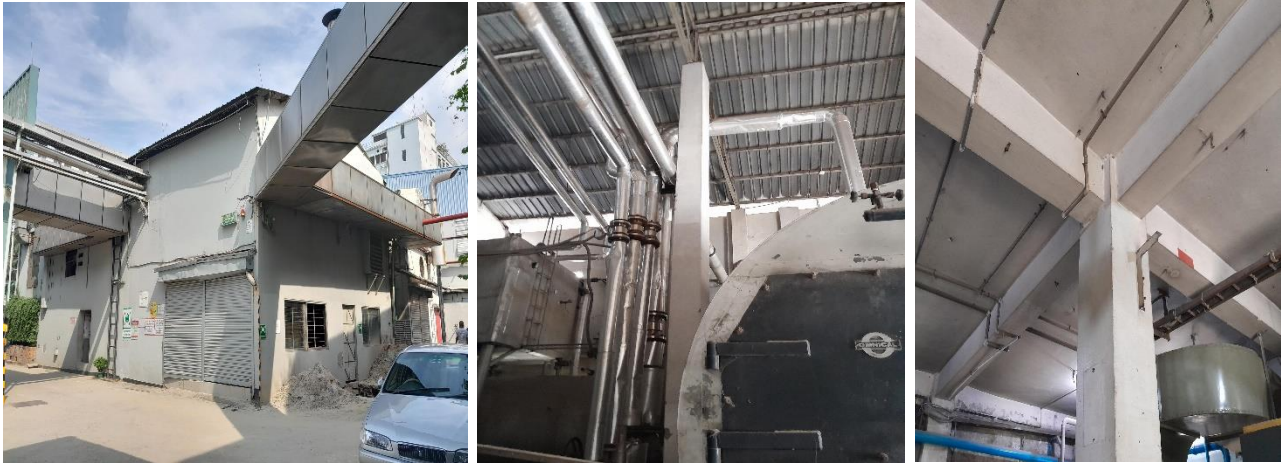
**Observation-23:** Lack of design report. (Building 9 (Utility-01)).

**Description:** As per BNBC, every building or structure designed shall have its design documents prepared by the provision of Section 1.9.1. The design documents shall include as-built drawings and a design report which shall be prepared in compliance with section 1.9.1, part 6 of BNBC.

During inspection, the design report was not available on site. The building engineer is required to prepare a design report based on in-situ material strength & software-based analysis and submit it to RSC for review.

| Lack of design report. (Building 9 (Utility-01)). | The building engineer is required to prepare a design report based on in-situ material strength & software-based analysis and submit it to RSC for review. | within 6 weeks |

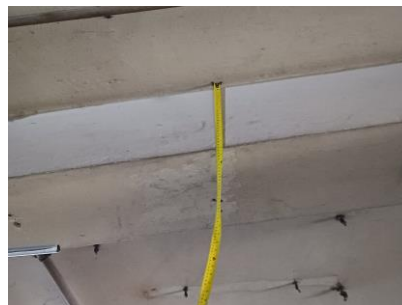
Ground floor onsite beam condition

**Observation-24:** Discrepancies in as-built drawings. (Building 9 (Utility-01)).

**Description:** During the inspection, some discrepancies were observed between as built drawing and the on-site condition.

- FB1 was found to be 250x500 instead of 250x375.
- In the truss frame all diagonal members were found single angle 40x40x5 instead of double angle 40x40x5.
- Foundation layout & details were missing for the external steel stair.

| Discrepancies in as-built drawings. (Building 9 (Utility-01)). | The building engineer is required to survey the full structure and produce accurate as-built drawings. | within 6 weeks |

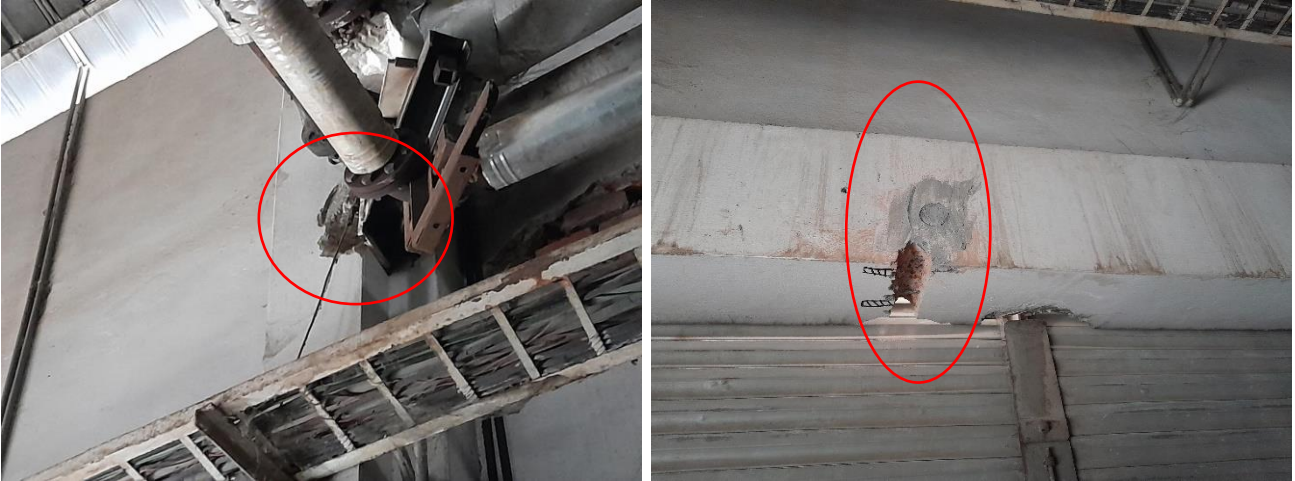
**Observation 25:** Damage beam & column in the boiler room. (Building 9 (Utility-01))

**Description:** Damage beam & column was observed in the boiler room of building 9. The building engineer is required to produce an investigation report regarding the extent of damage beam & column and provide remedial measures accordingly.

| Damage beam & column in the boiler room. (Building 9 (Utility-01)) | The building engineer is required to produce an investigation report regarding the extent of damage beam & column and provide remedial measures accordingly. | within 6 weeks |

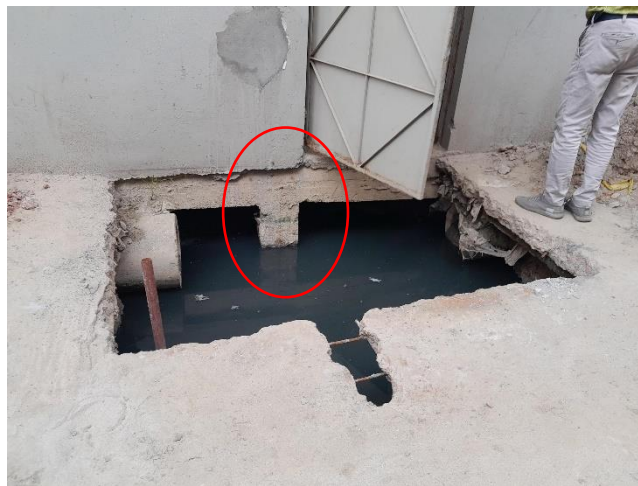
**Observation 26:** Verify clear cover of RC column under water. (Building 9 (Utility-01))

**Description:** During inspection, one RC column was found underwater. The building engineer is required to verify the clear cover of the RC column and take necessary remedial measures if required.

| Verify clear cover of RC column under water. (Building 9 (Utility-01)) | The building engineer is required to verify the clear cover of the RC column and take necessary remedial measures if required. | within 6 months |

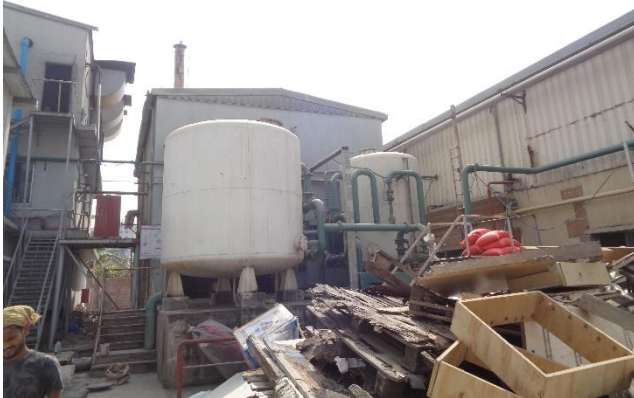
**Observation-27:** Absence of design report (Shed-4).

**Description:** As per BNBC, every building or structure designed shall have its design documents prepared in accordance with the provision of Section 1.9.1. The design documents shall include as built drawings and a design report which shall be prepared in compliance with section 1.9.1, part-6 of BNBC. During inspection, the design report was not available on site. The building engineer is required to prepare a design report in compliance with BNBC 1.9.1.

| Absence of design report (Shed-4) | The building engineer is required to prepare a set of design reports in compliance with section 1.9.1, part 6 of BNBC. | within 6 weeks |

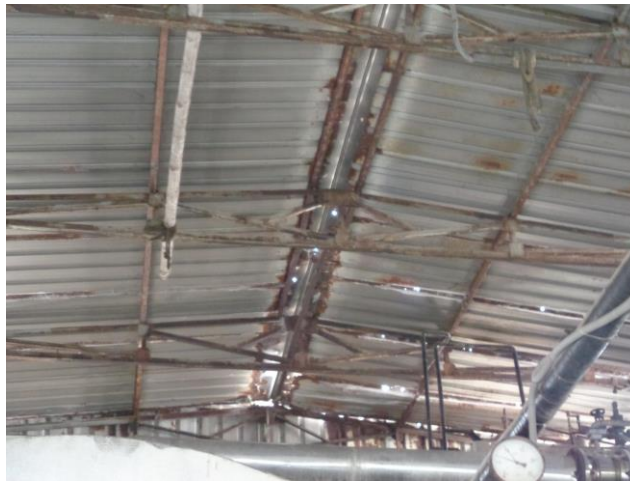
**Observation-28:** Corrosion on steel members (Shed-4).

**Description:** Corrosion was found on steel members. Factory is required to provide rust proof paint on steel members.

| Corrosion on steel members (Shed-4). | Factory is required to provide rust-proof paint on steel members. | within 6 months |

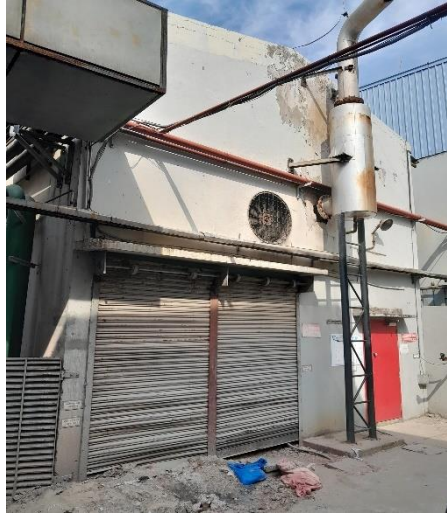
**Observation-29:** Lack of design report. (shed 5 (Generator room)).

**Description:** As per BNBC, every building or structure designed shall have its design documents prepared following the provision of Section 1.9.1. The design documents shall include as-built drawings and a design report which shall be prepared in compliance with section 1.9.1, part 6 of BNBC.

During inspection, the design report was not available on site. The building engineer is required to prepare a design report based on in-situ material strength & software-based analysis and submit it to RSC for review.

| Lack of design report. (shed 5 (Generator room)). | The building engineer is required to prepare a design report based on in-situ material strength & software-based analysis and submit it to RSC for review. | within 6 weeks |

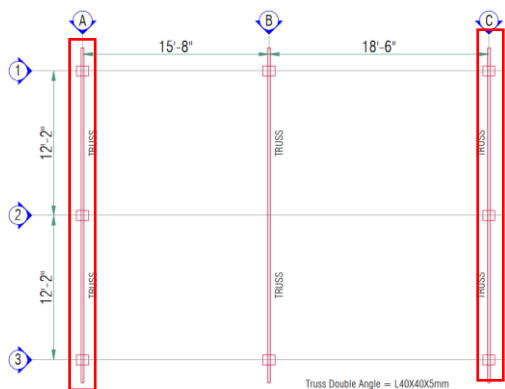
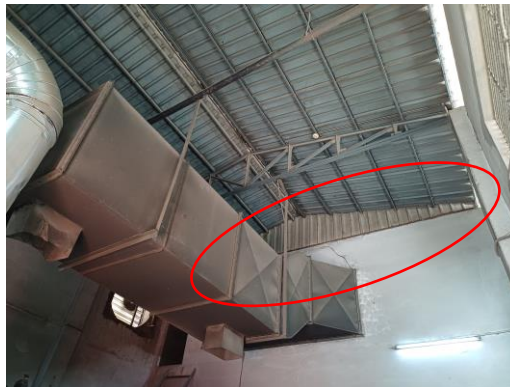
**Observation-30:** Discrepancies in as-built drawings. (Shed 5 (Generator room)).

**Description:** During the inspection, some discrepancies were observed between as-built drawing and the on-site condition. The truss frame was not found at grids A & C.

However, The building engineer is required to survey the full structure and produce accurate as-built drawings.

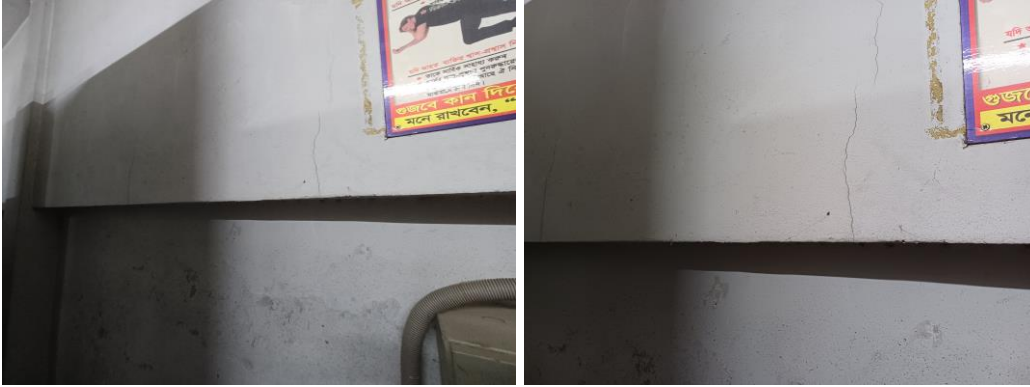
**Observation-31:** Hairline crack on tie beam. (Shed 5 (Generator room)).

**Description:** During inspection hairline crack observed on tie beam. The building engineer is required to investigate the type of crack and provide remedial measures if required.

| Hairline crack on tie beam. (Shed 5 (Generator room)). | The building engineer is required to investigate the type of crack and provide remedial measures if required. | within 6 weeks |

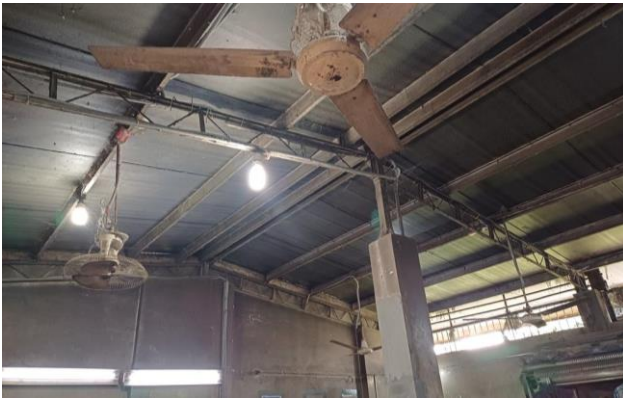
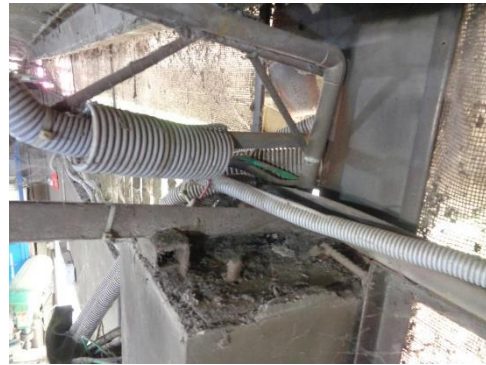
**Observation-32:** Lack of lateral stability system (Shed 07 - Workshop).

Poor Connection

**Description:** Lack of lateral stability system, apparent inadequate members and non-engineered connection were observed. The building engineer is required to check the member, connection & stability system of the structure and suggest proper remediation accordingly.

| Lack of lateral stability system (Shed 07 - Workshop). | The building engineer is required to check the member, connection & stability system of the structure and suggest proper remediation accordingly. | within 6 weeks |
