# Texeurop (BD) Ltd. (Extension)

Holding 19/1, Vogra, Ward-15, GCC, Bason PS, Gazipur-1702  
(23.983317N, 90.382354E)

22 November 2023

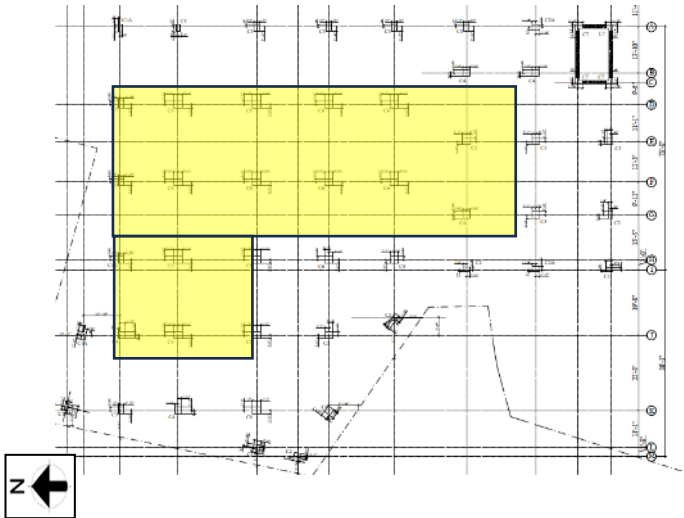
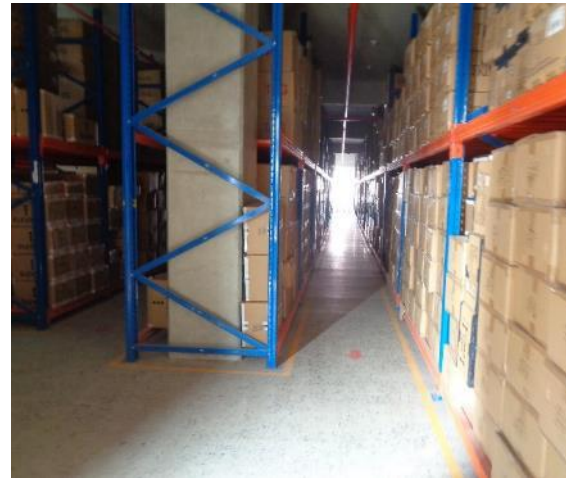
Typical floor loading

#### Observation-1: Stress in column above normal design limit (Building No. 06: New Building)

**Description:** The cursory calculation indicates that columns are stressed above the normal design limit at the marked locations considering floor live load of 3 kPa for the typical floors, 6 kPa for storage area and 1.5 kPa for the roof. We have considered minimum concrete strength (16.3 MPa) and rebar strength 500 MPa from available rebar test report. The building engineer is required to review design and column stresses based on in-situ concrete strength at the marked location.

| Observation | Action Plan | Timeline |
|---|---|---|
| Stress in column above normal design limit (Building No. 06: New Building) | The building engineer is required to review design and column stresses based on in-situ concrete strength at the marked location. | within 6 weeks |
| Stress in column above normal design limit (Building No. 06: New Building) | Produce and actively manage load management plan. | within 6 weeks |
| Stress in column above normal design limit (Building No. 06: New Building) | Implement remediation work if required. | within 6 months |
| Stress in column above normal design limit (Building No. 06: New Building) | Implement load management plan | within 6 months |

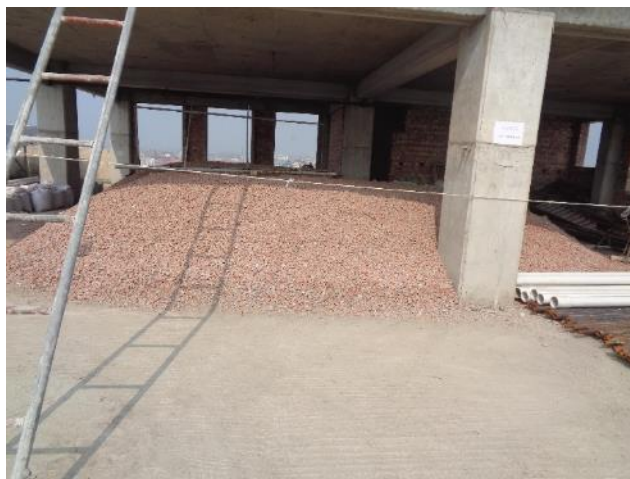
**Observation-4:** Construction material on roof slab (Building No. 06: New Building)

**Description:** Construction material was found on roof slab. The factory is required to remove all construction materials from roof slab.

| Observation | Action Plan | Timeline |
|---|---|---|
| Construction material on roof slab (Building No. 06: New Building) | The factory is required to remove all construction materials from roof slab. | within 6 weeks |

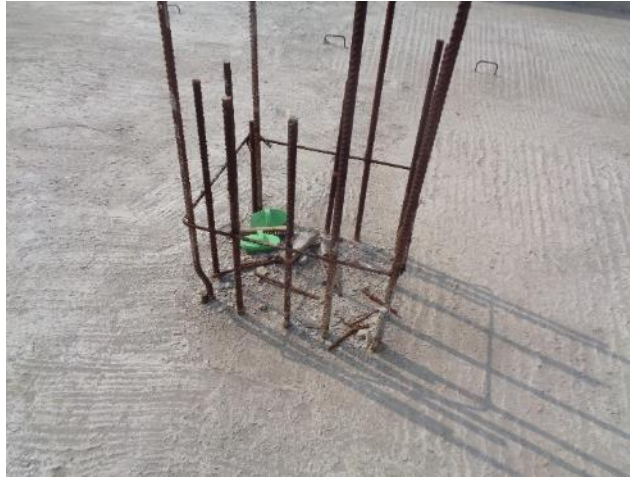
**Observation-5:** Exposed rebar at roof level (Building No. 06: New Building)

**Description:** Exposed rebar at roof level. The building engineer is required to provide rust proof paint on all exposed rebar.

| Observation | Action Plan | Timeline |
|---|---|---|
| Exposed rebar at roof level (Building No. 06: New Building) | The building engineer is required to provide rust proof paint on all exposed rebar. | within 6 months |

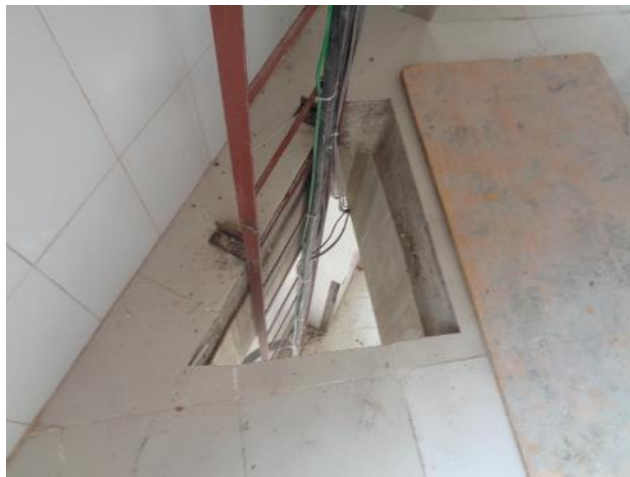
**Observation-6:** Falling hazard through hole inside floors (Building No. 06: New Building)

**Description:** Falling hazard was observed through hole inside floors. The building engineer is required to cover all hole to prevent falling hazard.

| Observation | Action Plan | Timeline |
|---|---|---|
| Falling hazard through hole inside floors (Building No. 06: New Building) | The building engineer is required to cover all hole to prevent falling hazard. | within 6 weeks |

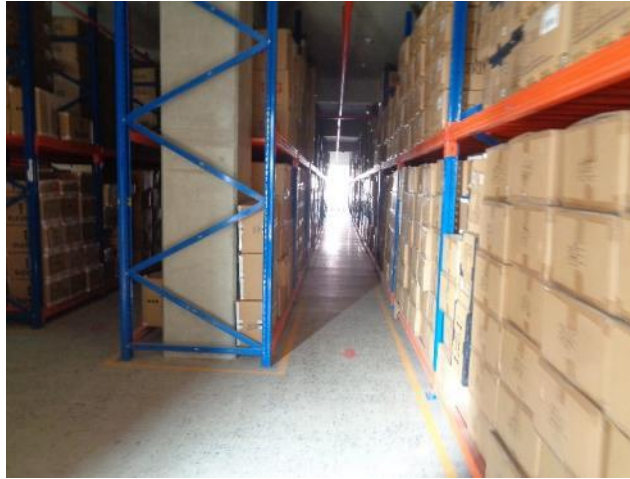
**Observation-7:** Nonstructural elements found not anchored/braced (Building No. 06: New Building)

**Description:** Nonstructural elements found not anchored/braced. The building engineer is required to brace/anchor all nonstructural elements including storage racks within the factory.

| Observation | Action Plan | Timeline |
|---|---|---|
| Nonstructural elements found not anchored/braced (Building No. 06: New Building) | The building engineer is required to brace/anchor all nonstructural elements including storage racks within the factory. | within 6 months |

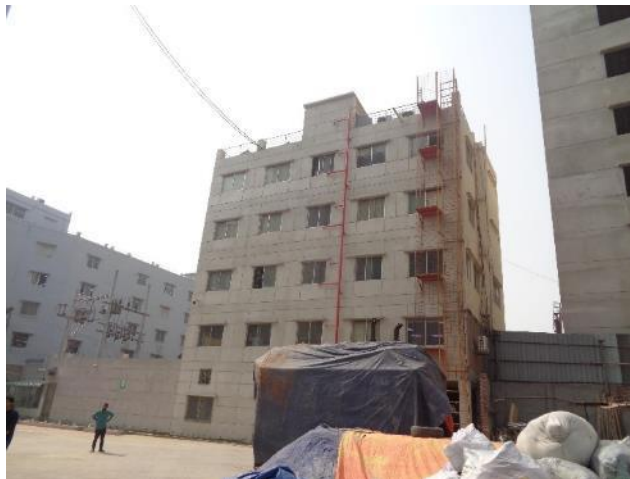
**Observation-8:** Absence of design report/ geotechnical investigation report/structural drawings (Substation Building)

**Description:** As per BNBC, every building or structure designed shall have its design documents prepared in accordance with the provision of Section 1.9.1. The design document shall include a design report, and a set of structural drawings, which shall be prepared in compliance with section 1.9.1.1 and section 1.9.1.2 as per BNBC. At the time of inspection, no structural drawing/geotechnical investigation report/design report were available. The building engineer is required to prepare a Detailed Engineering Assessment (DEA) including a geotechnical investigation report for this structure.

| Observation | Action Plan | Timeline |
|---|---|---|
| Absence of design report/ geotechnical investigation report/structural drawings (Substation Building) | The building engineer is required to prepare a Detailed Engineering Assessment (DEA) including a geotechnical investigation report for this structure. | within 6 weeks |
| Absence of design report/ geotechnical investigation report/structural drawings (Substation Building) | The building engineer is required to produce as-built structural drawing including foundation details. | within 6 weeks |
| Absence of design report/ geotechnical investigation report/structural drawings (Substation Building) | Implement remediation work if required. | within 6 months |
