# Kaixi Fashion Bangladesh Co Ltd

FS-SFB # 02,DEPZ(Old Zone),Ashulia,Savar,Dhaka-1349

15 November 2023

## 2. Observations

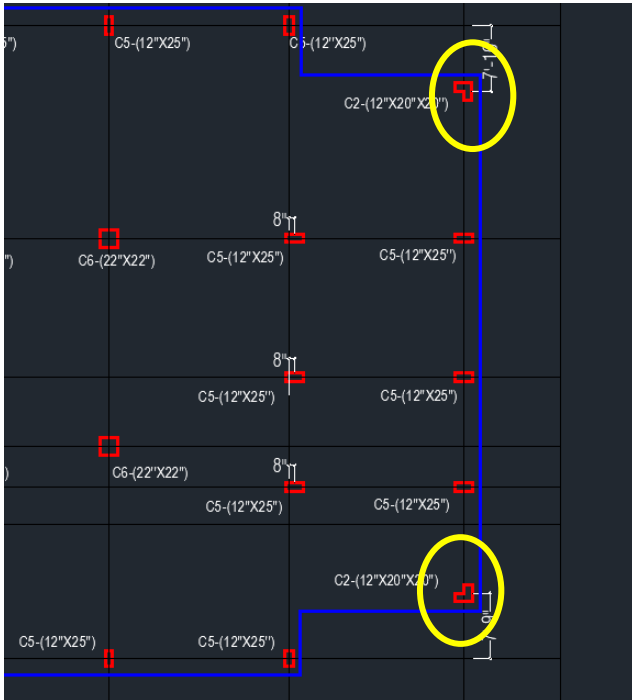
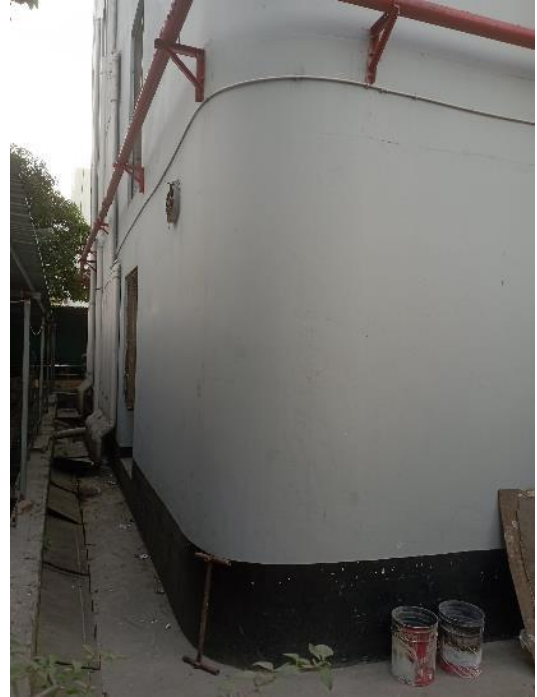
#### Observation-1: Discrepancy and missing information in as-built drawing (Main Building)

**Description:** L shape column is shown for each corner of the building, but arch shape column was found onsite.

| Observation | Action Plan | Timeline |
|---|---|---|
| Discrepancy and missing information in as-built drawing (Main Building) | The building engineer is required to update as-built drawing and revise the design report with analysis accordingly. | within 6 weeks |
| Discrepancy and missing information in as-built drawing (Main Building) | Implement remediation work if required. | within 6 months |

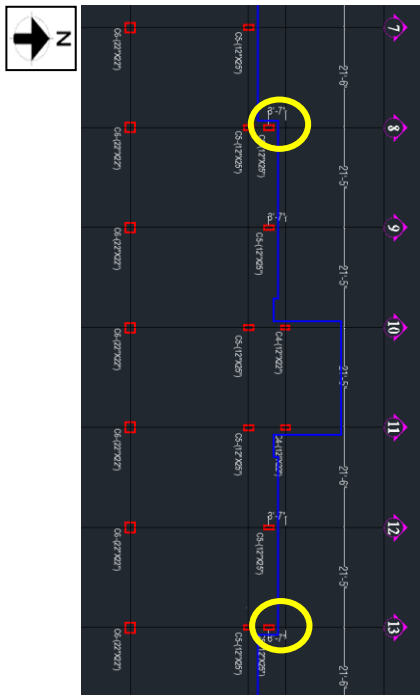
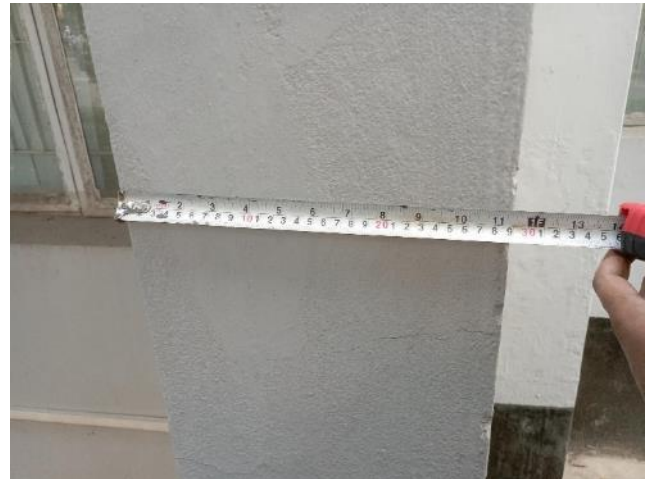
**Description:** Marked columns were shown as 625mmX300mm in drawing but found as 625mmX250mm.

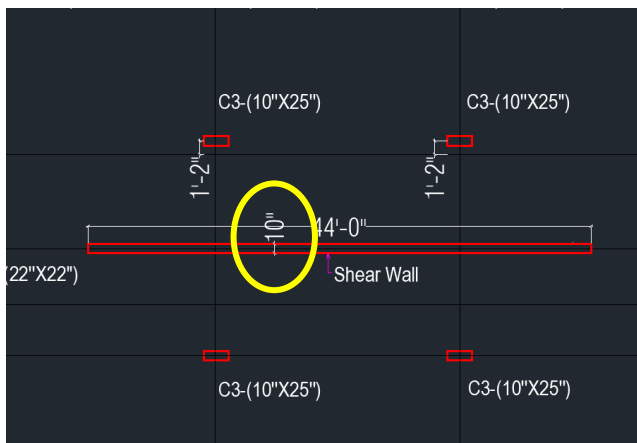
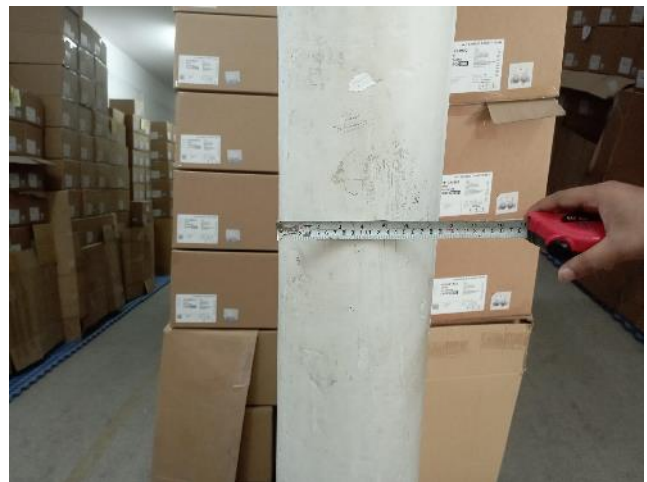
**Description:** Shear wall thickness was measured as 200 mm instead of 250 mm.

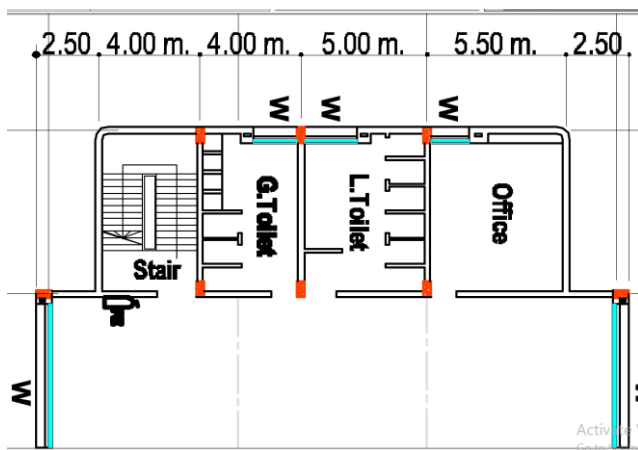
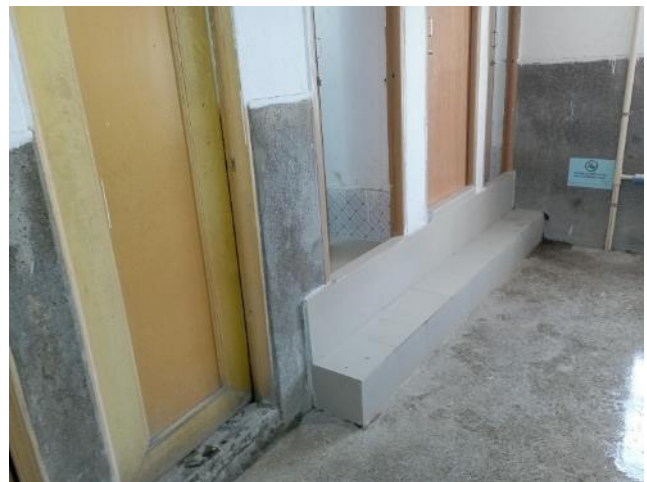
**Description:** 500 mm floor build up found in toilet area which was not shown in as built drawing.

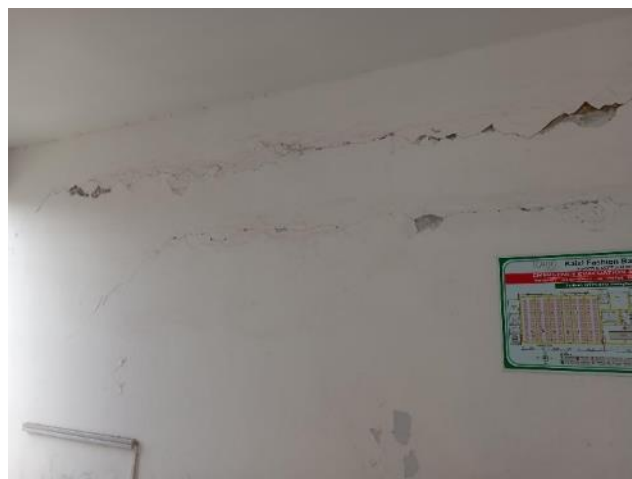
**Observation-2:** Crack on brick wall (Main Building)

**Description:** Crack was found on brick wall at several locations. The building engineer is required to investigate the area and repair the crack with a suitable method.

| Observation | Action Plan | Timeline |
|---|---|---|
| Crack on brick wall (Main Building) | Building engineer is required to investigate the area and repair the crack with a suitable method. | within 6 weeks |

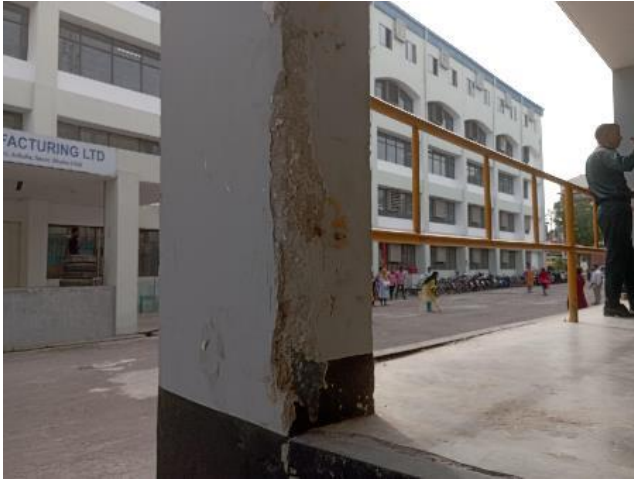
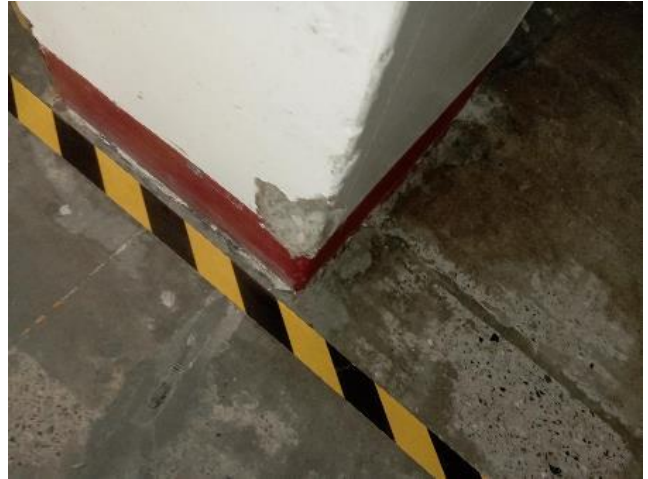
**Observation-3:** Column surface damage due to vehicle/trolley impact (Main Building).

**Description:** Column surface was found damaged due to vehicle/trolley impact. The building engineer is required to repair the damaged column and provide adequate barriers to avoid vehicle/trolley impact.

| Observation | Action Plan | Timeline |
|---|---|---|
| Column surface damage due to vehicle/trolley impact (Main Building) | The building engineer is required to repair the damaged column and provide adequate barriers to avoid vehicle/trolley impact. | within 6 weeks |

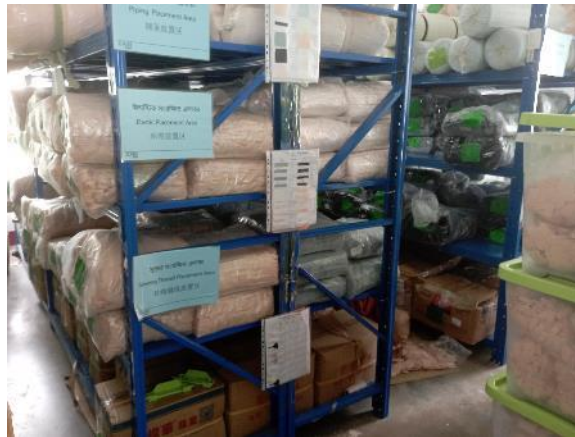
**Observation-4:** Nonstructural elements found not anchored/braced (Main Building).

**Description:** Nonstructural elements found not anchored/braced. The building engineer is required to brace/anchor all nonstructural elements including storage racks within the factory.

| Observation | Action Plan | Timeline |
|---|---|---|
| Non-structural elements found unbraced/not anchored (Main Building) | Factory is required to brace/anchor all nonstructural elements. | within 6 months |

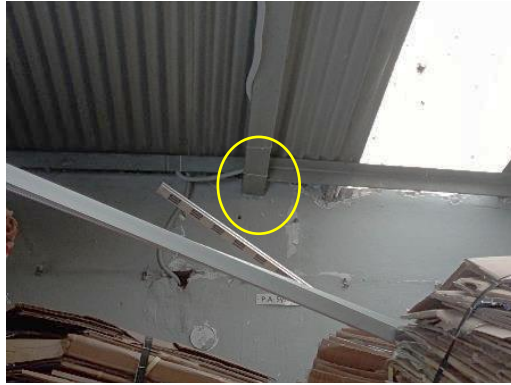
**Observation-5:** Apparently inadequate connection (Utility Shed)

**Description:** Steel members were found inserted into brick wall therefore connection of steel members appeared to be inadequate. The building engineer is required to check the connection and suggest remedial action.

| Observation | Action Plan | Timeline |
|---|---|---|
| Apparently inadequate connection (Utility Shed) | The building engineer is required to check the connection and suggest remedial action. | within 6 weeks |
| Apparently inadequate connection (Utility Shed) | Implement remediation work where required | within 6 months |

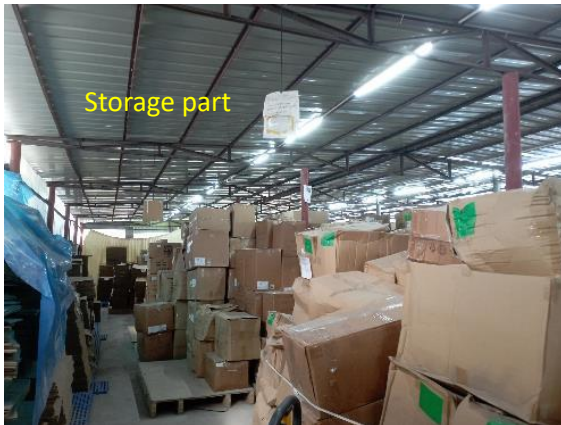
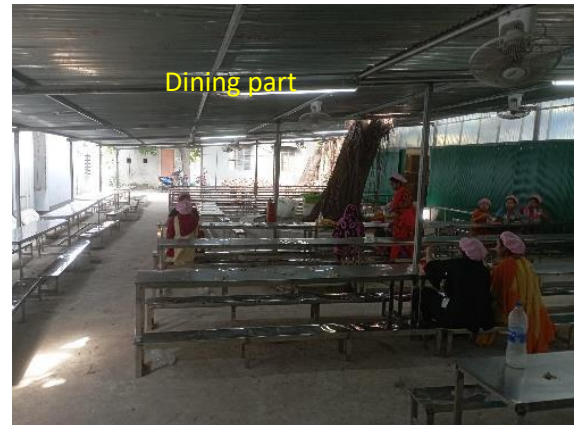
**Observation-6:** Lack of lateral stability and apparently non engineered shed (Storage & Dining Shed)

**Description:** No lateral load transfer media was found in the storage portion. And the dining portion was apparently non-engineered. The building engineer is required to check the lateral stability and connection adequacy of the structure and prepare a design report with necessary remedial actions.

| Observation | Action Plan | Timeline |
|---|---|---|
| Lack of lateral stability and apparently non engineered shed (Storage & Dining Shed) | The building engineer is required to check the lateral stability and connection adequacy of the shed. | within 6 weeks |
| Lack of lateral stability and apparently non engineered shed (Storage & Dining Shed) | Implement remediation work where required | within 6 months |

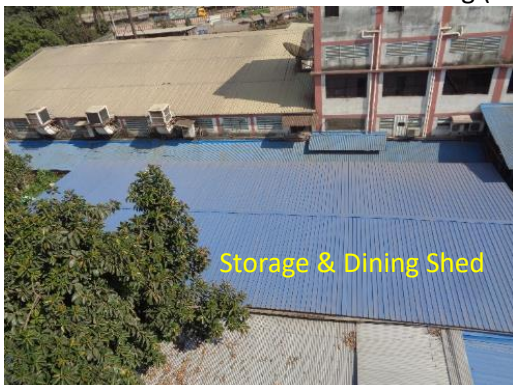
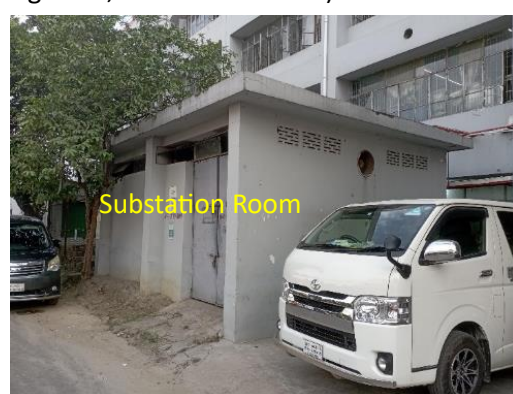
**Observation-7:** Lack of as-built drawing (Storage & Dining Shed, Substation Room)

**Description:** At the time of inspection as-built drawing of Storage & Dining Shed, Substation Room was not available onsite. The building engineer is required to produce as-built drawing of the structures.

| Observation | Action Plan | Timeline |
|---|---|---|
| Lack of as-built drawing (Storage & Dining Shed, Substation Room) | The building engineer is required to produce as-built drawings including structural connection detail. | within 6 weeks |
