# Barnali Collections Ltd

20 November 2023

## Structural Inspection Report

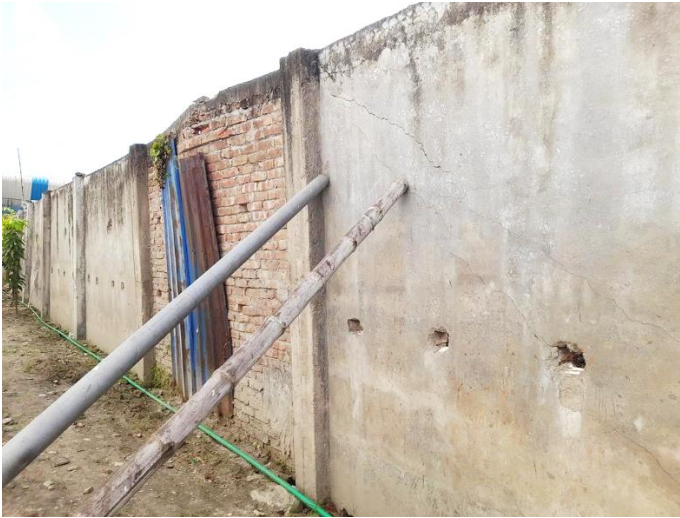
### Observation-1: Boundary wall leaned south side of Building 1 (Production Building)

Leaned Boundary wall

**Description:** During the inspection, a portion of the boundary wall was found leaning toward the factory premises on the south side of Building 1 (Production Building). Earthwork is ongoing on the far side of the boundary wall. The boundary wall is potential to hazard.

| Observation | Action Plan | Timeline |
|---|---|---|
| Boundary wall leaned south side of Building 1 (Production Building) | The factory is required to immediately restrict the entry to the south side set back of the building and provide necessary support to the deflected walls to avoid potential collapse. | Immediate |
| | The factory is required to demolish the deflected/damaged portion of the boundary wall. During the demolition work, the factory is required to follow standard safety practice as per BNBC. | within 6 weeks |
| | Further new construction of the boundary wall should be properly designed and supervised by a qualified structural engineer. | within 6 months |

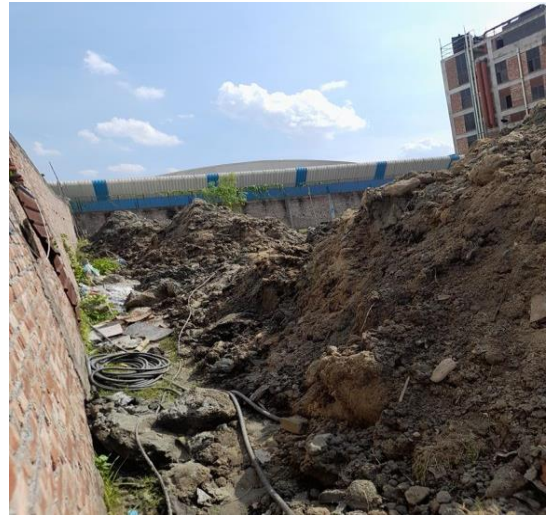
Earthwork ongoing opposite of the wall

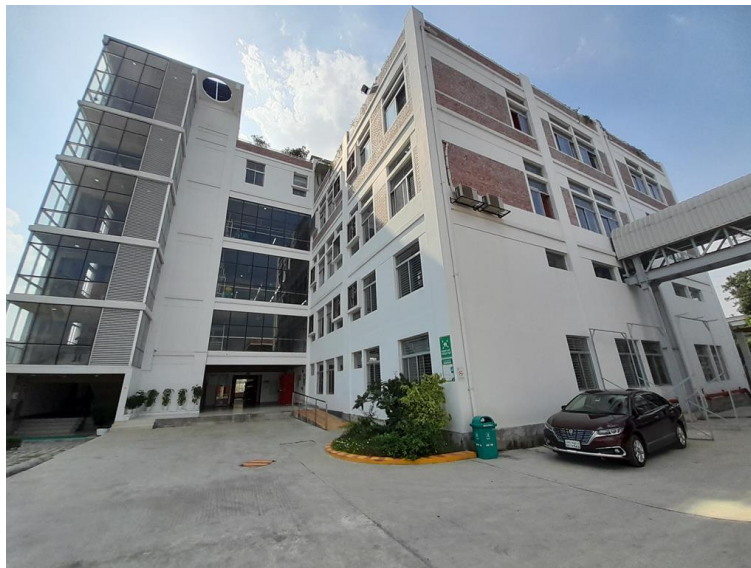
### Observation-2: Lack of design documents (Building 1 - Production Building).

**Description:** As per BNBC, every building or structure designed shall have its design documents prepared in accordance with the provision of Section 1.9.1. During inspection, the design report was not available on site. In addition, the available test results are insufficient to meet the evaluation and acceptance criteria of BNBC.

The building engineer is required to prepare a set of design documents including as built drawings and a design report based on in-situ material strength and software-based analysis which shall be prepared in compliance with section 1.9.1, part-6 of BNBC.

| Observation | Action Plan | Timeline |
|---|---|---|
| Lack of design documents (Building 1 - Production Building). | Verify in situ concrete strength (100mm dia. cores from 4 columns) from lower tier of the building. | within 6 weeks |
| | The building engineer is required to prepare a set of design documents including as built drawings and a design report based on in-situ material strength and software-based analysis which shall be prepared in compliance with section 1.9.1, part-6 of BNBC. | within 6 weeks |
| | Carry out suggested remedial works if required. | within 6 months |

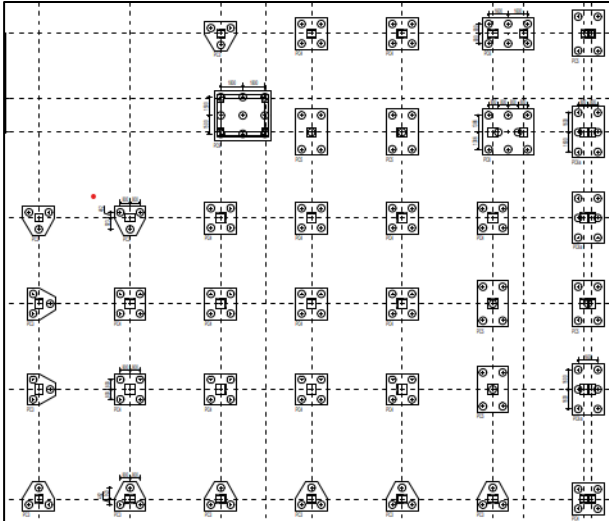
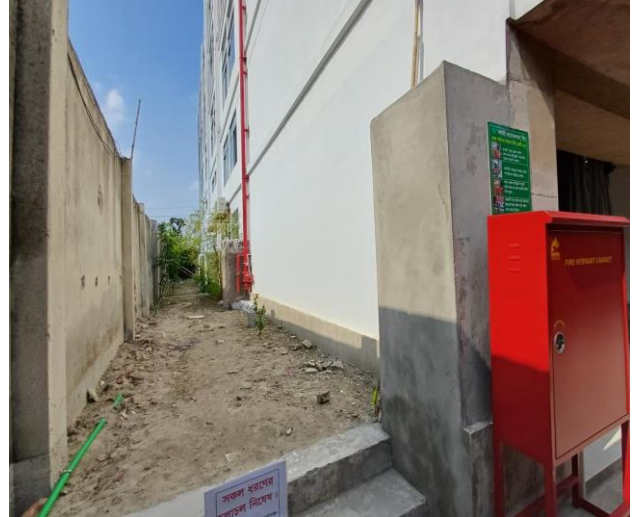
**Observation-3:** Eccentricity of pile cap (Building 1 - Production Building).

**Description:** Factory may have to extend the building horizontally southside of the building. As per pile cap layout at grid 7 & 8, double column was observed on single pile cap. One column was constructed up to the full height of the building, but another one was constructed up to mid-height of ground floor. So, the pile cap became eccentric. Building engineer is required to check adequacy of the pile cap for eccentricity.

| Observation | Action Plan | Timeline |
|---|---|---|
| Eccentricity of pile cap (Building 1 - Production Building). | The building engineer is required to check adequacy of the pile cap for eccentricity. | within 6 weeks |
| | Carry out remedial work if required. | within 6 months |

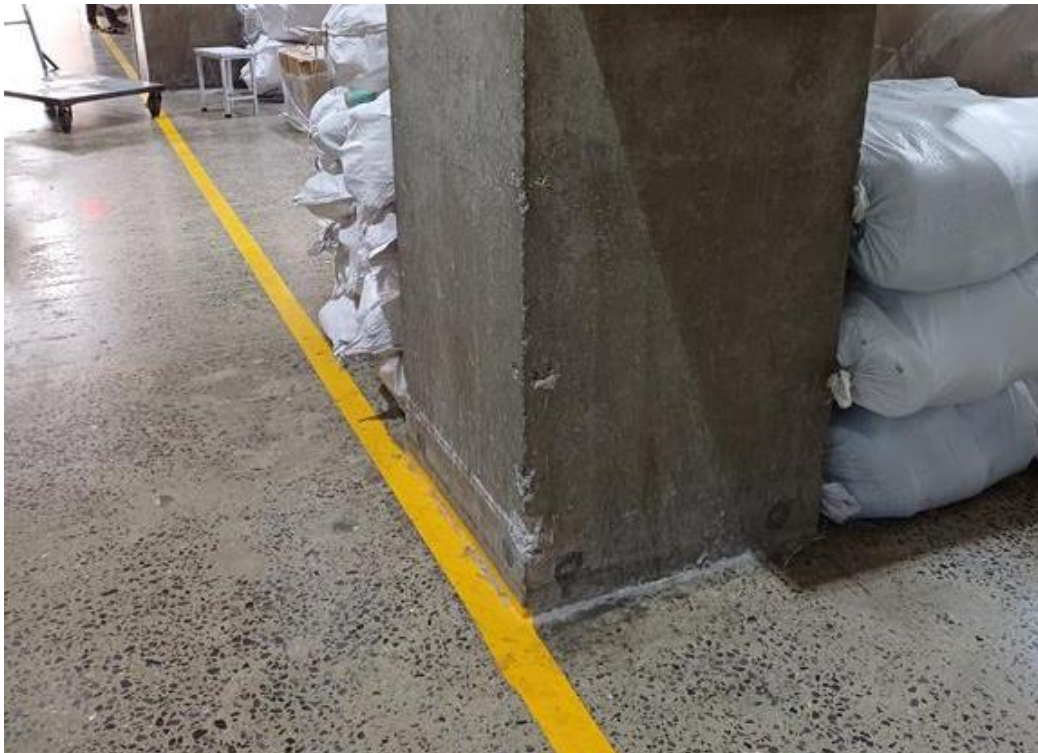
**Observation-4:** Column susceptible to trolley impact (Building 1 - Production Building).

**Description:** Some columns on the ground floor were found susceptible to trolley impact. The building engineer is required to provide barriers around the column to prevent trolley impact.

| Observation | Action Plan | Timeline |
|---|---|---|
| Column susceptible to trolley impact (Building 1 - Production Building). | The building engineer is required to provide barriers around the column to prevent trolley impact. | within 6 months |

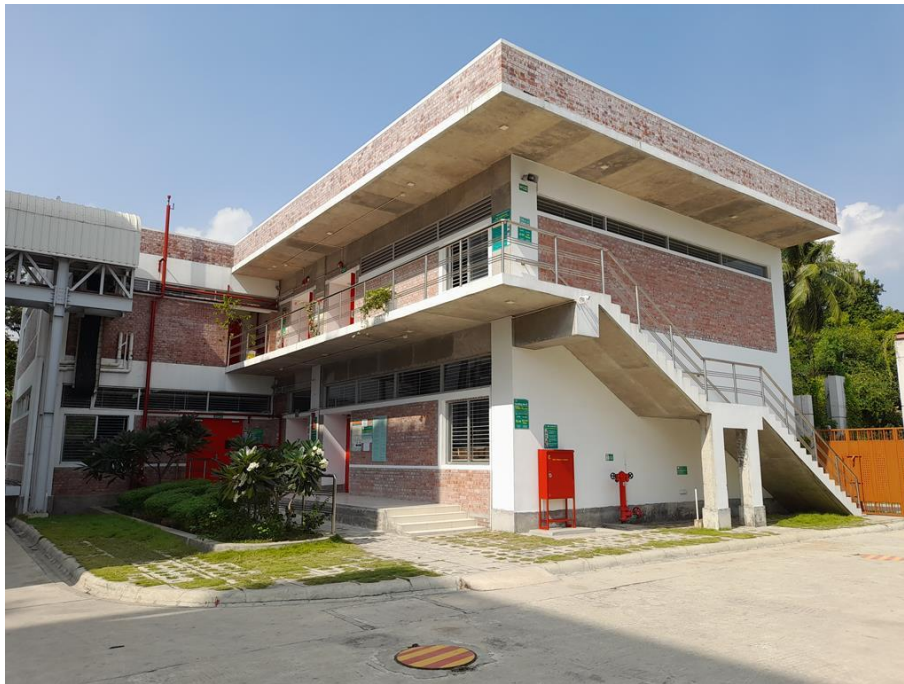
**Observation-5:** Lack of design documents (Building 2 - Utility Building).

**Description:** As per BNBC, every building or structure designed shall have its design documents prepared in accordance with the provision of Section 1.9.1. During inspection, the design report was not available on site. In addition, the available test results are insufficient to meet the evaluation and acceptance criteria of BNBC.

The building engineer is required to prepare a set of design documents including as built drawings and a design report based on in-situ material strength and software-based analysis which shall be prepared in compliance with section 1.9.1, part-6 of BNBC.

| Observation | Action Plan | Timeline |
|---|---|---|
| Lack of design documents (Building 2 - Utility Building). | Verify in situ concrete strength (100mm dia. cores from 4 columns) from lower tier of the building. | within 6 weeks |
| | The building engineer is required to prepare a set of design documents including as built drawings and a design report based on in-situ material strength and software-based analysis which shall be prepared in compliance with section 1.9.1, part-6 of BNBC. | within 6 weeks |
| | Carry out suggested remedial works if required. | within 6 months |
