# Cortex Apparels Ltd

Holding # 160/1, Madhabpur, Ward-01,  
Kashimpur Metro, Gazipur-1349, Bangladesh  
(24.007779N, 90.262224E)

26 November 2023

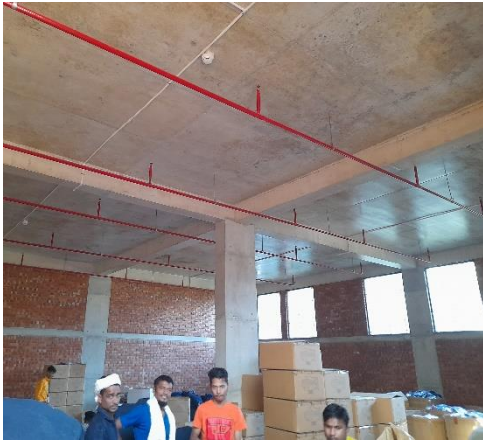
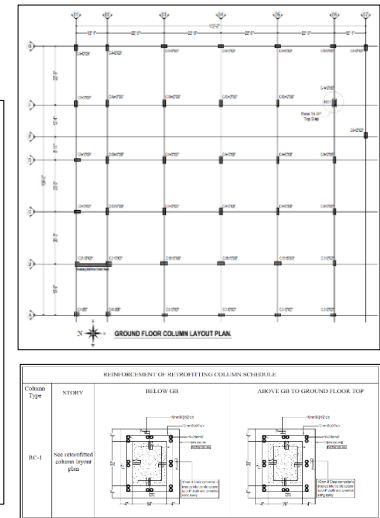
**Observation-1:** Columns appear to exceed Euler force. (Main Production Building).

From the above table it is clear that one column is Overstressed. This column needs to be retrofitted. All other columns are safe and sound.

From left- Ground floor Column, O/S of column shown in DEA report & proposed retrofitting details of column

**Description:** Ground floor columns are 4.31 m in length and 300X750 mm in size. The length/width=14.36 indicate that the columns are critical for slenderness effect. Factory has proposed the retrofitting for a column at grid- F/6. The building engineer is required to check and address this issue in the design report of all the required columns.

| Observation | Action Plan | Timeline |
|---|---|---|
| Columns appear to exceed Euler force.<br>(Main Production Building). | The building engineer is required to update the DEA documents. | within 6 weeks |
| | Carry out suggested remedial works if required. | within 6 months |

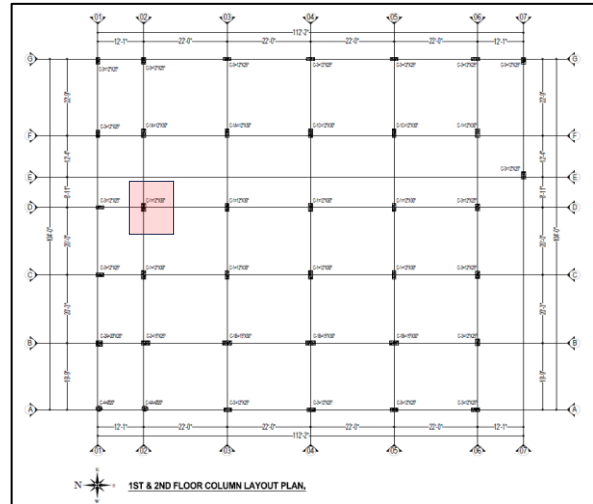
Column details for the C5 & C6

In column layout plan, Column ID-C1D has been shown at grid-D/2. But no details of the column have been provided in the column schedule. The size and shape of the C5 & C6 column do not match between as-built drawing and site condition.

| Observation | Action Plan | Timeline |
|---|---|---|
| Inconsistency in DEA documents.<br>(Main Production Building). | The building engineer is required to survey the full structure and produce accurate as-built drawings. | within 6 weeks |
| | The building engineer is required to review the DEA documents based on in-situ material strength & software-based analysis and submit the documents to RSC for review. | within 6 weeks |

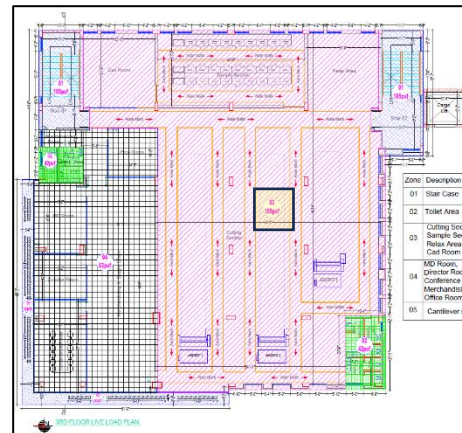
63 psf has been assigned in FEA model

105 psf has been shown load plan

The load assignment in FEA model does not match between FEA model and provided load plan.

| Observation | Action Plan | Timeline |
|---|---|---|
| | Produce and manage the load plan as per BNBC. | within 6 weeks |
| | Implement the floor loading plan | within 6 months |

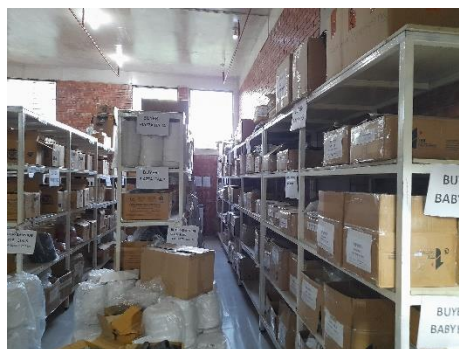
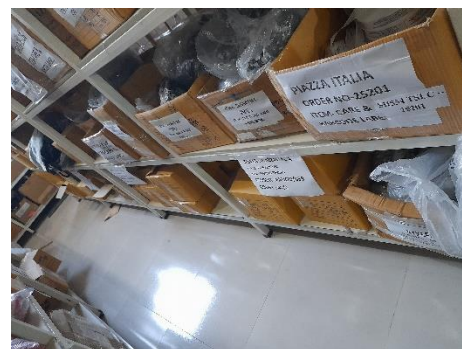
**Observation-3:** Non-structural elements not anchored or braced (Main Production Building)

**Description:** Racks on different floors are not adequately anchored or braced to resist lateral (earthquake) forces. Building engineer is required to adequately anchor and brace all non-structural elements to resist earthquake forces to comply with the BNBC.

| Observation | Action Plan | Timeline |
|---|---|---|
| Non-structural elements not anchored or braced (Main Production Building) | Building engineer is required to adequately anchor and brace all non-structural elements to resist earthquake forces to comply with the BNBC. | within 6 weeks |

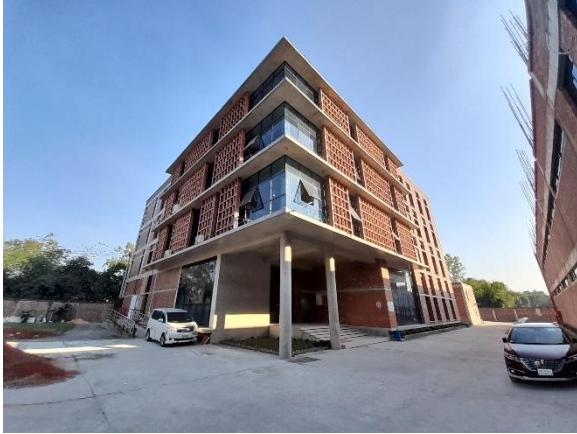
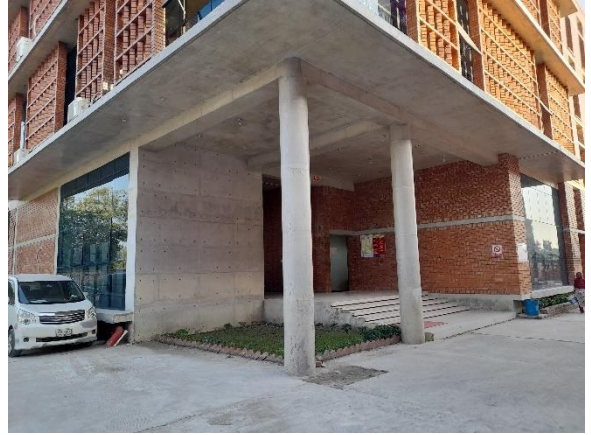
**Observation-4:** Column susceptible to vehicle impact (Main Production Building)

**Description:** Circular columns of the front area are susceptible to vehicle impact. The Building engineer is required to take necessary measures to prevent the vehicle impact by providing the barrier around the columns.

| Observation | Action Plan | Timeline |
|---|---|---|
| Column susceptible to vehicle impact<br>(Main Production Building) | The factory engineer is required to take necessary measures to prevent the vehicle impact by providing barrier around the columns. | within 6 months |

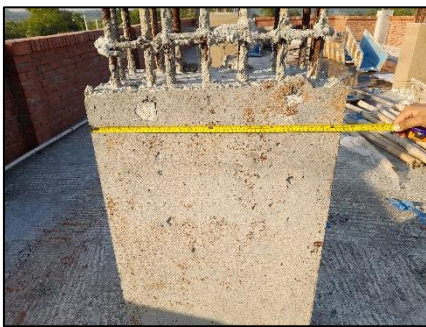
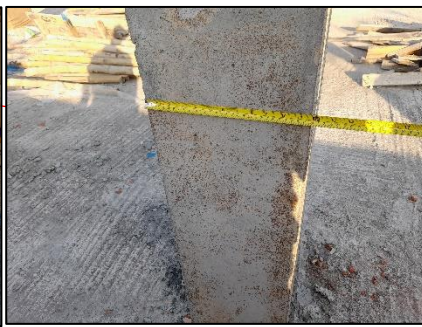
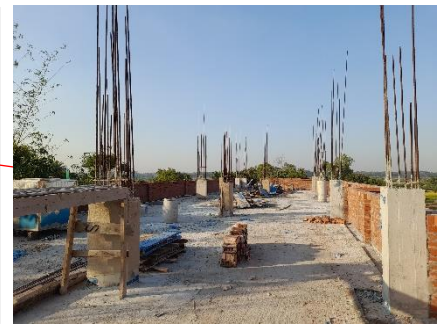
**Observation-5:** Discrepancies in as built drawings (Admin Building).

Column size measurement for C7 Column

Re-bar number confirmed at roof

**Description:** During inspection, numerous mismatches were found in the column between onsite condition and as-built drawing. The size of the columns- C3A, C6A and C7 do not match with as-built drawing. Also the number of the re-bar for the columns C2, C4 and C5A mismatches with as-built drawings.

| Observation | Action Plan | Timeline |
|---|---|---|
| Discrepancies in as built drawings. (Admin Building) | The building engineer is required to survey the full structure and produce accurate as-built drawings. | within 6 weeks |
| | The building engineer is required to revise the design documents based on actual site condition. | within 6 months |

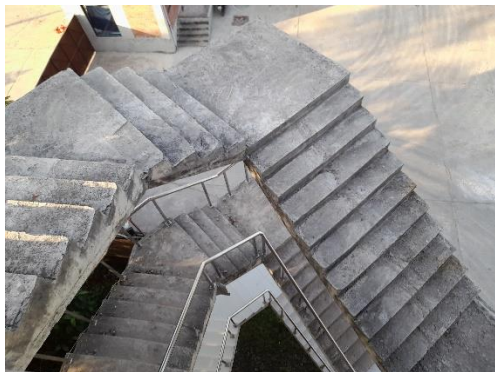
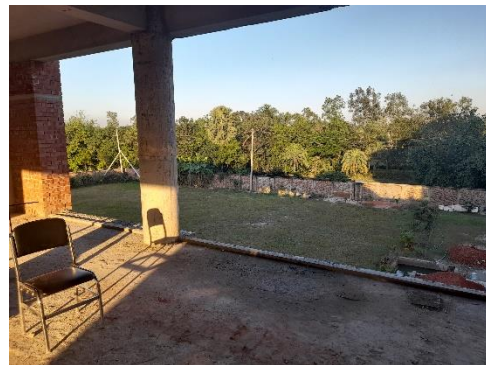
**Observation-6:** Lack of edge protection (Admin Building).

**Description:** During the inspection, Edge protection (Parapet wall/Railing) was not observed on the 2<sup>nd</sup> floor and stairs. Building is required to provide edge protection to avoid falling hazards.

| Observation | Action Plan | Timeline |
|---|---|---|
| Lack of edge protection (Admin Building). | Building is required to provide edge protection on the roof and stair to avoid falling hazard. | within 6 weeks |

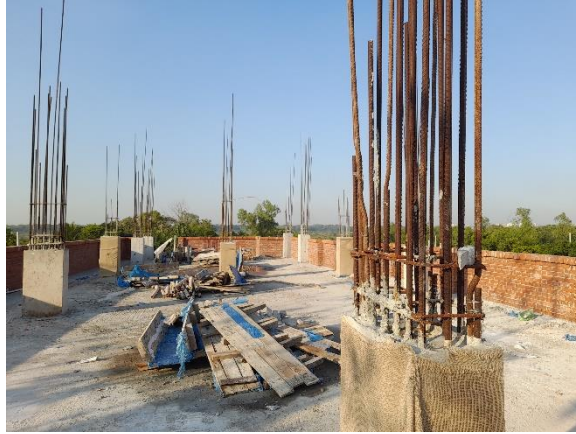
**Observation-7:** Exposed re-bar at roof (Admin Building).

**Description:** Exposed reinforcement was found on rooftop columns. Building engineer is required to take necessary measures to prevent corrosion in exposed rebar.

| Observation | Action Plan | Timeline |
|---|---|---|
| Exposed re-bar at roof.<br>(Admin Building). | All exposed reinforcement is to be protected from corrosion which may cause degradation of the concrete. | within 6 weeks |

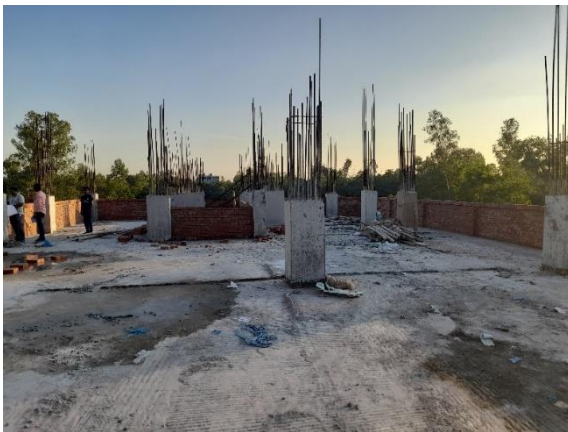
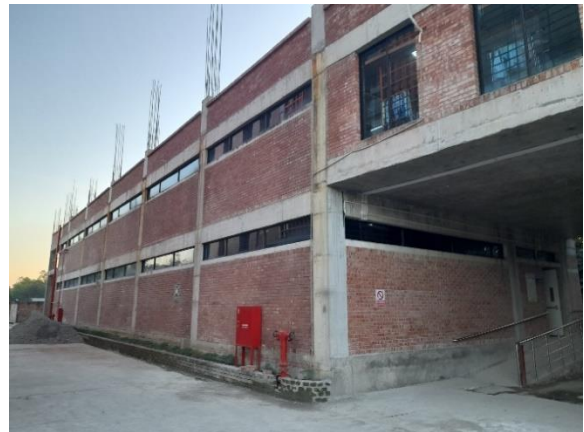
**Observation-8:** Discrepancies in as-built drawings (Warehouse Building).

Re-bar numbers confirmed at roof

**Description:** During the inspection, the number of the re-bar for columns and C2 and C4 do not match with as-built drawing and actual site condition.

| Observation | Action Plan | Timeline |
|---|---|---|
| Discrepancies in as built drawings.<br>(Warehouse Building) | The building engineer is required to survey the full structure and produce accurate as-built drawings. | within 6 weeks |
| | The building engineer is required to revise the design documents based on actual site condition. | within 6 months |

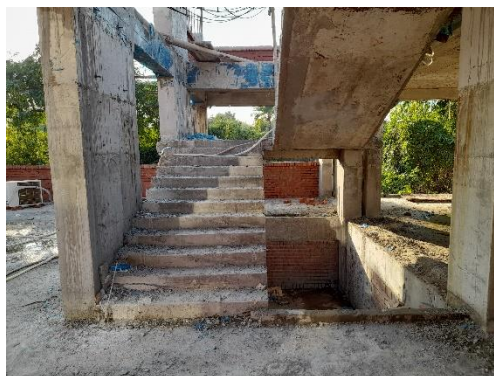
**Observation-9:** Lack of edge protection (Warehouse Building).

**Description:** During the inspection, Edge protection (Parapet wall/Railing) was not observed on the stairs. Building is required to provide edge protection to avoid falling hazards.

| Lack of edge protection<br>(Warehouse Building). | Building is required to provide edge protection on the roof and stair to avoid falling hazard. | within 6 weeks |

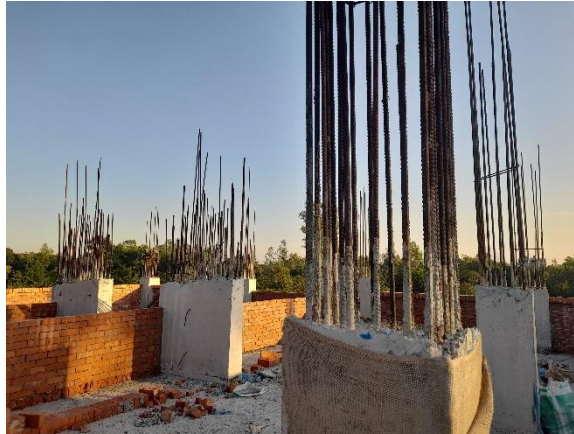
**Observation-10:** Exposed re-bar at roof (Warehouse Building).

**Description:** Exposed reinforcement was found on rooftop columns. Building engineer is required to take necessary measures to prevent corrosion in exposed rebar.

| Exposed re-bar at roof.<br>(Warehouse Building). | All exposed reinforcement is to be protected from corrosion which may cause degradation of the concrete. | within 6 weeks |

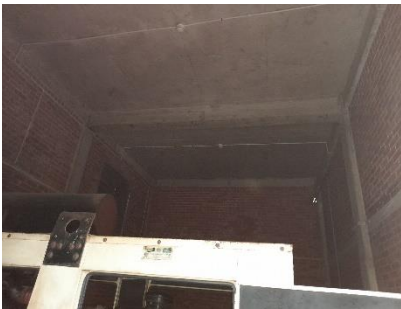
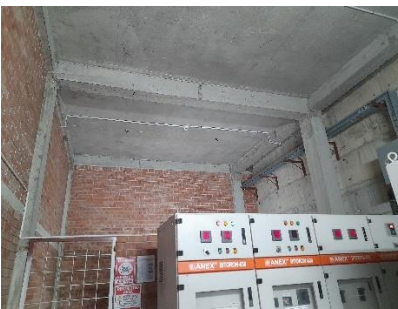
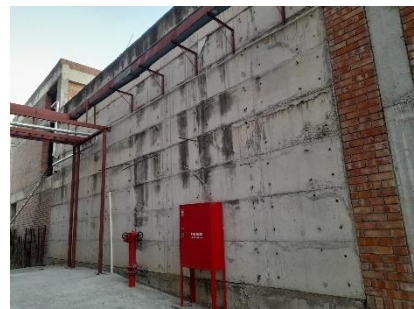
**Observation-11:** Lack of design report (Utility Building).

Interior of the utility building

RC wall of the utility Building

**Description:** As per BNBC, every building or structure designed shall have its design documents prepared following the provision of Section 1.9.1. During inspection, the design report and as built structural drawing was not available on site.

The building engineer is required to prepare a set of design documents including as built drawings, live load plan at roof and a design report based on in-situ material strength and software-based analysis which shall be prepared in compliance with section 1.9.1, part-6 of BNBC.

| Lack of Design Report.<br>(Utility Building) | The building engineer is required to prepare a set of design documents including as built drawings and a design report as per BNBC | within 6 weeks |
| | Carry out remedial works if required. | within 6 months |

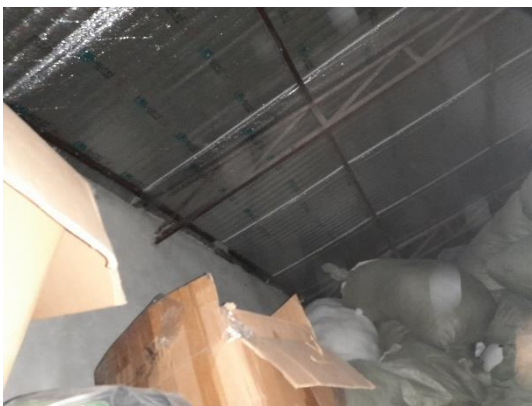
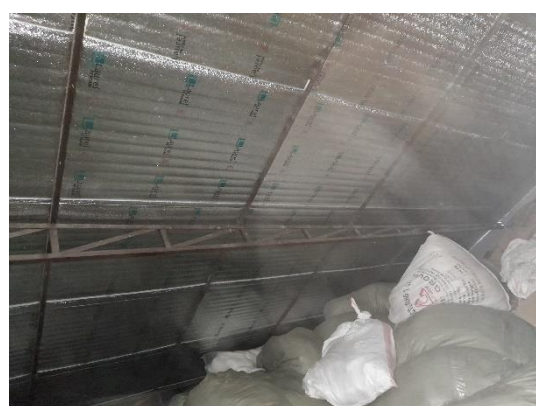
**Observation-12:** Non-engineered structure (Wastage Shed).

**Description:** Lack of lateral stability system (strut and bracing), apparent inadequate members and non-engineered connection was observed. The building engineer is required to check the member, connection & stability system of the structure and suggest proper alternatives accordingly.

| Non-engineered shed.<br>(Wastage Shed) | The building engineer is required to check the member, connection & stability system of the roof shed and suggest proper alternatives accordingly. | within 6 weeks |
| | Carry out suggested remedial works. | within 6 months |

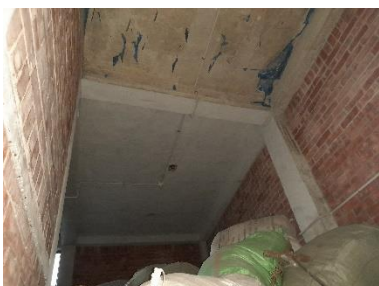
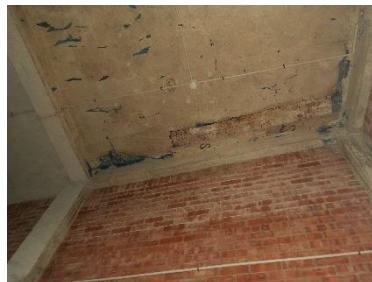
**Observation-13:** Lack of design report (Gate House).

**Description:** As per BNBC, every building or structure designed shall have its design documents prepared in accordance with the provision of Section 1.9.1. During inspection, the design report and as built structural drawing was not available on site.

The building engineer is required to prepare a set of design documents including as built drawings, live load plan at roof and a design report based on in-situ material strength and software-based analysis which shall be prepared in compliance with section 1.9.1, part-6 of BNBC.

| Lack of Design Report.<br>(Gate House) | The building engineer is required to prepare a set of design documents including as built drawings and a design report as per BNBC | within 6 weeks |
| | Carry out remedial works if required. | within 6 months |
