# INITIAL FIRE SAFETY INSPECTION REPORT

**Vintage Denim Ltd. (Extension)**

**RSC ID: 24601**

**Date: 16 November 2023**

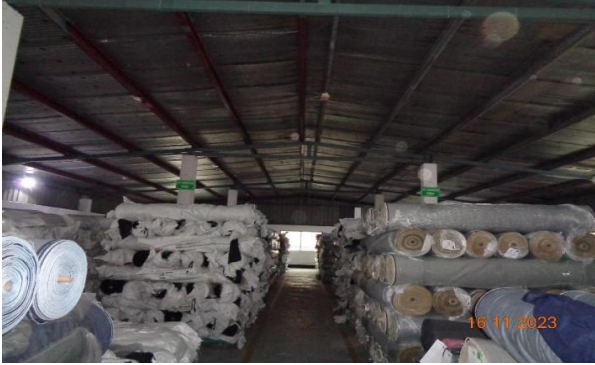
| SI No. | Category | Findings | Required Action | Remediation Time Frame |
|--|---|--|--|---|
| F-1 | Fire Rated Construction | The main structural elements of the building are constructed by steel which is non-rated and were found in exposed condition without any fire protection. (Interim Structure). | The building is interim steel structure which shall be type-I construction. So, provide require rating in the structural elements of the buildings. Consult with a qualified fire protection engineer. Follow BNBC 2006-Table 3.2.4, 3.1.9 and 3.3.1 as reference. | Within 6 months |

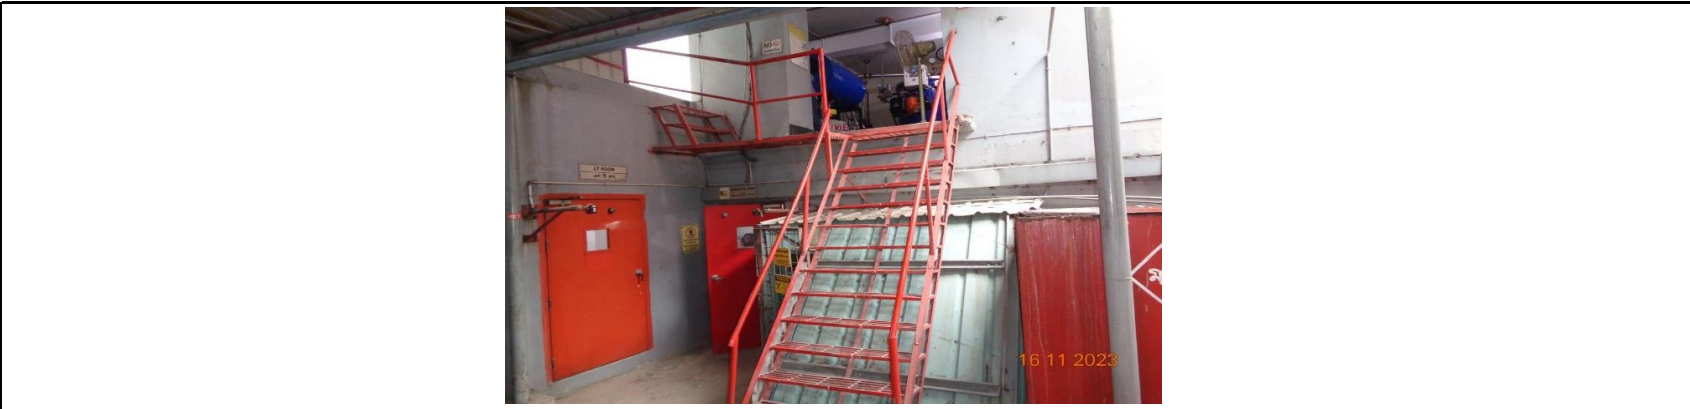
| SI No. | Category | Findings | Required Action | Remediation Time Frame |
|--|---|--|--|---|
| F-2 | Fire Rated Construction | The boiler room was not separated by fire rated construction due to unprocted openings.<br><b>Location:</b> Gas generator room. | Separate the boiler and transformer rooms by a minimum 1-hr fire-rated construction. Seal and/or protected all openings to maintain the required fire separations. | Within 3 months |

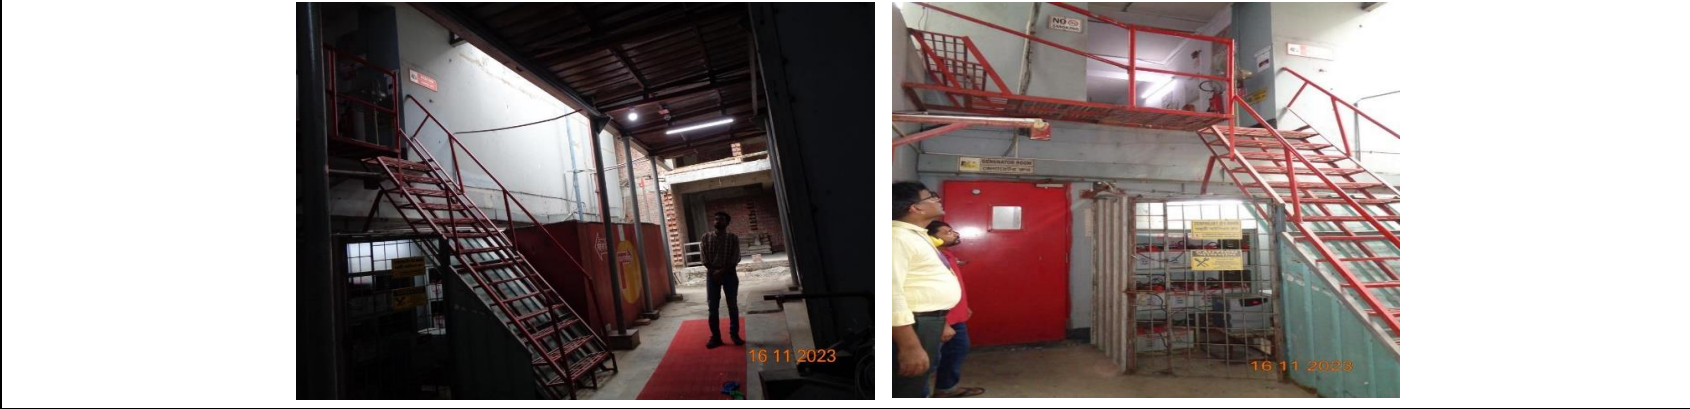
| F-3 | Fire Rated Construction | <p>The egress court ( exit discharge path) is found unprotected.</p> <p><b>Location:</b> Gas generator room.</p> | <p>Seal all penetrations and openings along the discharge path, up to a height of 10 ft. to provide a minimum 1-hr fire seperation.</p> | Within 3 months |

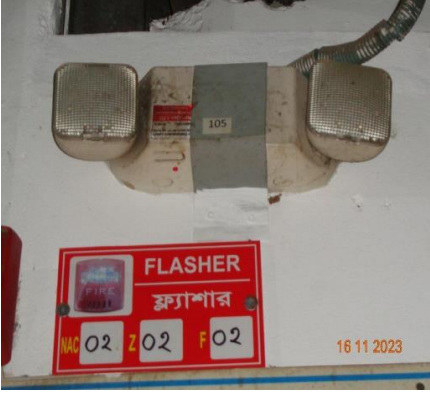
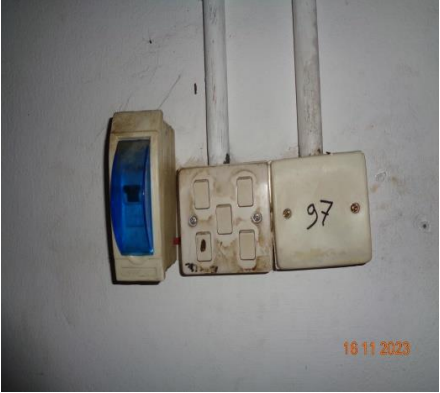
| F-4 | Egress Lighting | <p>Manual on-off switch is provided for emergency lighting / exit sign units.<br/> <b>Location:</b> Fabric store.</p> | <p>Remove manual on/off switches from emergency lighting / exit signage units to prevent them from being switched off.</p> | <p>Within 1 month</p> |

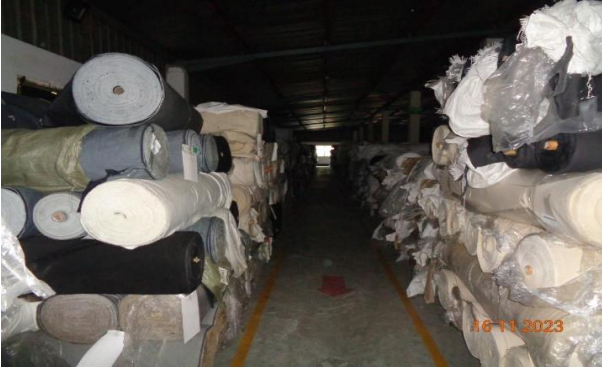
| F-7 | Means of Egress | Travel distance of egress exceeds limit on the Fabric store. | Reconfigure the egress arrangement or provide an additional exit so that the travel distance for group H occupancies shall not exceed 30m (100ft). | Within 1 months |

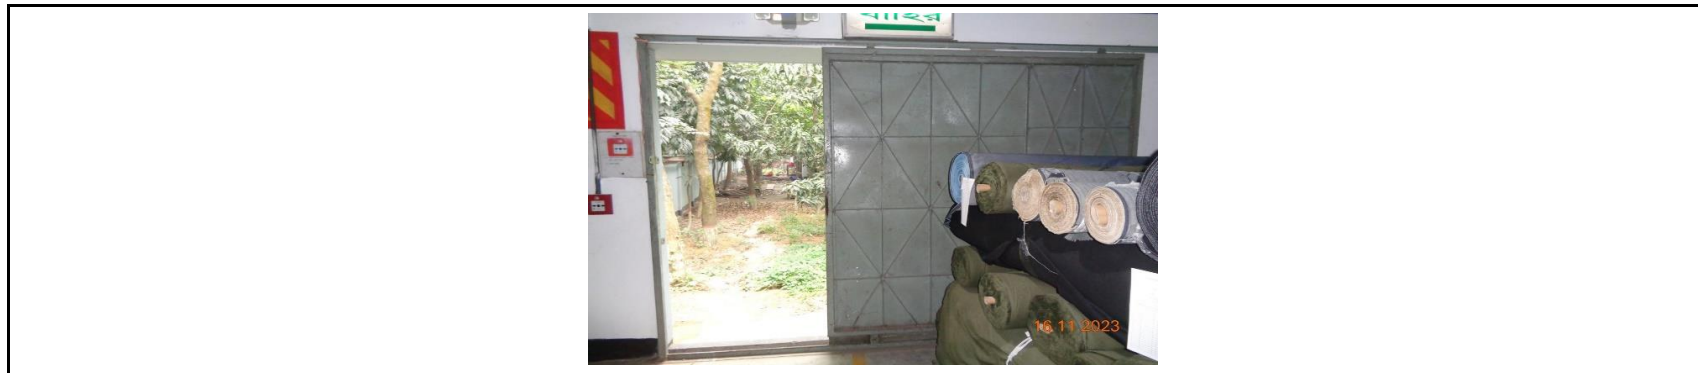
| F-9 | Means of Egress | Sliding doors are provided at building exits.<br><b>Location:</b> Fabric store. | Replace all collapsible and sliding doors along the means of egress with side-hinged, swinging egress doors. | Within 1 month |

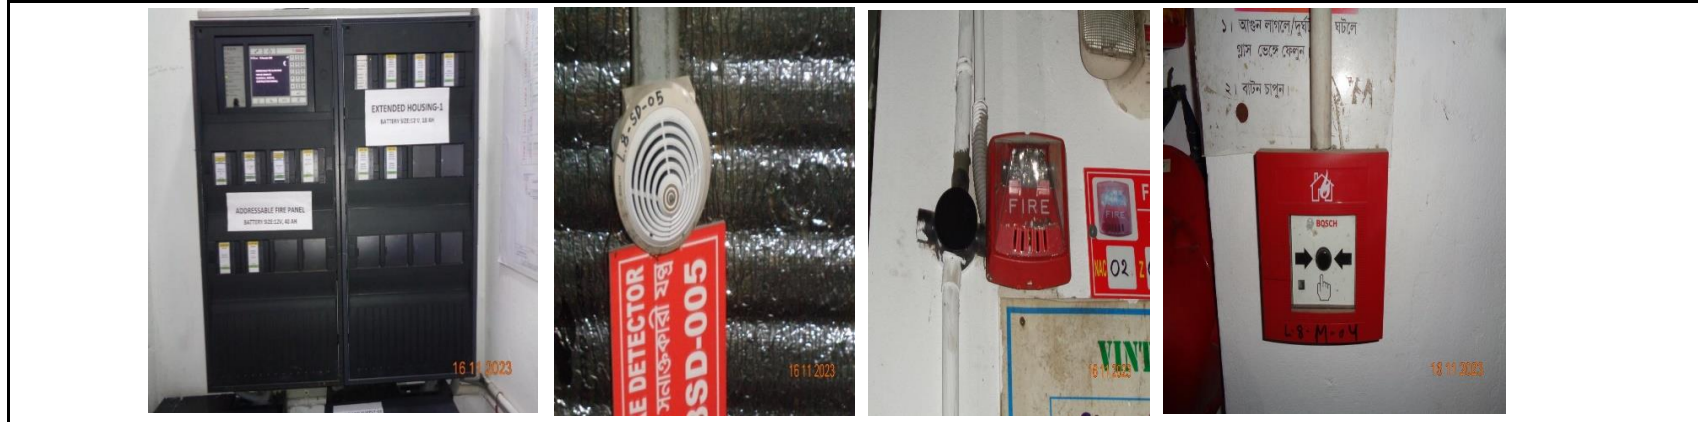
| F-10 | Fire Alarm and Detection System (FADS) | The addressable fire alarm and detection system integrally installed with an existing ID(10196) buildings which has gone through T&C process and currently under Final Verification stage. | The outstanding issues related to the system shall be remediated following the last T&CVI report of ID-10196 and apply RSC for Final Verification Inspection (FVI). The design and docuemnts shall be updated combinly with old ID. | within 1 Month |
