# Probashi Knitwear Ltd. (Relocated)

Plot: 1,3,5,6,7,8, Block-N, Eastern Houseing, Pallabi 2nd Phase, Mirpur-12, Dhaka-1216, Bangladesh.  
(23.835684, 90.354626)

12 November 2023

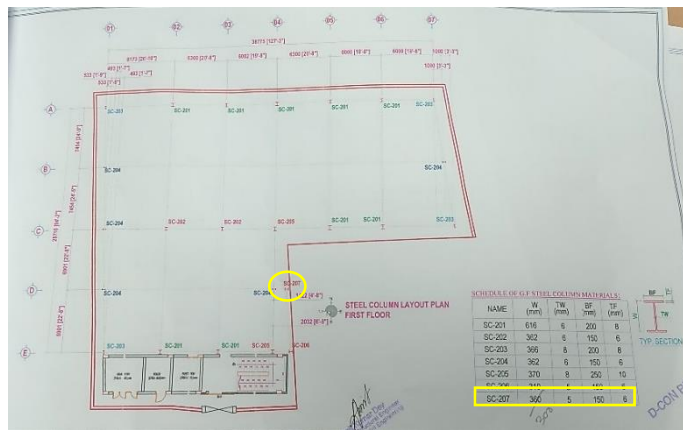
Column Layout (1<sup>st</sup> floor)

### Observation-1: Mismatch in as-built drawing. (Main Production Building)

**Description:** Web of SC 207 column on 1<sup>st</sup> floor not matched with drawings. 300 mm web was found instead of 350 mm. Moreover, the wall bracing sectional details of grid 07 did not fully match with onsite condition. The building engineer is required to survey the structure and prepare accurate as-built drawings.

| Observation | Action Plan | Timeline |
|---|---|---|
| Mismatch in as-built drawing. (Main Production Building) | Building engineer is required to survey the structure and prepare accurate as-built drawings. | within 6 weeks |

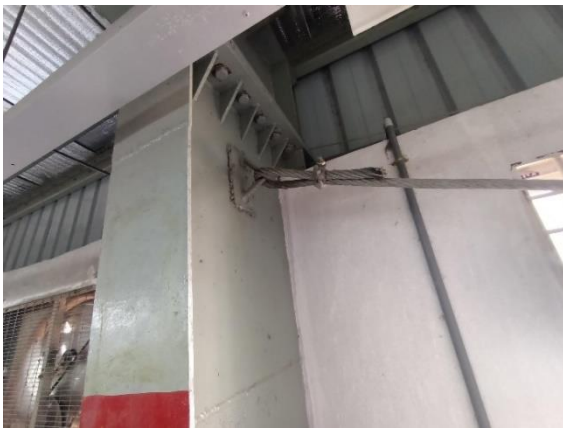
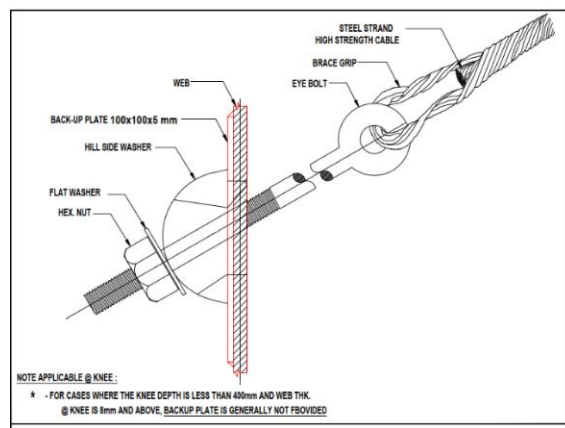
Improper connection

**Description:** Bracings are not connected as per drawings. Only hooks bar are used for connection. Building engineer is required to update the as-built drawing with connection details.

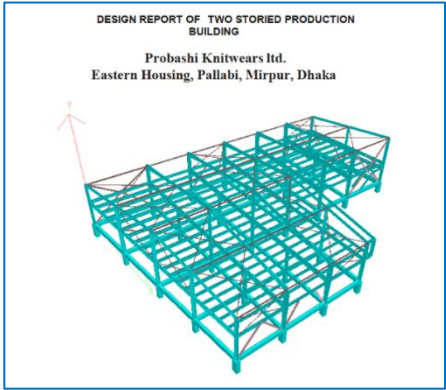
| 3D view of the framing system (L-shaped building) | Corner of the building |
| <b>Description:</b> A set of design reports have been prepared considering Ordinary Concentrically Braced Frame (OCBF). But re-entrant corner and torsional irregularity check are not provided in the design report. The prepared design report needs to be revised incorporating the mentioned issues and submitted to RSC for review. | |

| Observation | Action Plan | Timeline |
|---|---|---|
| Re-entrant corner and torsional irregularity check were not found in the design report. (Main Production Shed) | Prepared design report to be revised incorporating the mentioned issues and submitted to the RSC for review. | within 6 weeks |
| Re-entrant corner and torsional irregularity check were not found in the design report. (Main Production Shed) | Carry out remediation work if required. | within 6 months |

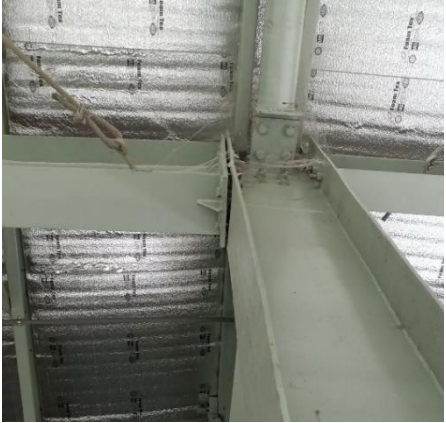
| Connection gap | Bolt/nut missing |
| <b>Description:</b> Nut/bolt missing, and significant gaps observed in beam joint at several locations. Building engineer is required to install missing nut/bolts and repair the gap with suitable method. | |

| Observation | Action Plan | Timeline |
|---|---|---|
| Nut/bolt missing and connection gap. (Main Production Shed) | Building engineer is required to install missing nut/bolts and repair the gap with suitable method. | within 6 weeks |

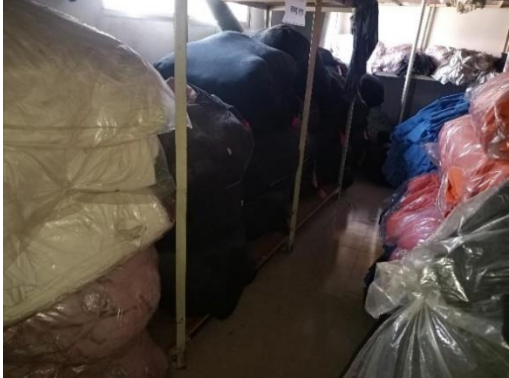
| Racks | Plastic tank |
| <b>Description:</b> Some racks on floors (Main Production Building) and plastic water tanks on the roof (Utility Building) were not anchored or braced to resist lateral (earthquake) forces. The factory is required to anchor/brace all non-structural elements adequately to resist earthquake forces. | |

| Observation | Action Plan | Timeline |
|---|---|---|
| Non-structural elements not anchored or braced. (Main Production Shed and Utility Building). | The factory is required to anchor/brace all non-structural elements adequately to resist earthquake forces. | within 6 months |
