# Islam Garments Ltd. (Knitwear Division) (Extension)

Block-F, Holding # 119/1, Jarun, Konabari, Gazipur  
(23.995441, 90.327008)

6 November 2023

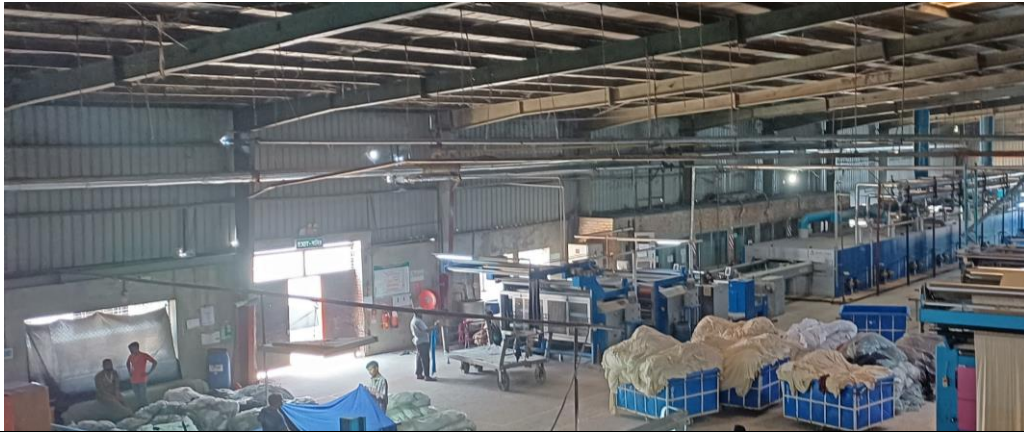
**Observation 1:** Lack of lateral stability system.

No compression strut in the long direction

**Description:** Portal frame was observed in the short direction. Compression strut or load transfer media was not observed in the long direction.

| Observation | Action Plan | Timeline |
|---|---|---|
| Lack of lateral stability system. (Shed-9) | Building engineer is required to check the lateral stability of the shed as part of the Engineering Assessment (EA). | within 6 weeks |
| | Carry out remedial work where required. | within 6 months |

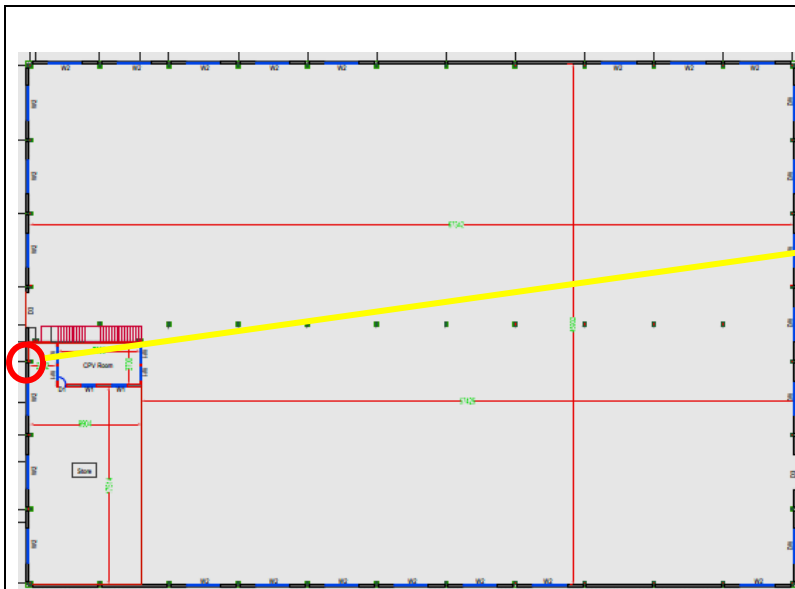
Mezzanine Floor Plan

**Observation 2:** Mismatches in as-built drawing.

| Observation | Action Plan | Timeline |
|---|---|---|
| Mismatches in as-built drawing. (Shed-9) | Building engineer is required to prepare accurate as-built drawings as per site condition. | within 6 weeks |

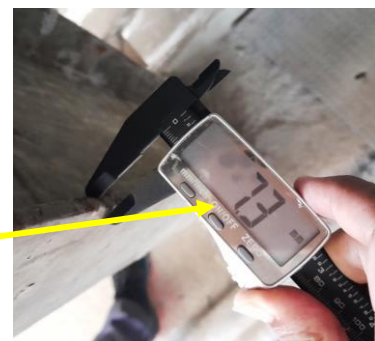
Steel column schedule

**Description:** Flange thickness of SC-1 column was found 7.3 mm instead of 8mm.

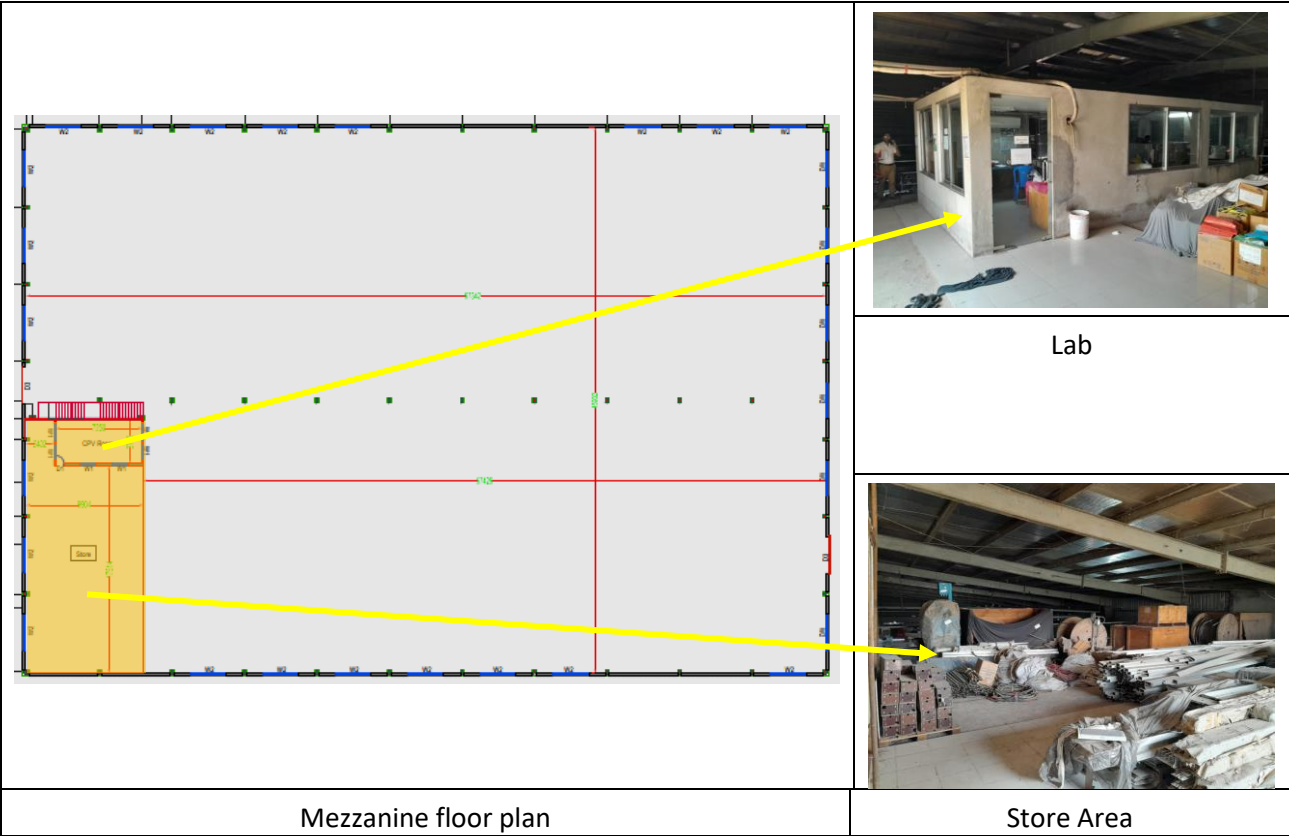
**Observation-3:** Load plan not prepared for the mezzanine floor.

**Description:** Load plan was not prepared for the mezzanine floor.

| Observation | Action Plan | Timeline |
|---|---|---|
| Load Plan not prepared for the Mezzanine floor. (Shed-9) | Building engineer is required to produce load plan for mezzanine floor. | within 6 weeks |

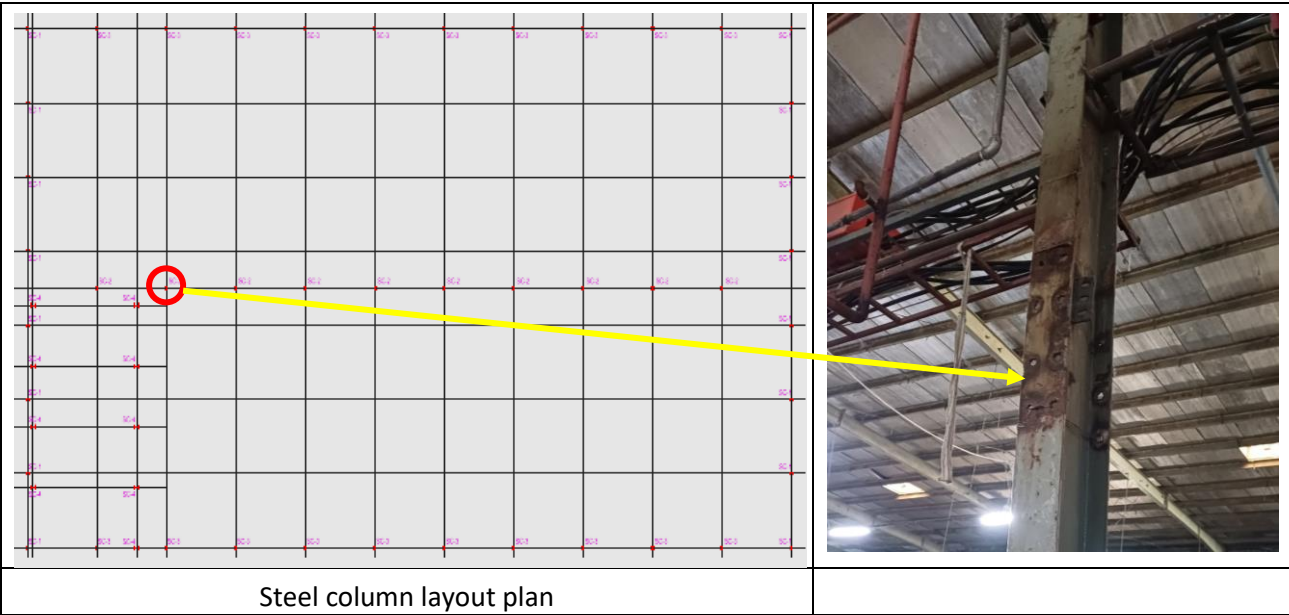
**Observation-4:** Perforation on steel column.

**Description:** Perforation was found at flange of several columns.

| Observation | Action Plan | Timeline |
|---|---|---|
| Perforation on steel column. (Shed-9) | Building engineer is required to rectify the perforated area of steel columns by a suitable method. | within 6 weeks |

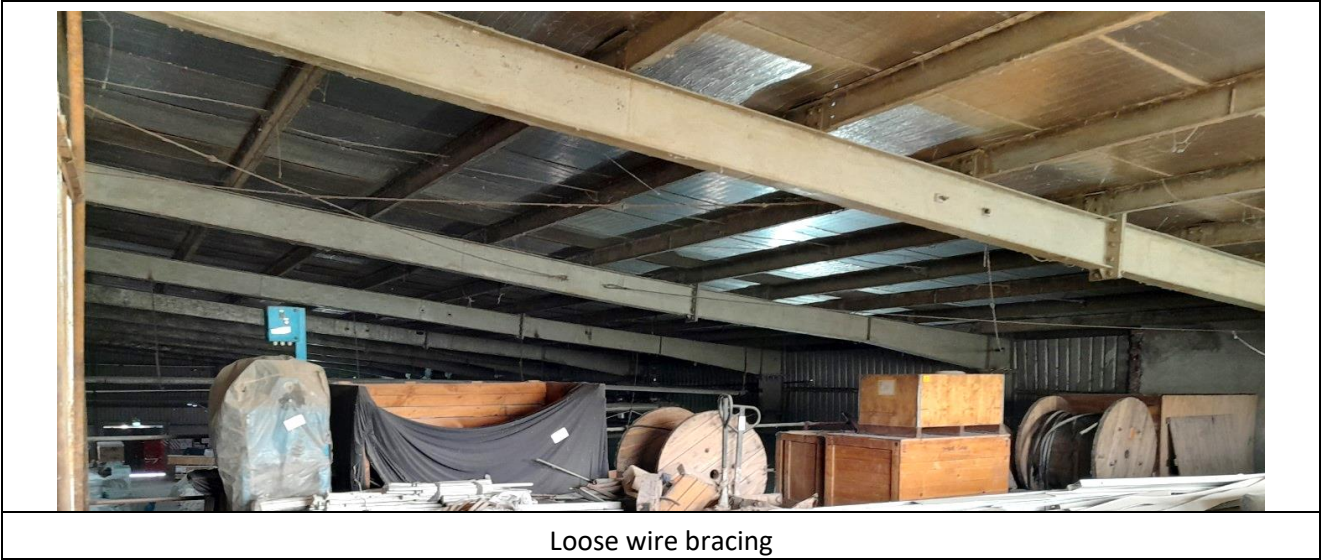
**Observation-5:** Loose roof bracing.

**Description:** Roof wire bracing was found as loosened state.

| Observation | Action Plan | Timeline |
|---|---|---|
| Loose roof bracing. (Shed-9) | Tighten the loose bracing. | within 6 months |

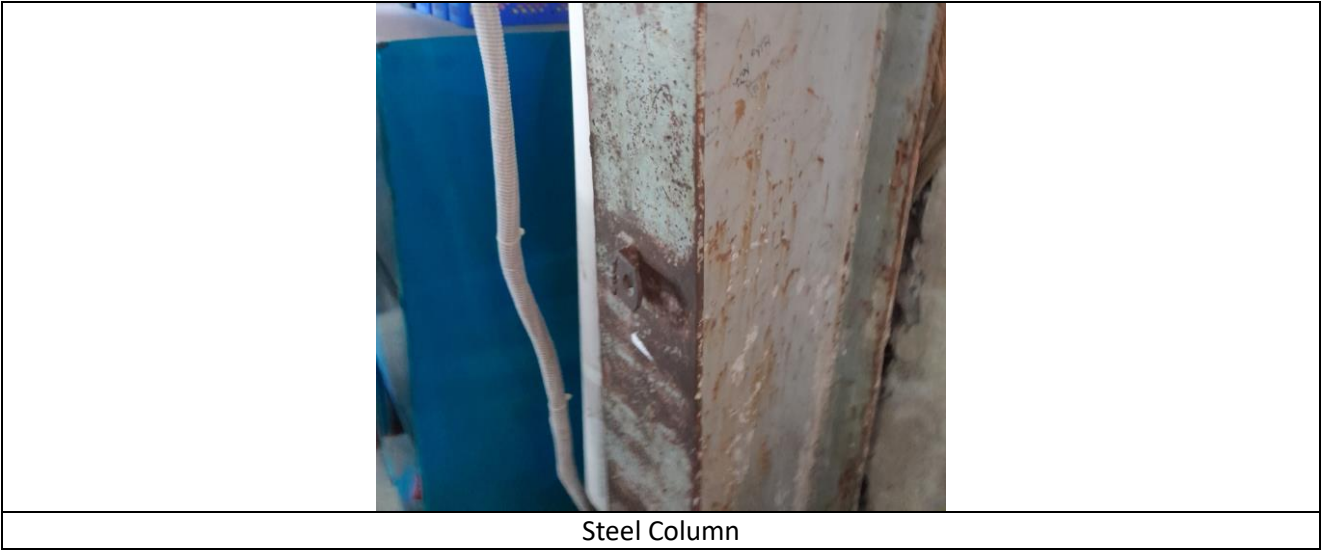
**Observation-6:** Corrosion on steel members.

**Description:** Corrosion was observed on some steel members.

| Observation | Action Plan | Timeline |
|---|---|---|
| Corrosion on steel members. (Shed-9) | Apply rust proof paint on corroded members. | within 6 months |

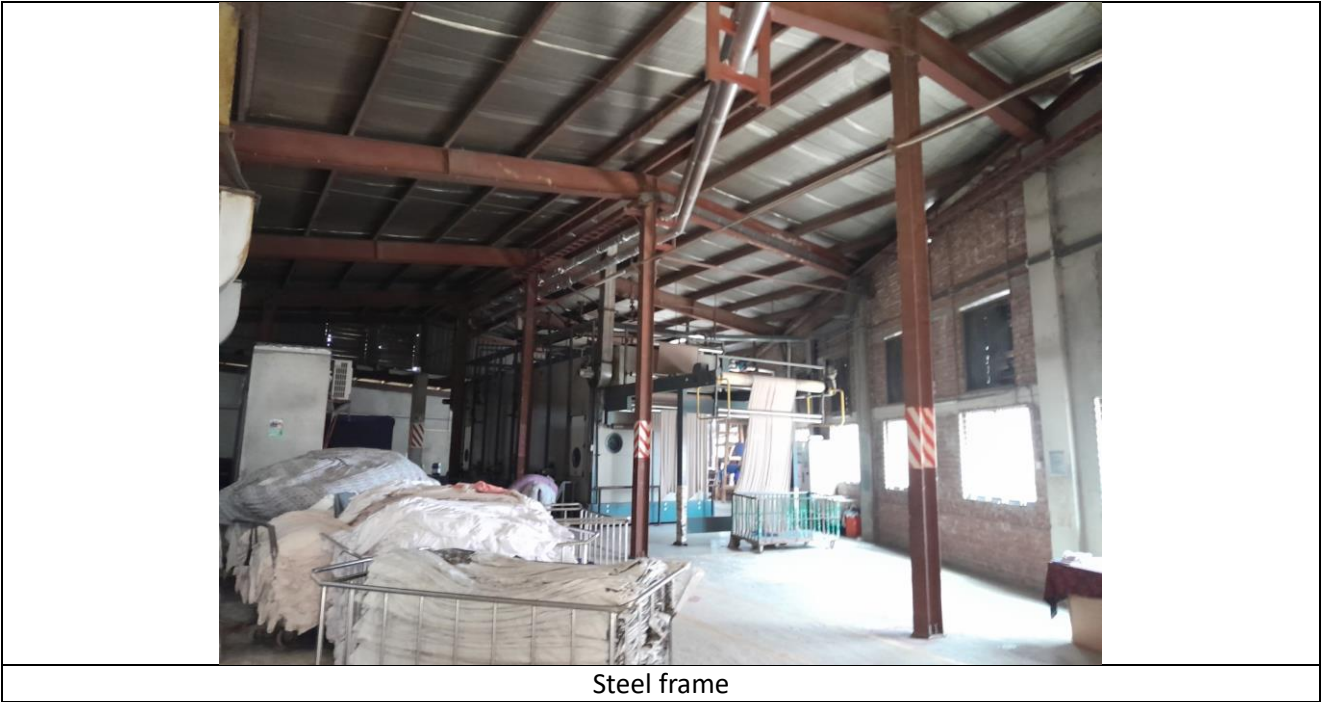
Steel frame

**Observation-7:** Absence of lateral stability.

**Description:** Undefined lateral stability system was observed.

| Observation | Action Plan | Timeline |
|---|---|---|
| Absence of lateral stability. (Shed-17) | Building engineer is required to check the lateral stability of the shed as part of the Engineering Assessment (EA). | within 6 weeks |
| | Carry out remedial work where required. | within 6 months |
