# KAC Fashion Wear Ltd (Extension 2)

29 November 2023

## Structural Inspection Report

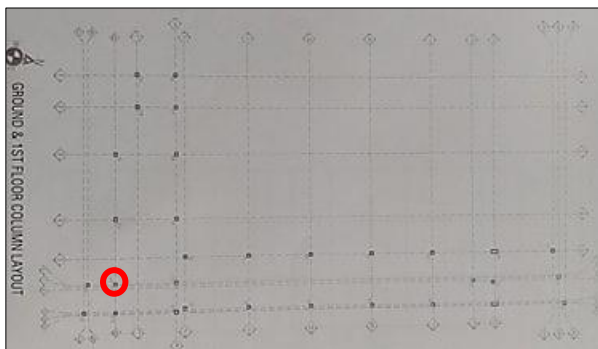
Column layout

### Observation-1: High stress in column & foundation.

**Description:** Cursory calculation indicates that the stress in column & foundation exceeds normal design limit considering 2 kPa floor live load, overhead water tank loads based on minimum concrete strength (14.1 MPa) and ultimate soil bearing capacity (1.5 tsf) from test report. The building engineer is required to check the design, loads and stress of columns & foundations of the building based on in-situ material strength & actual soil bearing capacity and suggest necessary remedial actions accordingly. Also, suggest immediate action if required by further testing & calculation.

| Item | Observation | Action Plan | Timeline |
|---|---|---|---|
| 01 | High stress in column & foundation. (Office Building) | Verify in-situ material strength by taking a minimum of 4 cores from the lower tier of existing column. | within 6 weeks |
| 02 | High stress in column & foundation. (Office Building) | Investigate the bearing capacity of soil around the close vicinity of the building foundations. | within 6 weeks |
| 03 | High stress in column & foundation. (Office Building) | Conduct Detail Engineering Assessment (DEA) to check the design, loads and stress of columns & foundations of the building based on in-situ material strength and soil bearing capacity. | within 6 weeks |
| 04 | High stress in column & foundation. (Office Building) | Produce and actively manage a floor loading plan for all floor plates based on foundation, column & floor capacity. | within 6 weeks |
| 05 | High stress in column & foundation. (Office Building) | Carry out suggested remedial works if required. | within 6 months |
| 06 | High stress in column & foundation. (Office Building) | Implement floor load management program. | within 6 months |

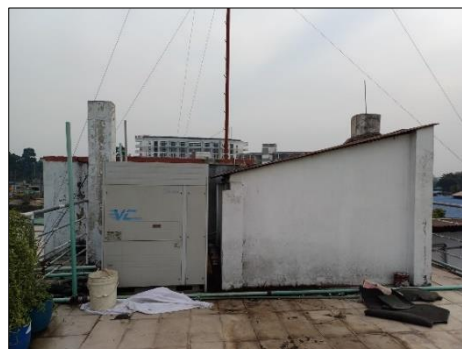
OHT, tower & electrical equipment at roof

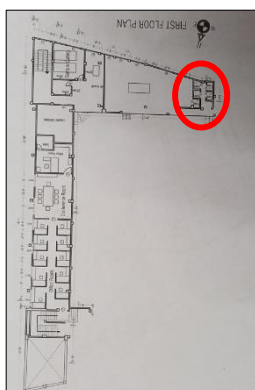
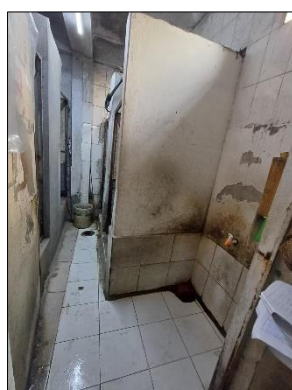
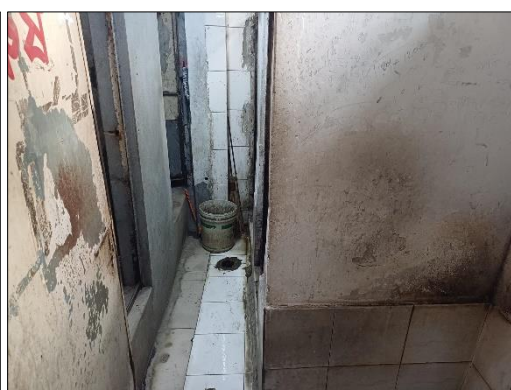
### Observation-2: High loading on cantilever slab.

**Description:** High floor-built ups (350mm at left toilets & 200 mm at right toilets) and partition walls were observed on the 125 mm cantilever slab. The span-depth ratio of the slab exceeds the normal design limit. The building engineer is required to check the design, loads and stress in the cantilever slabs of the building based on in-situ material strength and suggest necessary remedial actions.

| Item | Observation | Action Plan | Timeline |
|---|---|---|---|
| 07 | High loading on cantilever slab. | The building engineer is required to check the design, loads and stress in the cantilever slabs based on in-situ material strength and suggest necessary remedial actions. | within 6 weeks |
| 08 | High loading on cantilever slab. | Carry out suggested remedial works. | within 6 months |

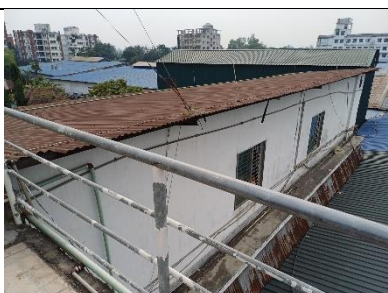
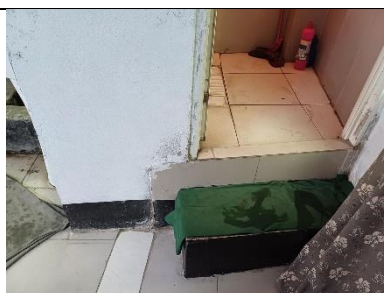
### Observation-3: Lack of information in provided drawing.

**Description:** Telecom tower, high floor-built ups, steel connection details and level difference & expansion joint between north & south parts were not mentioned in the drawings.

| Item | Observation | Action Plan | Timeline |
|---|---|---|---|
| 09 | Lack of information in provided drawing. | The building engineer is required to survey the whole structure and prepare accurate as-built drawings. | within 6 weeks |

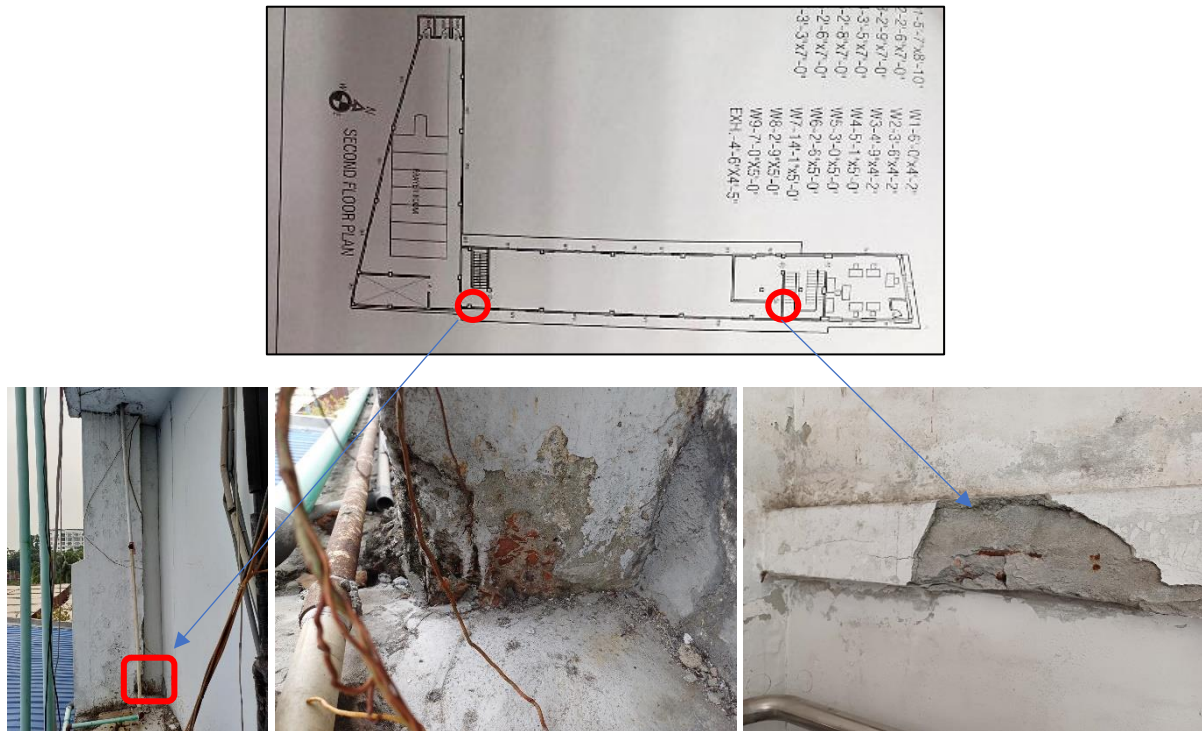
**Observation-4:** Severe corrosion of rebar in column & slab.

**Description:** Severe rebar corrosion was found on the 2nd floor column & roof slab. Furthermore, appearance of corrosion in re-bar were found in several locations of the building. The building engineer is required to investigate the reason & extents of corrosion and prepare an investigation report with necessary remedial actions.

| Item | Observation | Action Plan | Timeline |
|---|---|---|---|
| 10 | Severe corrosion of rebar in column & slab. | The building engineer is required to investigate the reason & extents of corrosion and prepare an investigation report with necessary remedial actions. | within 6 weeks |
| 11 | Severe corrosion of rebar in column & slab. | Carry out suggested remedial works. | within 6 months |

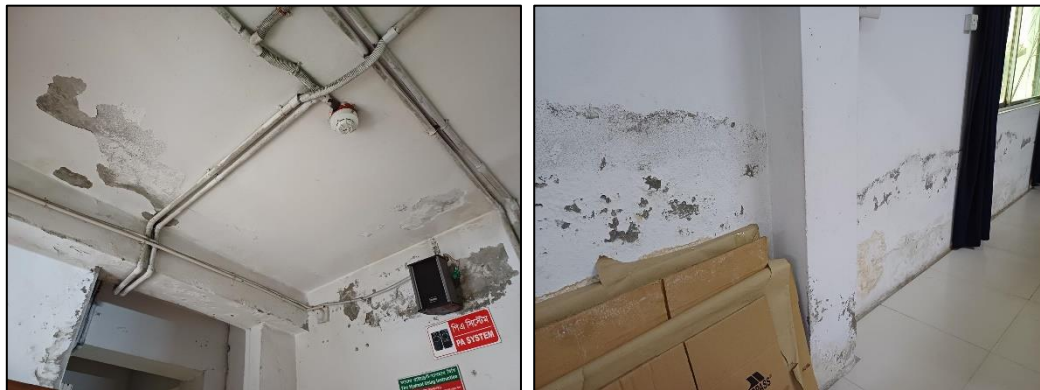
**Observation-5:** Dampness throughout the building.

**Description:** Dampness was found throughout the building. The building engineer is required to seal the source of water and carry out necessary remedial works as per engineers' suggestion.

| Item | Observation | Action Plan | Timeline |
|---|---|---|---|
| 12 | Dampness throughout the building. | The building engineer is required to seal the source of water and carry out necessary remedial works as per engineers' suggestion. | within 6 months |
