# KSI Karnaphuli Shoes Industries Ltd.(Garments) (Extension)

Plot # G1 & G2, Korean Export Processing Zone, Anowara, Chattogram-4376

21 September 2023

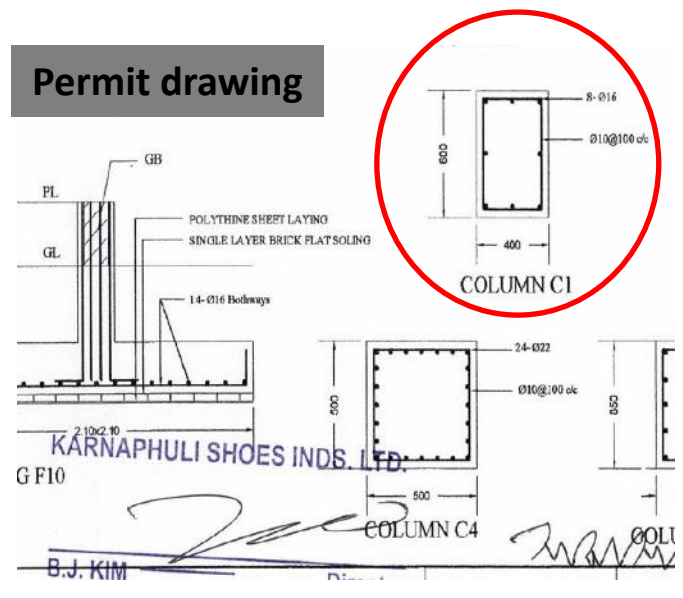
Discrepancy (Column size) between analysis file and permit drawing

Column size in the analysis file did not match with the permit drawing. Also, rebar tensile strength is considered 72,500 psi but in analysis, 60,000 psi is assigned. Factory is required to revise the design documents and submit to RSC for further review.

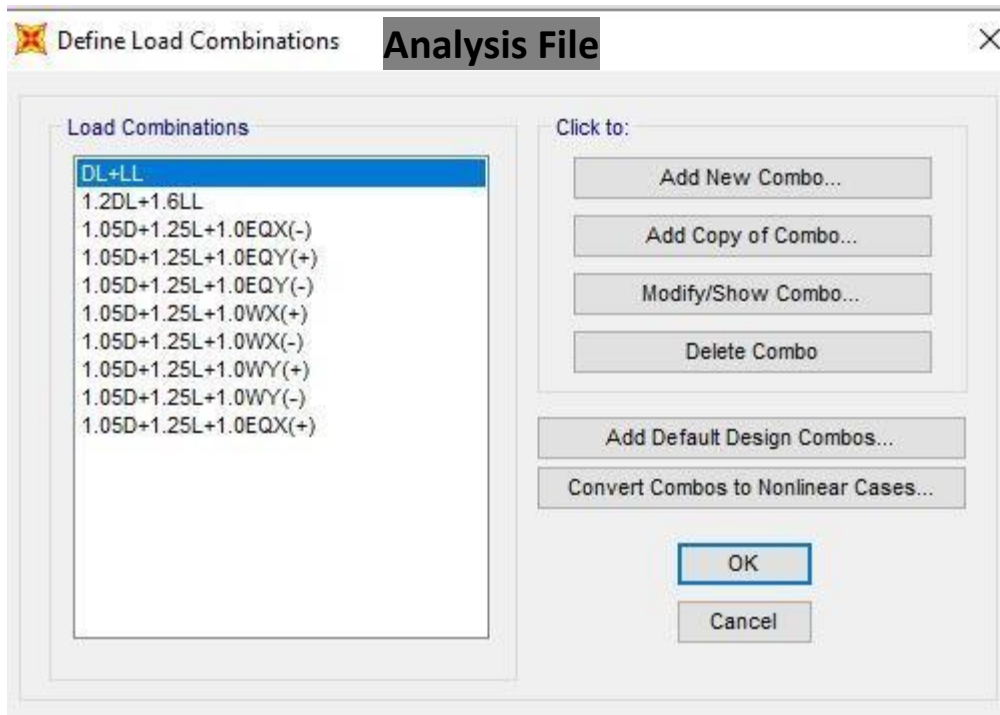
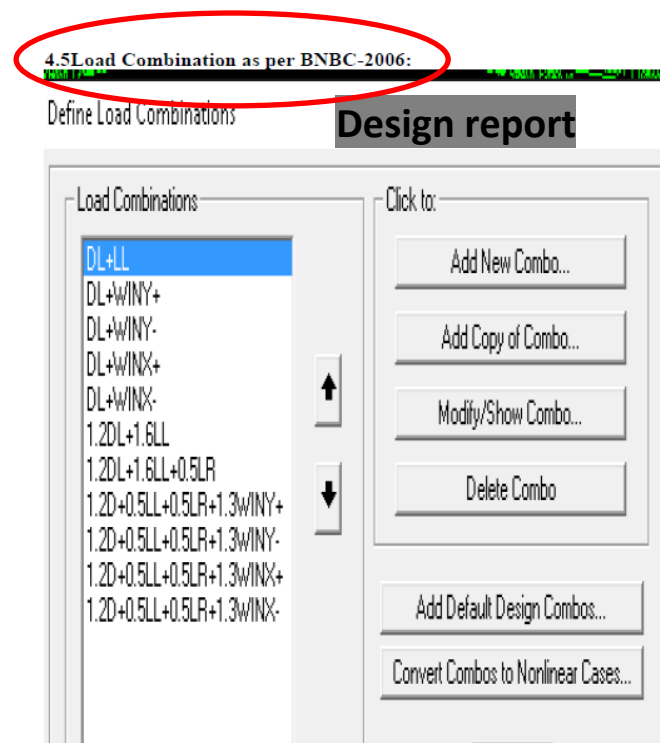
Discrepancy (Material strength) between analysis file and design report

## Discrepancy in load combination between analysis file and design report

Load combination in analysis file does not match with the provided load combination (BNBC-2006) in design report. Building engineer is required to revise both analysis and design report following one design code.

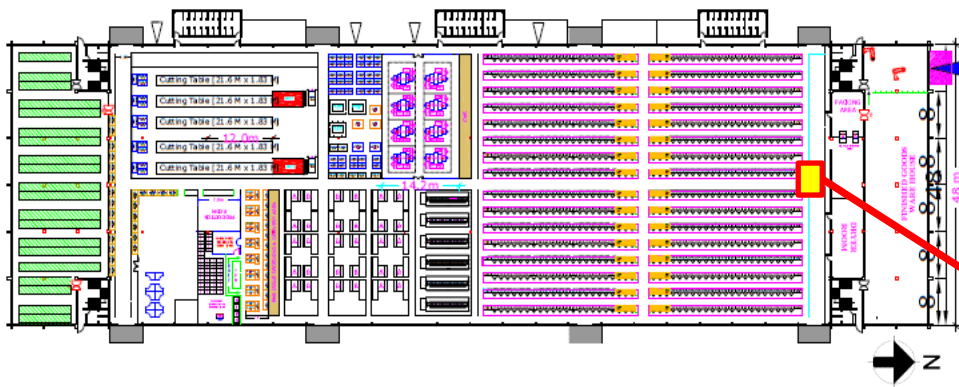
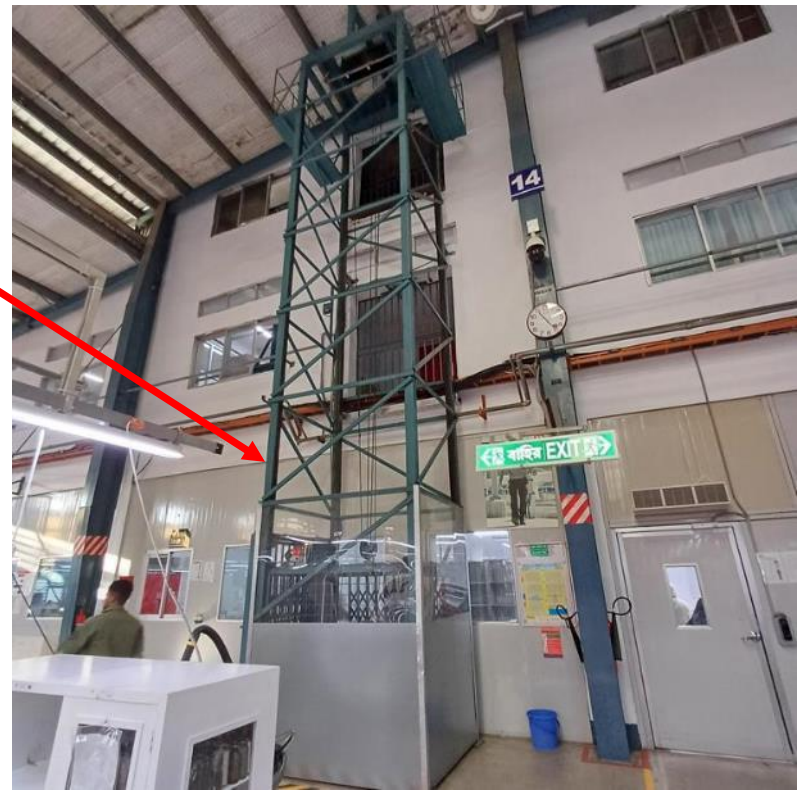
Undocumented hoist lift found

During inspection, undocumented hoist lift found at the north side of Building 14. Building engineer is required to prepare both analysis and design report for the steel hoist lift and incorporate detail calculations for all lateral loads in the design report in compliance with the BNBC (section 1.9.1 of part-6).

| Item No. | Observation | Recommended Action Plan | Recommended Timeline |
|---|---|---|---|
| 03 | Undocumented hoist lift found. (Building-14) | Building engineer is required to prepare both analysis and design report for the steel hoist lift and incorporate detail calculations for all lateral loads in the design report in compliance with the BNBC (section 1.9.1 of part-6). | 6-weeks |

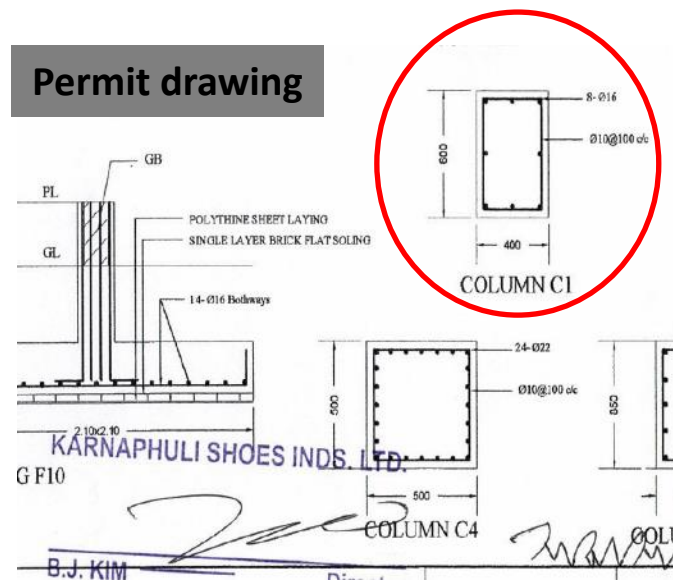
Column size discrepancy between analysis file and permit drawing

Column size in the analysis file did not match with the permit drawing. Also, rebar tensile strength is considered 72,500 psi but in analysis, 60,000 psi is assigned. Factory is required to revise the design documents and submit to RSC for further review.

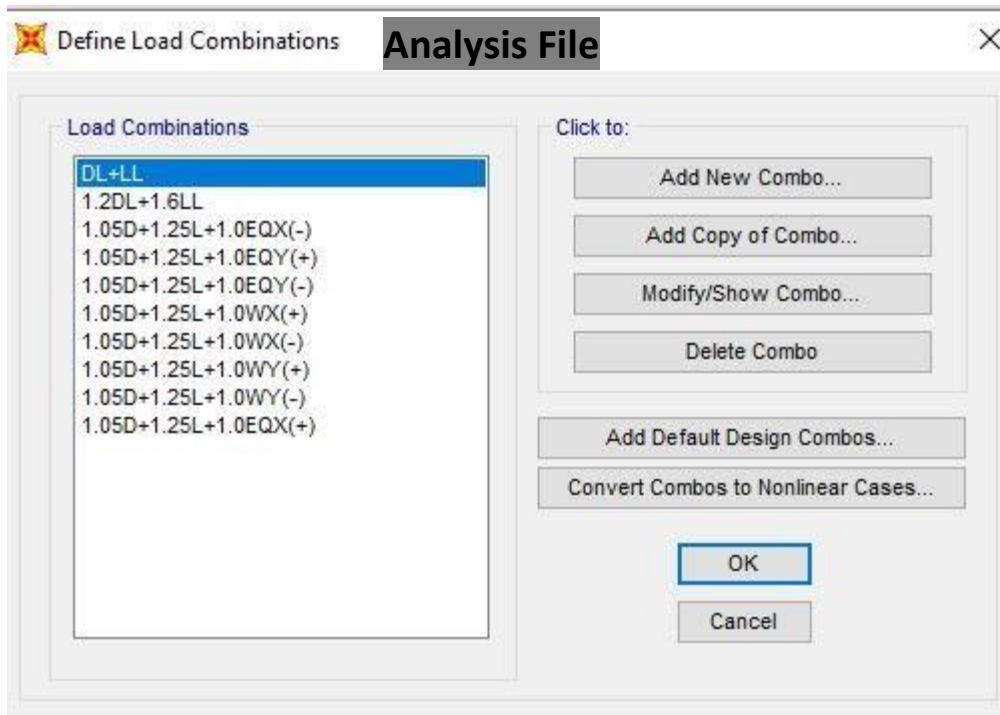
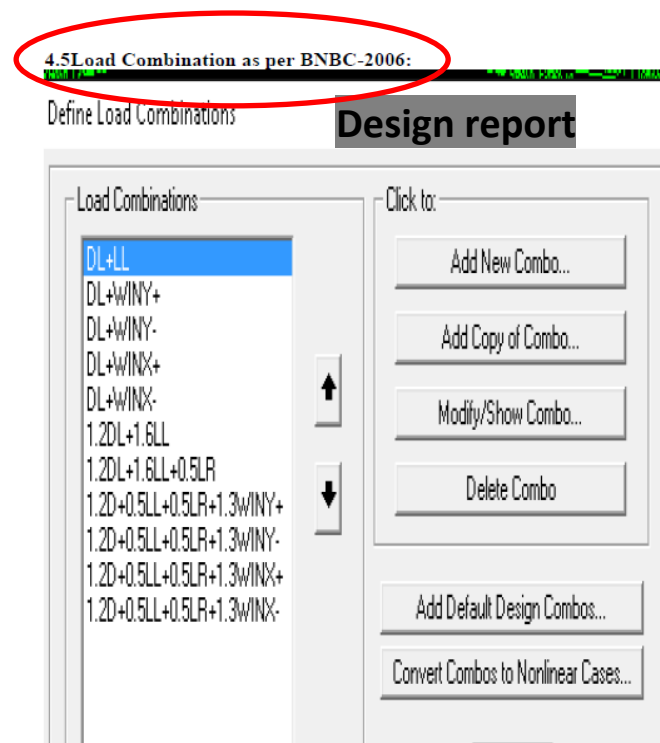
Material strength discrepancy between analysis file and design report

## Discrepancy in load combination between analysis file and design report

Load combination in analysis file does not match with the provided load combination (BNBC-2006) in design report. Building engineer is required to revise both analysis and design report following one design code.

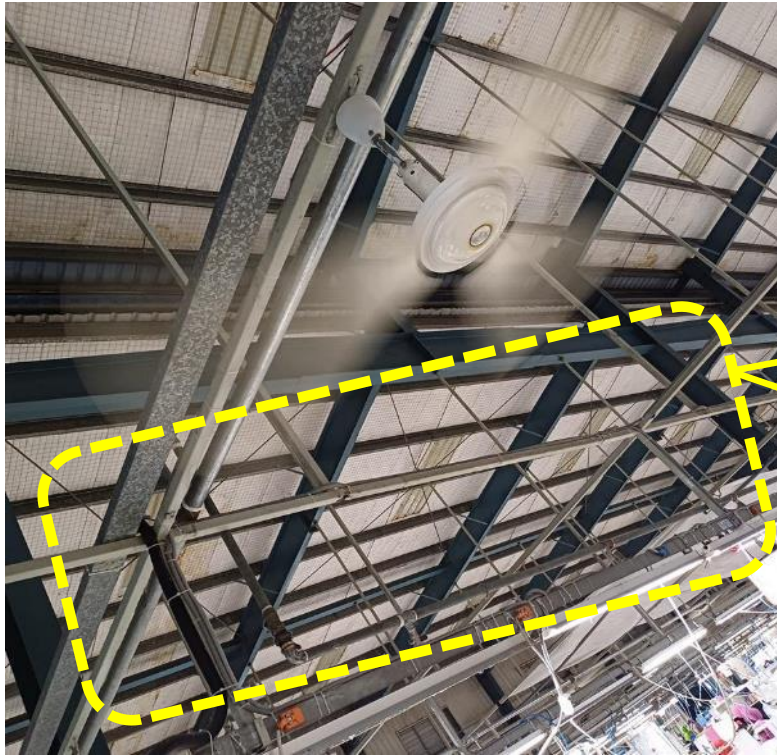
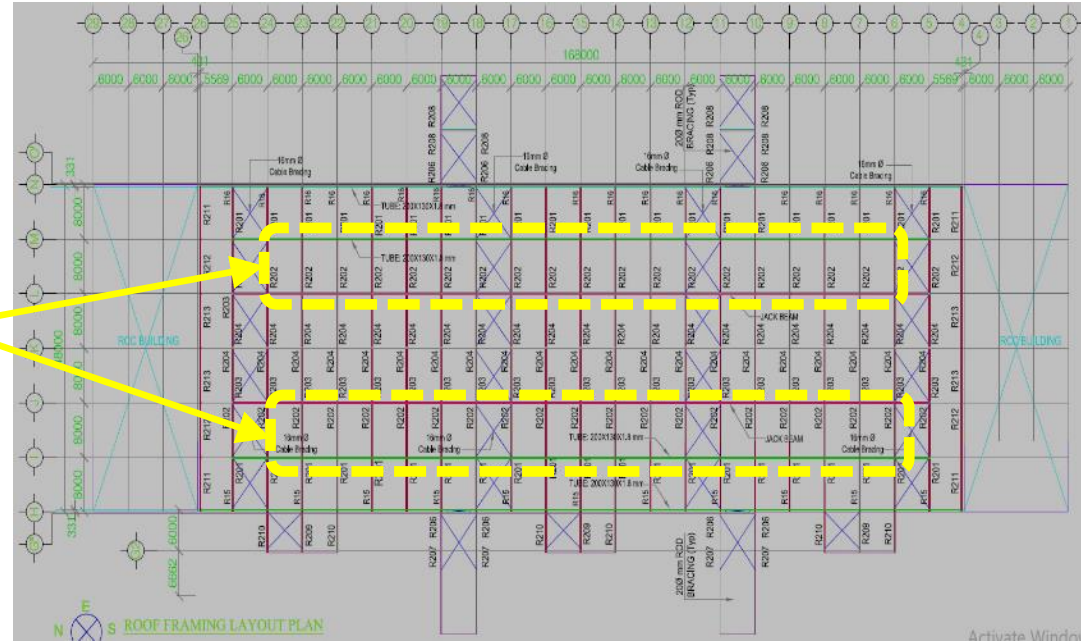
On site bracings does not match with the bracing layout of as-built drawing

During inspection, bracings were found on site which were not shown in the bracing layout of as-built drawing. Factory engineer is required to survey the whole structure and update the as-built drawing. Also, Building engineer is required to update the design document in compliance with section 1.9.1 as per BNBC 2006.

| Item No. | Observation | Recommended Action Plan | Recommended Timeline |
|---|---|---|---|
| 07 | Discrepancies and missing information in as-built drawing. (Building-18) | Building engineer is required to update the design document including in compliance with section 1.9.1 as per BNBC 2006. | 6-weeks |

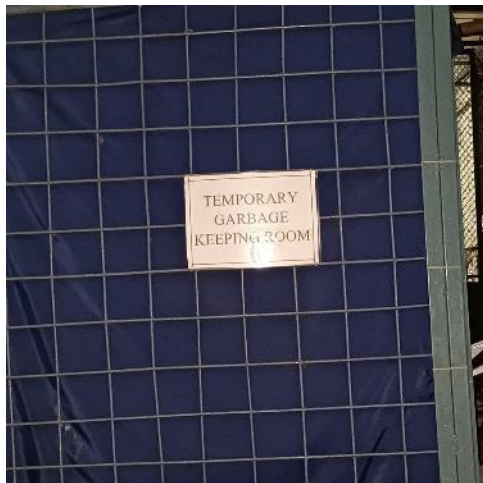
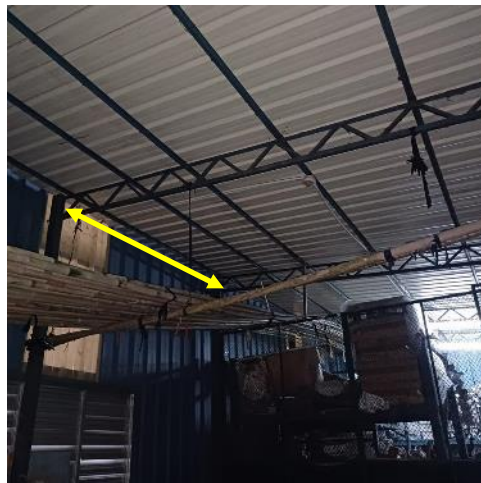
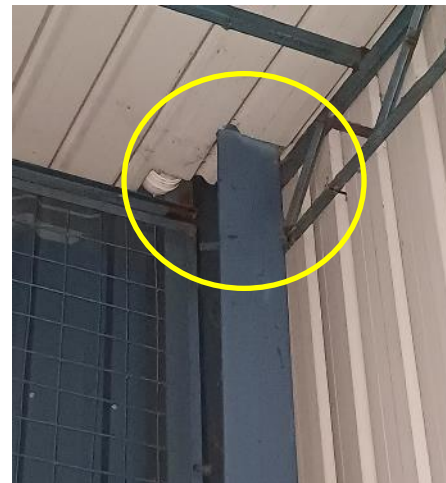
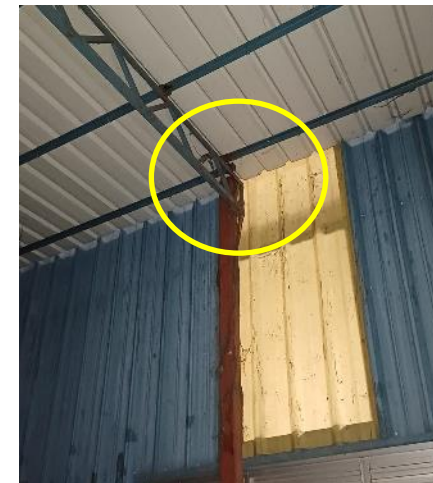
Lack of lateral stability in Temporary Garbage Store

Apparently inadequate connection in store room

Connection of steel truss members to steel columns were appeared to be inadequate. Factory engineer is required to check the connection adequacy for uplift forces as part of EA.

Also, lack of lateral stability was found in adjacent steel sheds (Temporary garbage store, store room and material store). Building engineer is required to check the lateral stability of the structures.

| Item No. | Observation | Recommended Action Plan | Recommended Timeline |
|---|---|---|---|
| 09 | Lack of lateral stability and inadequate connection. (Building-18) | Building engineer is required to check the lateral stability of the structures. | 6-weeks |

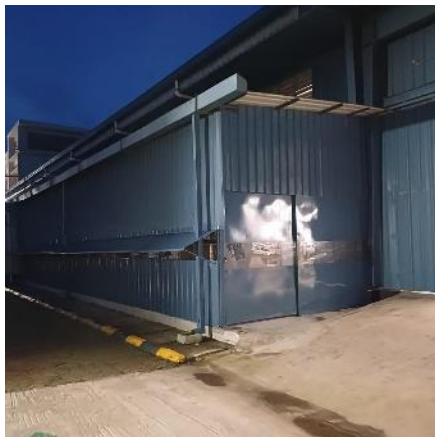
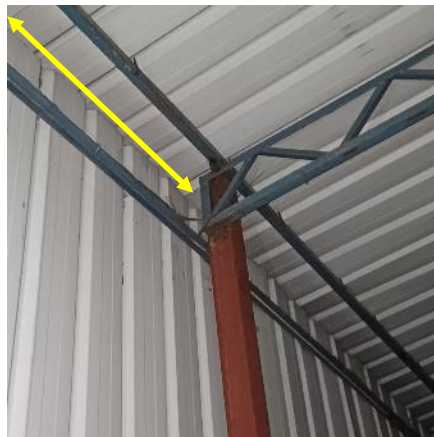
Lack of lateral stability in Material Store

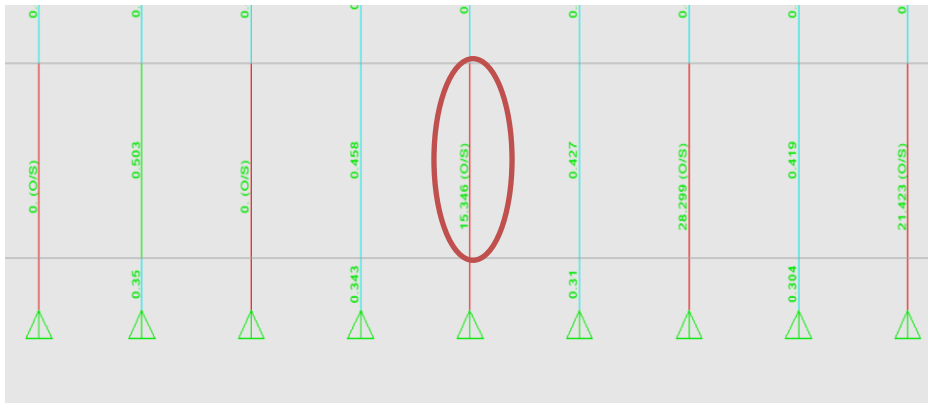
Overstress column (RCC) in FEA model

Design strength of concrete is considered 3500 Psi. in the analysis

A design report was available on site which indicate stone chips was considered for concrete design. But brick chips was found on site. In FEA model RC OHWT load was not assigned and some overstressed columns were also observed both in RC and steel part. Building engineer is required to update the FEA model, design report and other requirements as per BNBC.

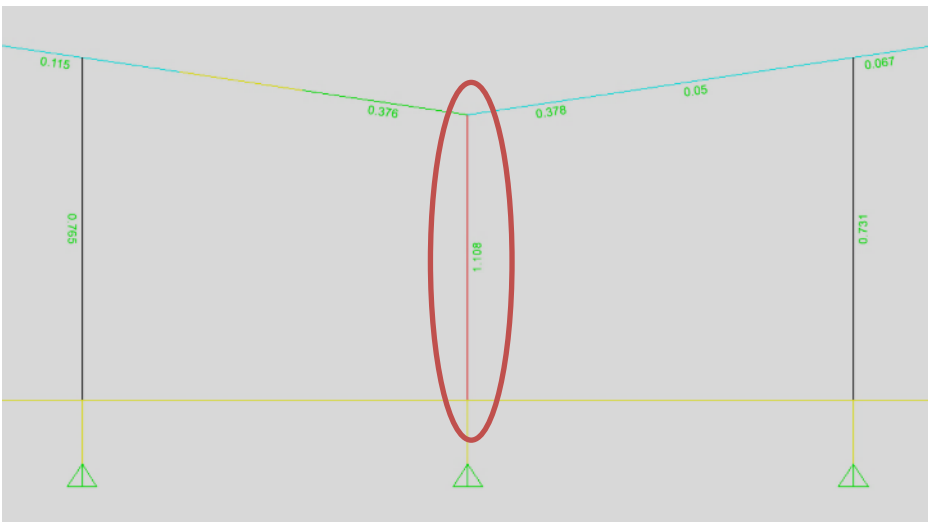
Overstress column (Steel) in FEA model

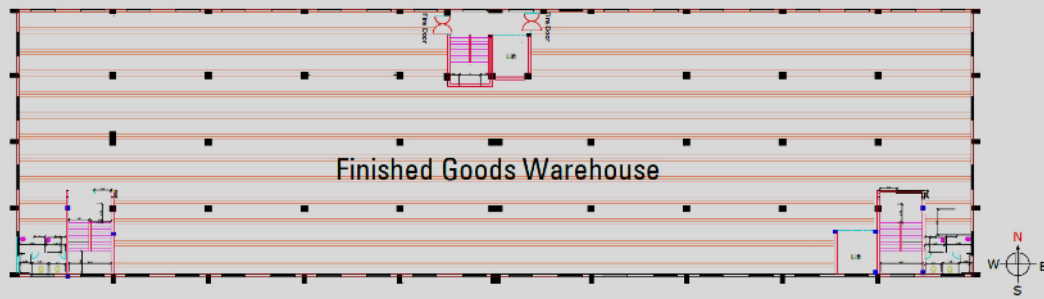
2<sup>nd</sup> floor (South part) load plan: Finished goods warehouse:  
3 kN/m<sup>2</sup> live load

The first and second floor of south part of the building is allotted for storage. As per BNBC, the minimum floor live load for storage is 6 kN/m<sup>2</sup> (126 psf). But the first and second floor of the building is designed for 3 kN/m<sup>2</sup> live loads. Factory engineer is required to revise the load plan and related design documents based on BNBC requirement.

| Item No. | Observation | Recommended Action Plan | Recommended Timeline |
|---|---|---|---|
| 14 | Load plan not comply with BNBC requirements. (Building-19) | Implement the recommendations of design report.<br>Implement floor live load plan. | 6-months |

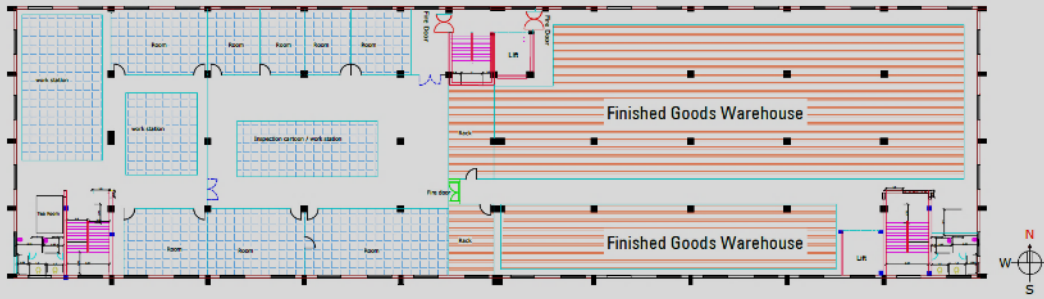
1<sup>st</sup> floor (South part) load plan: Finished goods warehouse:  
3 kN/m<sup>2</sup> live load

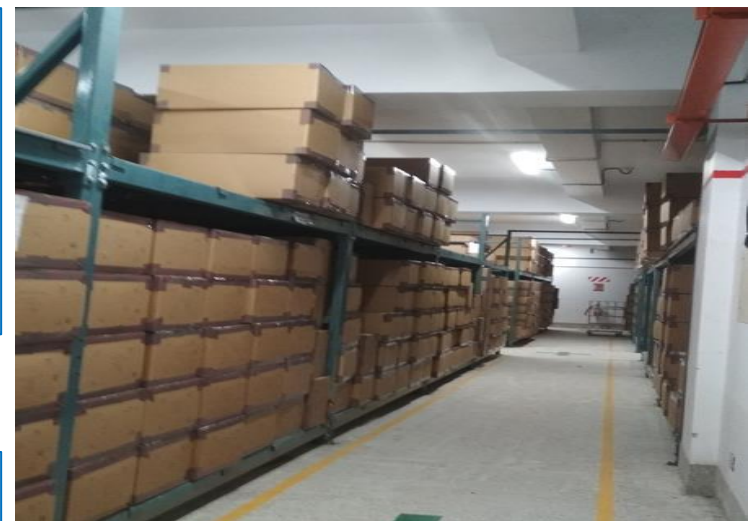
Storage on first floor

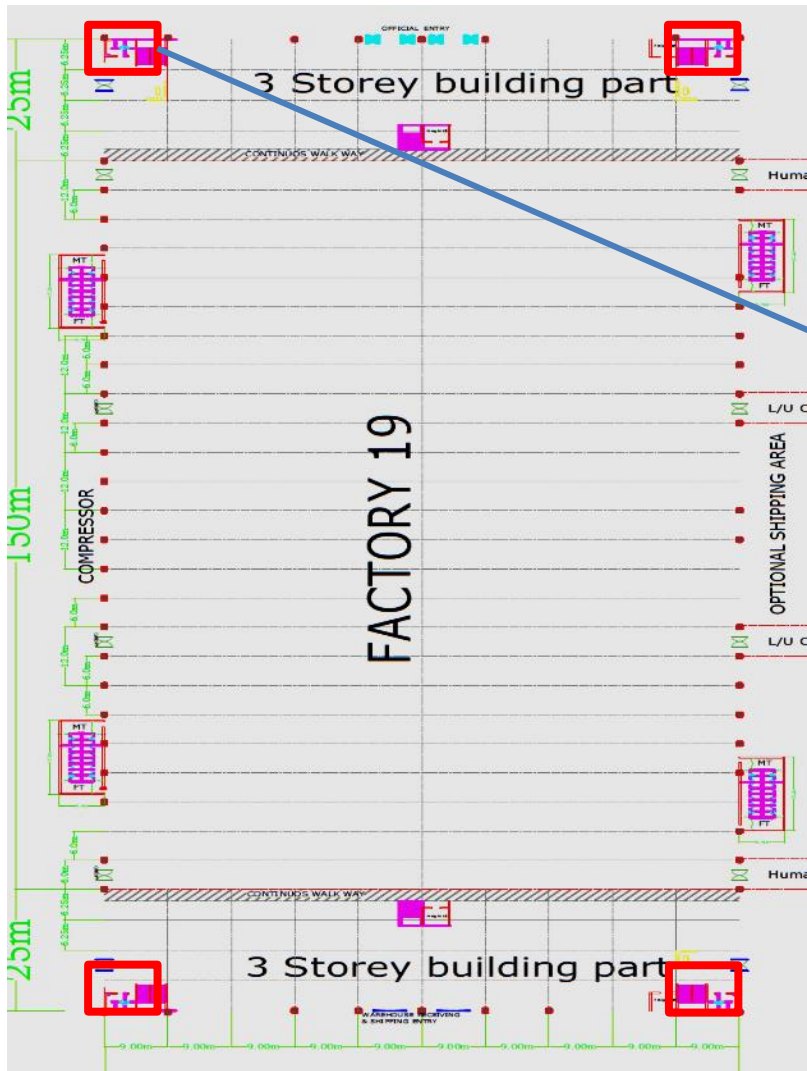
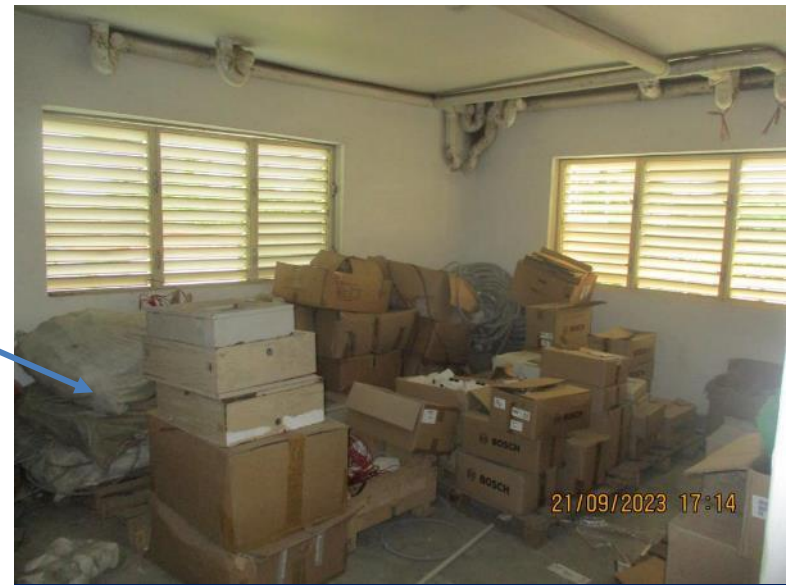
Mezzanine room (East & West)

Undocumented room at mezzanine level (ground floor) was found. Building engineer is required to survey the whole structure and prepare accurate as-built drawings.

Undocumented mezzanine level at both East & West stair (ground level) in both North and South part

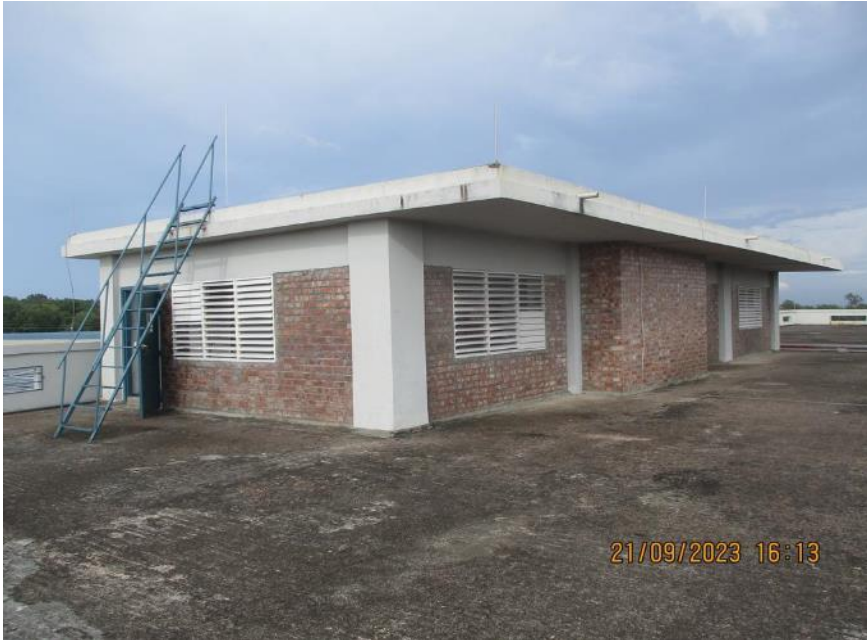
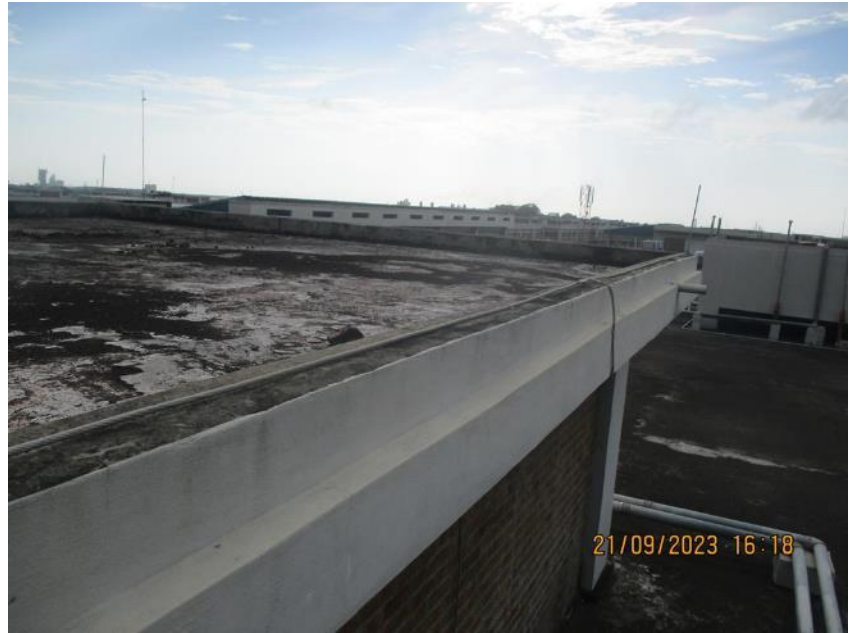
Falling hazard from stair roof top

Falling hazard observed in the stair roof top. Building engineer is required to take necessary measures to avoid possible falling hazard.

| Item No. | Observation | Recommended Action Plan | Recommended Timeline |
|---|---|---|---|
| 16 | Falling Hazard. (Building-19) | Building engineer is required to take necessary measures to avoid possible falling hazard. | 6-weeks |

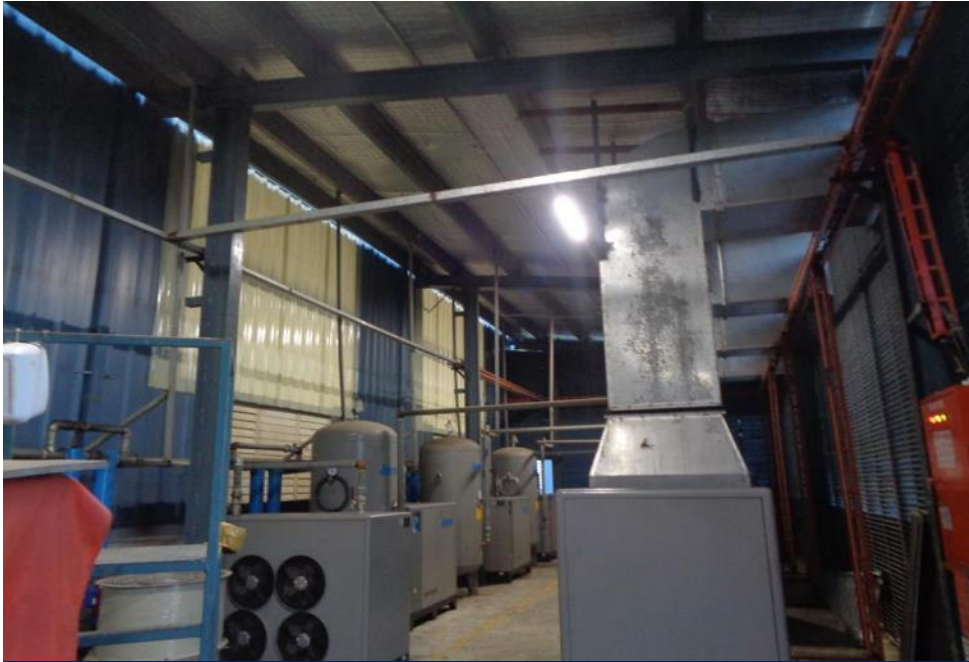
Absence of bracing system

No bracing system was observed. Also, the connection between steel column and pedestal was improper. The building engineer is required carry out Engineering Assessment (EA) to check the connection & lateral stability of the structure and suggest proper remedial actions accordingly.

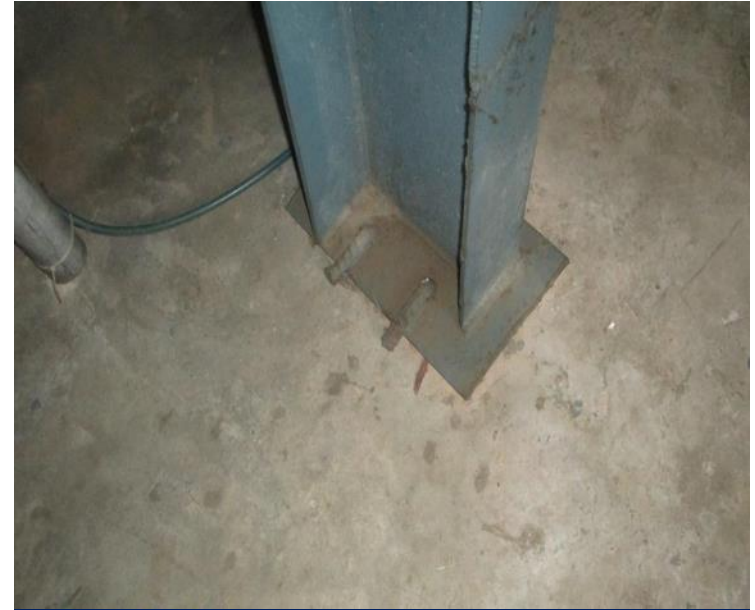
Improper connection between steel column and pedestal

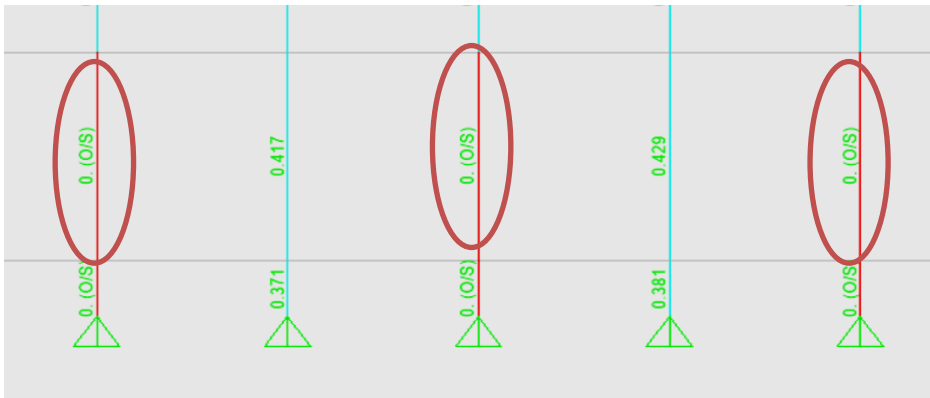
Overstress column (RCC) in FEA model

Design strength of concrete is considered 3500 Psi. in the analysis

A design report was available on site which indicate stone chips was considered for concrete design. But brick chips was found on site. In FEA model RC OHWT load was not assigned and some overstressed columns were also observed both in RC and steel part. Building engineer is required to update the FEA model, design report and other requirements as per BNBC.

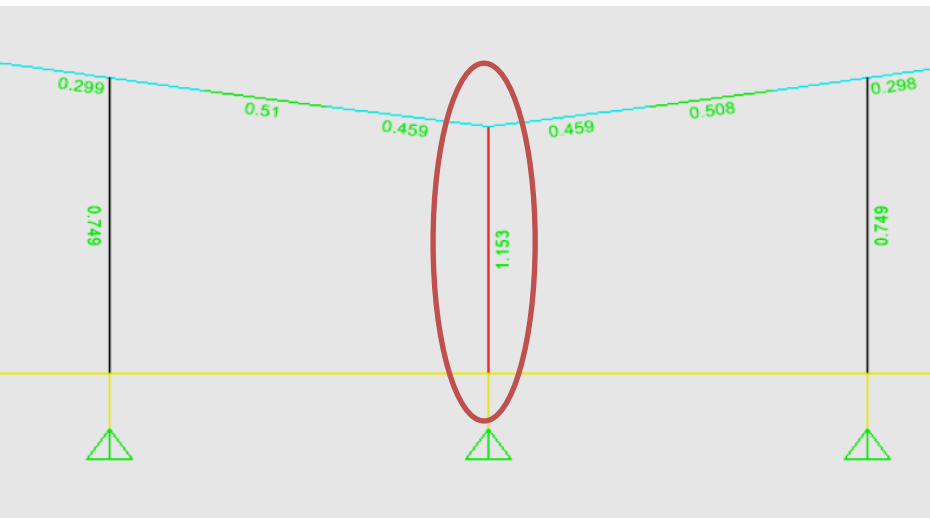
Overstress column (Steel) in FEA model

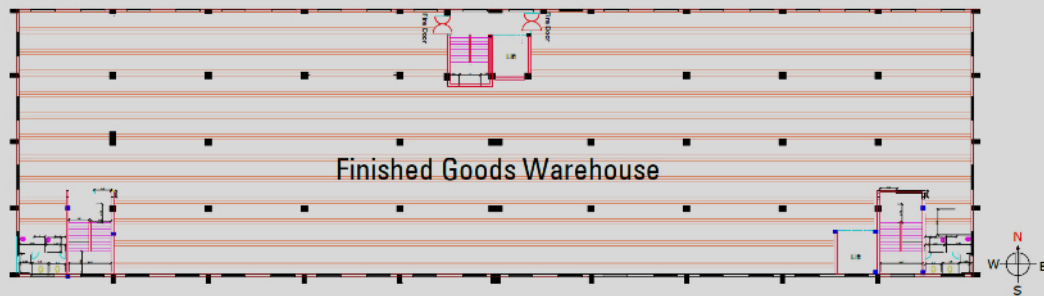
2<sup>nd</sup> floor (South part) load plan: Finished goods warehouse:  
3 kN/m<sup>2</sup> live load

The first and second floor of south part of the building is allotted for storage. As per BNBC, the minimum floor live load for storage is 6 kN/m<sup>2</sup> (126 psf). But the first and second floor of the building is designed for 3 kN/m<sup>2</sup> live loads. Factory engineer is required to revise the load plan and related design documents based on BNBC requirement.

| Item No. | Observation | Recommended Action Plan | Recommended Timeline |
|---|---|---|---|
| 22 | Load plan not comply with BNBC requirements. (Building-20) | Implement the recommendations of design report.<br>Implement floor live load plan. | 6-months |

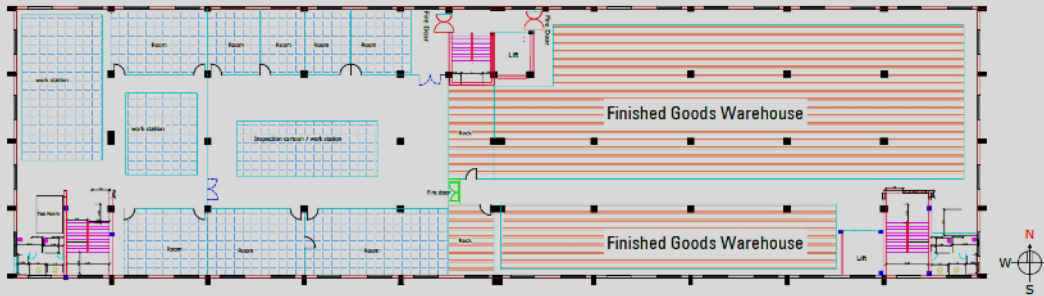
1<sup>st</sup> floor (South part) load plan: Finished goods warehouse:  
3 kN/m<sup>2</sup> live load

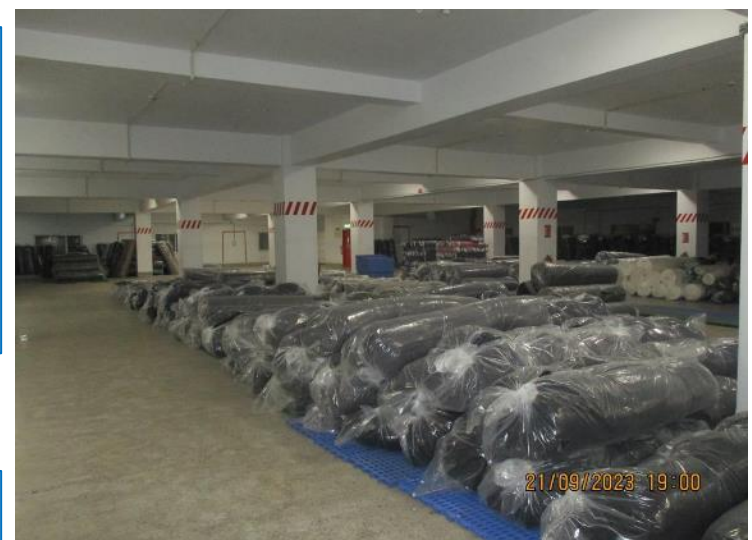
Storage on first floor

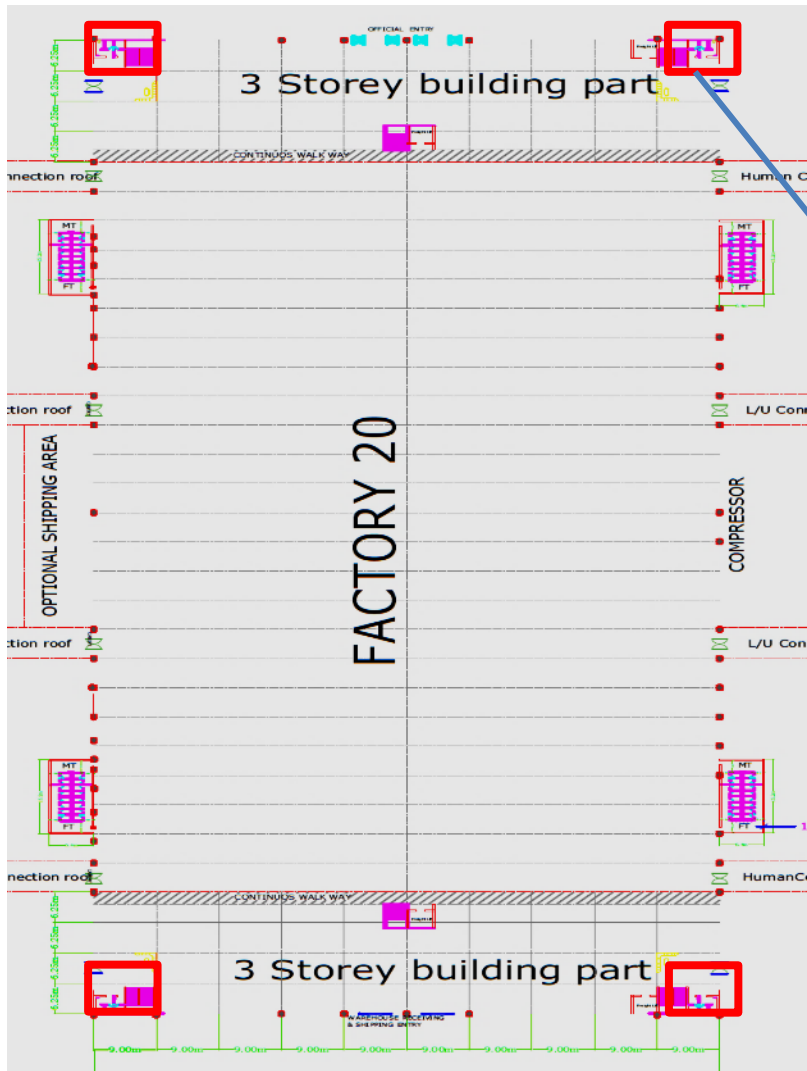
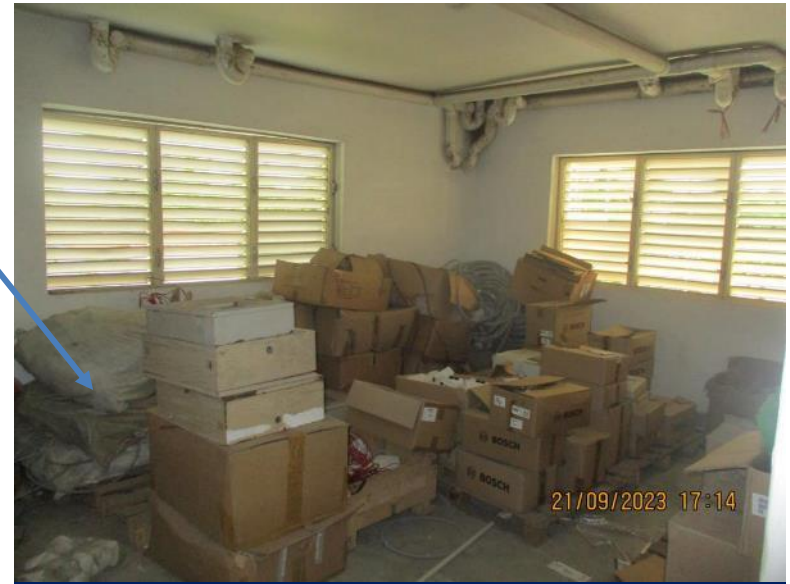
Mezzanine room (East & West)

Undocumented room at mezzanine level (ground floor) was found. Building engineer is required to survey the whole structure and prepare accurate as-built drawings.

Undocumented mezzanine level at both East & West stair (ground level) in both North and South part

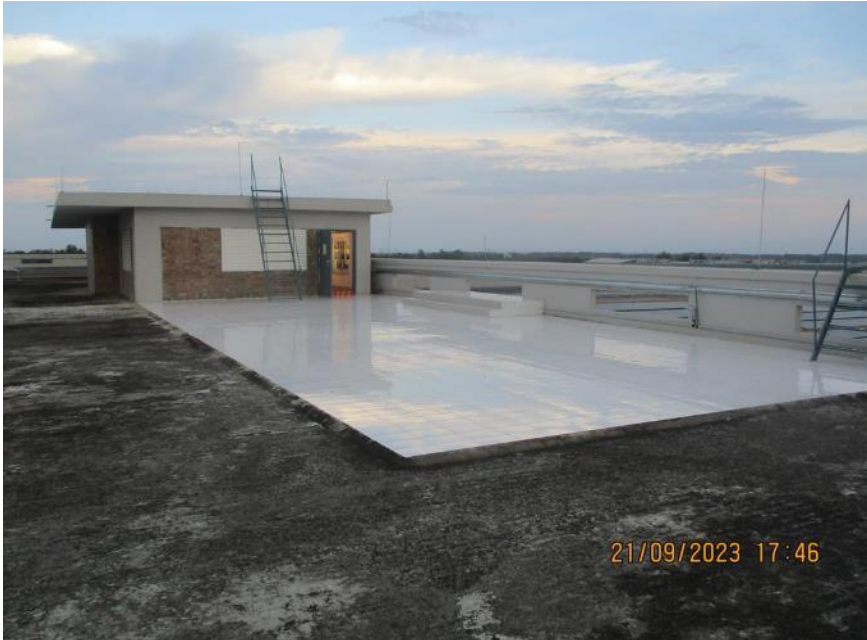
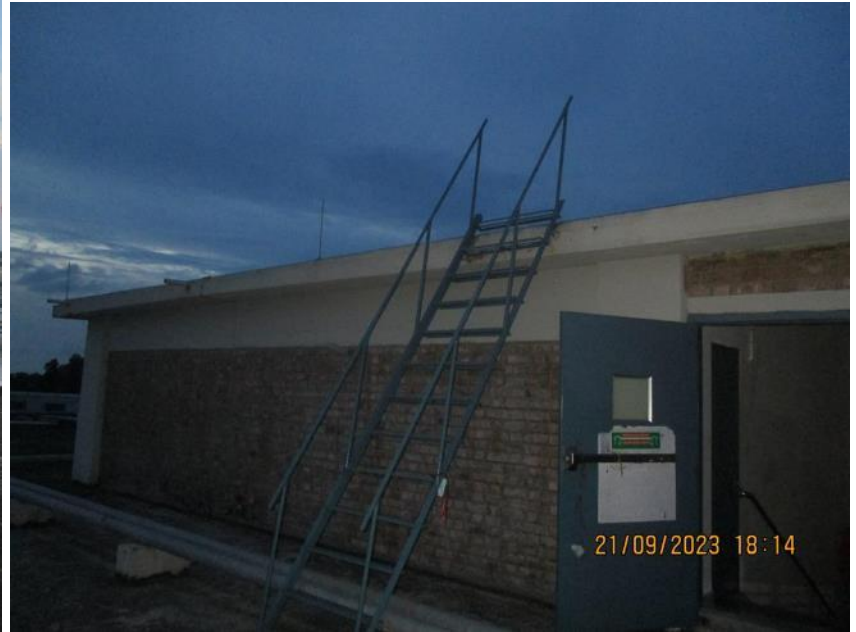
Falling hazard from stair roof top

Falling hazard observed in the stair roof top. Building engineer is required to take necessary measures to avoid possible falling hazard.

| Item No. | Observation | Recommended Action Plan | Recommended Timeline |
|---|---|---|---|
| 24 | Falling Hazard. (Building-20) | Building engineer is required to take necessary measures to avoid possible falling hazard. | 6-weeks |

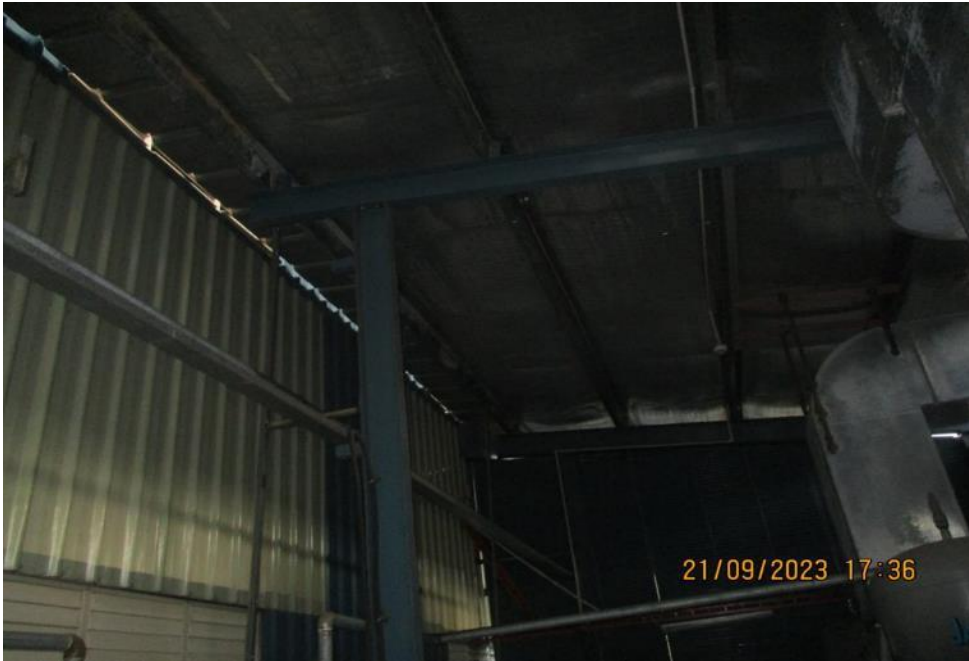
Absence of bracing system

No bracing system was observed. Also, the connection between steel column and pedestal was improper. The building engineer is required carry out Engineering Assessment (EA) to check the connection & lateral stability of the structure and suggest proper remedial actions accordingly.

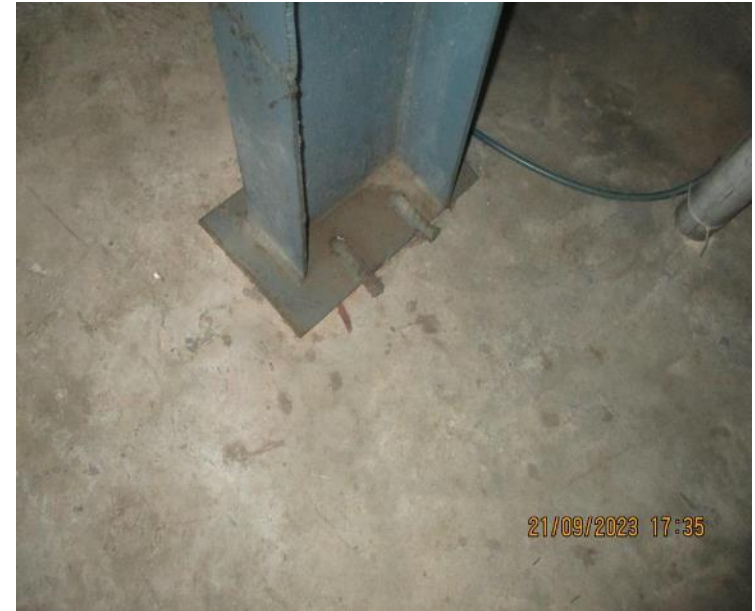
Improper connection between steel column and pedestal

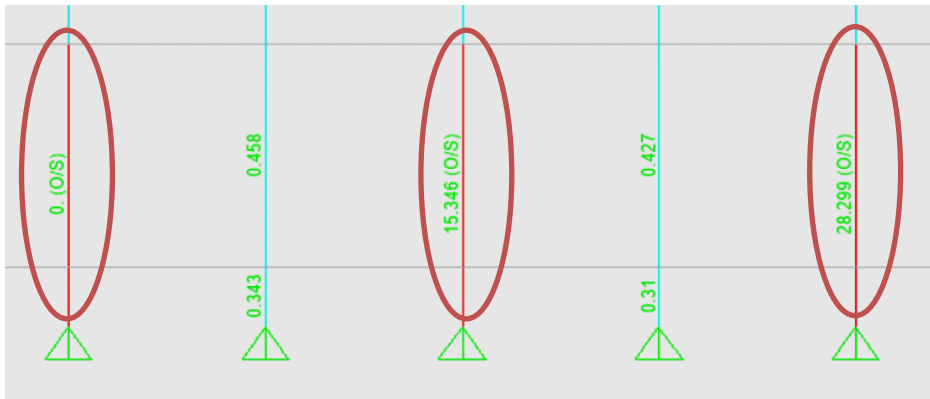
Overstress column (RCC) in FEA model

Design strength of concrete is considered 3500 Psi. in the analysis

A design report was available on site which indicate stone chips was considered for concrete design. But brick chips was found on site. In FEA model RC OHWT load was not assigned and some overstressed columns were also observed both in RC and steel part. Building engineer is required to update the FEA model, design report and other requirements as per BNBC.

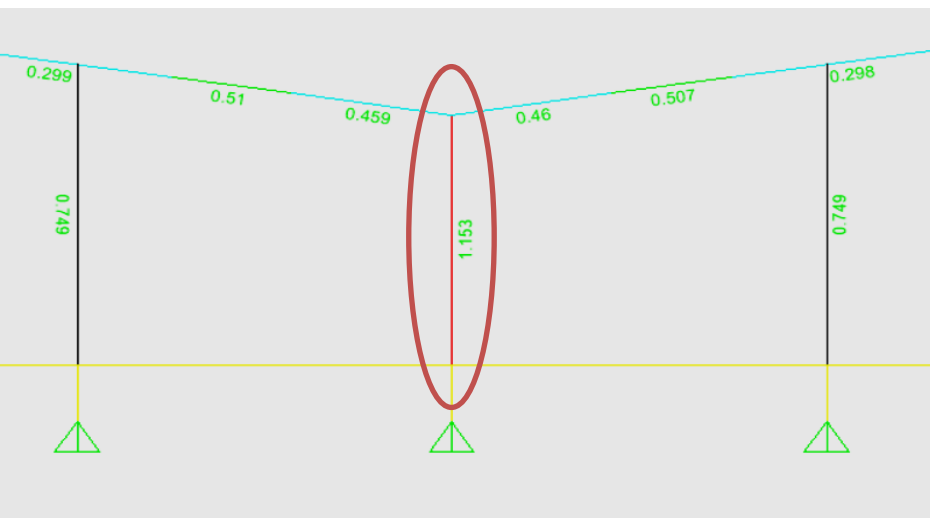
Overstress column (Steel) in FEA model

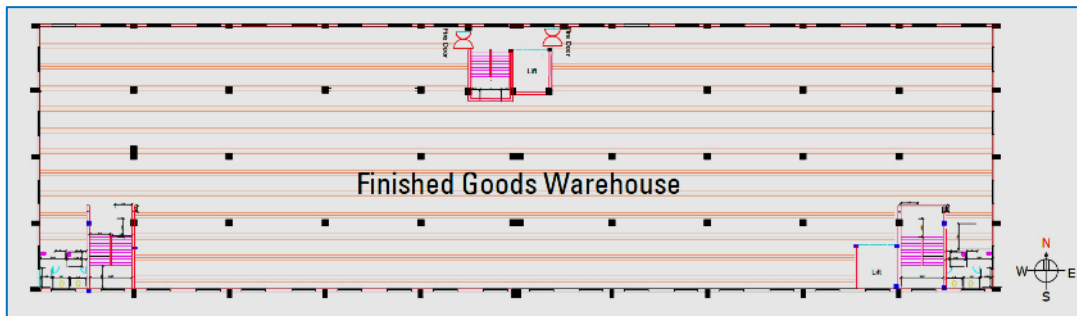
2<sup>nd</sup> floor (South part) load plan: Finished goods warehouse:  
3 kN/m<sup>2</sup> live load

The first and second floor of south part of the building is allotted for storage. As per BNBC, the minimum floor live load for storage is 6 kN/m<sup>2</sup> (126 psf). But the first and second floor of the building is designed for 3 kN/m<sup>2</sup> live loads. Factory engineer is required to revise the load plan and related design documents based on BNBC requirement.

| Item No. | Observation | Recommended Action Plan | Recommended Timeline |
|---|---|---|---|
| 31 | Load plan not comply with BNBC requirements. (Building-21) | Implement the recommendations of design report.<br>Implement floor live load plan. | 6-months |

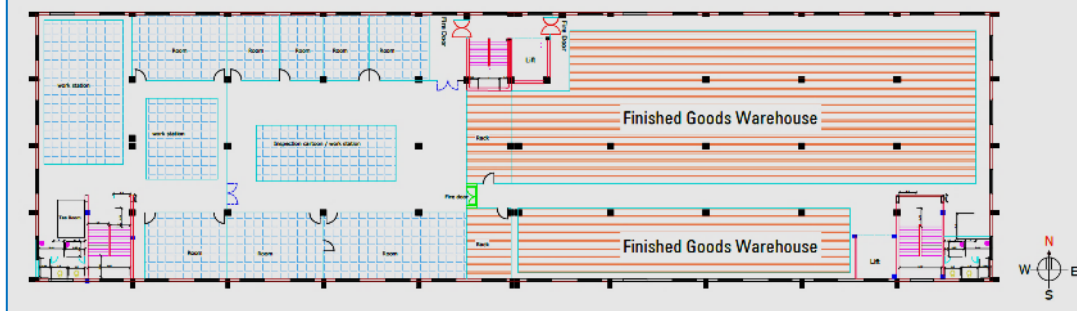
1<sup>st</sup> floor (South part) load plan: Finished goods warehouse:  
3 kN/m<sup>2</sup> live load

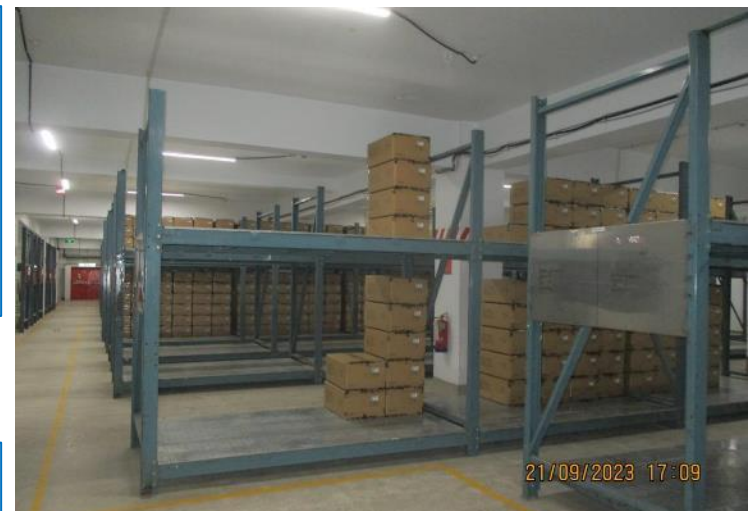
Storage on first floor
