# KSI Karnaphuli Shoes Industries Ltd.(Garments) (Extension)

Plot # G1 & G2, Korean Export Processing Zone, Anowara, Chattogram-4376

21 September 2023

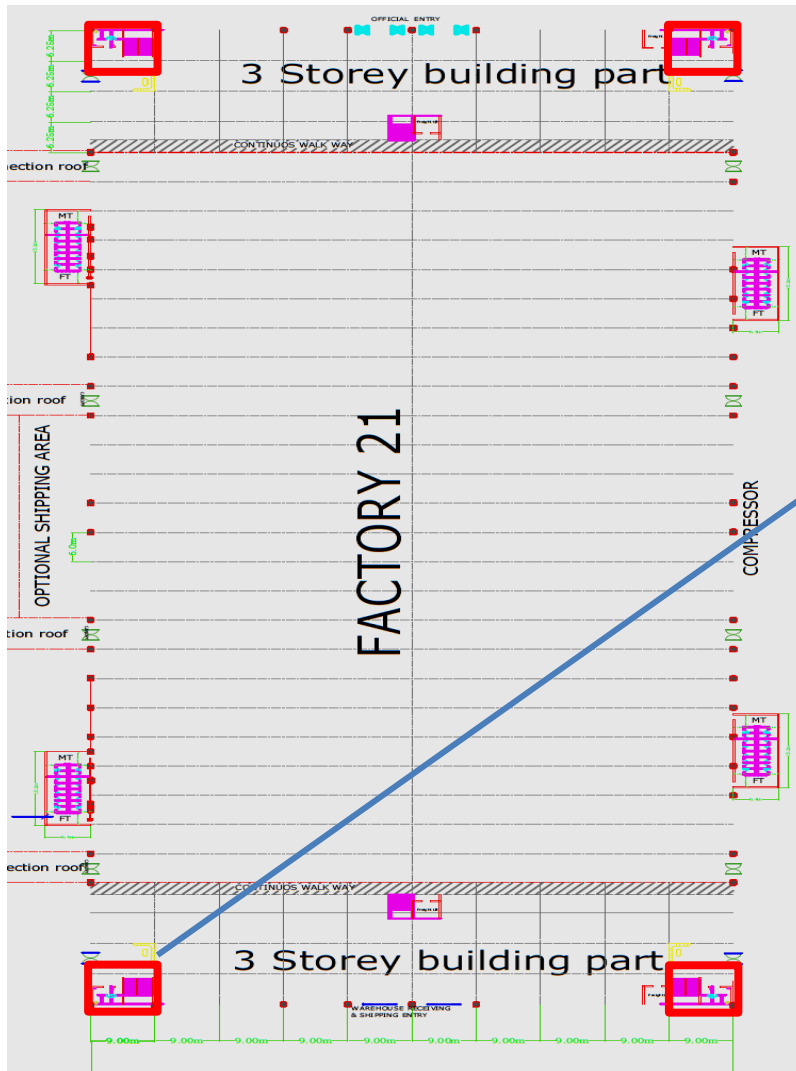
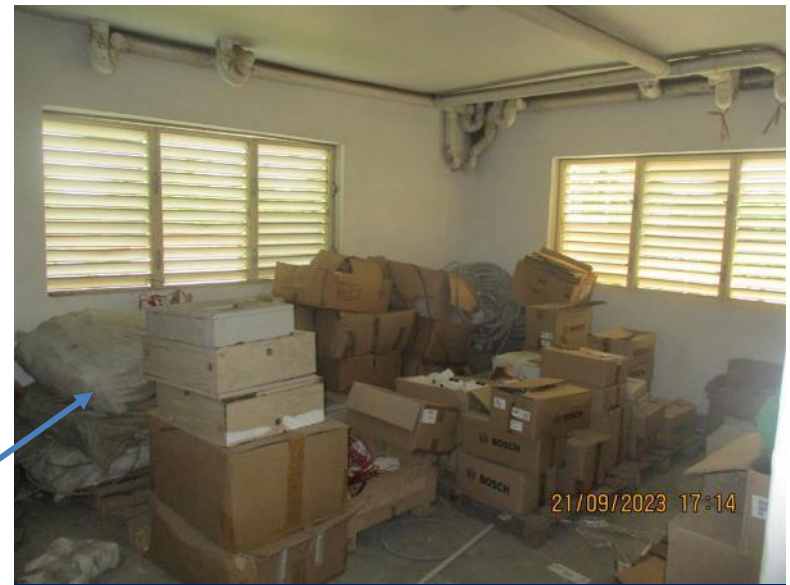
Mezzanine room (East & West)

Undocumented room at mezzanine level (ground floor) was found. Building engineer is required to survey the whole structure and prepare accurate as-built drawings.

Undocumented mezzanine level at both East & West stair (ground level) in both North and South part

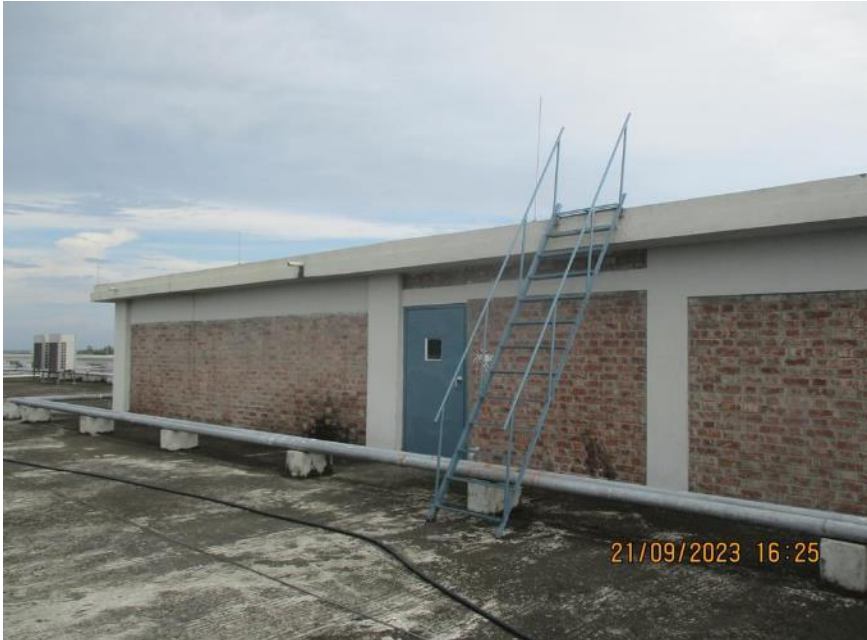
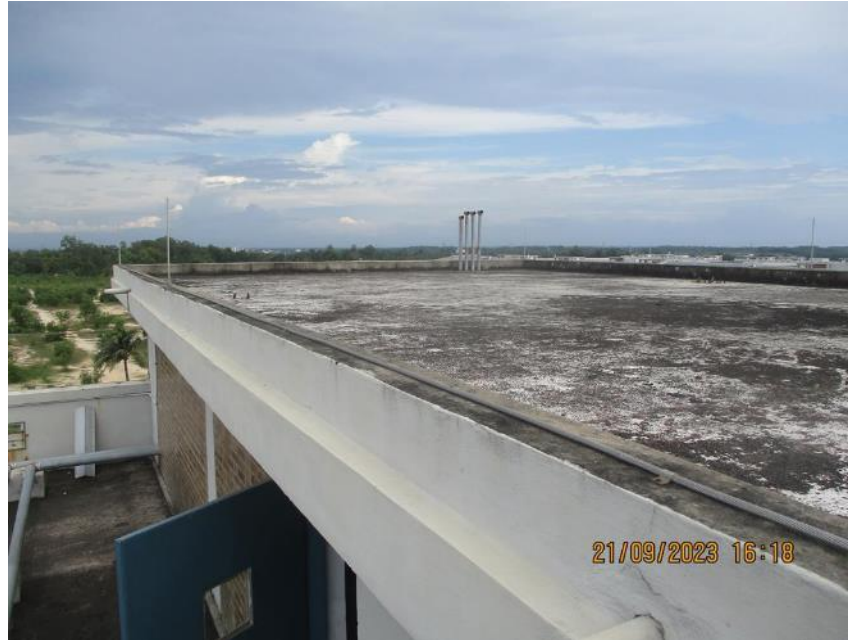
Falling hazard from stair roof top

Falling hazard observed in the stair roof top. Building engineer is required to take necessary measures to avoid possible falling hazard.

| Item No. | Observation | Recommended Action Plan | Recommended Timeline |
|---|---|---|---|
| 33 | Falling Hazard. (Building-21) | Building engineer is required to take necessary measures to avoid possible falling hazard. | 6-weeks |

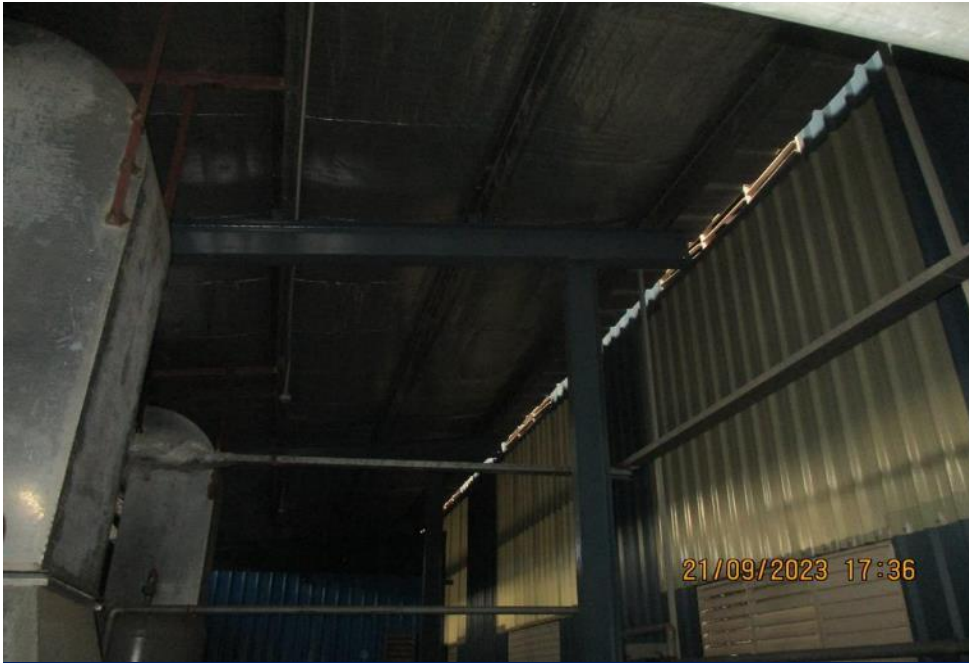
Absence of bracing system

No bracing system was observed. Also, the connection between steel column and pedestal was improper. The building engineer is required carry out Engineering Assessment (EA) to check the connection & lateral stability of the structure and suggest proper remedial actions accordingly.

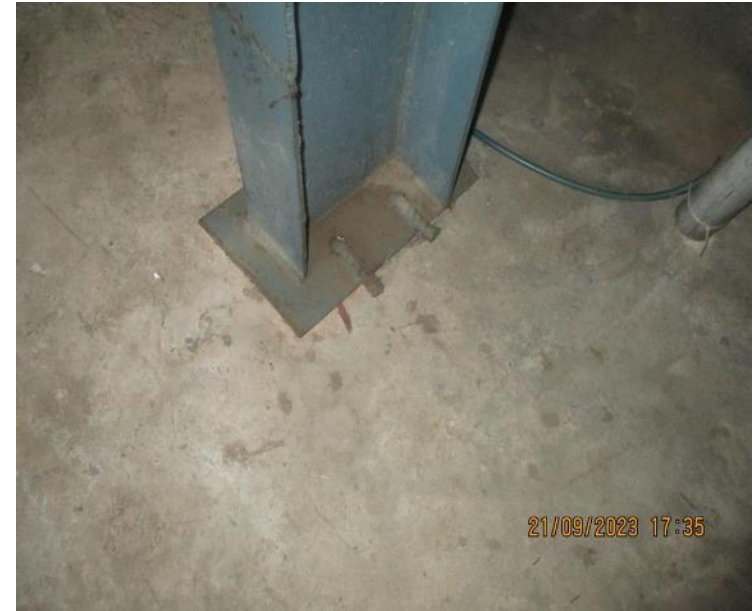
Improper connection between steel column and pedestal

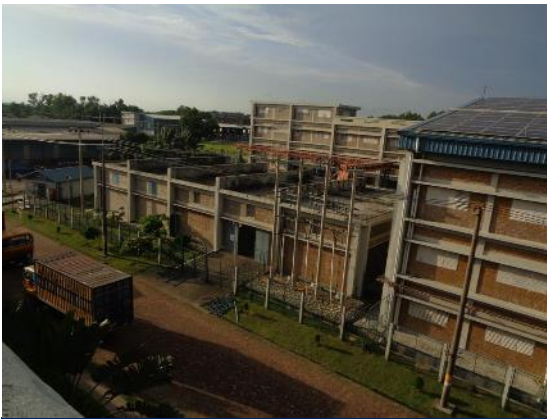
4<sup>th</sup> phase sub-station

As per BNBC, every building or structure designed shall have its design documents prepared in accordance with the provision of Section 1.9.1. During inspection, the design report was not available on site. The building engineer is required to prepare a set of design documents including a design report based on in-situ material strength and software-based analysis which shall be prepared in compliance with section 1.9.1, part-6 of BNBC.
