JM Fabrics Ltd. (Extension)

South Nayapara, 6 No Dogri, Bhawal, Mirzapur, Gazipur.

11th October 2023

Observations

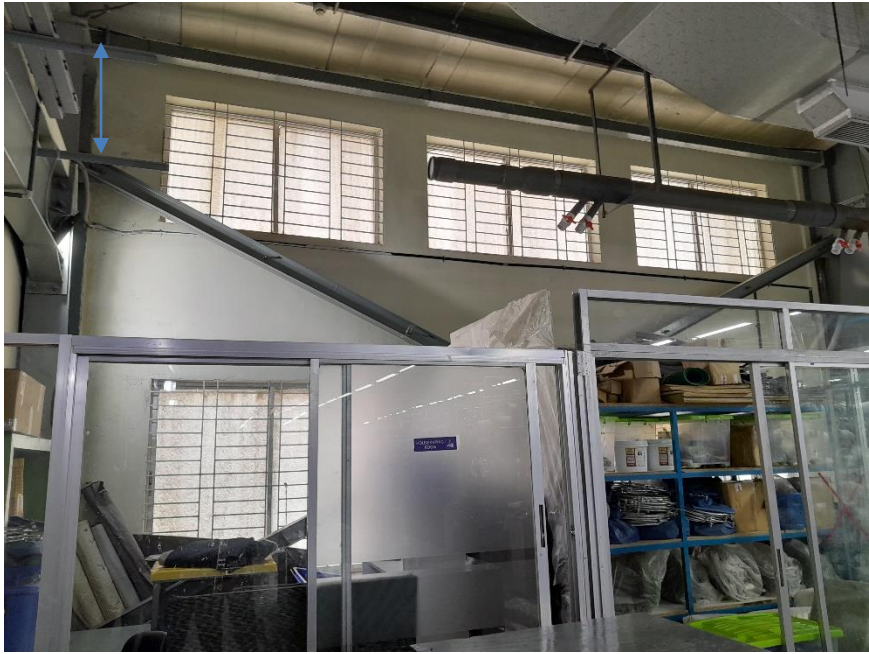
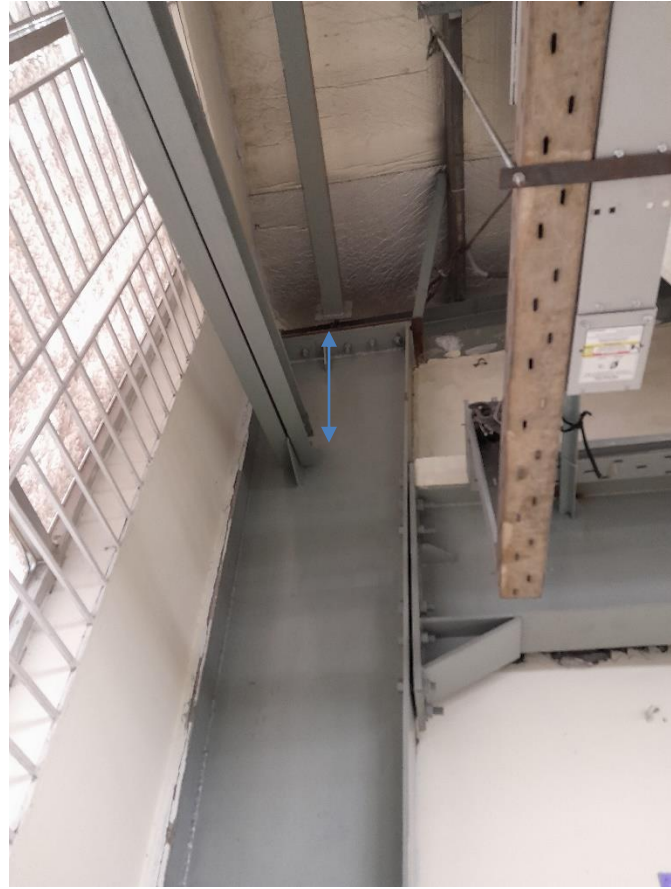
Eccentric bracing was observed in the building. Building engineer is required to incorporate the eccentric bracing in the design.

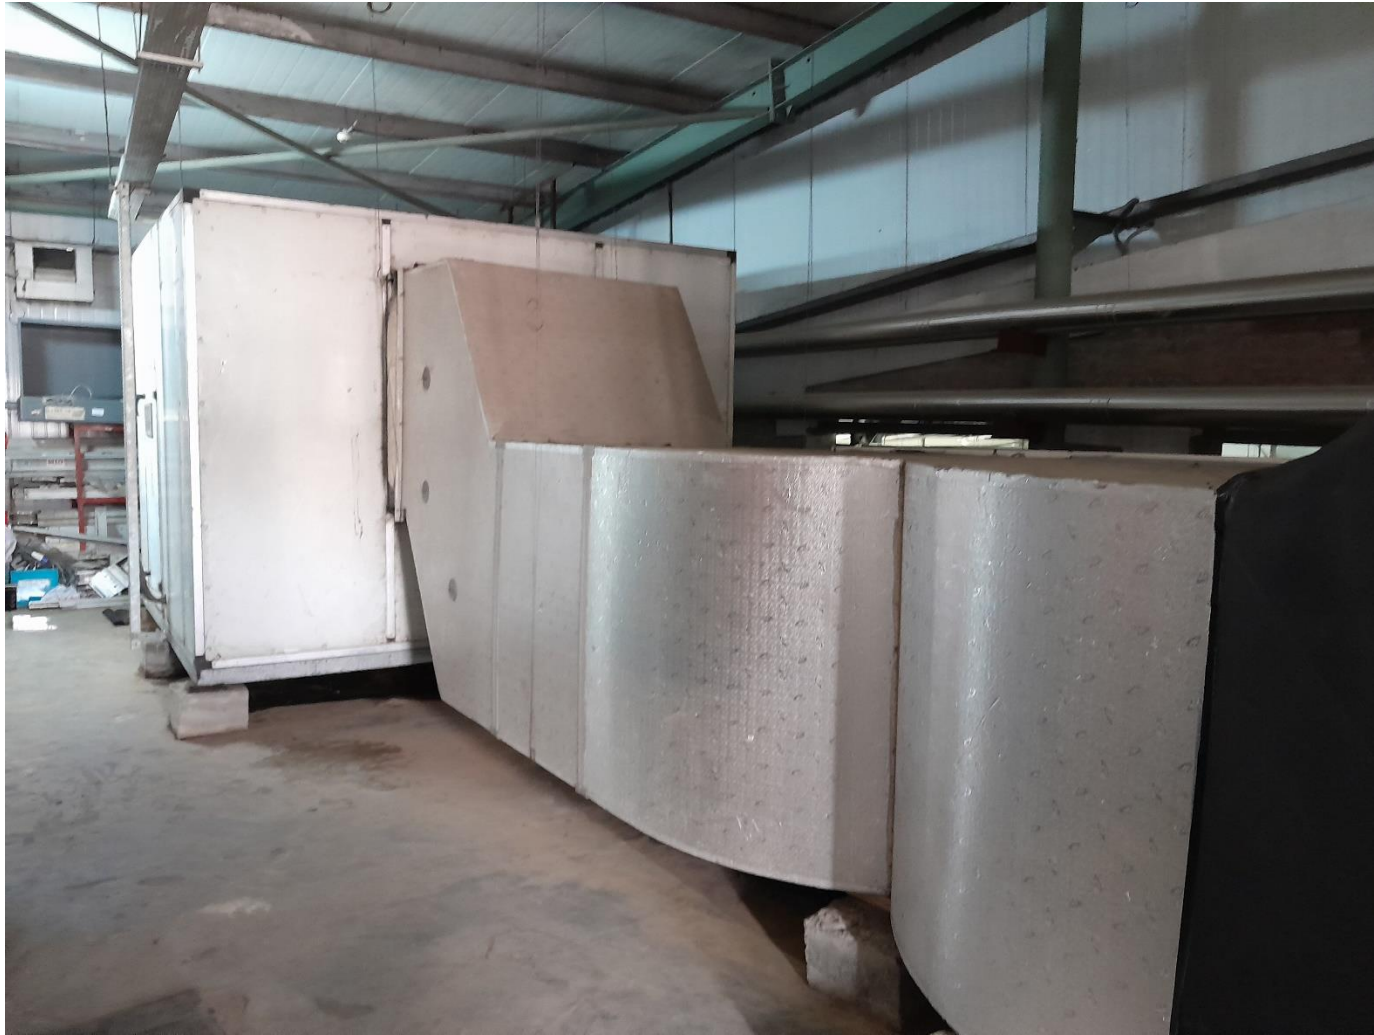
Significant vibration on the AHU room

Significant vibration was felt in the AHU roof. Building engineer is required to investigate the long-term effect of the vibration and suggest remediation

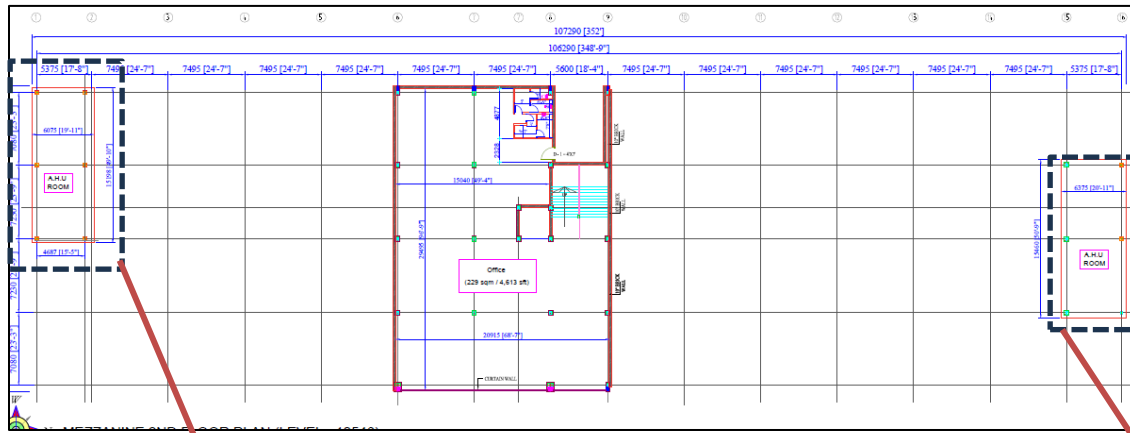
Roof layout plan

During inspection, two steel shed on roof was observed over the two A.H.U room area. However, no structural details of these 2 sheds were available in structural drawing. Building engineer is required to update as-built drawing incorporating all structural details of this sheds.

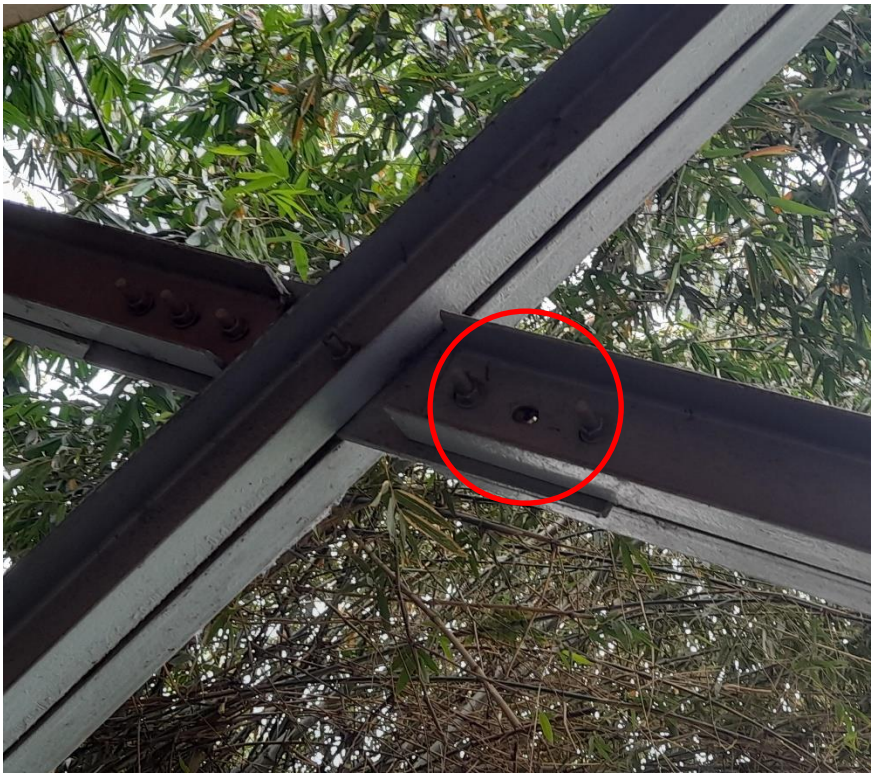
Bolt missing and significant gaps observed in rafter-column joint at several locations. Building engineer is required to install the missing bolts.

Bolt missing

Item No.	Observation	Recommended Action Plan	Recommended Timeline
06	Bolt missing and connection gap (Building-3)	Building engineer is required to repair the gap in connections with a suitable method.	6-weeks
07	Bolt missing and connection gap (Building-3)	Install the missing bolt where necessary.	6-weeks
08	Non-Engineered steel stair (Building-3)	The Building engineer is required to check the connection adequacy for uplift forces as part of EA.	6-weeks
09	Non-Engineered steel stair (Building-3)	Implement remedial work where required.	6-months
10	Absence of design documents (Building-4)	Building is required to prepare a set of design report in compliance with section 1.9.1.1 (part-6, BNBC).	6-weeks

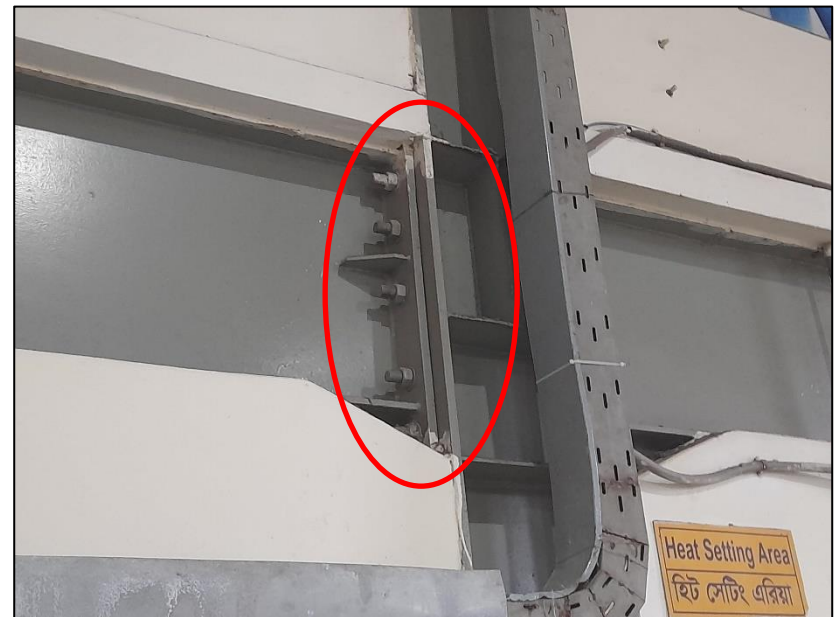
Gap observed in connections

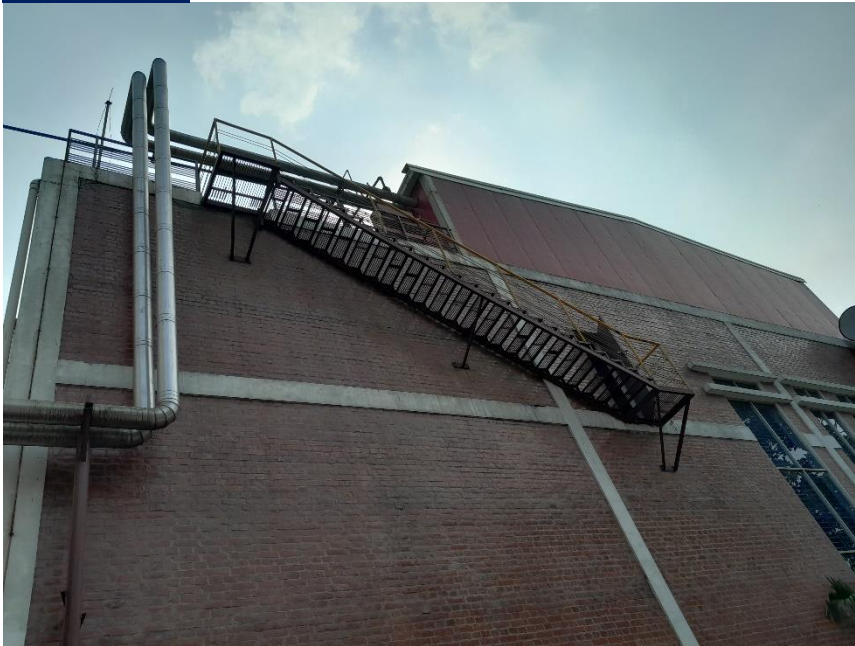
North

Undocumented external steel stair

There are external undocumented steel stairs from the 1st floor to the roof which was poorly connected to the RC beams of Building-3. Therefore, the connection of steel members to RC beams appeared to be inadequate. The Building engineer is required to check the connection adequacy as part of EA.

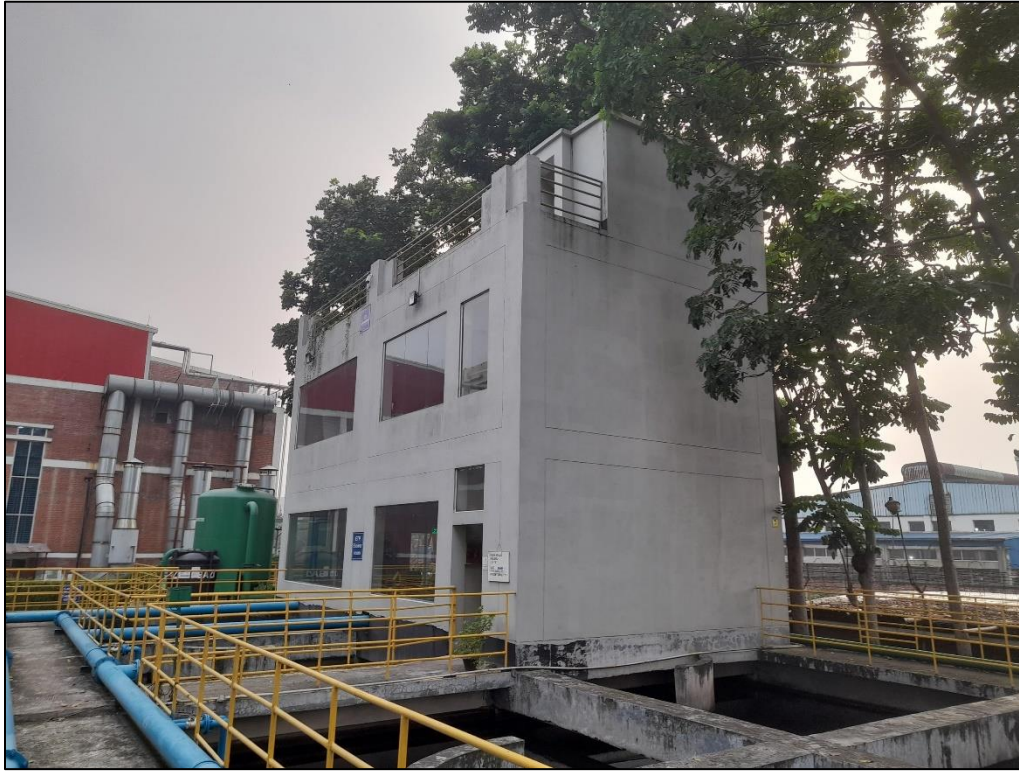
Building-4

As per BNBC, every building or structure designed shall have its design documents prepared in accordance with the provision of Section 1.9.1. The design document shall include a design report, and a set of structural drawings, which shall be prepared in compliance with section 1.9.1.1 and section 1.9.1.2 as per BNBC. At the time of inspection, design report was not available which is required to be prepared in compliance with section 1.9.1.1 (part-6, BNBC).

Item No.	Observation	Recommended Action Plan	Recommended Timeline
11	Absence of design documents (Building-4)	Implement remediation work if required.	6-months
12	Discrepancies in as-built drawing (Building-4)	Building engineer is required to resurvey the whole structure and update the as-built drawing accordingly.	6-weeks
13	Apparently non engineered structure (Shed-2)	Building engineer is required to check the connection adequacy for uplift forces as part of EA otherwise replace with engineered structure.	6-weeks
14	Apparently non engineered structure (Shed-2)	Implement remedial work where required.	6-months
15	Lack of Lateral Stability (Shed-3, Shed-4, Shed-5 & Shed-6)	Building engineer is required to check the lateral stability and connections of the shed.	6-weeks

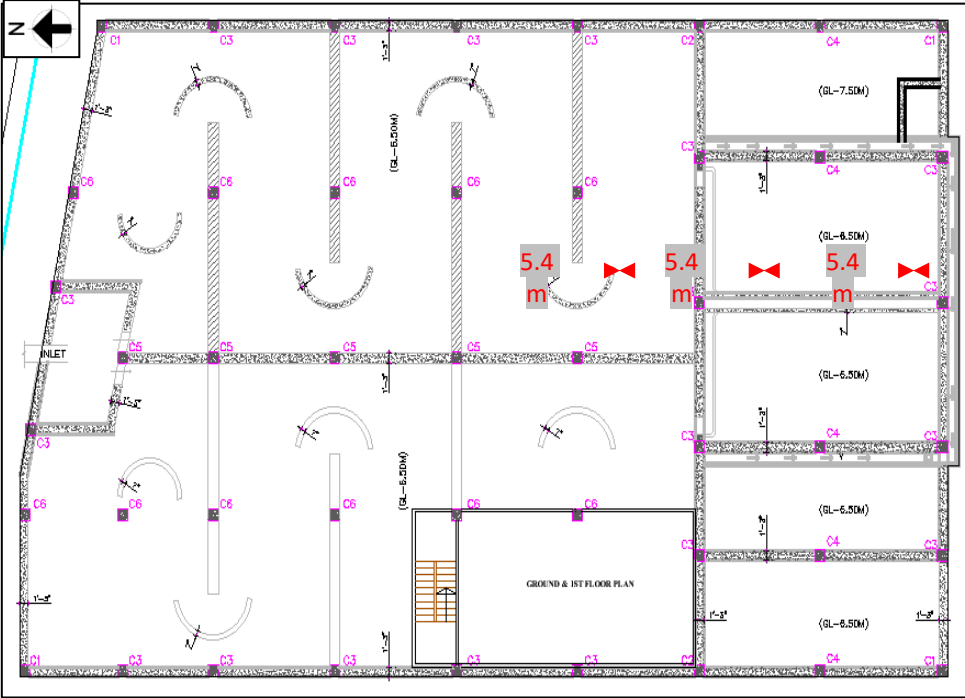
Column Layout

As per the column schedule from the available structural drawing, the dimension of column C6 was shown 20" X 20". However, during the inspection, all C6 columns were measured 15" X 20". Building engineer is required to resurvey the whole structure and update the as-built drawing accordingly.

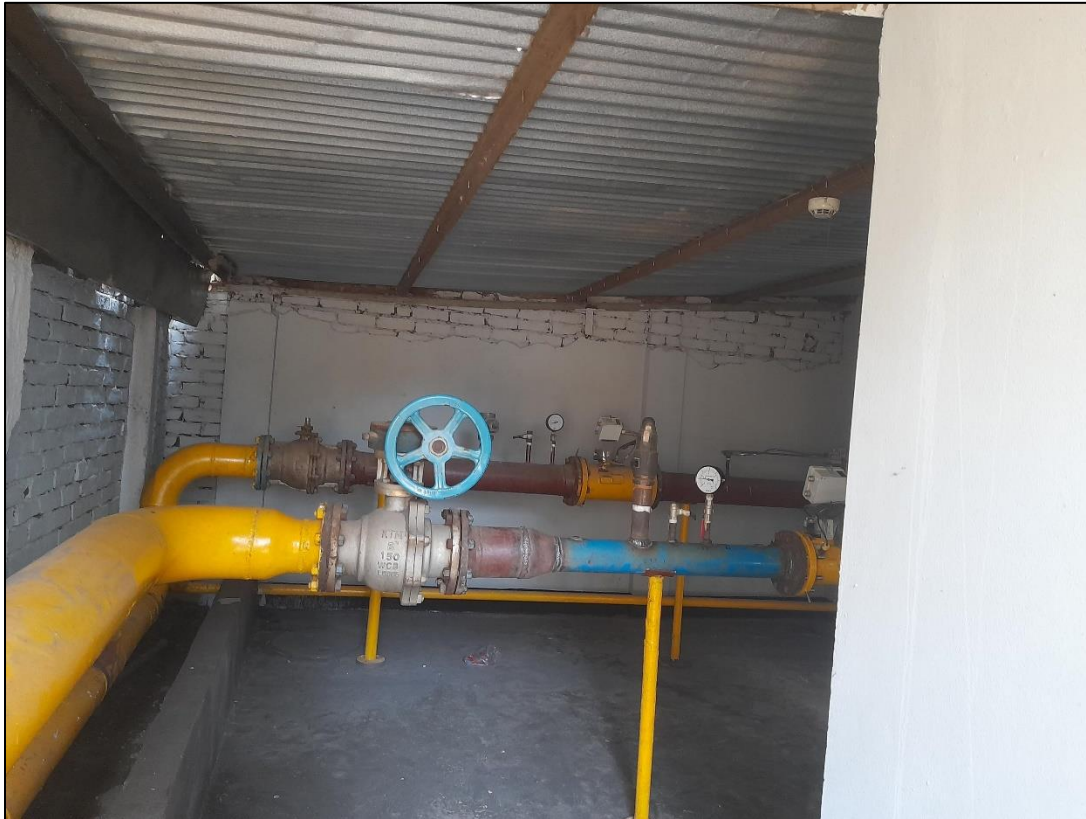
Poor connection between steel members

This shed appeared to be non-engineered due to poor connection and inadequate member size. Building engineer is required to check the connection adequacy for uplift forces as part of EA and implement remediation work where required.

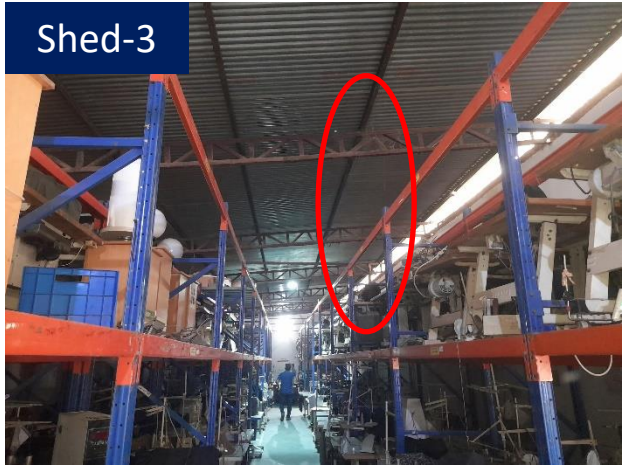
Shed-3

Truss frame is provided along short direction. Any compression member along long direction with any lateral bracing was not available. Therefore, lateral stability along long direction is questionable. Building engineer is required to check the lateral stability for Shed-3, Shed-4, Shed-5 & Shed-6.

Item No.	Observation	Recommended Action Plan	Recommended Timeline
16	Lack of Lateral Stability (Shed-3, Shed-4, Shed-5 & Shed-6)	Complete remedial works where necessary.	6-months
17	Lack of information in as-built drawing (Shed-3, Shed-4, Shed-5 & Shed-6)	Building engineer is required to update as-built drawing incorporating all structural details of these sheds.	6-weeks
18	Lack of Lateral Stability (Shed-7)	Building engineer is required to check the lateral stability of the shed and prepare an Engineering Assessment (EA) report.	6-weeks
19	Lack of Lateral Stability (Shed-7)	Complete remedial works where necessary.	6-months
20	Lack of as-built drawing of mezzanine floor (Shed-7)	Building engineer is required to prepare full set of as-built drawings incorporating all structural details of this structure.	6-weeks

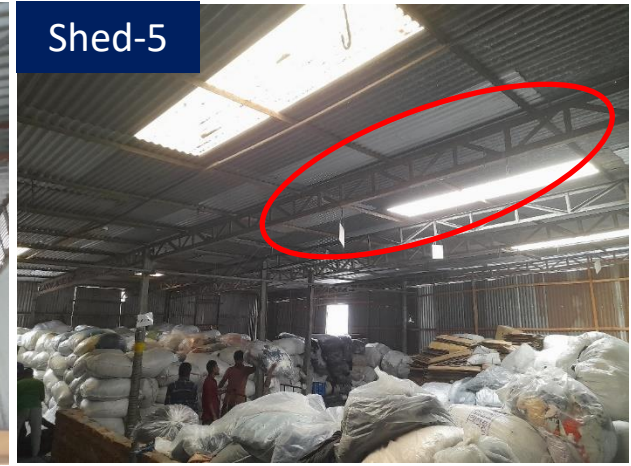
Shed-5

No bracing/Compression strut was provided along the long direction.

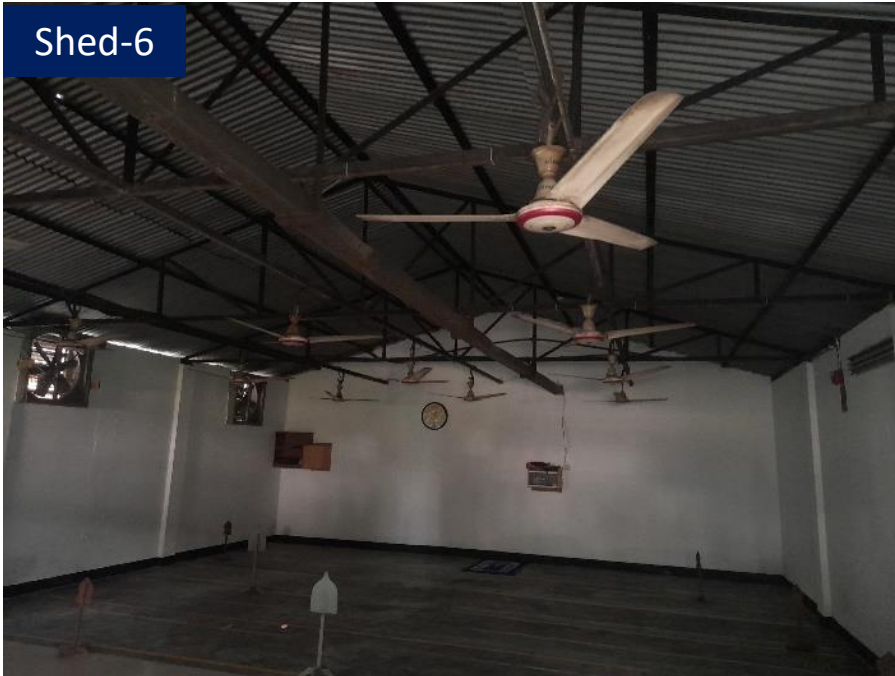
Shed-6

Truss frame along short direction.

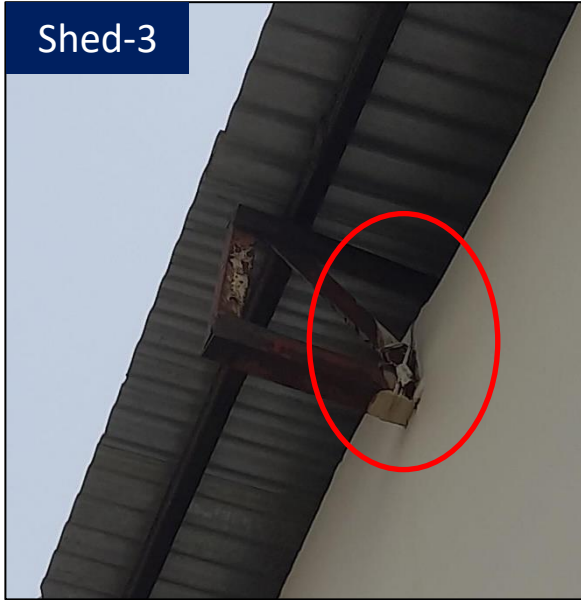
Shed-3

Trusses of Shed-3, Shed-4, Shed-5 & Shed-6 were found arbitrarily welded with rebar of RC column and inserted to brick wall therefore connection of steel members to brick wall and RC columns appeared to be inadequate. The Building engineer is required to check the connection adequacy for uplift forces as part of EA.

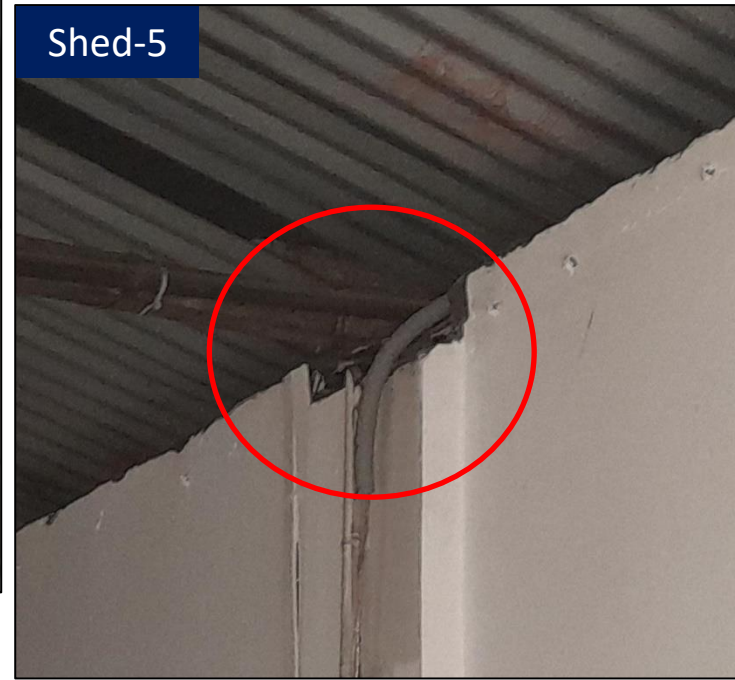
Shed-5

Purlin inserted to brick wall

Truss welded with rebar of RC column

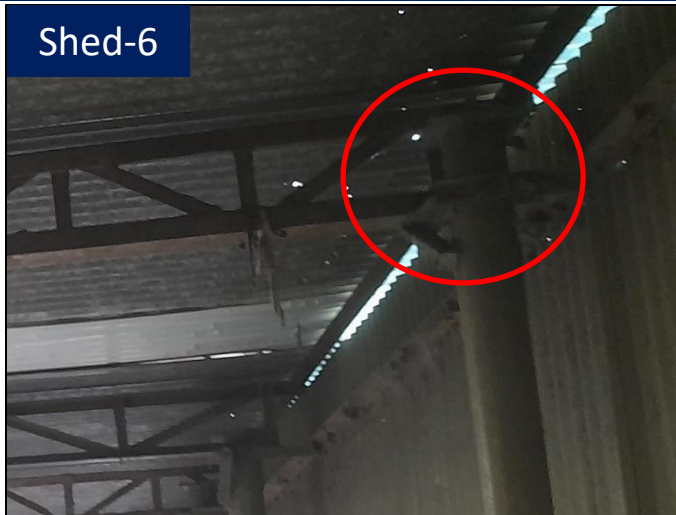
Shed-6

Poorly welded truss with steel pipe

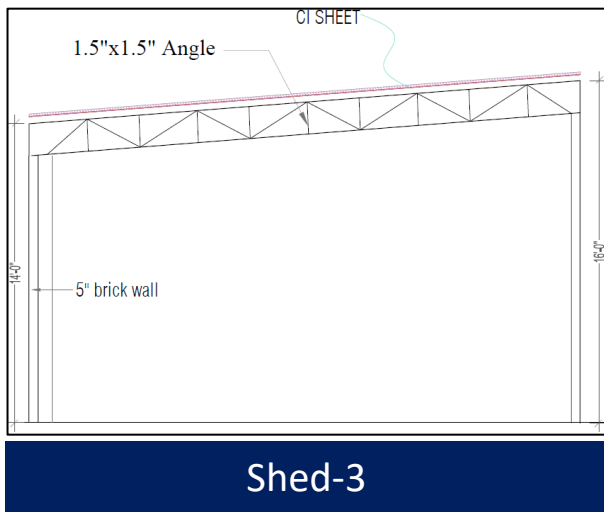
Shed-3

In available structural drawing, structural details like dimension and thickness of steel members for Shed-3, Shed-4, Shed-5 & Shed-6 were not provided. Building engineer is required to resurvey the whole structure and update as-built drawing accordingly.

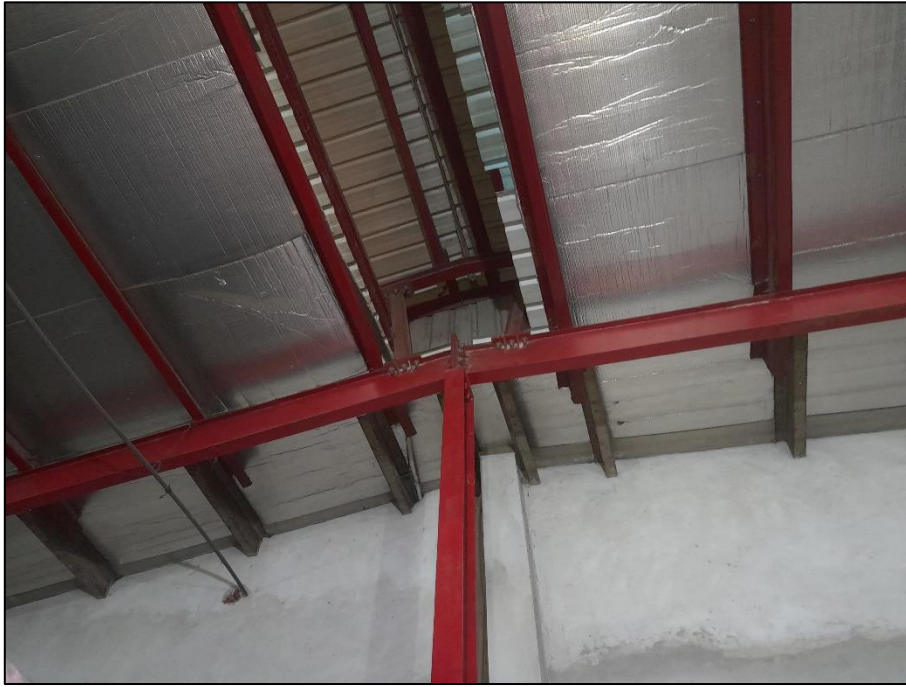
Portal frame along short direction.

Portal frame is provided along the short direction. Any compression member along long direction with any lateral bracing was not available. Therefore, lateral stability along long direction is questionable. Building engineer is required to check the lateral stability of the structure.

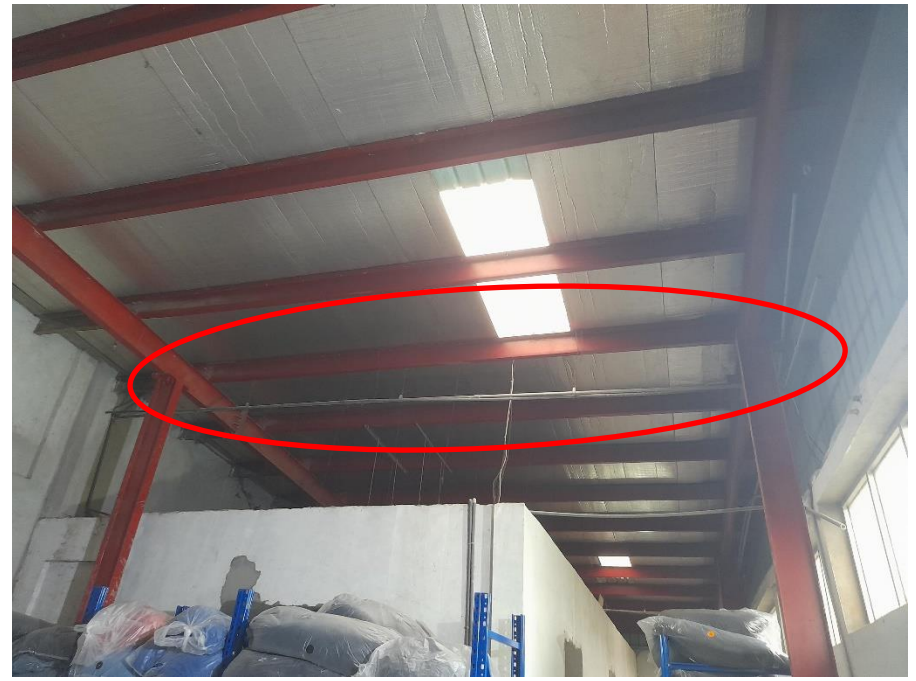
No bracing/Compression strut was provided along the long direction.

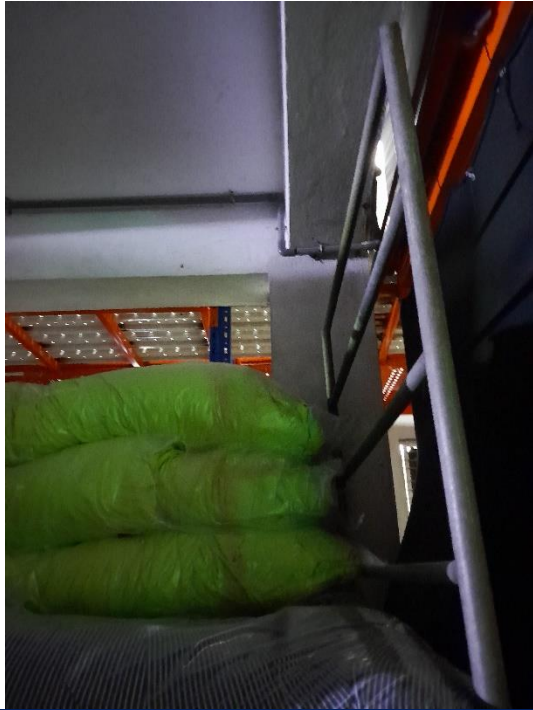
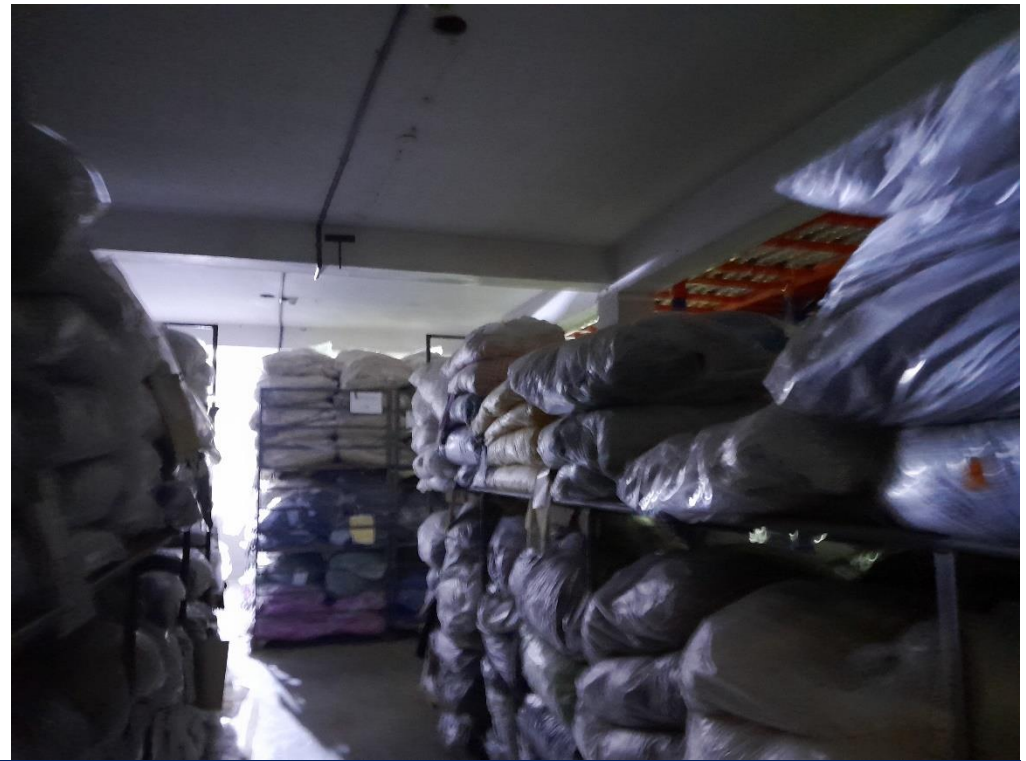
RC mezzanine structure.

During inspection, a single storied RC mezzanine floor was observed inside Shed-7 which was structurally separated. However, as-built drawing was not available for this structure. Building engineer is required to prepare full set of as-built drawings incorporating all structural details of this structure.
