Modiste (Bangladesh) Ltd. (Extension)

51/ C (A,B) Fouzderhat Heavy I/A, Sagorika Road, Chittagong
(22.358262 91.771981)

18 October 2023

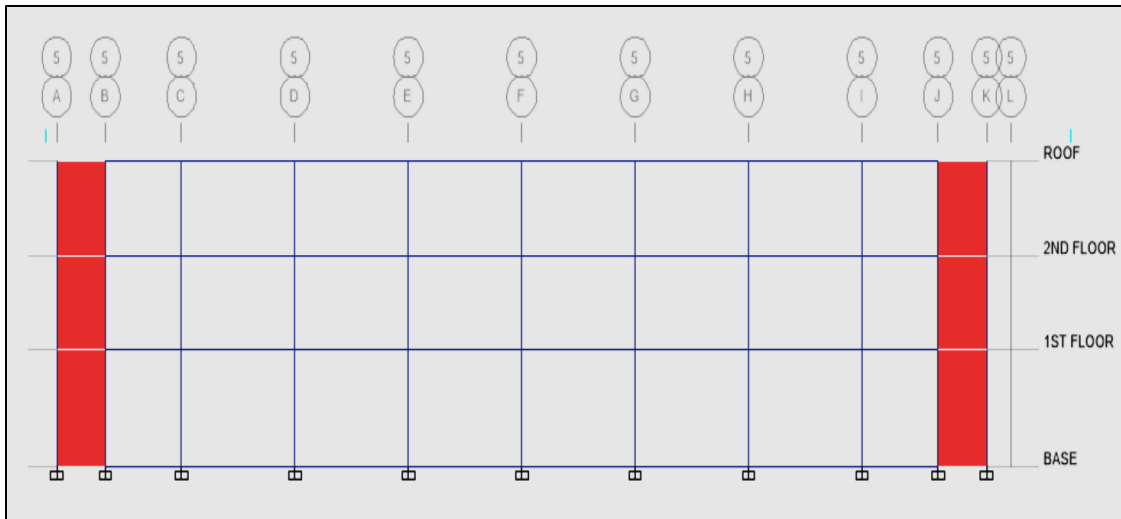
Shear walls consideration in analysis & stability system

Design documents with software (FEA) analysis file was available on site for building-A. In FEA lift core was considered up to the roof level. But in drawings lift core was shown up to the plinth level. Also lift core was not found above the plinth level on site. Building engineer is required to confirm the lift core presence above plinth level and update the FEA model, check the stability system, design report and other requirements as per BNBC.

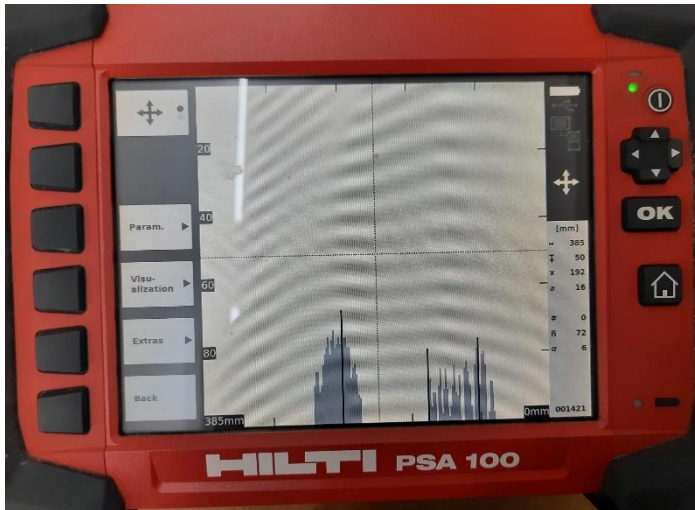
Ferro-scanning: 4 rebar at short face

Rebar at C-2 type column not matched with drawings. Four rebars were found at short face and seven rebars were found at long face instead of five and eight, respectively. Total eighteen rebars were found instead of twenty-two rebars. Building engineer is required to confirm the amount of rebar in column and update the drawing.

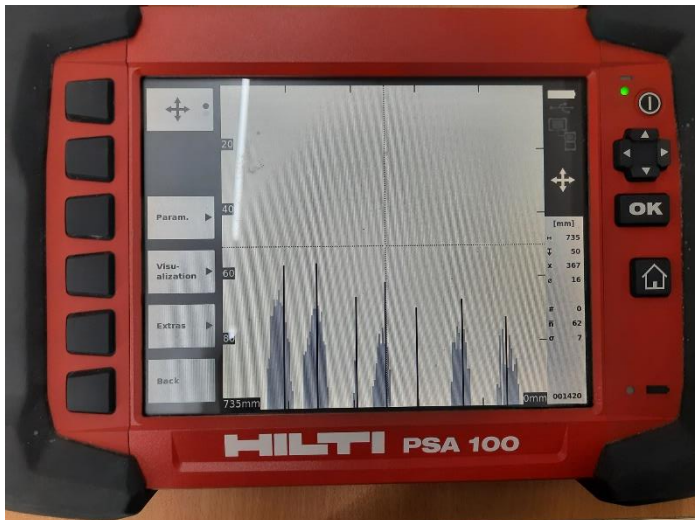
Ferro-scanning: 7 rebar at long face

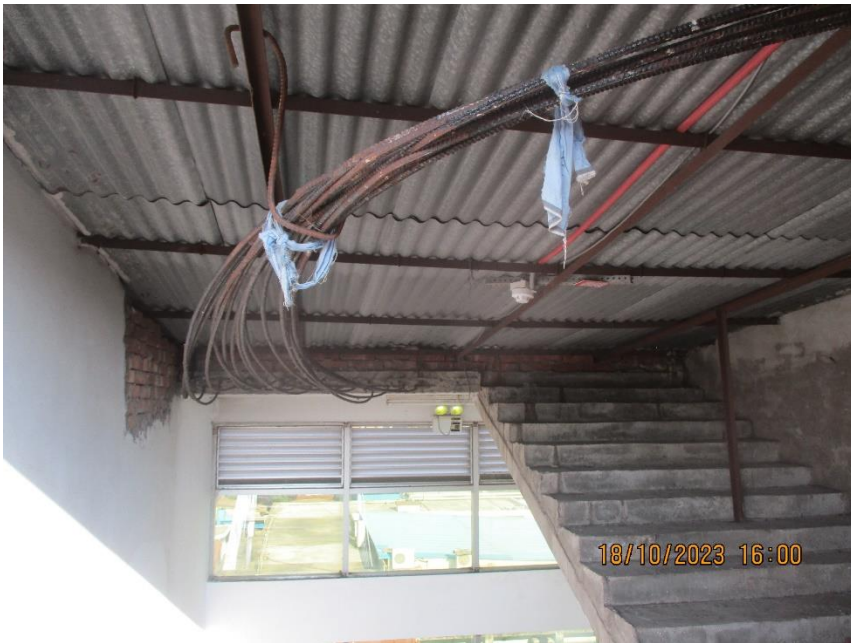
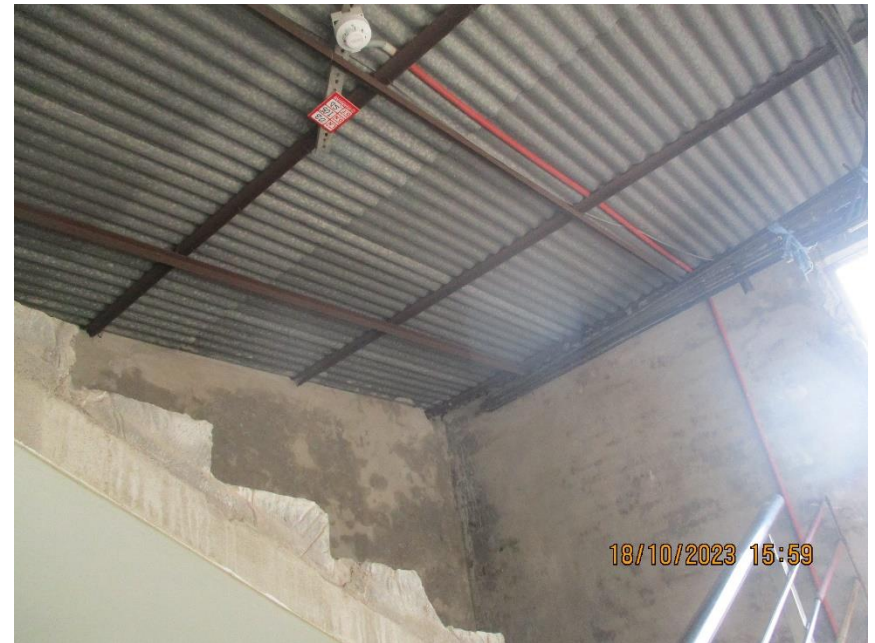
Non-engineered stair roof shed

Non-engineered stair roof shed was observed on the roof.
Building engineer is required to check the stability against the uplift forces.

Item No.	Observation	Recommended Action Plan	Recommended Timeline
07	Non-engineered stair roof shed. (Building-A)	Carry out remedial works where necessary.	6-months
08	Dampness at ceiling of 1st and 2nd floor. (Building-A)	Building engineer is required to seal the source of water and repair the damp areas with suitable method.	6-weeks
09	Information missing in the design report. (Store shed)	Building engineer is required to incorporate all types of adequacy checks in the design report and the report should comply with section 1.9.1 of BNBC (part 6).	6-weeks
10	Information missing in the design report. (Store shed)	Carry out remedial works (if any) after reviewed by the RSC.	6-months
11	Information missing in the design report. (Childcare and Doctor's Room)	Building engineer is required to incorporate all types of adequacy checks in the design report and the report should comply with section 1.9.1 of BNBC (part 6).	6-weeks

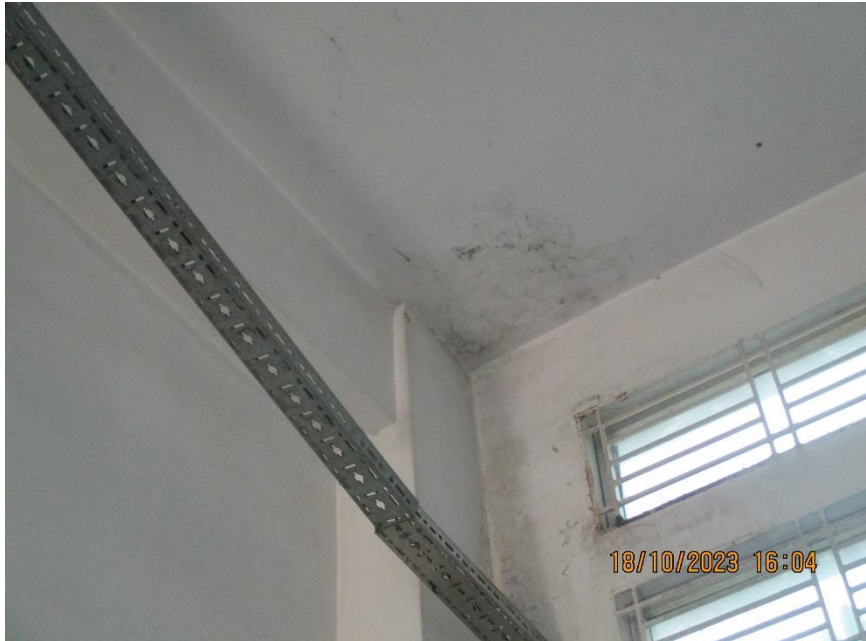
Dampness on slab soffit

Dampness on ceiling of 1st and 2nd floor was observed. Building engineer is required to seal the source of water and repair the damp areas with suitable methods.

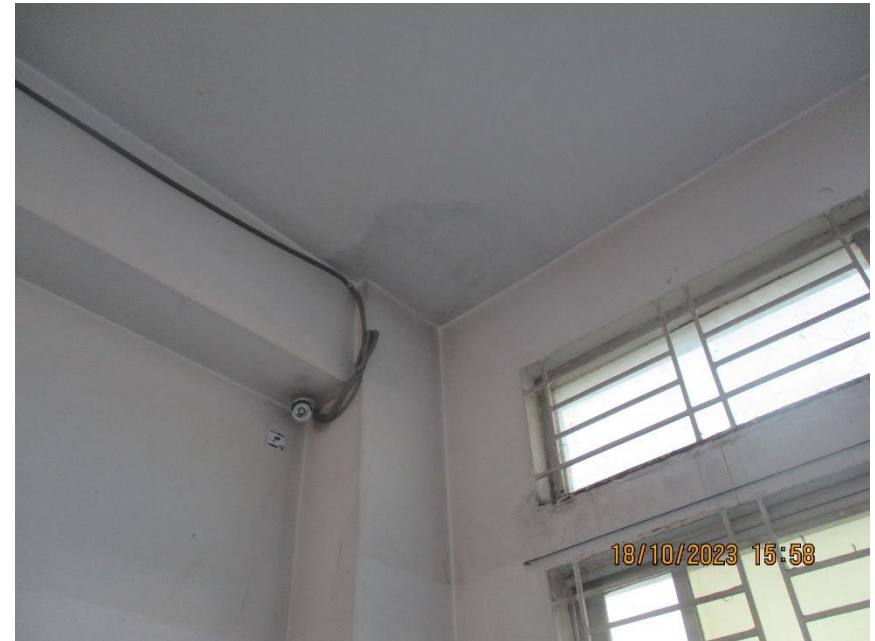
Dampness on slab soffit

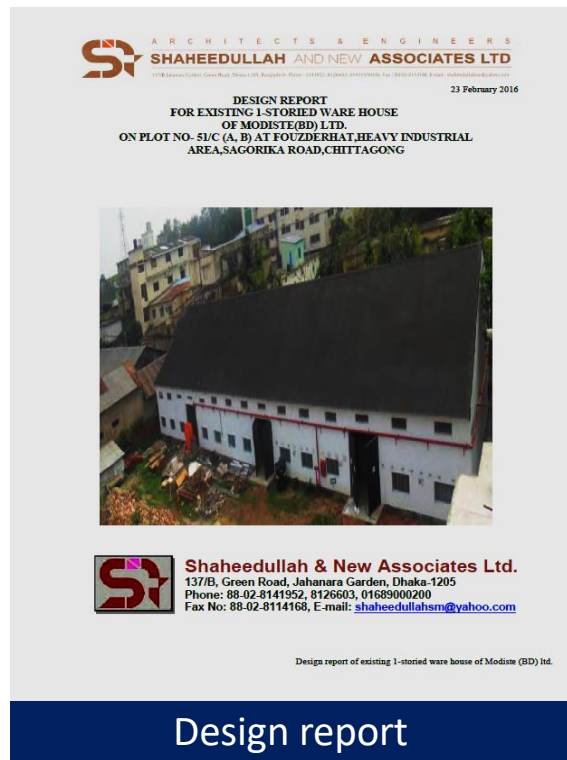
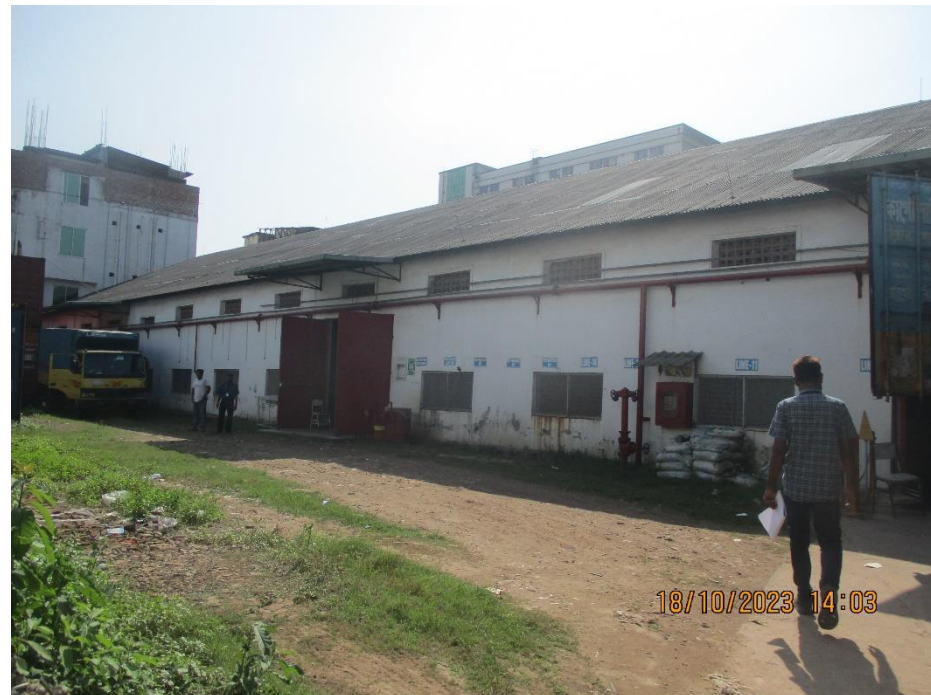
Store shed

Information missing in the design report

A Design Report was available for the store shed which was prepared based on software analysis. Adequacy of connections and serviceability checks as per BNBC were not incorporated in the design report.

The building engineer is required to incorporate adequacy check of connections and serviceability check in the design report and submit to the RSC for review.

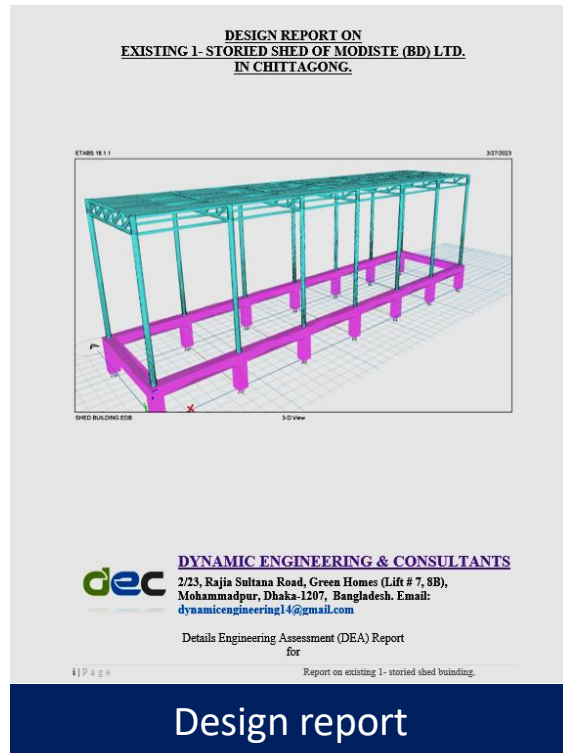
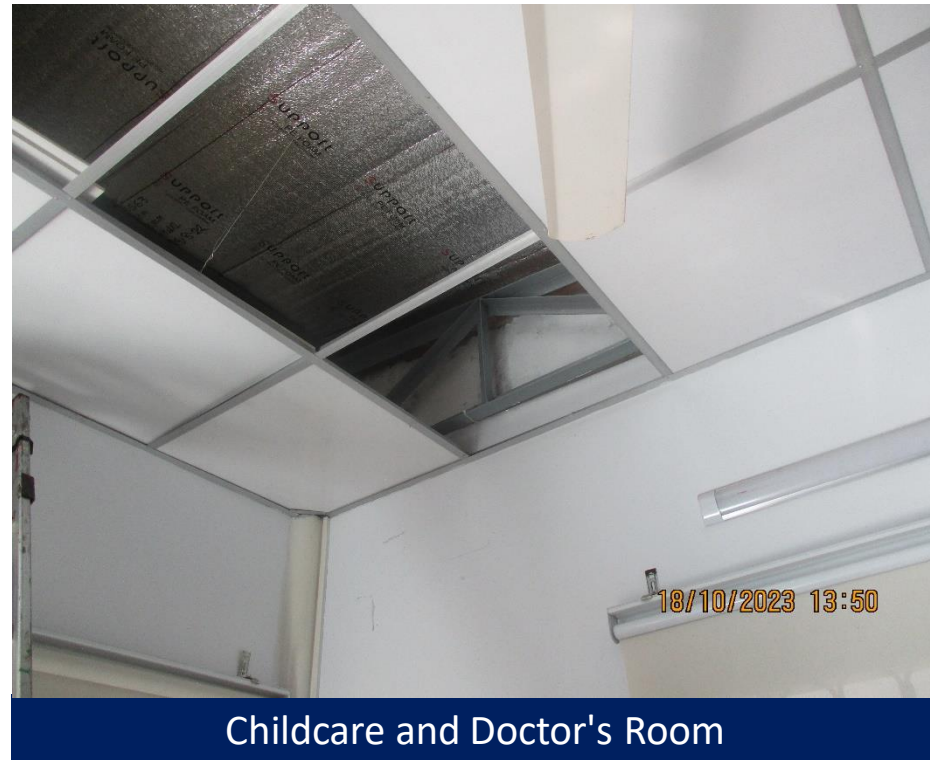
Information missing in the design report

A Design Report was available for the childcare and doctor's room which was prepared based on software analysis. As per BNBC connection adequacy were not incorporated in the design report. The building engineer is required to incorporate adequacy check of connections in the design report and submit to the RSC for review.

12	Information missing in the design report. (Childcare and Doctor's Room)	Carry out remedial works (if any) after reviewed by the RSC.	6-months

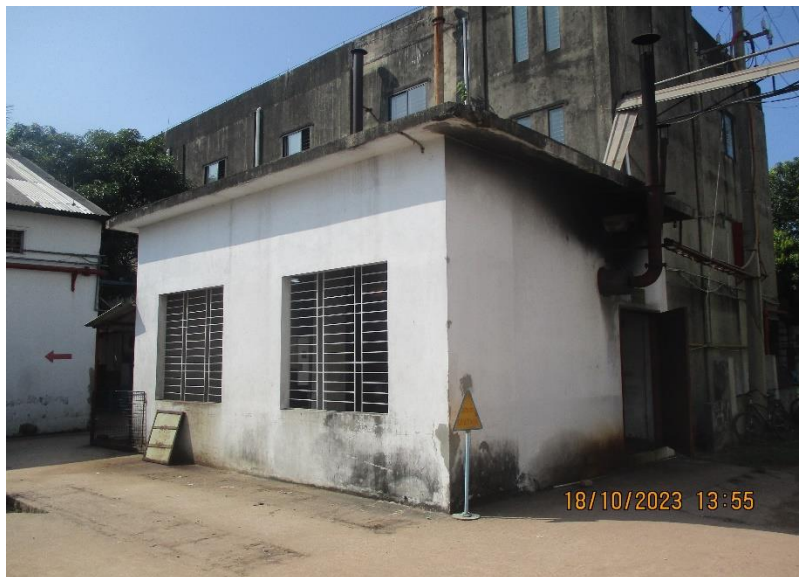
Generator room

Absence of as-built drawings

As-built drawings were not found for the generator room and fire command room. The building engineer is required to survey structures and prepare a full set of as-built drawings in compliance with section 1.9, part 6 of BNBC.

Item No.	Observation	Recommended Action Plan	Recommended Timeline
13	Absence of as-built drawings. (Generator room, Fire command room)	Building engineer is required to prepare a full set of structural drawings in compliance with section 1.9.1.2, part-6 of BNBC and submit it to RSC for review.	6-weeks
