# M.N. Dyeing, Printing & Washing Mills Ltd

Baniarchala, Bhabanipur, Gazipur sadar, Gazipur

24 Sep & 09 Oct 2023

# Observations

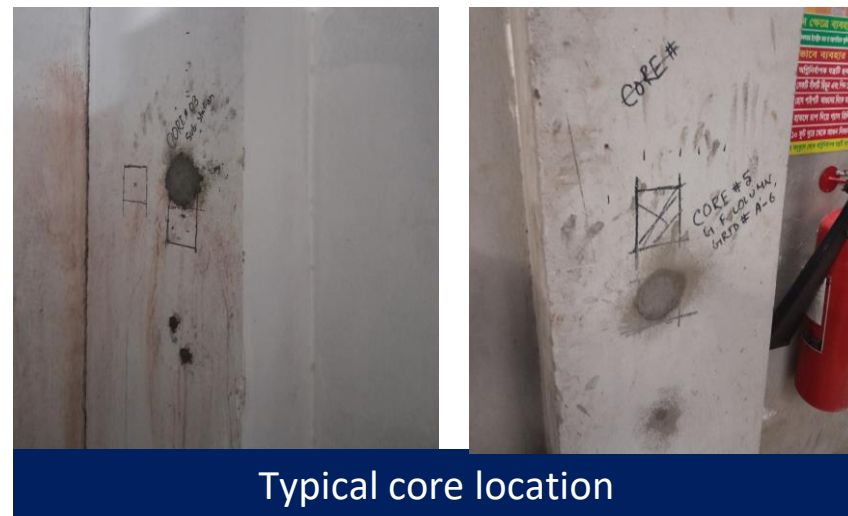
Provided concrete core test report (Typical)

**Concrete core layout plan not found on site**

At the time of inspection several sets of concrete core test report were available for the structures. However, no core test layout plan was found at site. Building engineer is required to produce a core layout and mark all the locations of the

| Item No. | Observation | Recommended Action Plan | Recommended Timeline |
|---|---|---|---|
| 01 | Concrete core layout plan not found on site (All structures) | The factory is required to prepare core layout plan. | 6-weeks |

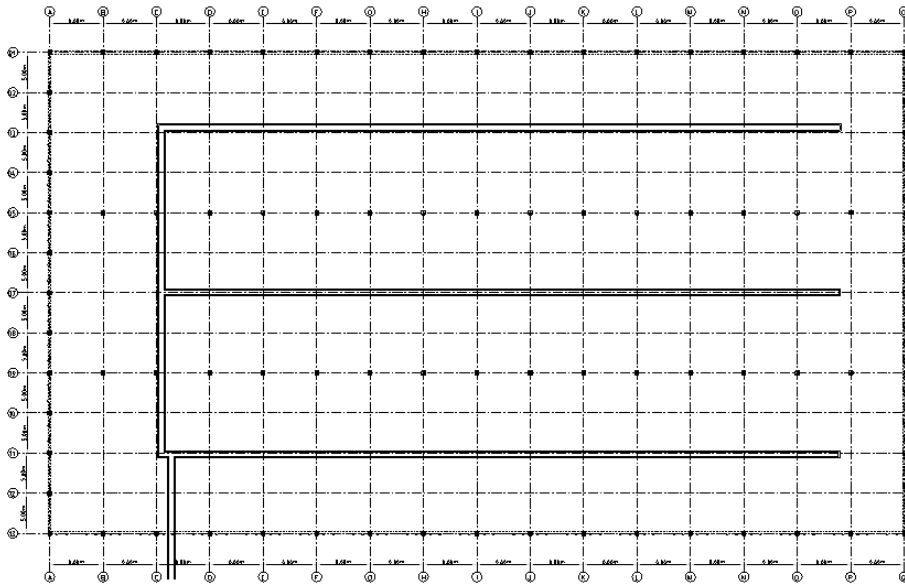
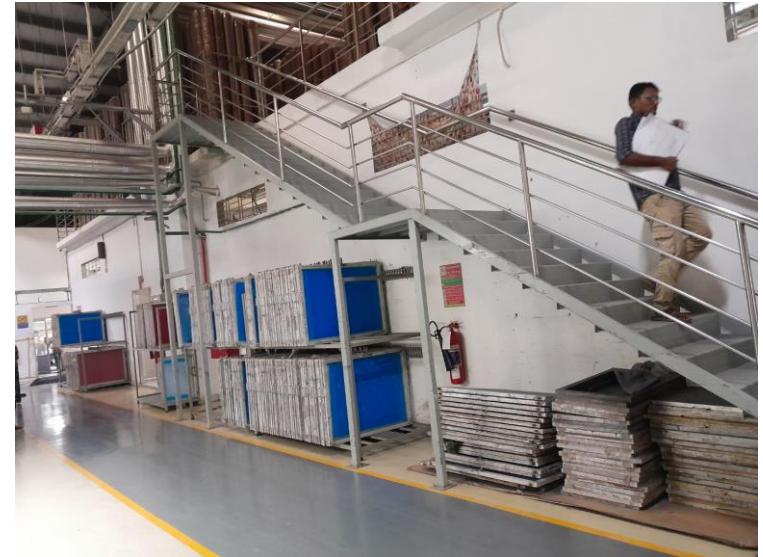
**Foundation Adequacy not shown in drawing  
(mezzanine portion)**

Foundation Adequacy not shown in drawing (mezzanine portion)

Foundation adequacy and details was not shown in as-built drawing of mezzanine floor. Building Engineer is required to revise the as-built drawing and other documents as per actual site condition.

| Item No. | Observation | Recommended Action Plan | Recommended Timeline |
|---|---|---|---|
| 04 | Foundation Adequacy not shown in design report (mezzanine portion-Printing Production Shed) | Building engineer is required to revise the as-built drawing and other documents as per the actual site condition. | 6-weeks |
| 05 | Foundation Adequacy not shown in design report (mezzanine portion-Printing Production Shed) | Incorporate foundation adequacy in the design report. | 6-weeks |

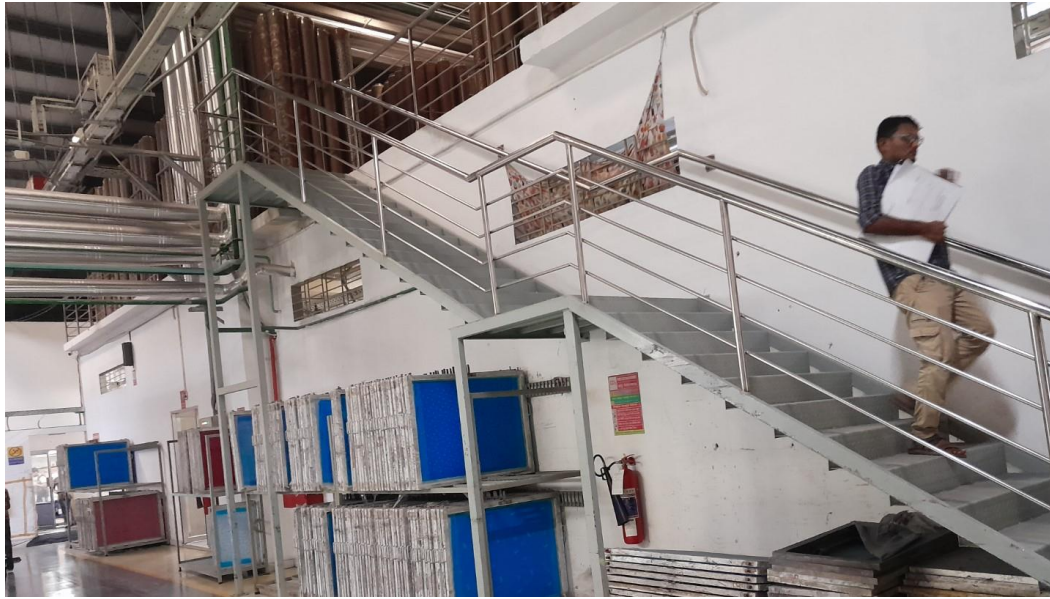
# **Apparently non-engineered steel stair**

Apparently non-engineered steel stair with inadequate member and connection

The stability system of steel stair and its connections are apparently non-engineered. Also, the member size seems to be inadequate. The building engineer is required to suggest proper alternatives to make the structure adequate and prepare necessary design documents accordingly.

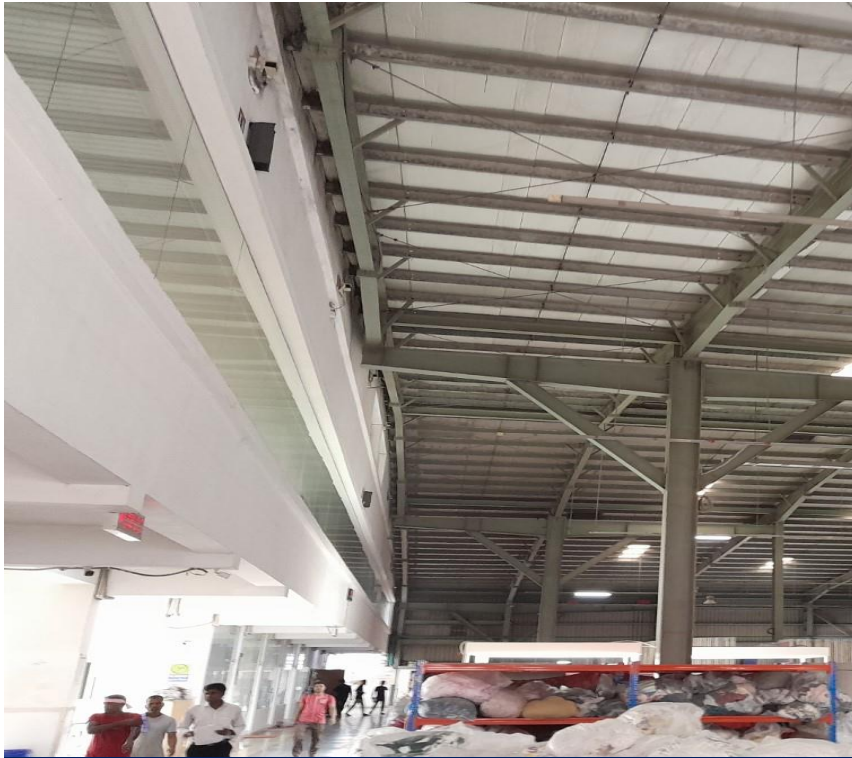
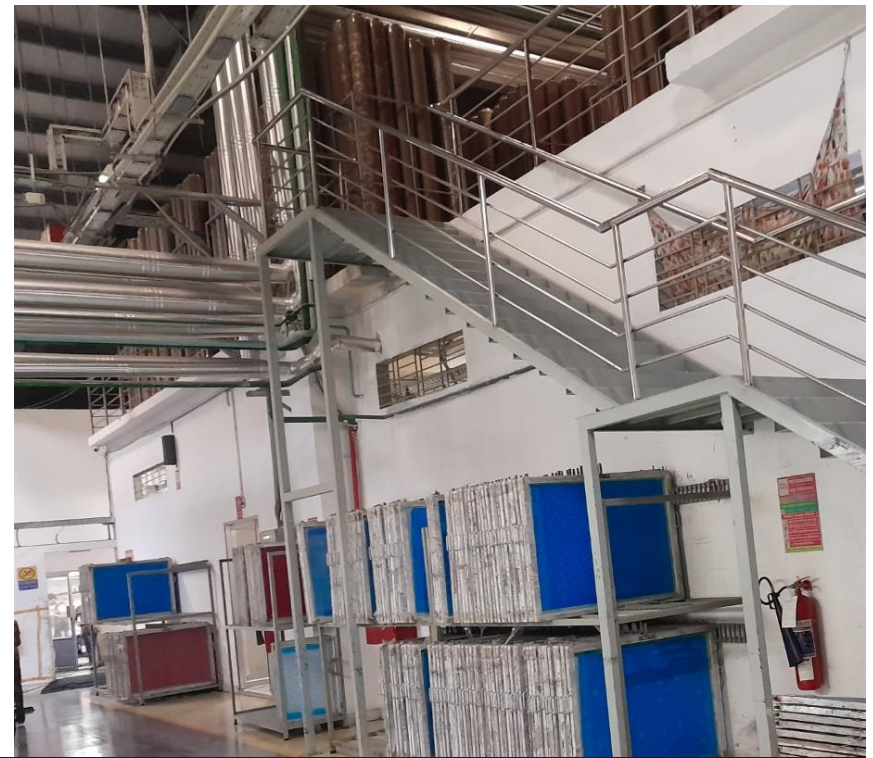
**Load plan not posted in Mezzanine Floor**

Mezzanine floor having no load plan

During inspection, load plan was not found posted in mezzanine floor, which is required to be prepared in compliance with section 1.9.1.1 (part-6, BNBC). Also post the load

| Item No. | Observation | Recommended Action Plan | Recommended Timeline |
|---|---|---|---|
| 07 | Load plan not posted in Mezzanine Floor (Printing Production Shed) | Produce and actively manage a set of floor live load plan for all floors based on column and foundation capacity. | 6-weeks |

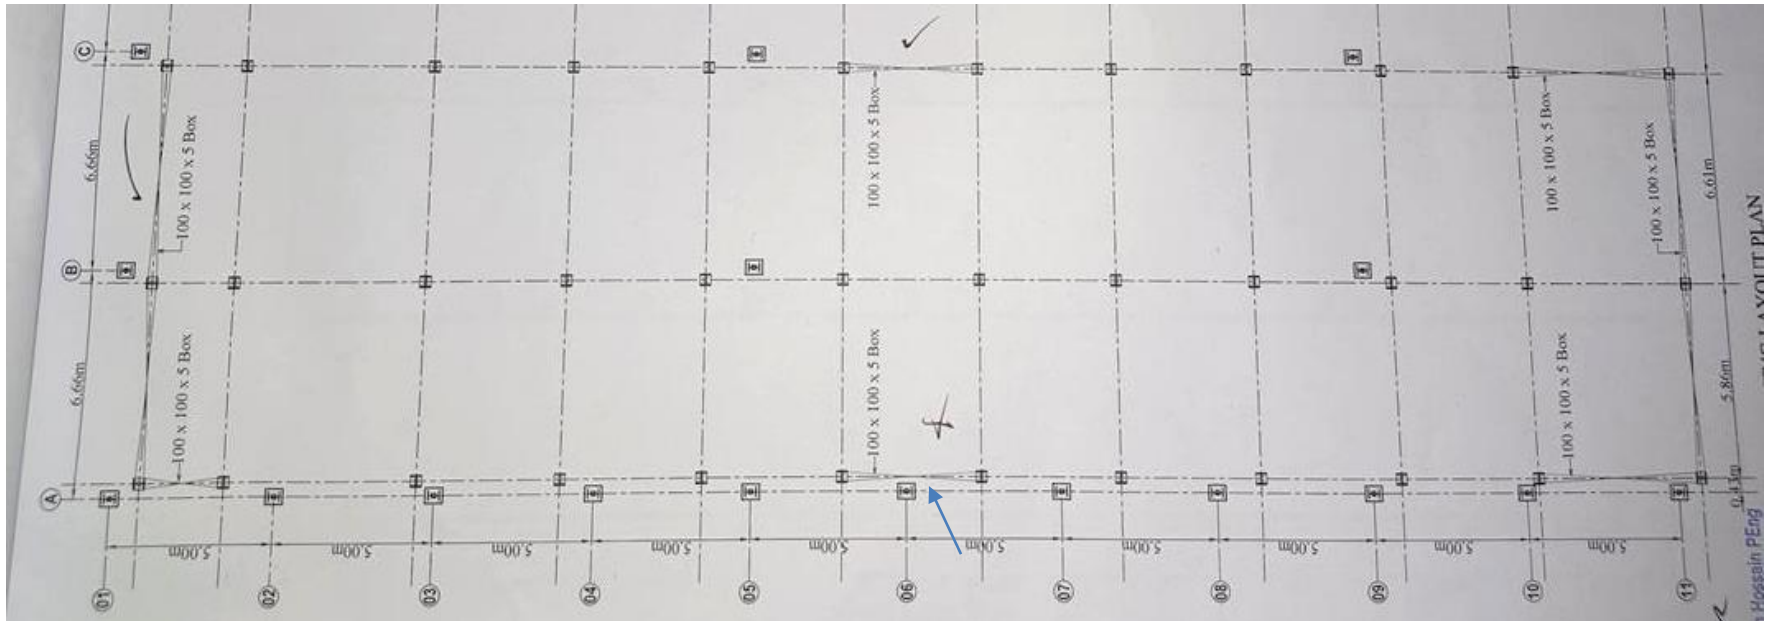
# **Bracing missing in Mezzanine Floor**

Bracing found missing in marked location

During inspection, as-built bracing layout was not matched with on-site condition. Building Engineer is required to revise the as-built drawing as per actual on-site condition.

| Item No. | Observation | Recommended Action Plan | Recommended Timeline |
|---|---|---|---|
| 09 | Bracing missing in Mezzanine Floor (Printing Production Shed) | The Building Engineer is required to revise the as-built drawing as per actual on-site condition and check the stability. | 6-weeks |
| 10 | Bracing missing in Mezzanine Floor (Printing Production Shed) | Carry out suggested remedial works if required. | 6-months |

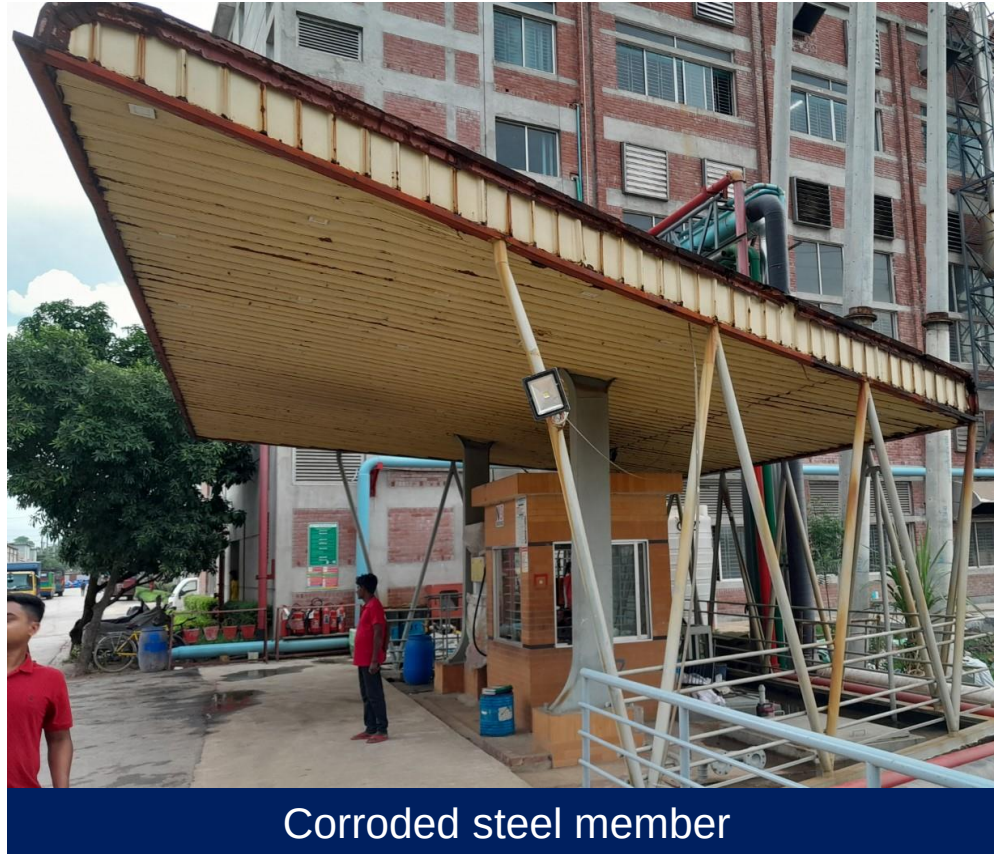
## **Corrosion on steel member**

Corroded steel member

Corrosion found in steel members at several locations. Building engineer is required to identify all corroded member, remove the corrosion and apply suitable anti-corrosive coating to the affected steel members.

| Item No. | Observation | Recommended Action Plan | Recommended Timeline |
|---|---|---|---|
| 11 | Corrosion on steel member (Diesel Station) | Building engineer is required to identify all corroded member, remove the corrosion and apply suitable anti-corrosive coating to the affected steel members. | 6-weeks |

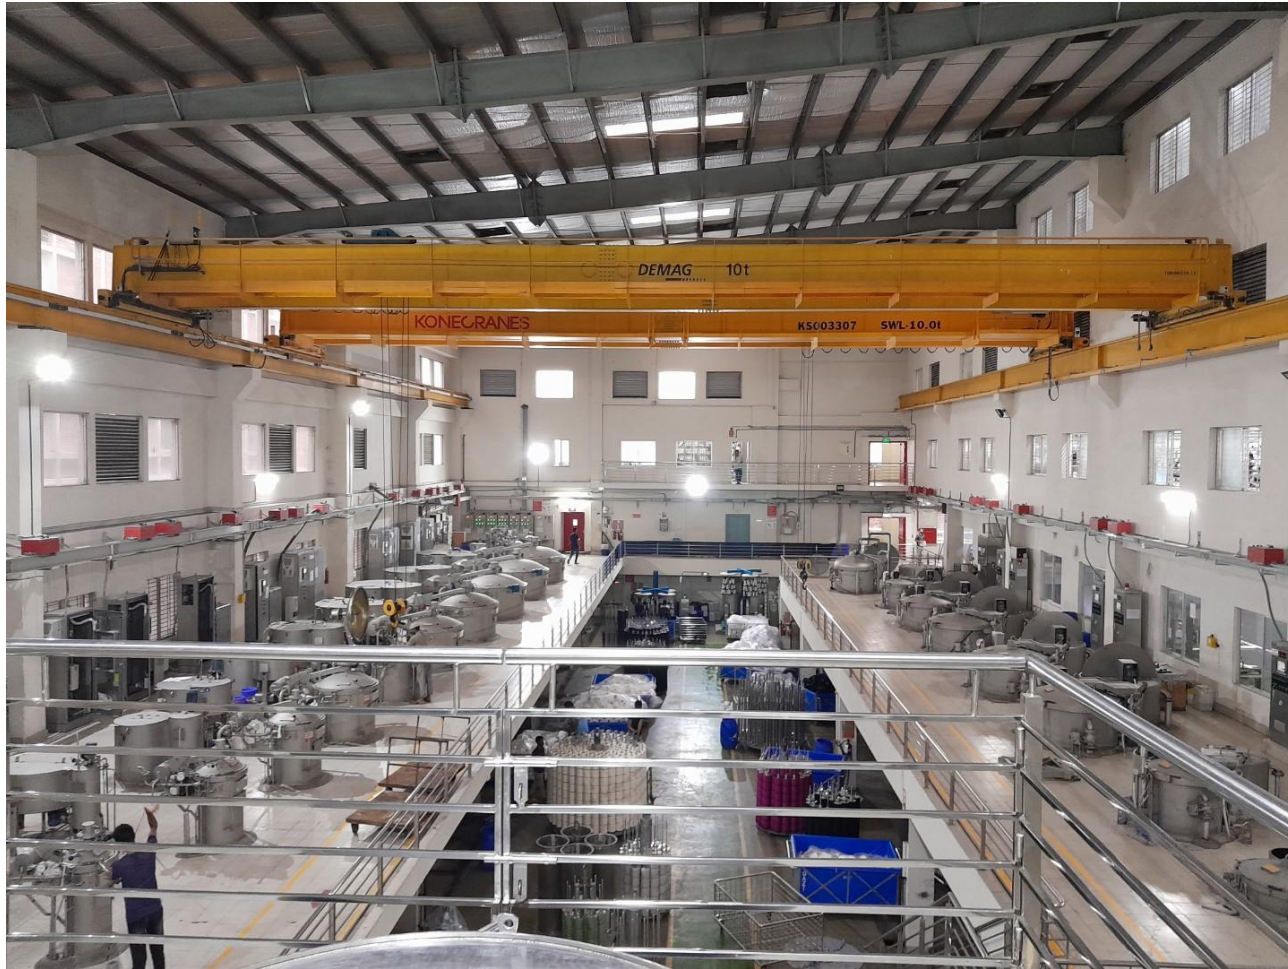
## **Structural connection between two buildings**

Building engineer is required to revised the design report and submit to RSC for review considering connections between two buildings (3-Storeyed fiber & yarn dyeing building and 2-storied utility building).

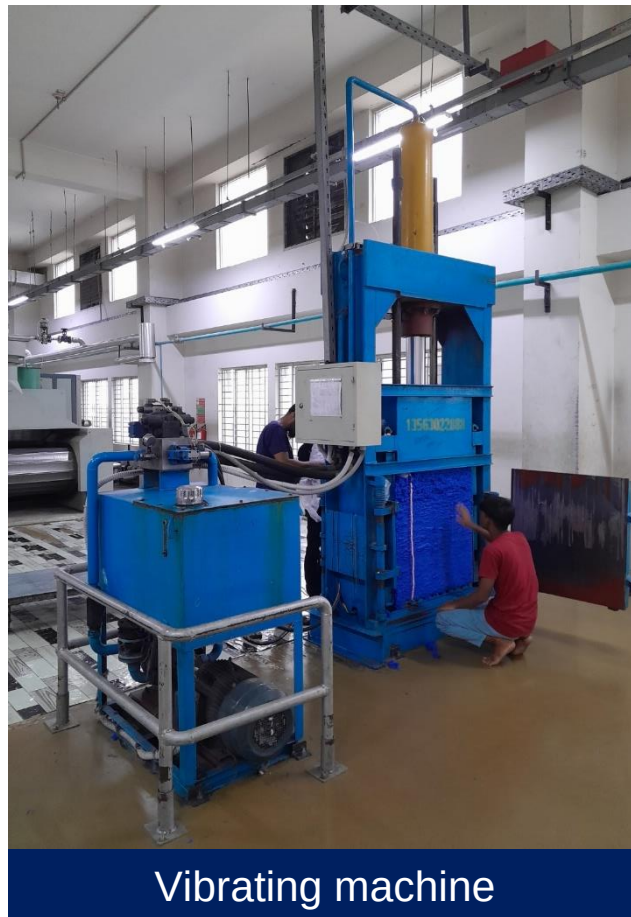
# Significant Vibration

Vibrating machine

Significant amount of vibration was observed on the floor due to operation of machine without any damper. The building engineer is required to suggest installation of proper damping elements.

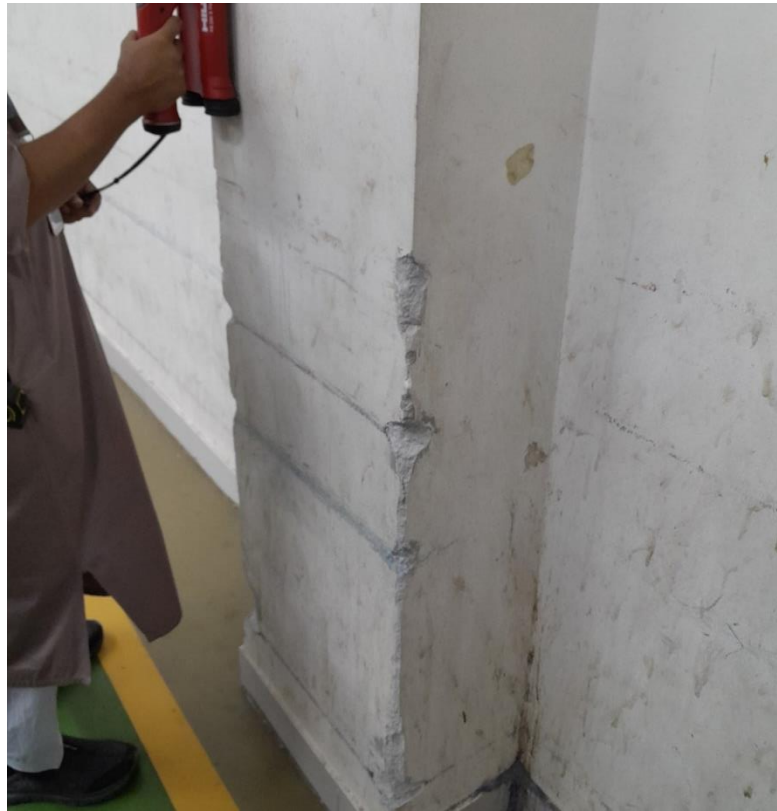
## **RCC Column suspectable for trolley Impact**

Damage RC Column due to trolley

During inspection, Damage in RC Column was found due to trolley Impact. Building engineer required to provide barrier around the RC column to protect from possible trolley impact.

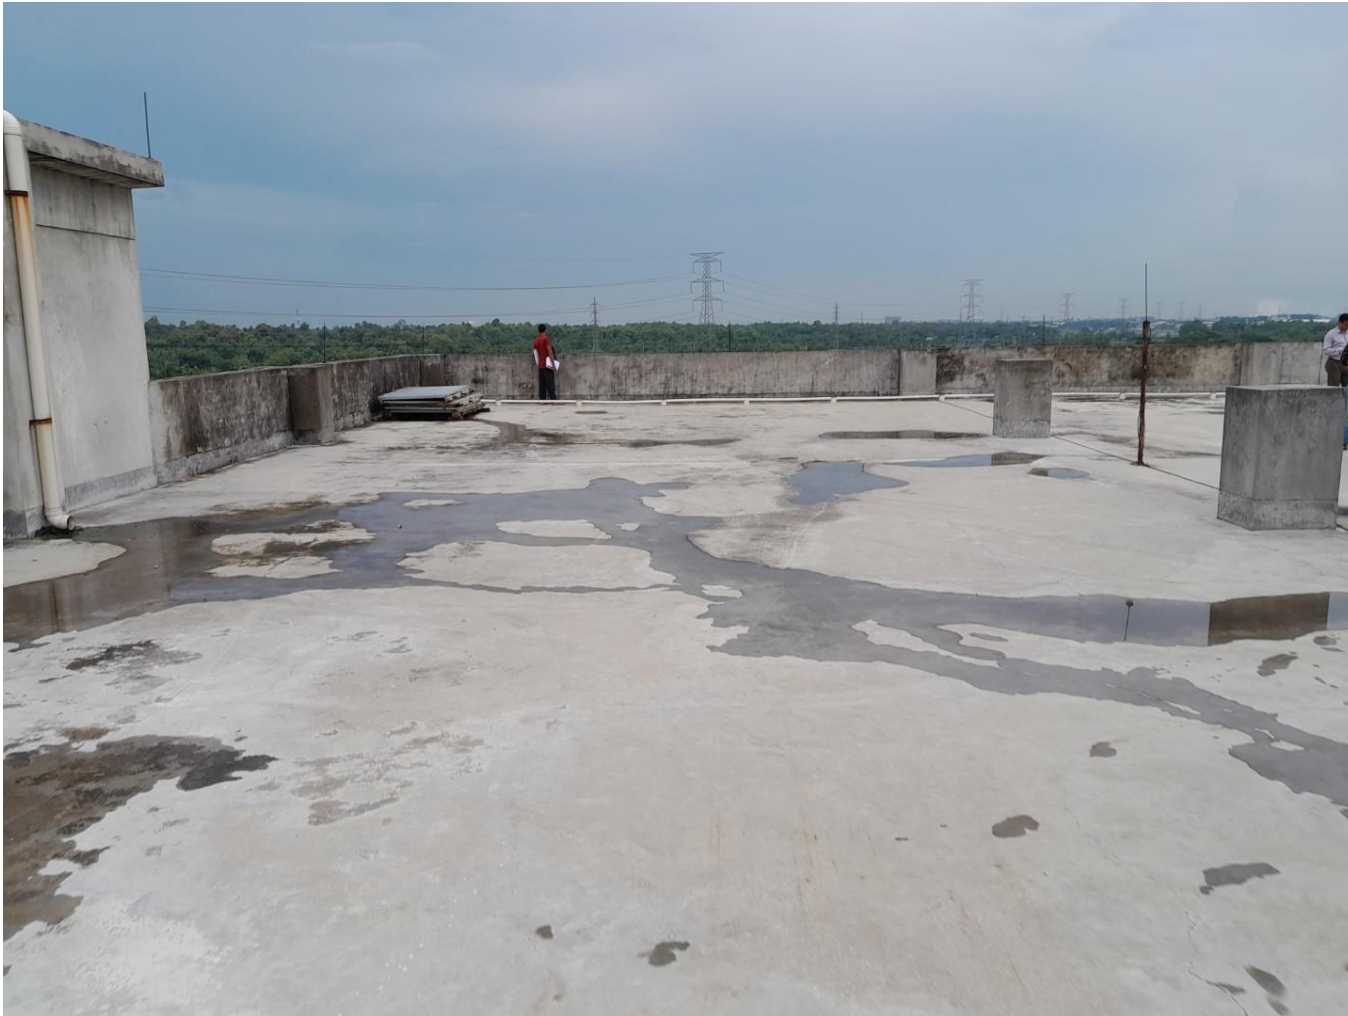
# **Water ponding on the roof**

Water ponding observed on the roof slab due to poor drainage system. The building engineer is required to develop proper drainage system with adequate sloping on roof.

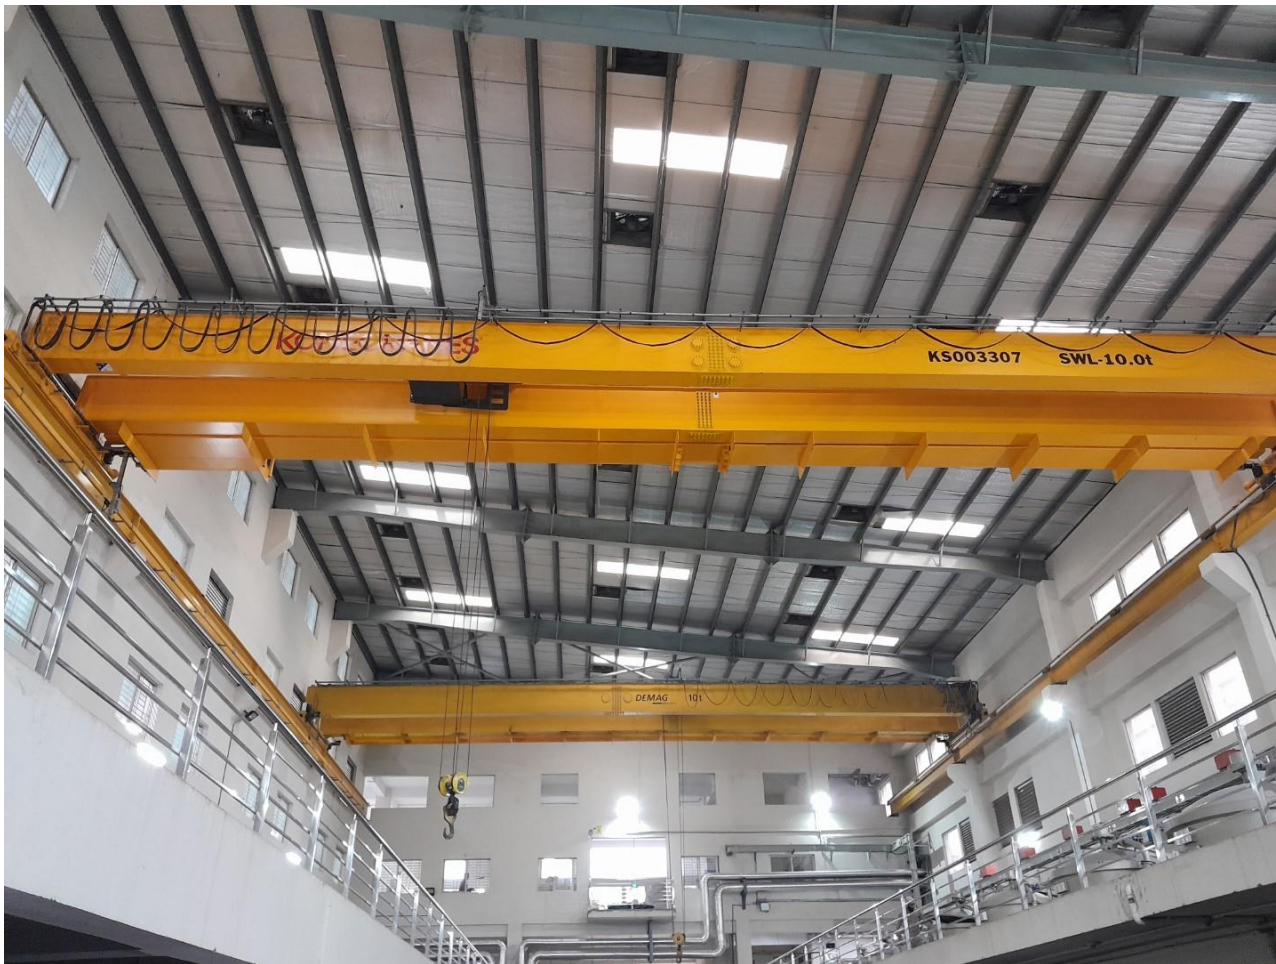
## **Additional Crane Loading**

Over-head crane was observed during inspection. The building engineer is required to check the structural adequacy due to additional

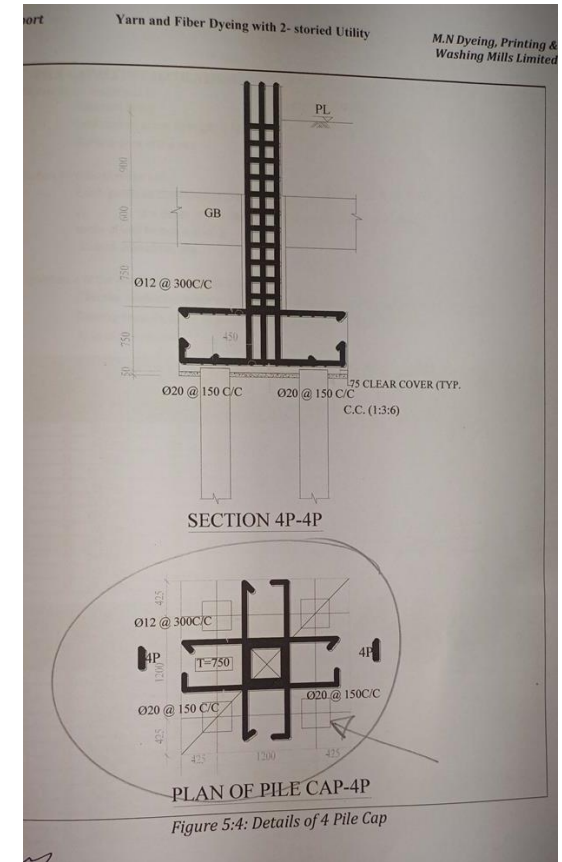
Calculation considering Cast-in-situ pile where drawing shows pre-cast pile

Building engineer is required to revised the design report and submit to RSC for review.

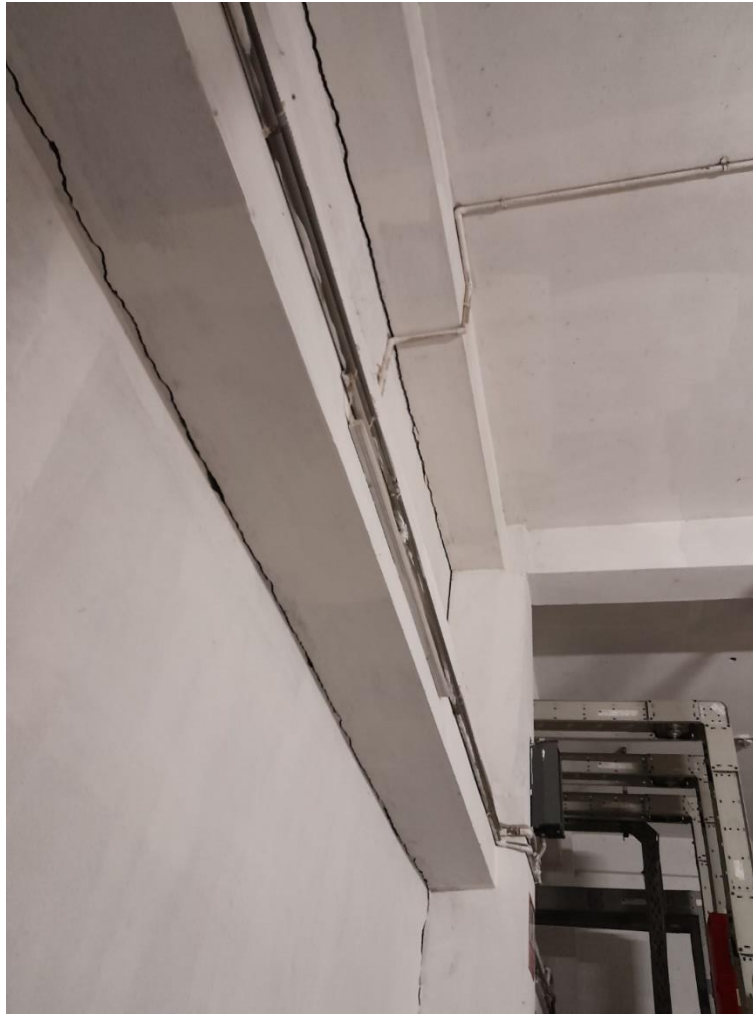
## **Significant Crack on Brick wall**

During inspection, significant crack on brick wall was observed. Building engineer is required to repair the crack using suitable methodology.

| Item No. | Observation | Recommended Action Plan | Recommended Timeline |
|---|---|---|---|
| 19 | Significant Crack on Brick wall (Fiber & yarn dyeing sub-station) | Building engineer is required to repair the crack using suitable methodology. | 6-weeks |

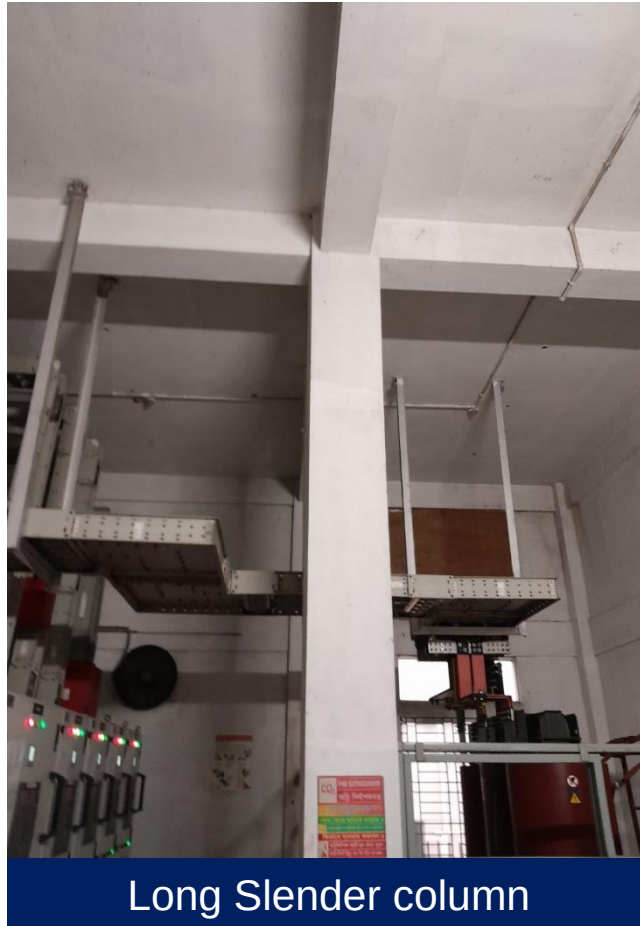
**Long column check need to address**

Long Slender column

During inspection, long slender column was observed. Building engineer is required to check the slenderness adequacy of the column and suggest proper remedial actions accordingly.

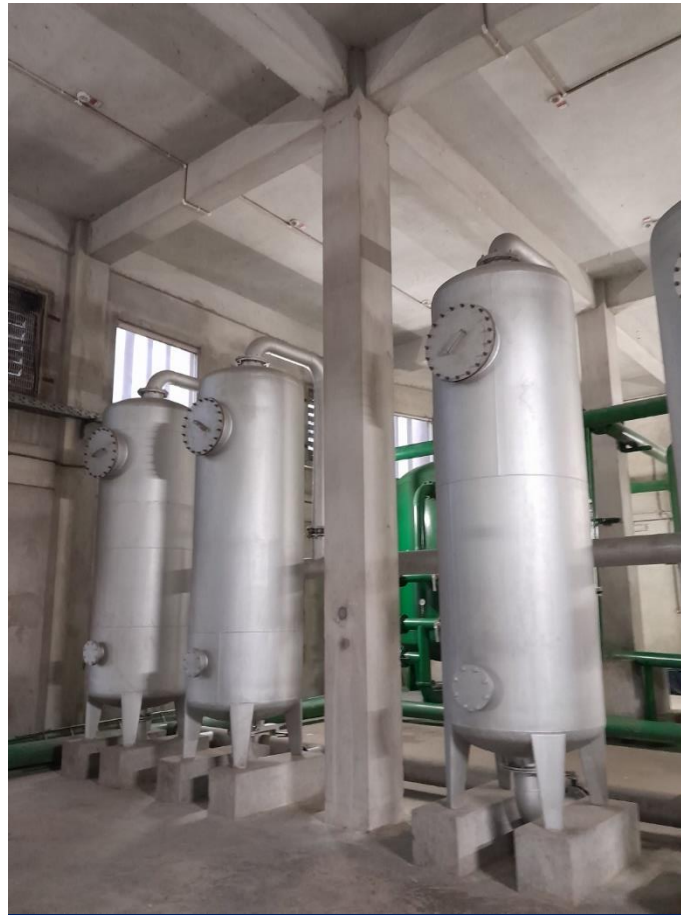
**Long column check need to address**

Long Slender column

During inspection, long slender column was observed. Building engineer is required to check the slenderness adequacy of the column and suggest proper remedial actions accordingly.

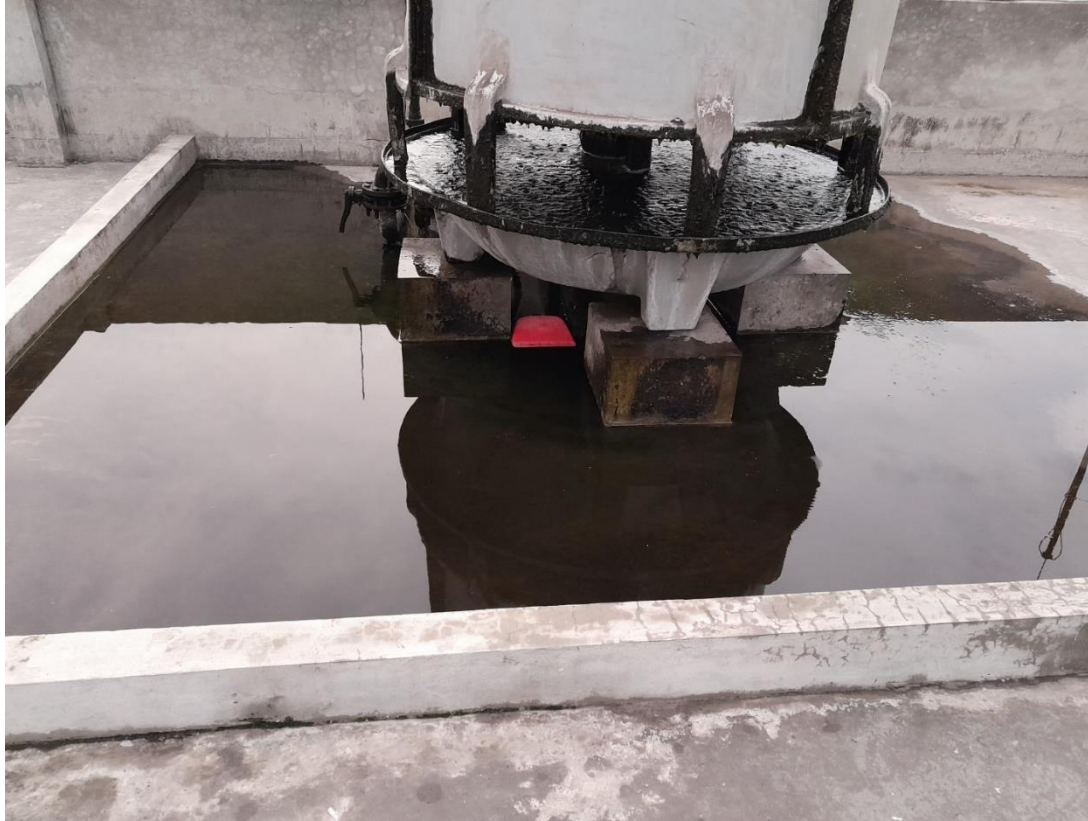
# **Water ponding on the roof**

Water ponding observed on the roof slab due to poor drainage system. The building engineer is required to develop proper drainage system with adequate sloping on roof.

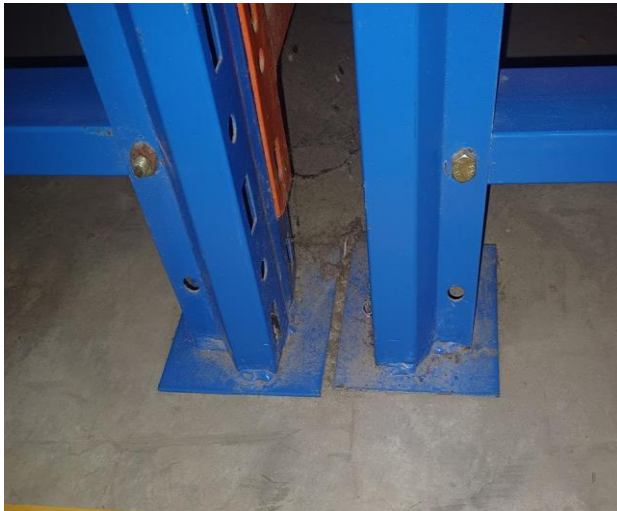
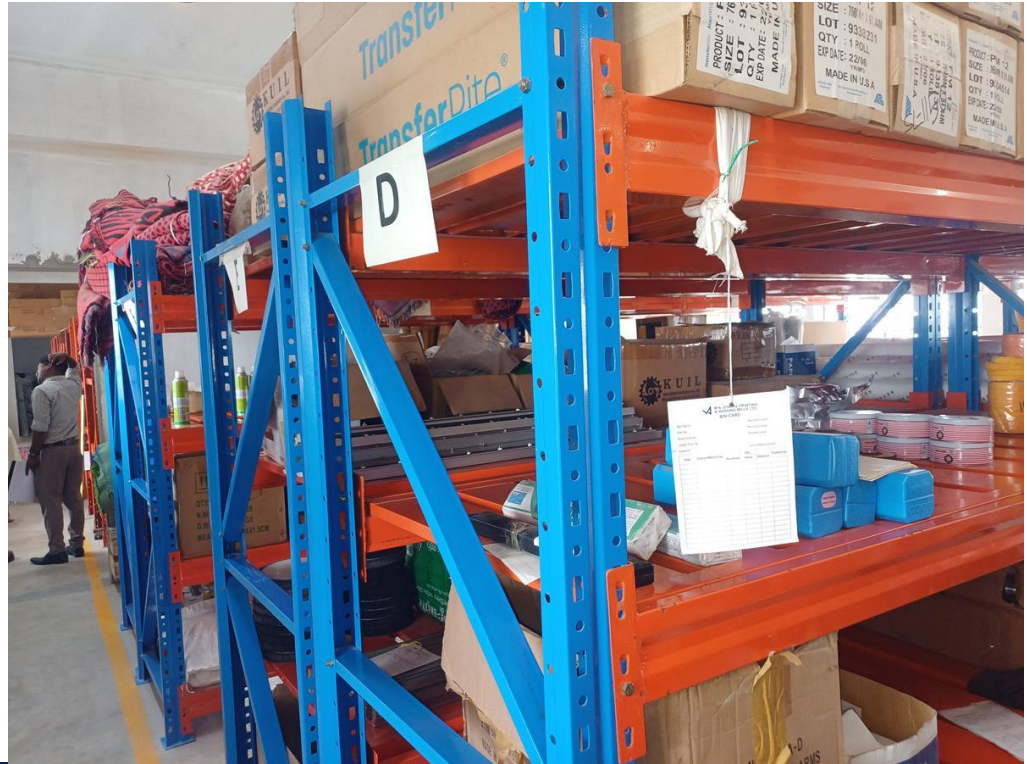
## **Lack of anchorage of storage rack**

Lack of anchorage of storage rack

During inspection, lack of anchorage of storage racks was found. Building engineer is required to brace/anchor all the non-structural elements.

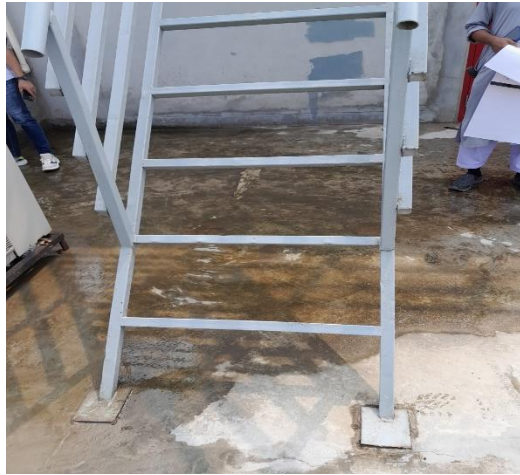
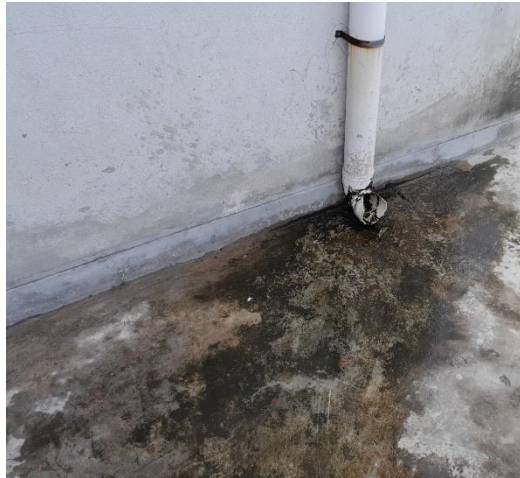
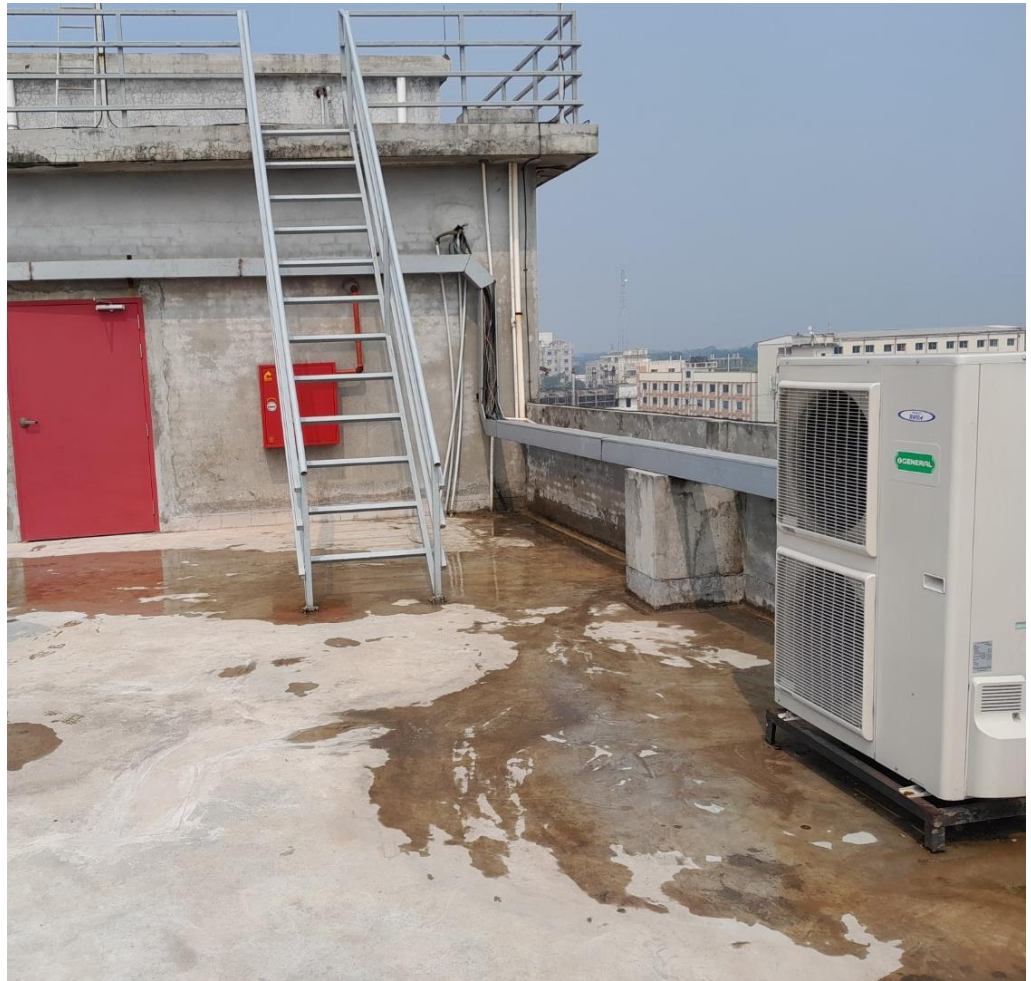
# **Water ponding on the roof**

Water ponding observed on the roof slab due to poor drainage system. The building engineer is required to develop proper drainage system with adequate

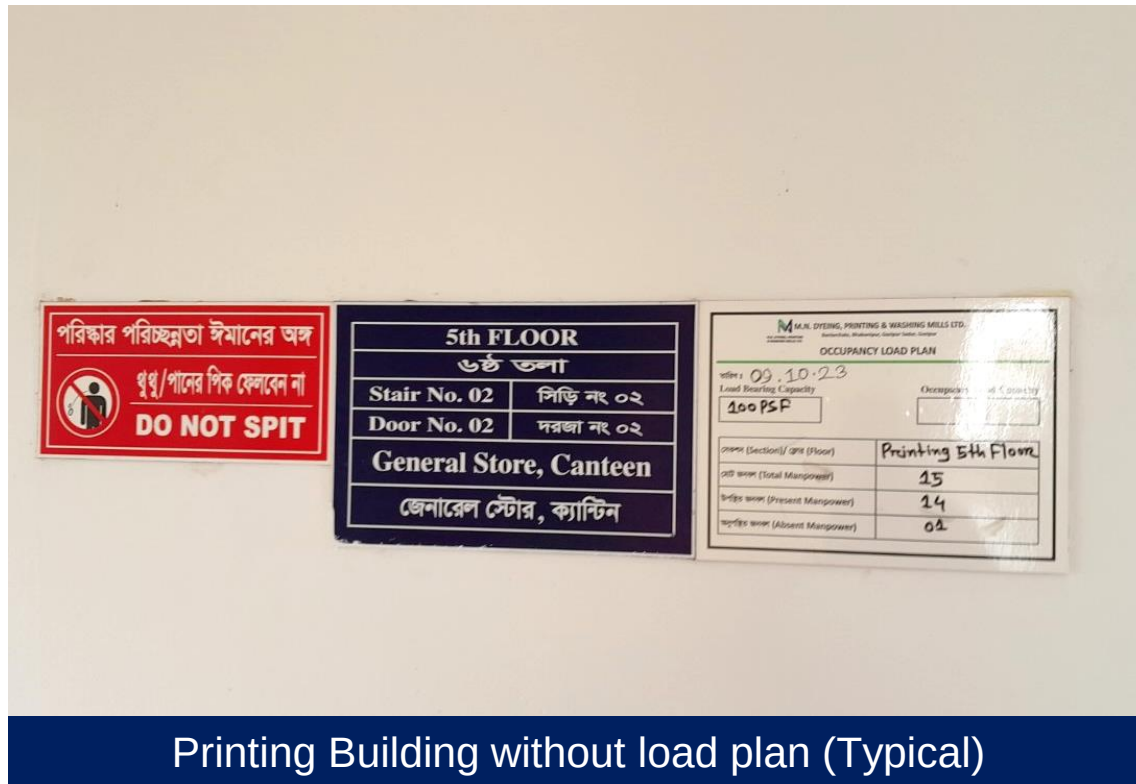
## **Lack of posting load plan**

Printing Building without load plan (Typical)

As per BNBC, every building or structure designed shall have its design documents prepared in accordance with the provision of Section 1.9.1, part-6 of BNBC. The design document shall include a design report, and a set of structural drawings, which shall be prepared in compliance with section 1.9.1.1 and section 1.9.1.2 as per BNBC.

During inspection, floor load plan was not found which is required to be prepared in compliance with section 1.9.1.1 (part-6, BNBC).

| Item No. | Observation | Recommended Action Plan | Recommended Timeline |
|---|---|---|---|
| 27 | Lack of posting load plan (6-Storied printing building) | Produce and actively manage a set of floor live load plan for all floors based on column and foundation capacity. | 6-weeks |

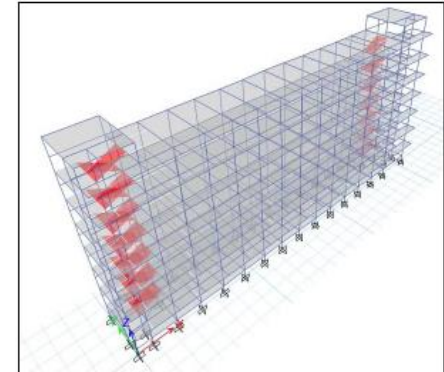
Figure 1: 3-D VIEW OF 7-STORIED PRINTING BUILDING FOR "MN PRINTING AND WASHING MILLS LIMITED"

**Lateral stability need to check in details**

The building is apparently slender (length to width ratio  $> 7$ ). The building engineer is required to check the lateral stability of the structure as per BNBC in details and suggest proper remedial actions if required.

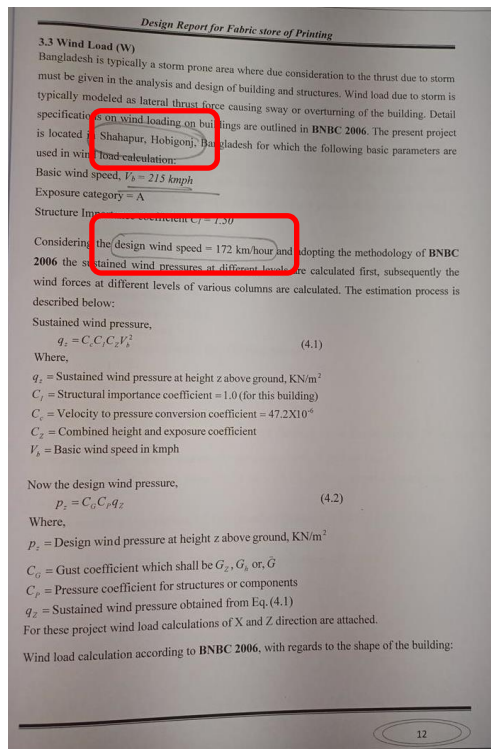
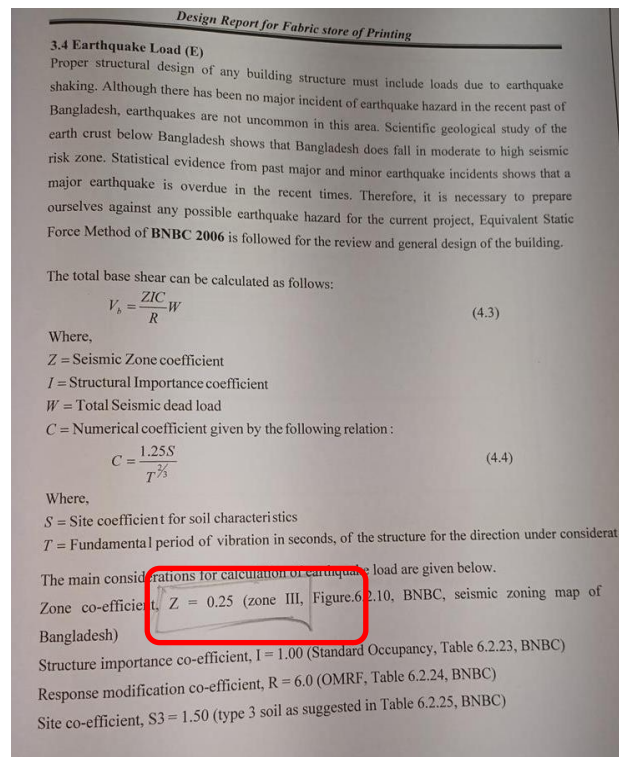
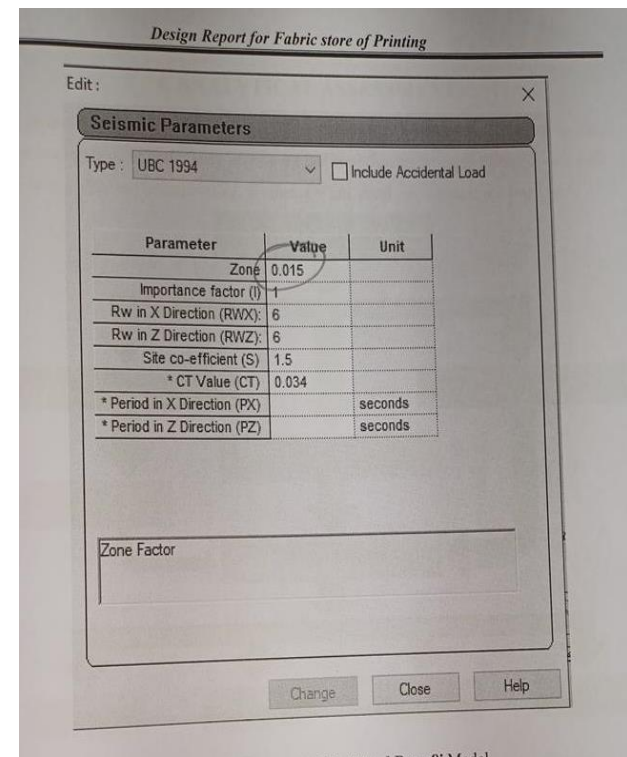
Mis-match in location and zone (Z)

Inconsistencies in design report was observed. Building engineer is required to revised the design report as per actual condition and submit to RSC for review.

| Item No. | Observation | Recommended Action Plan | Recommended Timeline |
|---|---|---|---|
| 31 | Inconsistencies in Design Report (Printing fabric store) | Building engineer is required to revised the design report as per actual condition and submit to RSC for review. | 6-weeks |

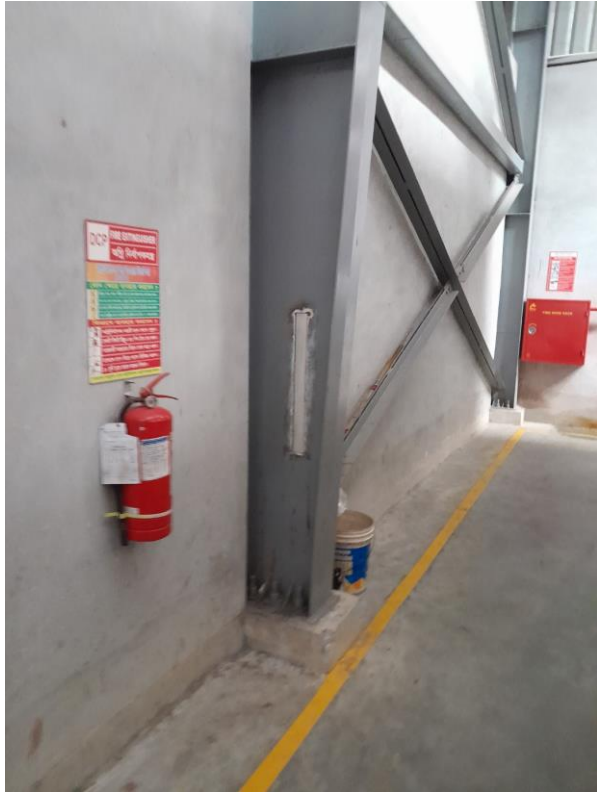
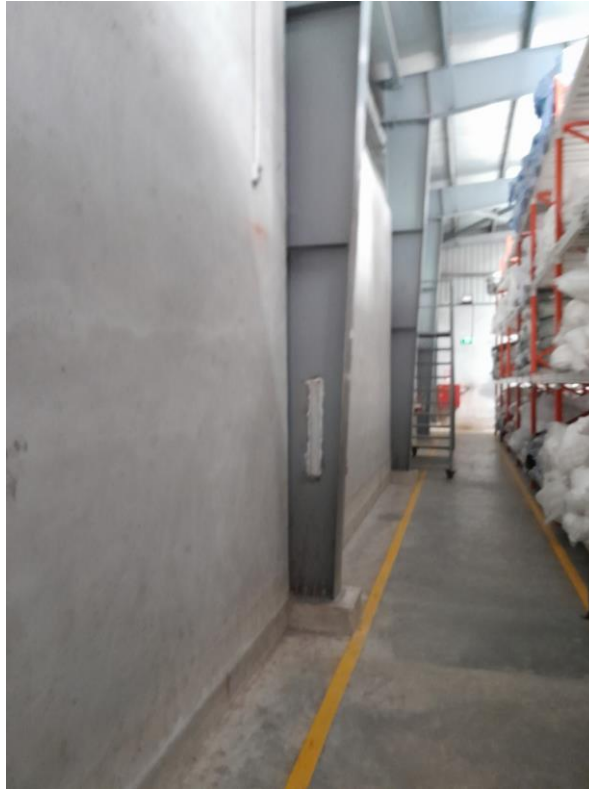
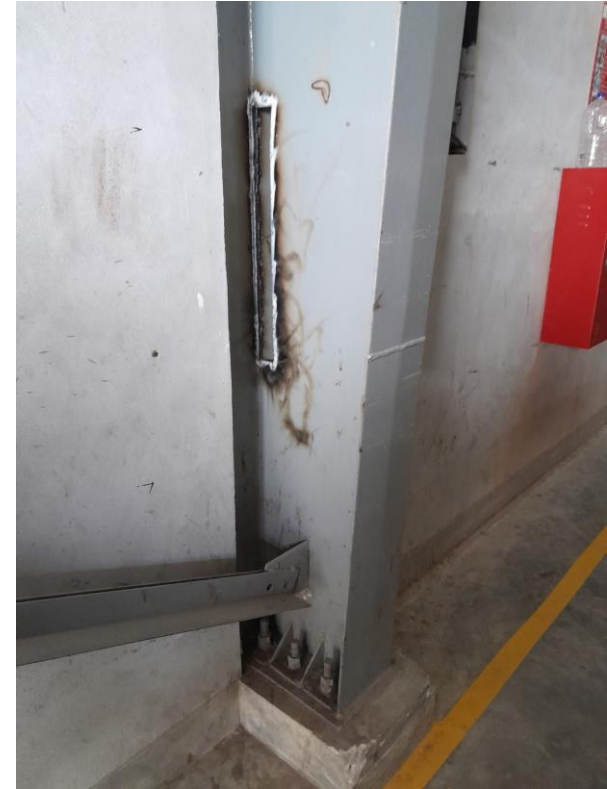
**Tested area not filled with specification**

Unfilled tested areas

Tested areas of steel structures were found not-filled during inspection. Building engineer is required to fill all the tested area immediately by suitable method.
