# M.N. Dyeing, Printing & Washing Mills Ltd

Baniarchala, Bhabanipur, Gazipur sadar, Gazipur

24 Sep & 09 Oct 2023

# Observations

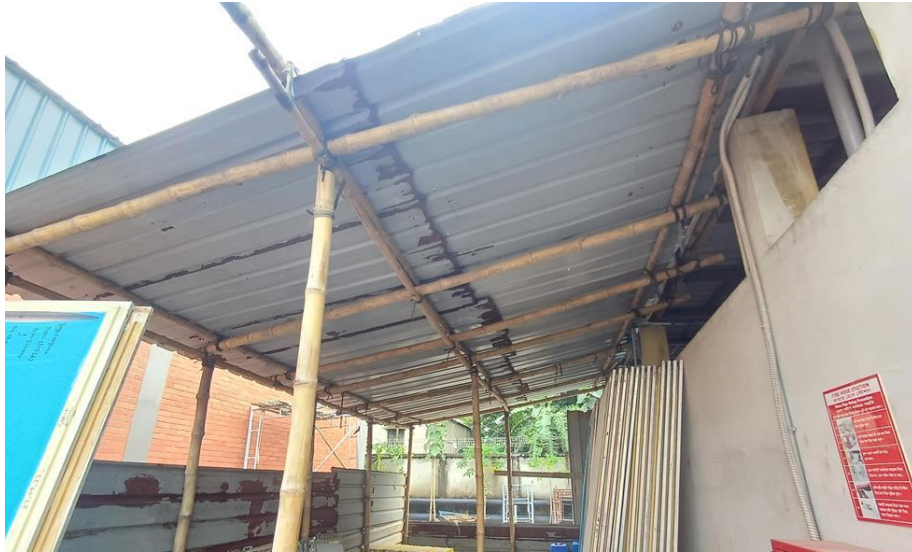
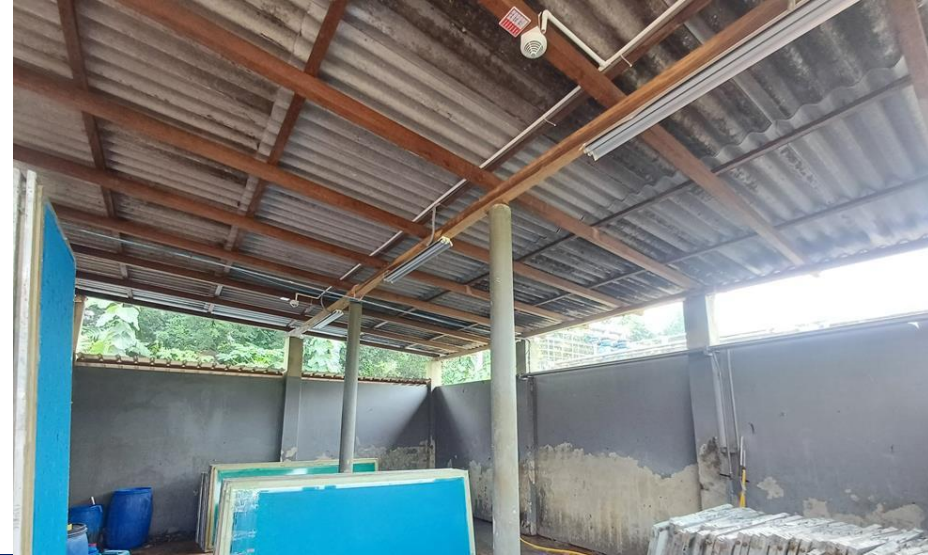
**Apparently non-engineered structure**

Apparently non-engineered structure with inadequate member and connection

The stability system of roof & peripheral walls and their connections are apparently non-engineered. The building engineer is required to suggest proper alternatives to make the structure adequate and prepare necessary design documents accordingly. Otherwise, the factory is required to replace the shed with well-designed structure.

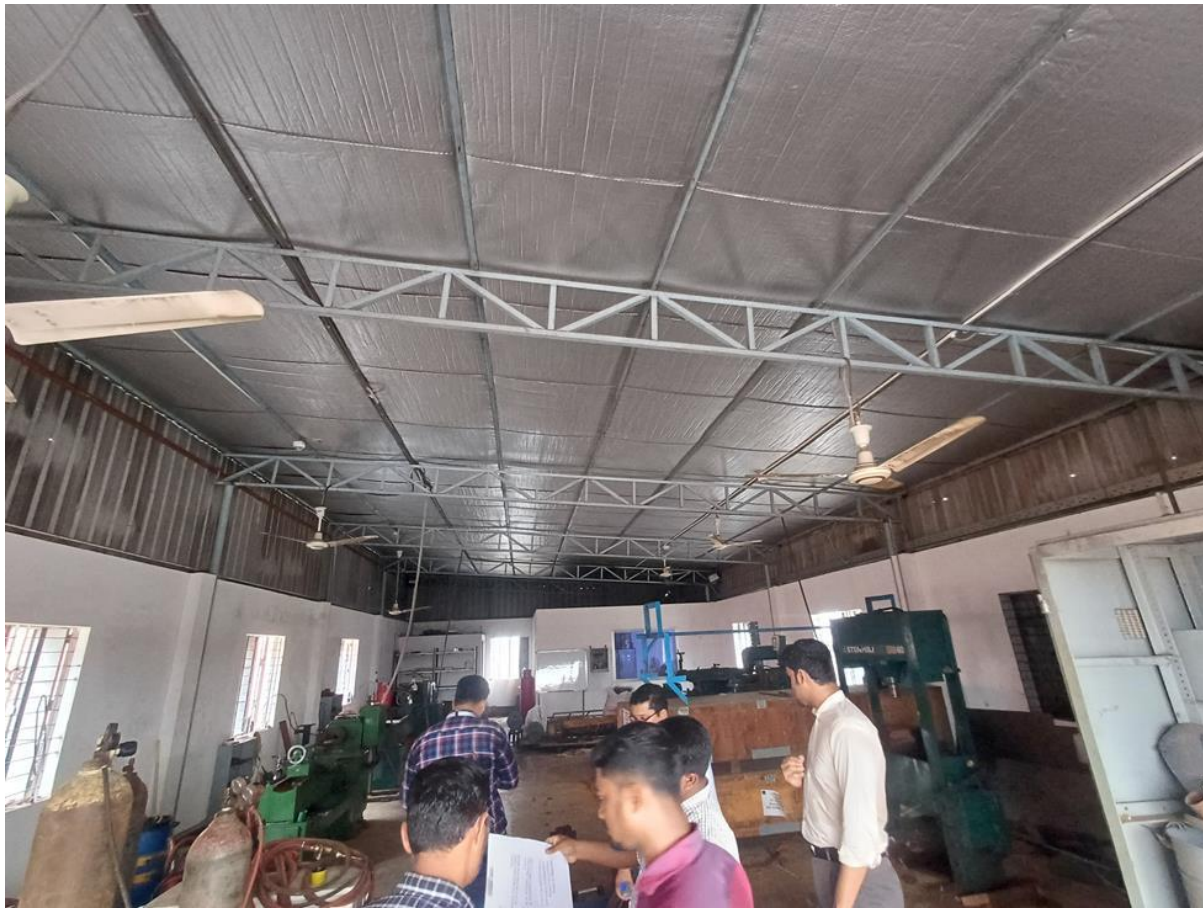
## **Lack of lateral stability System**

Truss along short direction was observed but no bracing or load transfer media was provided along long direction. Building engineer is required to check the lateral stability of the structure.

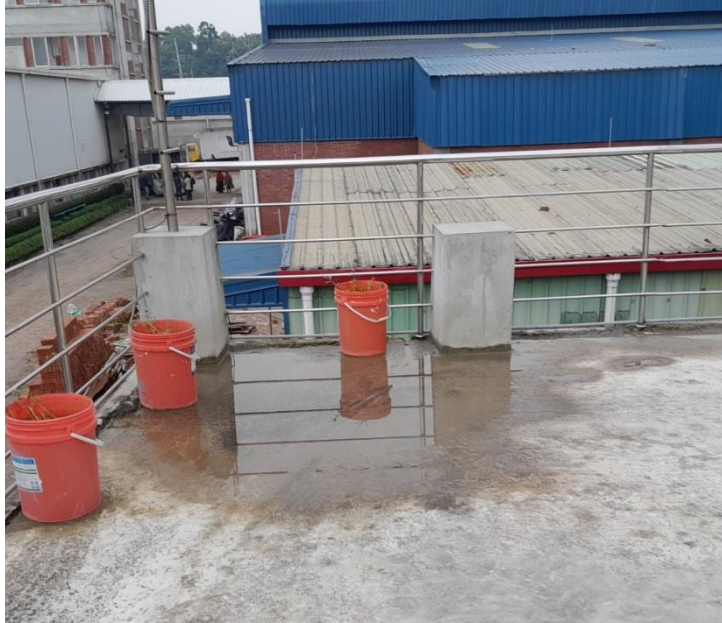
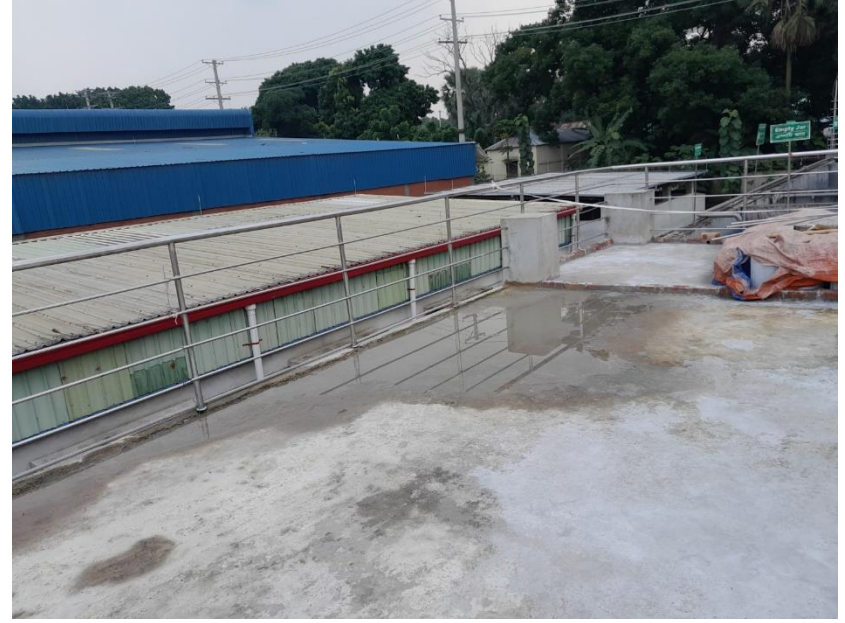
# Water ponding on the slab

Water ponding observed on the slab due to poor drainage system. The building engineer is required to develop proper drainage system with adequate sloping on

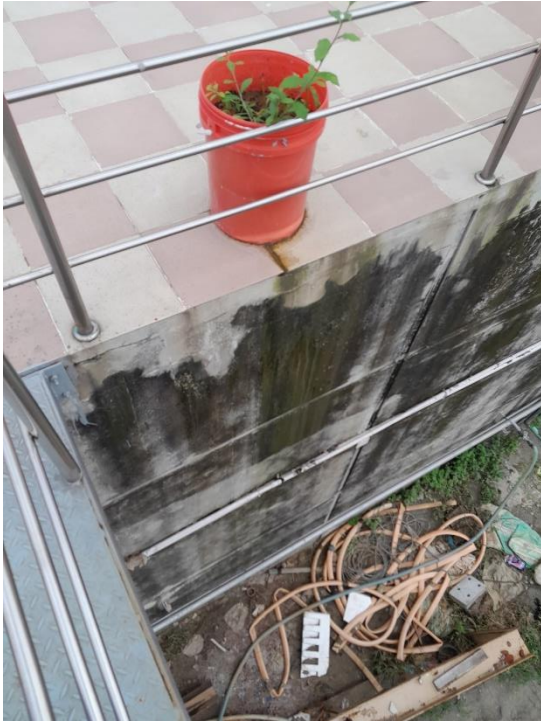
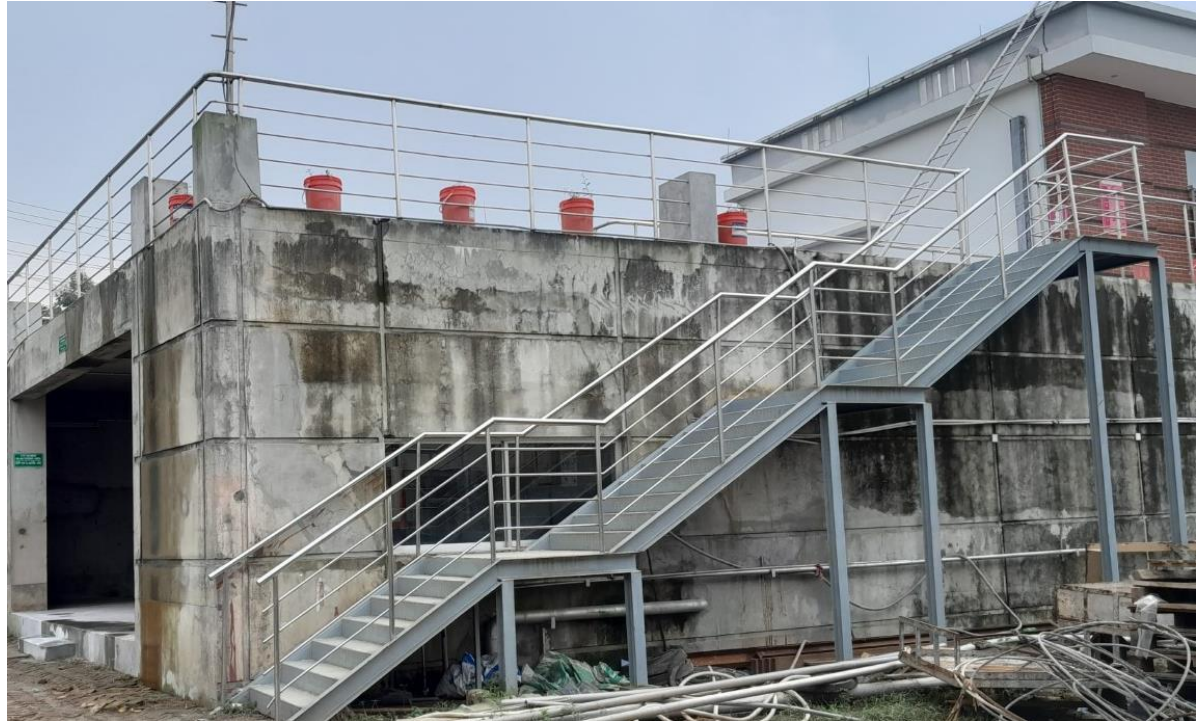
# Dampness on exterior walls

Dampness on Exterior wall

Dampness was observed at the exterior wall of ETP. The factory is required to seal the source of water and repair the damped area with suitable method.

| Item No. | Observation | Recommended Action Plan | Recommended Timeline |
|---|---|---|---|
| 39 | Dampness on exterior walls (ETP) | The building engineer is required to seal the source of water and repair the damped area with suitable method. | 6-weeks |

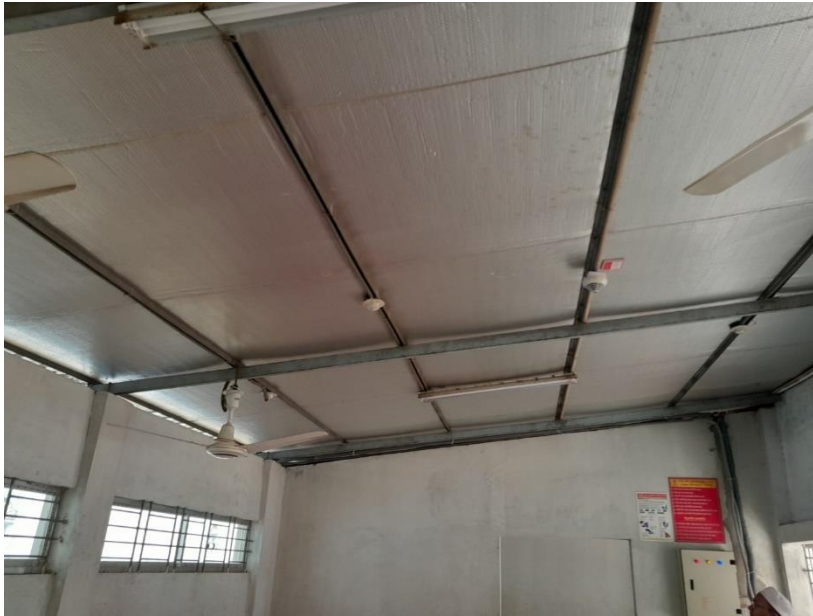
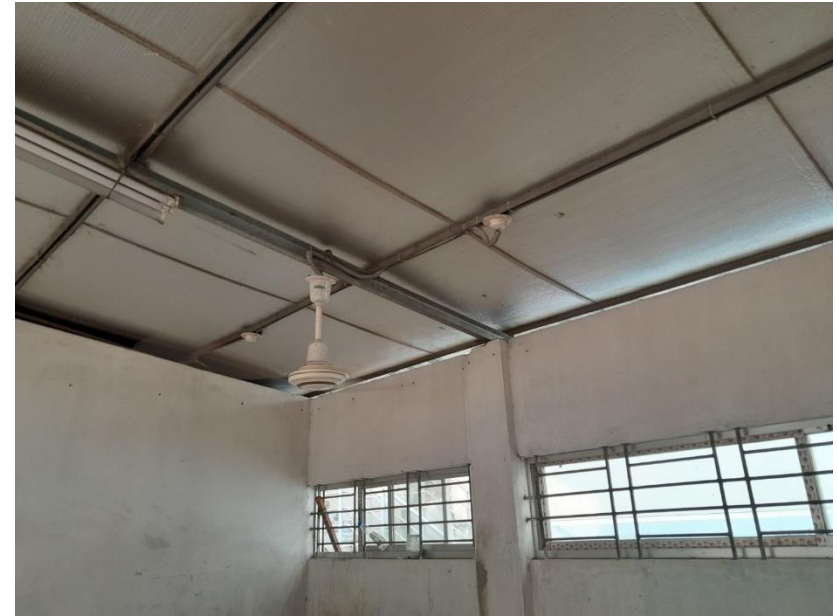
# **Poor connection against uplift pressure**

Apparently inadequate connections were observed at the lightweight roof of the single storied Sheds. The building engineer to check the connection adequacy of the lightweight roof against the uplift pressure of wind.

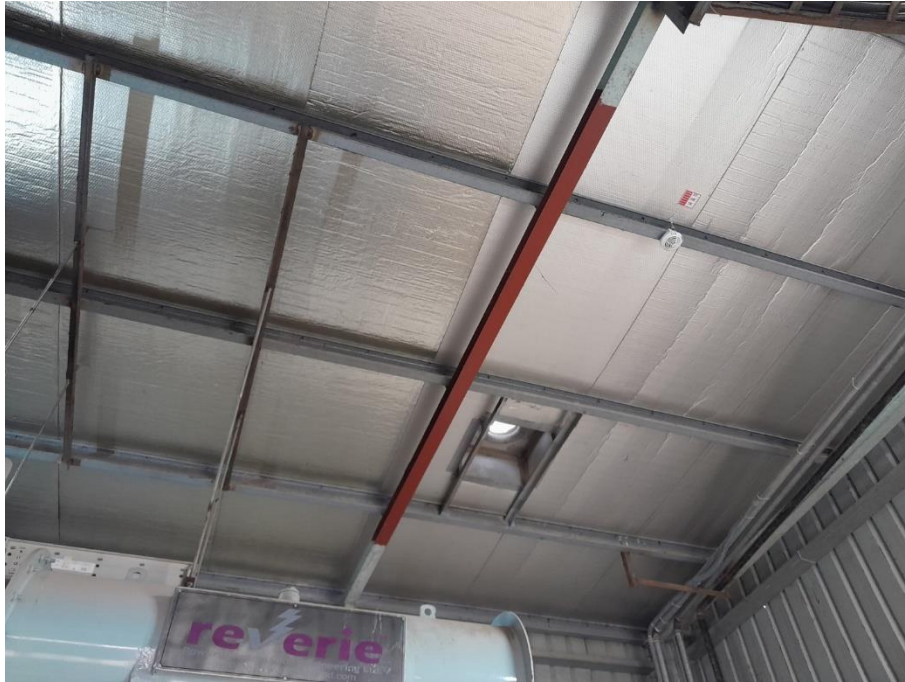
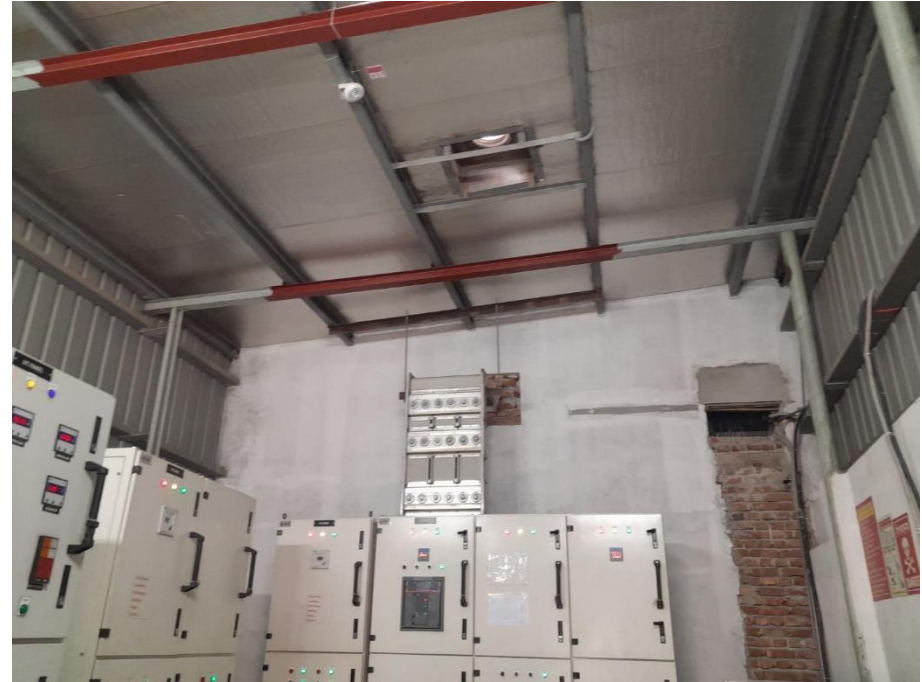
# **Lack of connection adequacy and lateral stability System**

Apparently inadequate member size and connections were observed in the lightweight roof. Building engineer is required to check the connection adequacy and lateral stability system of the structure.

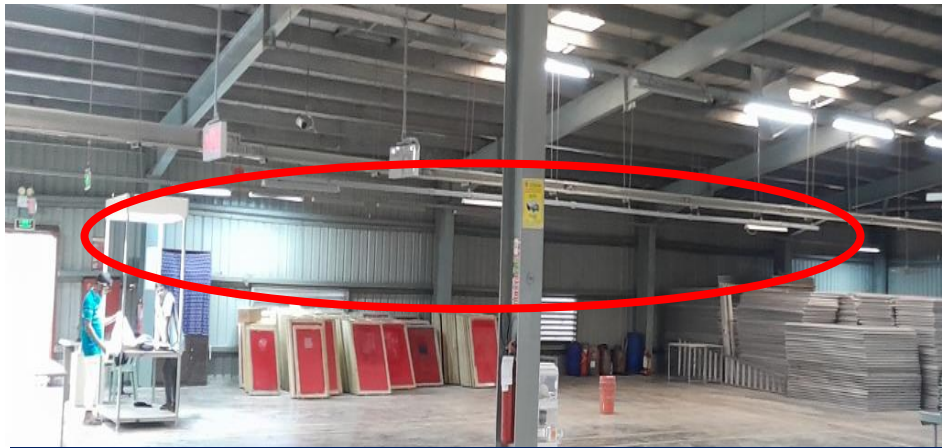
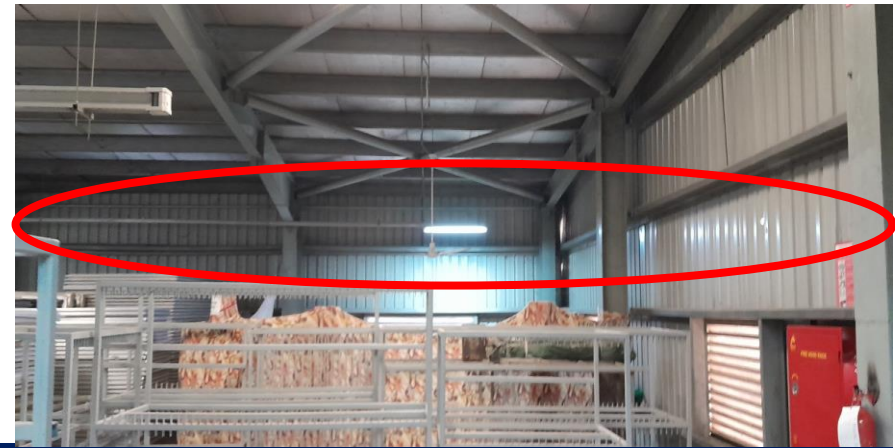
## **Lack of lateral stability system**

No compression member or vertical bracing observed and Strut missing

No vertical bracing and compression member was observed in the structure that indicates the lateral load path is not logical in long direction against lateral loading. Also strut members are shown in drawing, but no strut members are found during inspection. Building engineer is required to revise the drawing, design report, check the connection adequacy and lateral stability of

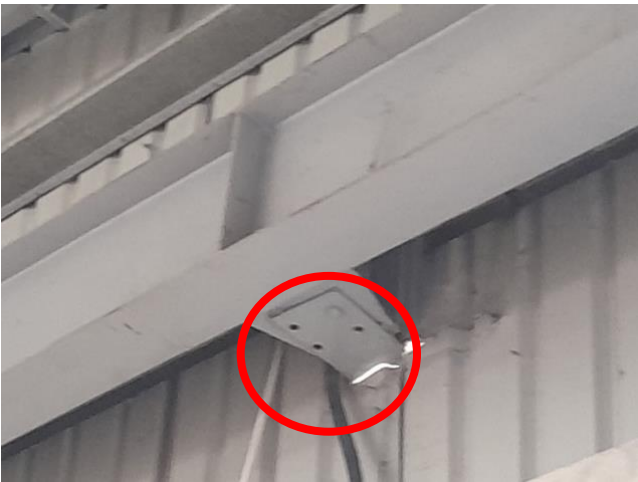
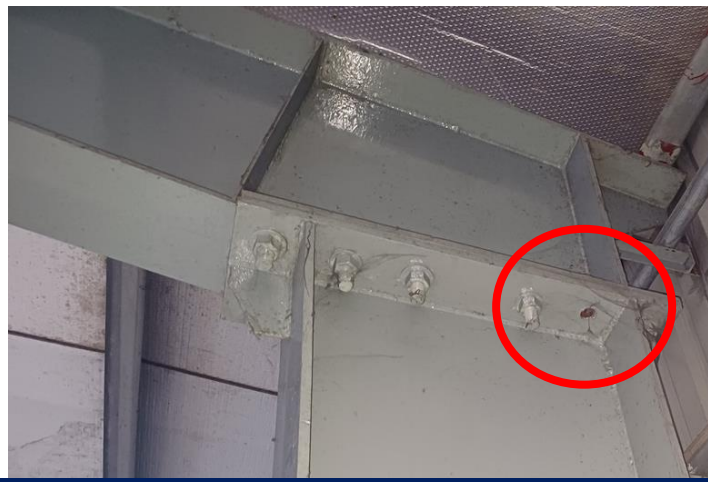
## **Bolt missing & connection gap**

Bolt missing

Bolt missing & connection gap found in several connection joints. Building engineer is required to identify all the locations and install missing bolts & resolve connection gaps

| Item No. | Observation | Recommended Action Plan | Recommended Timeline |
|---|---|---|---|
| 48 | Bolt missing & connection gap (2-Storeyed garments printing production shed) | Building engineer is required to identify all the locations and install missing bolts & resolve connection gaps accordingly. | 6-weeks |

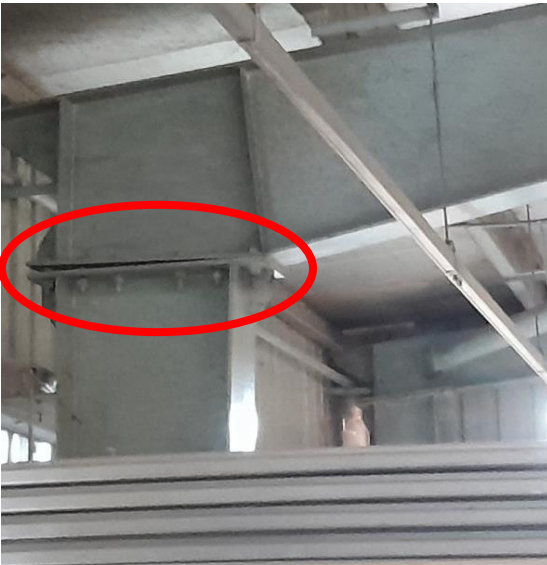
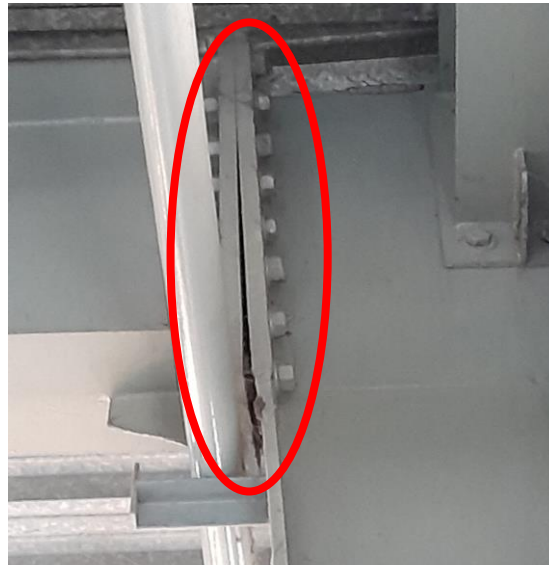
Connection gap
