Sparkle Knit Composite Limited

Kabirpur, Savar, Dhaka
(24.015723, 90.248490)
08 October 2023

Observations

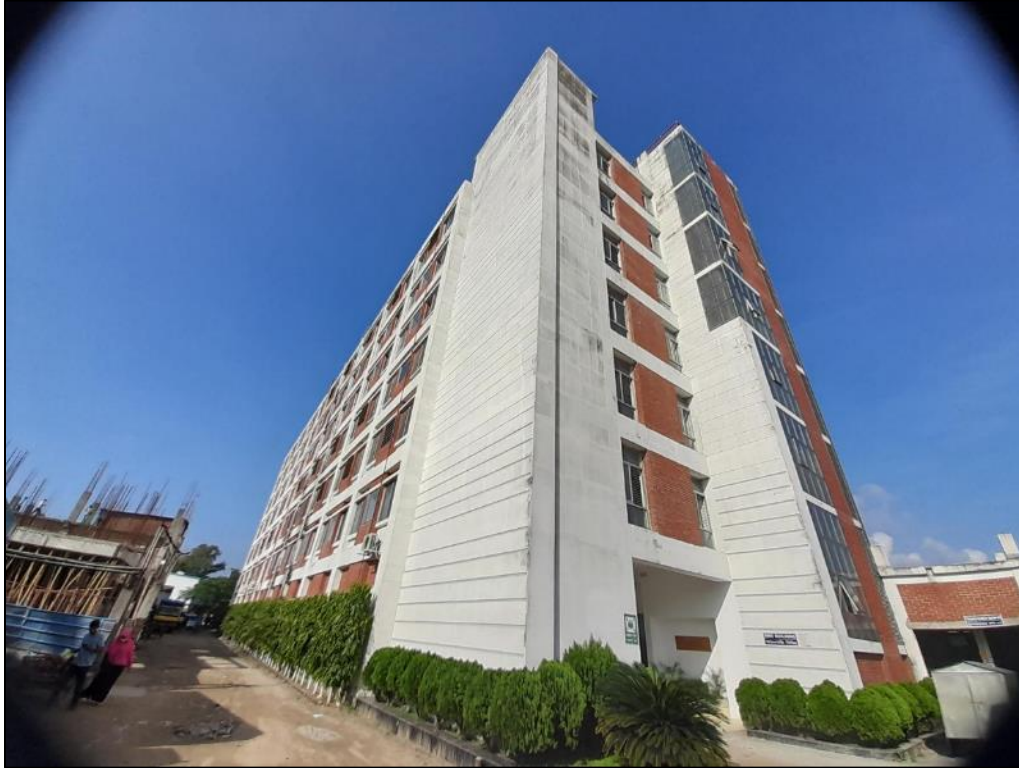
RMG Building

Absence of design documents

As per BNBC, every building or structure designed shall have its design documents prepared in accordance with the provision of Section 1.9.1. The design document shall include a design report, and a set of structural drawings, which shall be prepared in compliance with section 1.9.1.1 and section 1.9.1.2 as per BNBC. At the time of inspection, design report was not available which is required to be prepared in compliance with section 1.9.1.1 (part-6, BNBC-2006).

Item No.	Observation	Recommended Action Plan	Recommended Timeline
01	Absence of design documents (RMG Building)	Building engineer is required to prepare a set of design report in compliance with section 1.9.1.1 (part-6, BNBC).	6-weeks
02	Absence of design documents (RMG Building)	Implement remediation work if required.	6-months
03	Storage live load does not comply BNBC (RMG Building)	The factory engineer is required to revise the load plan as per BNBC requirement and check the design accordingly.	6-weeks
04	Storage live load does not comply BNBC (RMG Building)	Carry out suggested remedial work if required.	6-months
05	Non-structural elements found unbraced/not anchored (RMG Building)	Factory is required to brace/anchor all non-structural elements.	6-months

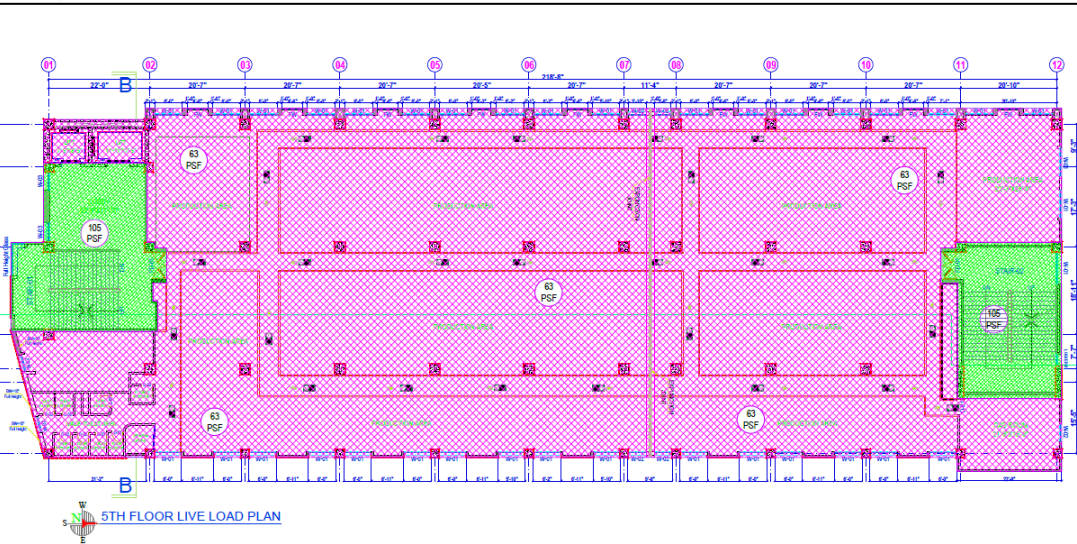
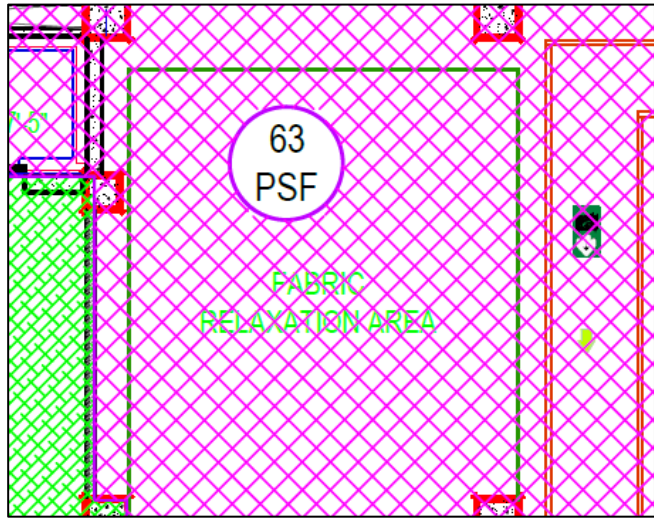
Live load plan- typical floor

Storage live load does not comply BNBC

Live load considered as 3 KPa for storage areas

Live load on typical floor is considered as 3 kPa in prepared load plan. As per BNBC- Part 6, live load for light storage areas is required to be considered minimum 6 kPa. However, the factory engineer is required to revise the load plan as per BNBC requirement and check the design accordingly.

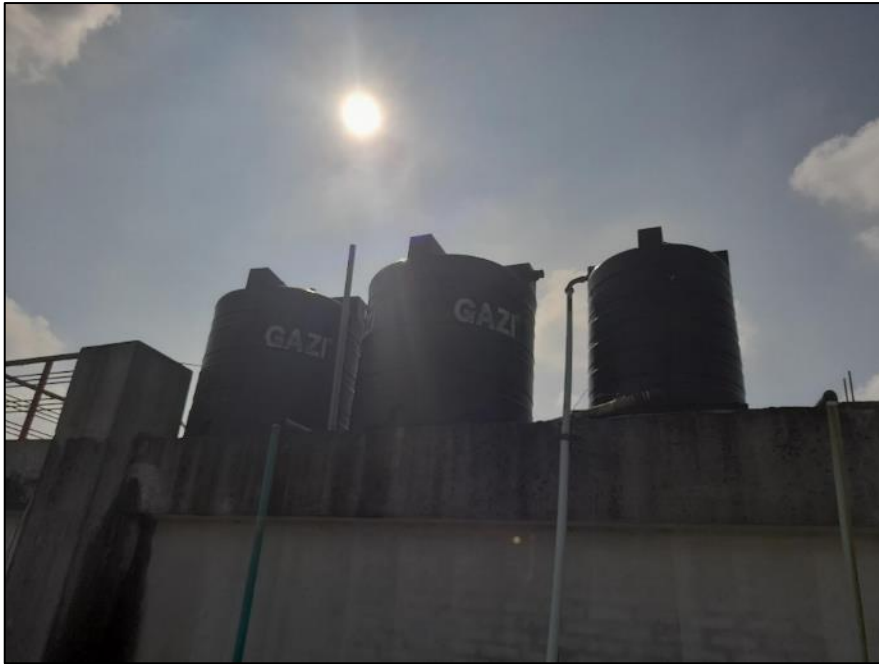
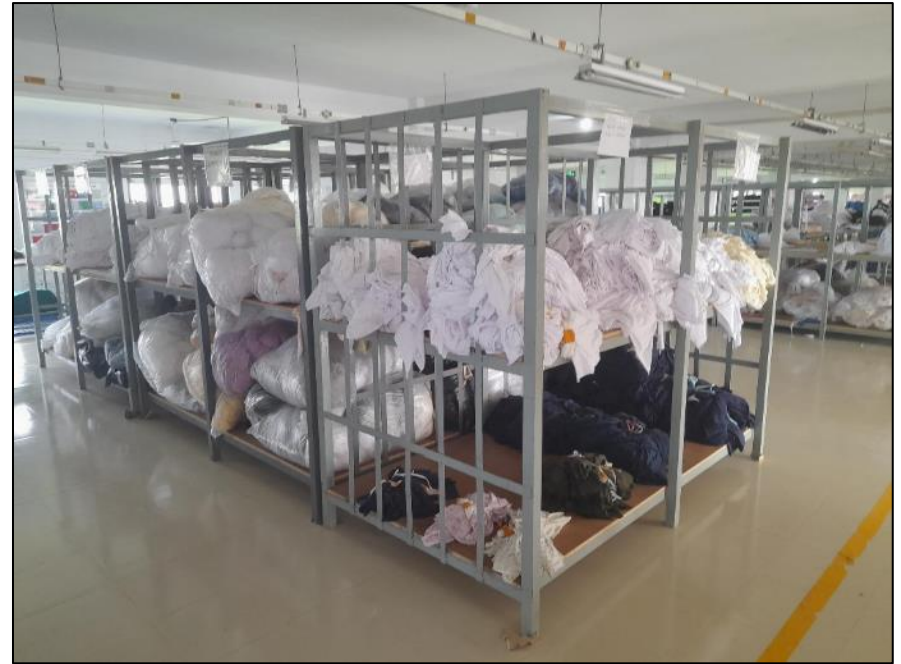
Non-structural elements found unbraced/not anchored

Storage racks within the building and PVC water tanks on roof found without braced/anchored

Non-structural elements suspended from, attached to, or resting atop the structure shall be adequately anchored and braced to resist earthquake forces. Factory is required to brace/anchor all non-structural elements.

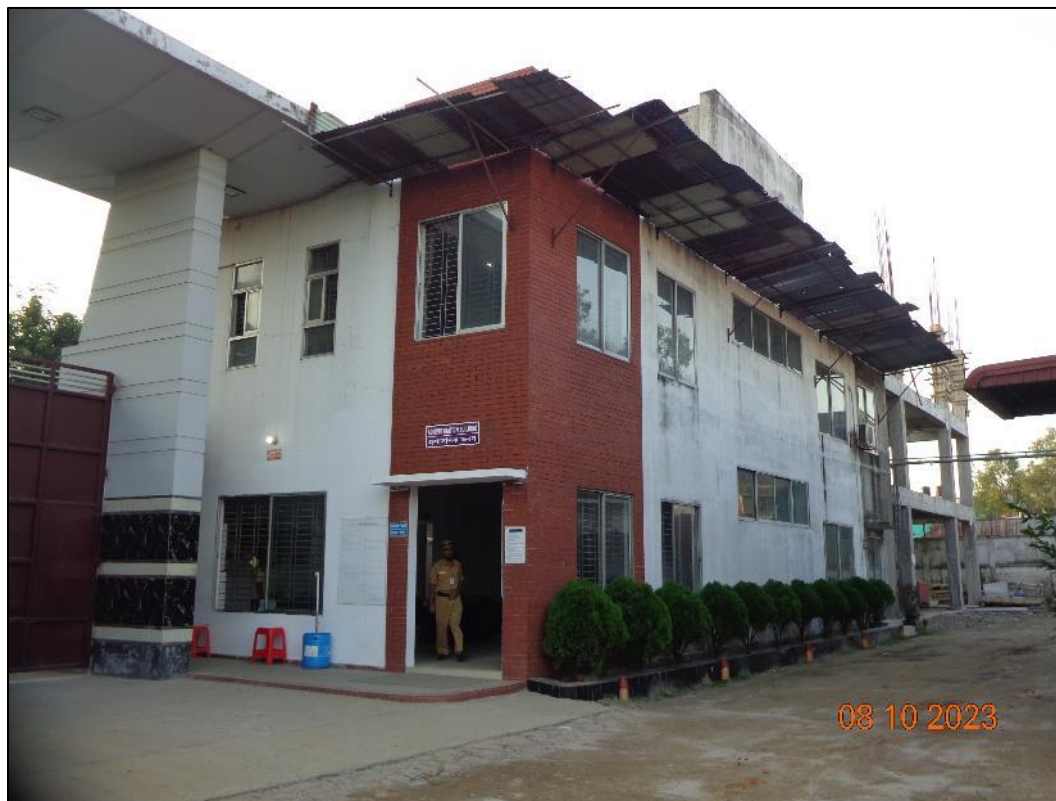
Absence of design documents

The Administration Building is two-storied reinforced concrete (RC) building and proposed for partially four storied as per permit drawing. There is a possibility of the future vertical extension of the building. Full set of the design documents was not available for the building.

As per BNBC, every building or structure designed shall have its design documents prepared in accordance with the provision of Section 1.9.1. The design document shall include a design report, and a set of structural drawings, which shall be prepared in compliance with section 1.9.1.1 and section 1.9.1.2 as per BNBC. At the time of inspection, design report was not available which is required to be prepared in compliance with section 1.9.1.1 (part-6, BNBC-2006).

Item No.	Observation	Recommended Action Plan	Recommended Timeline
06	Absence of design documents (Administration Building)	Building engineer is required to prepare a set of design report in compliance with section 1.9.1.1 (part-6, BNBC).	6-weeks
07	Absence of design documents (Administration Building)	Produce and actively manage floor live load plan.	6-weeks
08	Absence of design documents (Administration Building)	Implement remediation work if required.	6-months
09	Absence of design documents (Administration Building)	Implement allowable floor load plan.	6-months
10	Dampness at several locations (Administration Building)	Building Engineer is required to investigate the reason of dampness & apply suitable method to repair dampness.	6-weeks

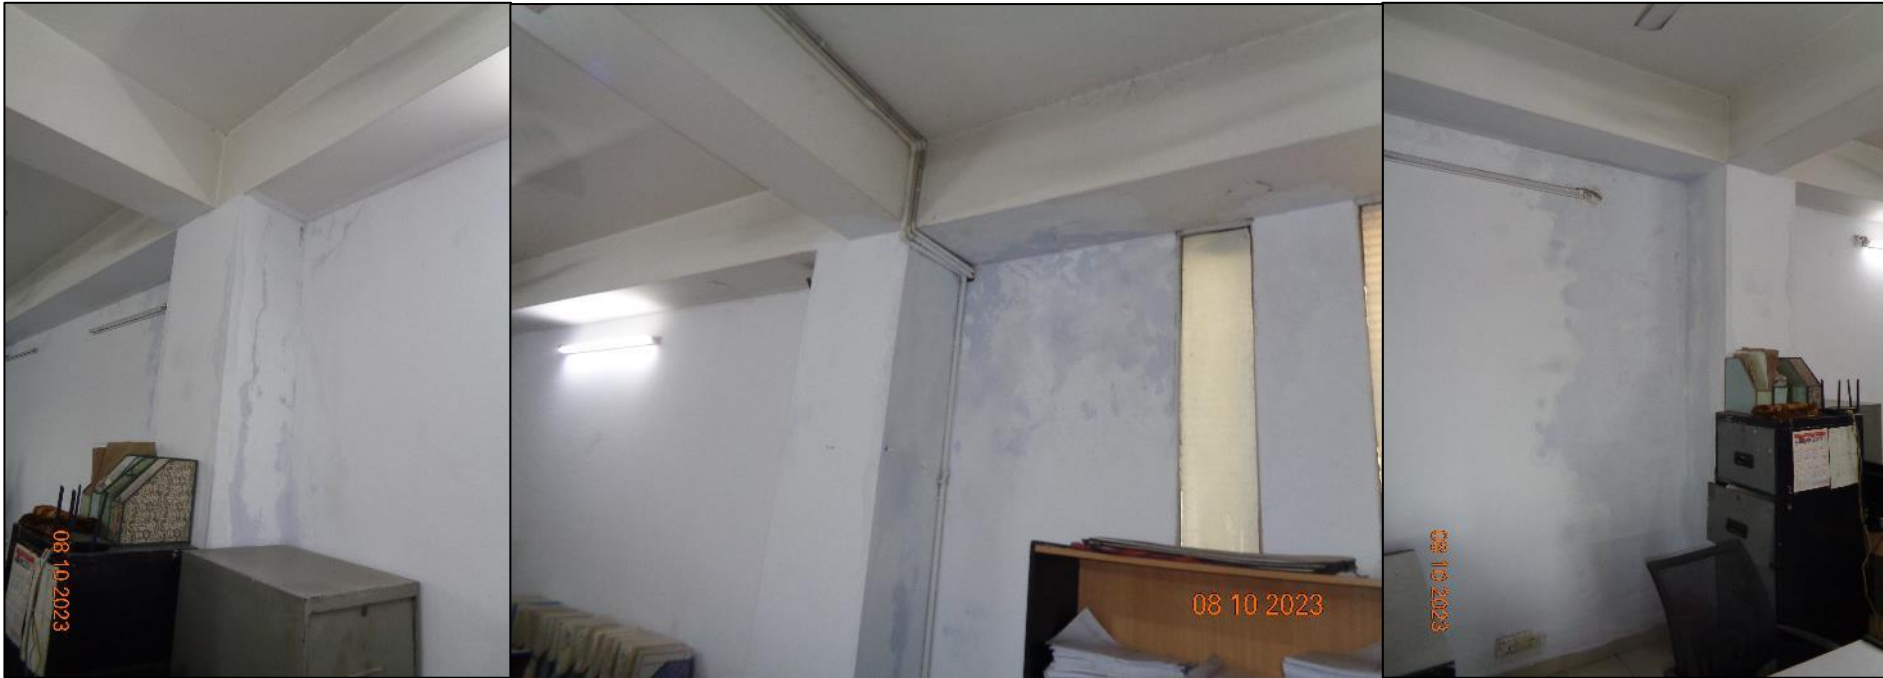
Dampness at several locations

Dampness on beam, Column and wall

Dampness was found in several locations of the structure. Building engineer is required to investigate the source of dampness and take necessary measures to prevent the dampness.

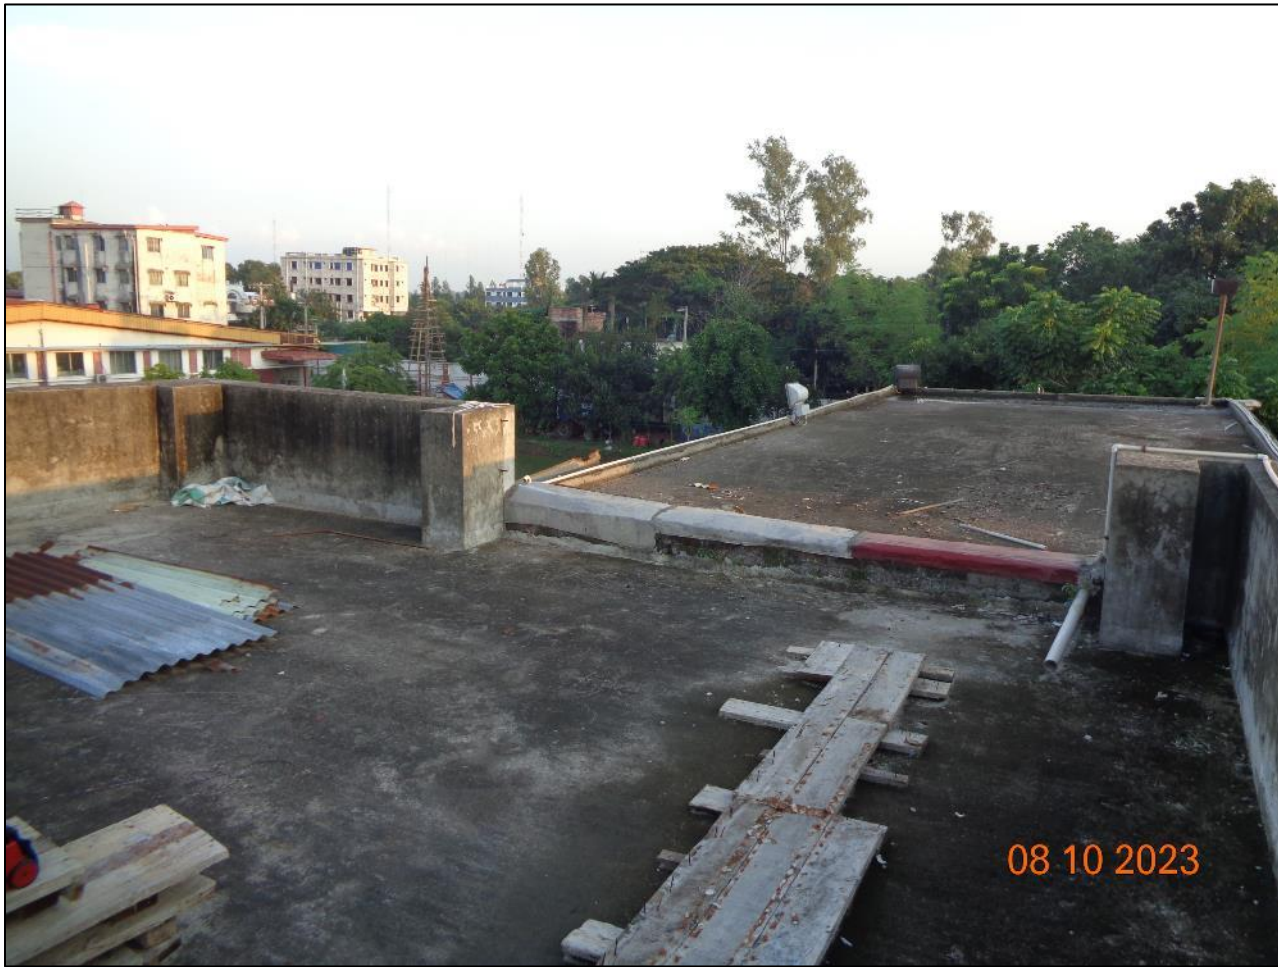
Lack of edge protection

Parapet wall missing at roof

During inspection, Edge protection (Parapet wall/Railing) was not observed on roof and stair. Factory is required to provide edge protection to avoid falling hazard.

Item No.	Observation	Recommended Action Plan	Recommended Timeline
11	Lack of edge protection (Administration Building)	Factory is required to provide edge protection on roof and stair to avoid falling hazard.	6-weeks
12	Storage live load does not comply BNBC (Warehouse Building)	As part of EA, the building engineer is required to revise the floor live load plan following BNBC requirements and revise the design documents accordingly.	6-weeks
13	Storage live load does not comply BNBC (Warehouse Building)	Implement the recommendations of EA report.	6-months
14	Storage live load does not comply BNBC (Warehouse Building)	Implement the floor load management plan (post accepted load plan, mark the storage area & height and maintain floor loads accordingly).	6-months
15	Lack of edge protection (Warehouse Building)	Factory is required to provide edge protection on roof and stair to avoid falling hazard.	6-weeks

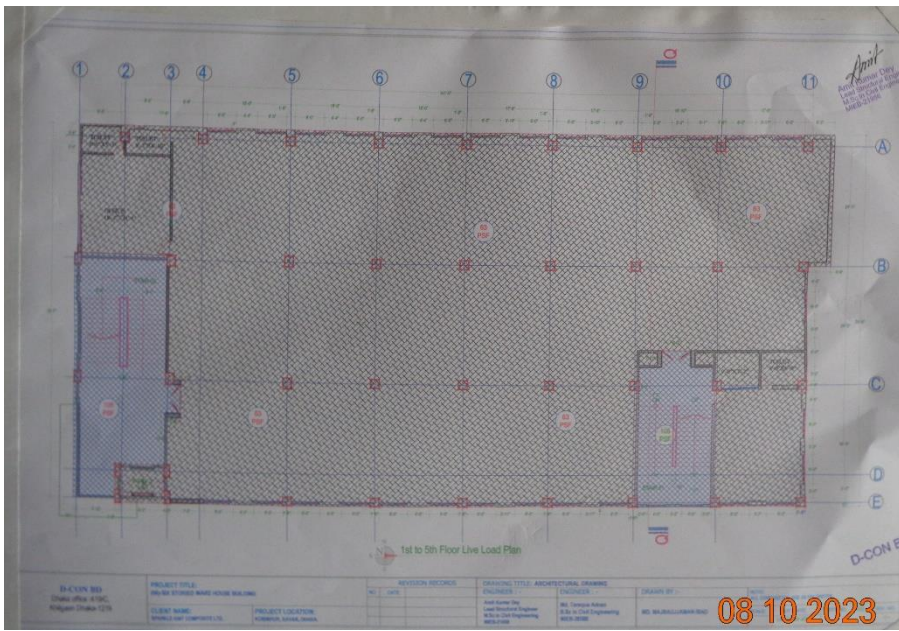
Storage live load does not comply BNBC

Posted load plan for 1st floor (3kPa)

The live load has been considered 3 kPa for the storage area instead of 6 kPa as per BNBC-2006.

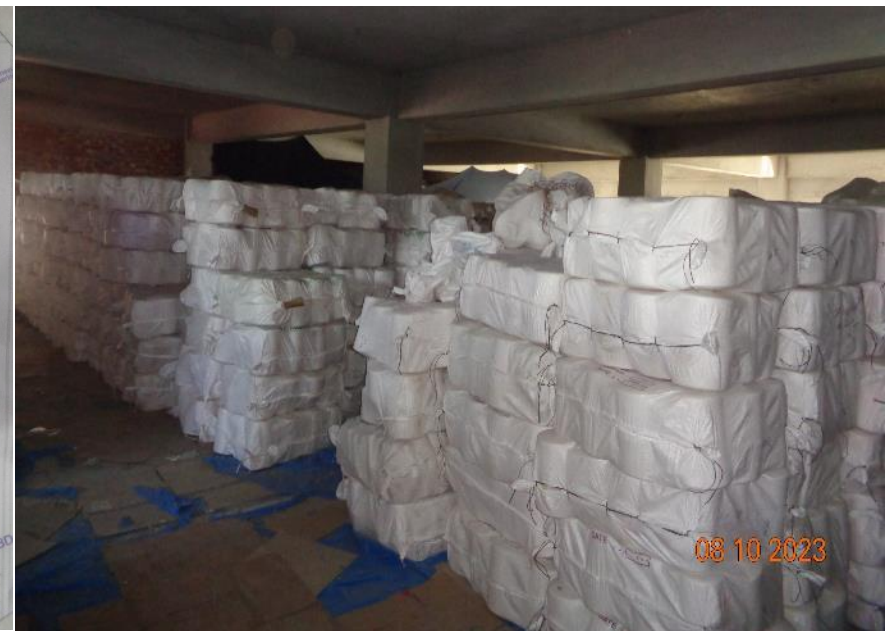
Floor loading at 1st floor

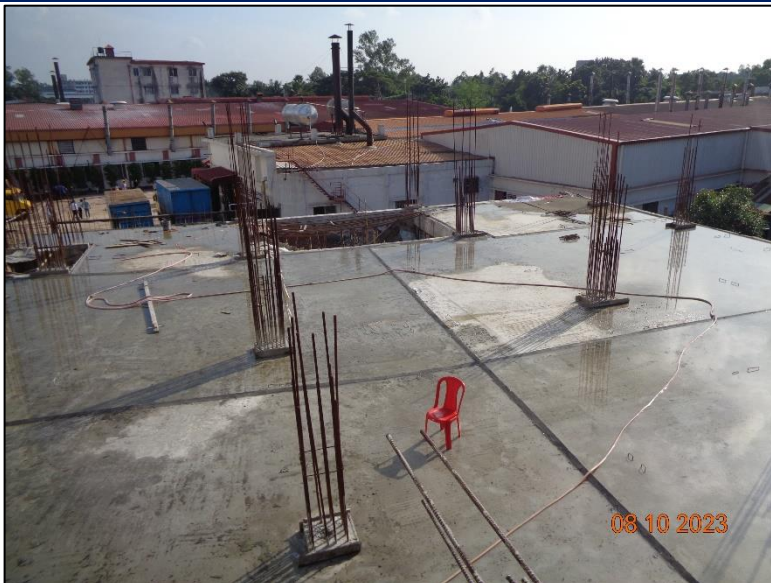
Extension work was found ongoing

The building is two-storied reinforced concrete (RC) building and proposed for six storied as per as per permit drawing. Construction works was found ongoing. Factory is required to performed the details engineering assessment (DEA) for the structure based on floor live load as per BNBC and extension.

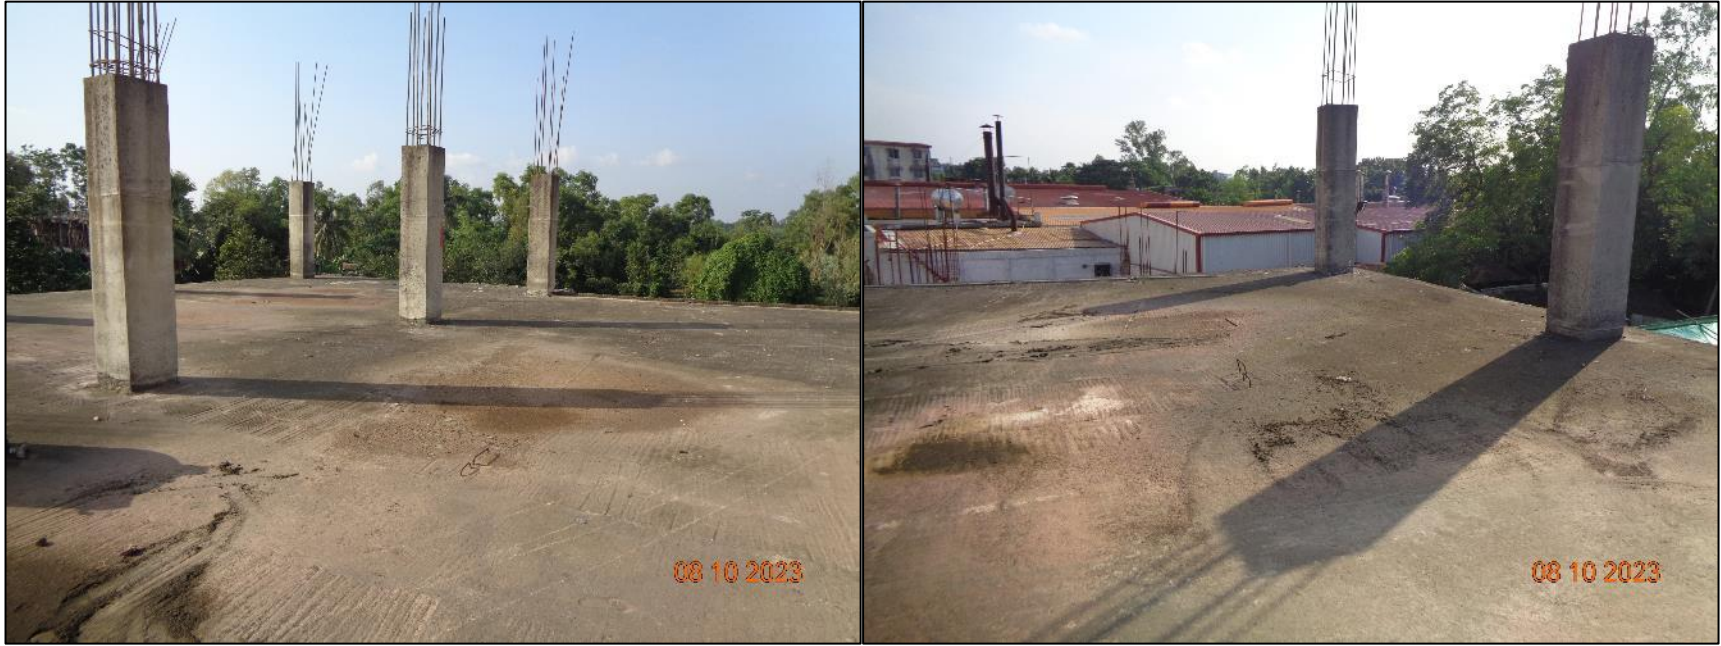
Lack of edge protection

Parapet wall missing at roof

During inspection, Edge protection (Parapet wall/Railing) was not observed on roof and stair. Factory is required to provide edge protection to avoid falling hazard.

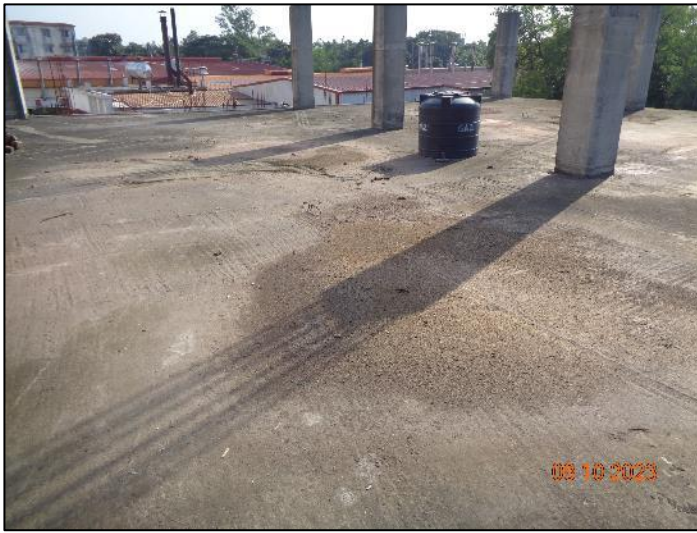
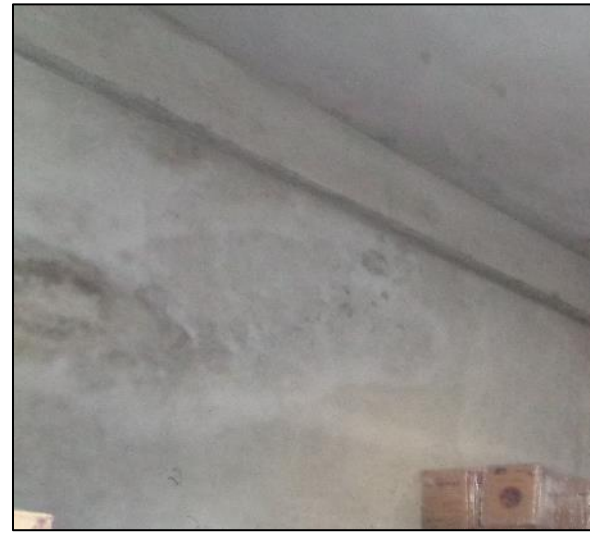
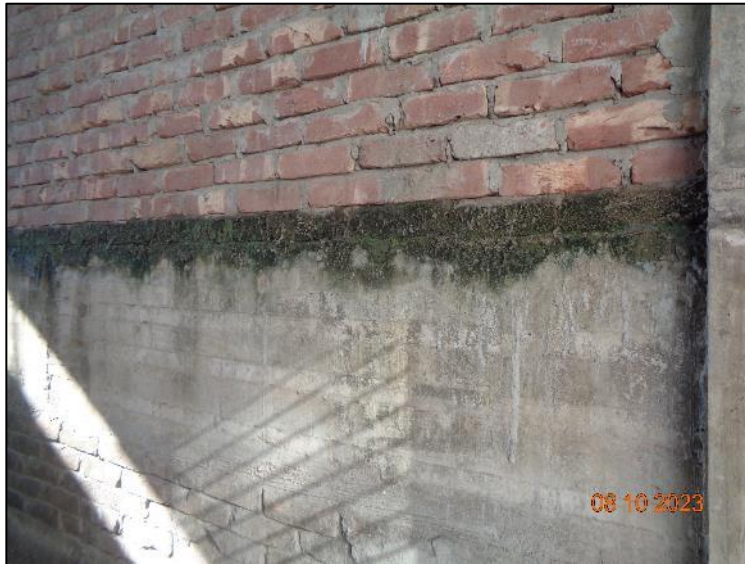
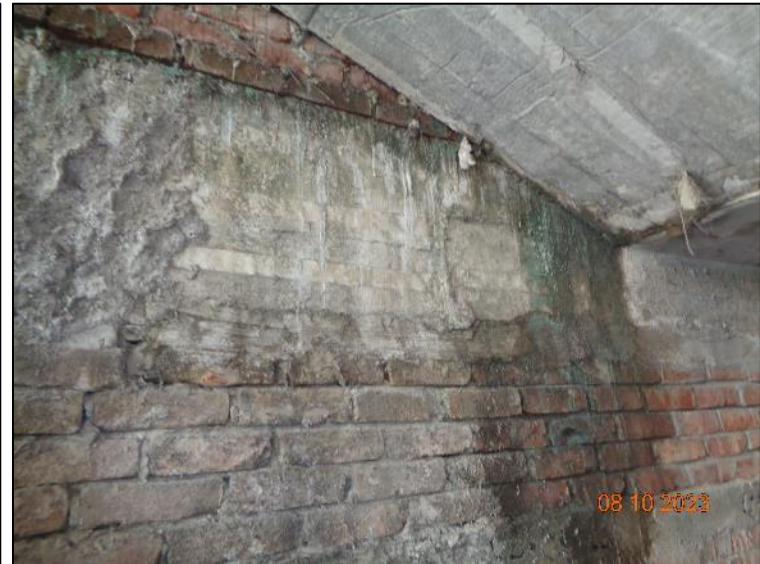
Dampness at several locations

Signage of water ponding at roof, dampness at beam & wall

Dampness was found in several locations of the structure. Building engineer is required to investigate the source of dampness and take necessary measures to prevent the dampness.

16	Dampness at several locations (Warehouse Building)	Building Engineer is required to investigate the reason of dampness & apply suitable method to repair dampness.	6-weeks

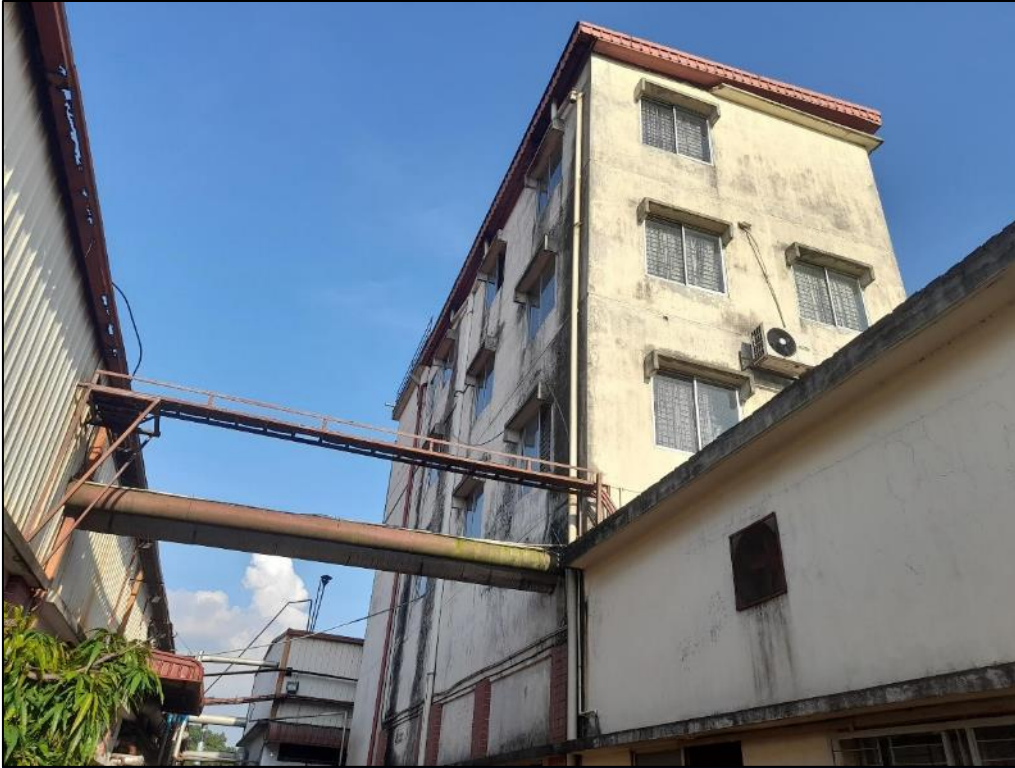
WTP Building

Absence of design documents

As per BNBC, every building or structure designed shall have its design documents prepared in accordance with the provision of Section 1.9.1. The design document shall include a design report, and a set of structural drawings, which shall be prepared in compliance with section 1.9.1.1 and section 1.9.1.2 as per BNBC. At the time of inspection, design report was not available which is required to be prepared in compliance with section 1.9.1.1 (part-6, BNBC).

Item No.	Observation	Recommended Action Plan	Recommended Timeline
17	Absence of design documents (WTP Building)	Building engineer is required to prepare a set of design report in compliance with section 1.9.1.1 (part-6, BNBC).	6-weeks
18	Absence of design documents (WTP Building)	Implement remediation work if required.	6-months
19	Apparently inadequate connection (WTP Building)	The Building engineer is required to check the connection adequacy for uplift forces as part of EA.	6-weeks
20	Apparently inadequate connection (WTP Building)	Implement remedial work where required.	6-months
21	Lack of Lateral Stability (Dyeing & Finishing Shed)	The building engineer is required to carry out Engineering Assessment (EA) to check the lateral stability of the structure and prepare full set of design report with necessary remedial actions.	6-weeks
22	Lack of Lateral Stability (Dyeing & Finishing Shed)	Complete remedial works where necessary.	6-months

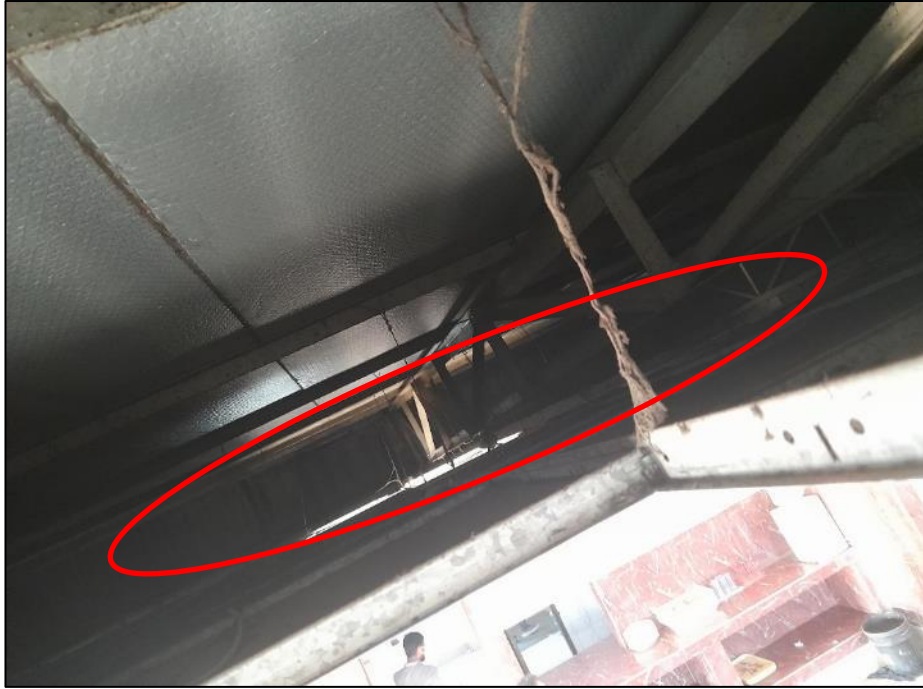
Purlin inserted to brick wall

Trusses of 3rd floor steel shed were found arbitrarily welded with rebar of RC column and inserted to brick wall therefore connection of steel members to brick wall and RC columns was appeared to be inadequate. The Building engineer is required to check the connection adequacy for uplift forces as part of EA.

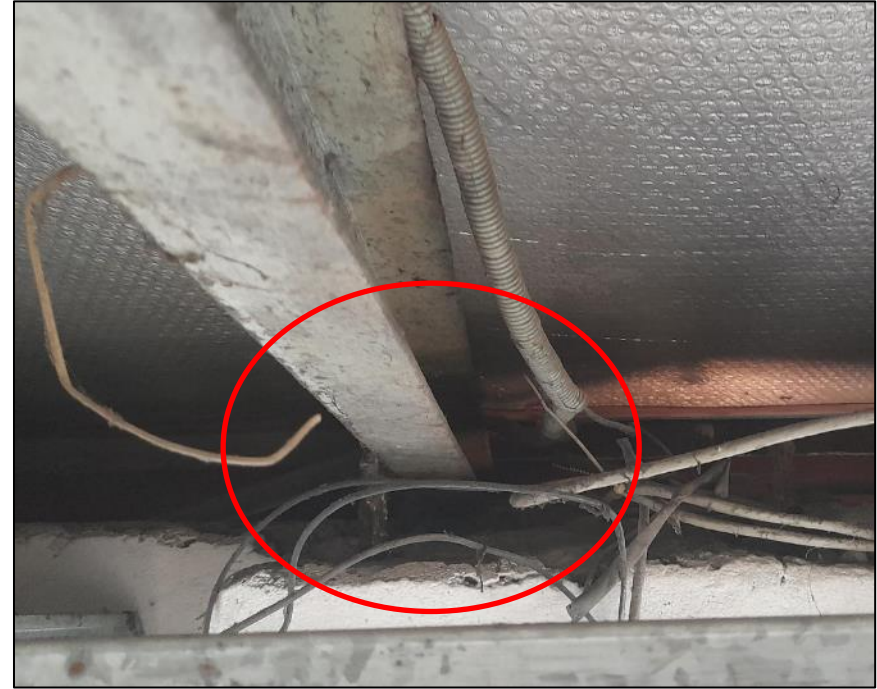
Truss welded with rebar of RC column)

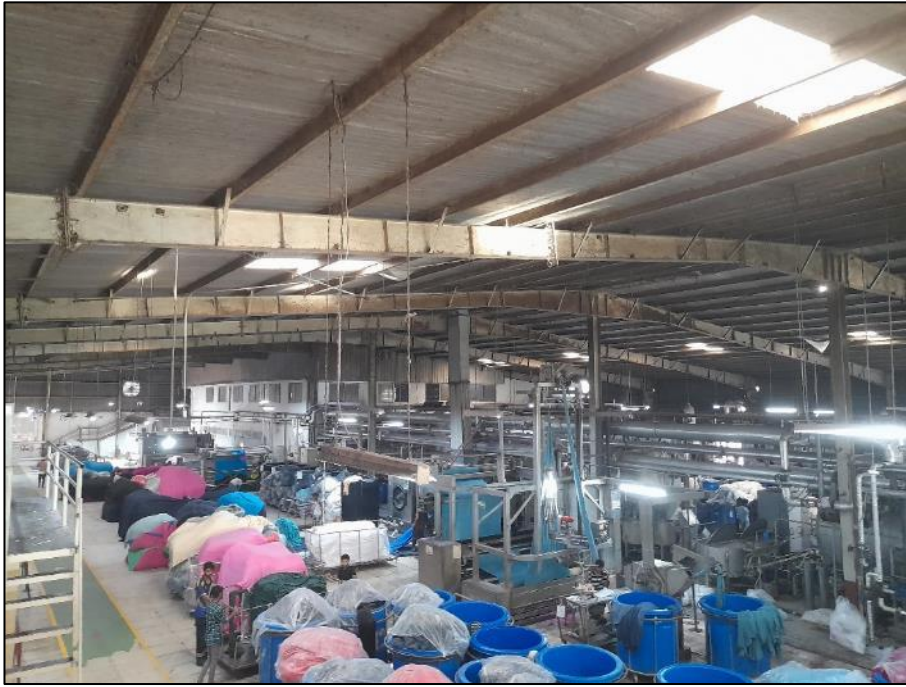
Portal frame along short direction.

Portal frame is provided along short direction. Any compression member along long direction with any lateral bracing was not available. Only roof bracing was provided along short direction therefore, lateral stability along long direction is questionable. The building engineer is required to carry out Engineering Assessment (EA) to check the lateral stability of the structure and prepare full set of design report with necessary remedial actions.

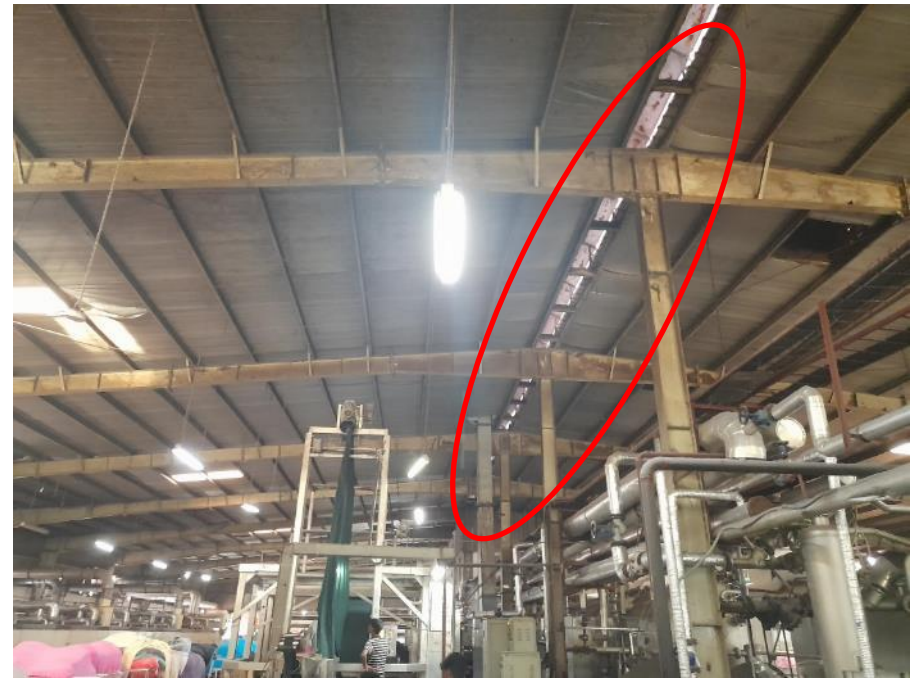
No bracing/Compression strut was provided along the long direction.

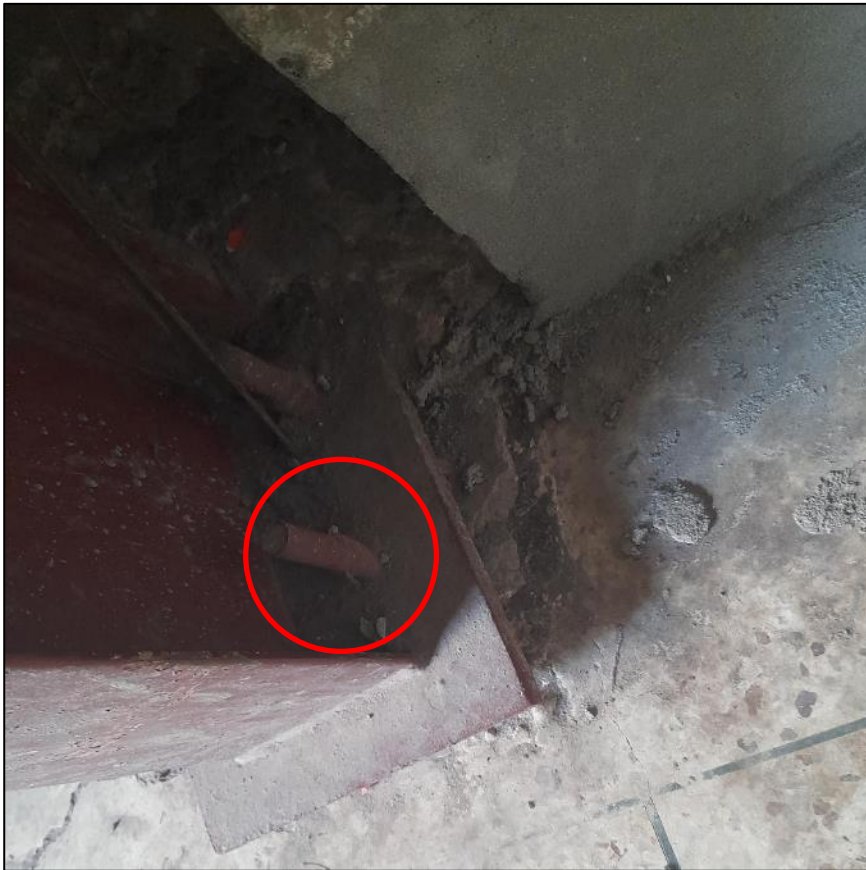
Bolt missing and significant gaps observed in rafter-column joint at several locations. Building engineer is required to carry out suitable remedial works.

Bolt missing

Item No.	Observation	Recommended Action Plan	Recommended Timeline
23	Bolt missing and connection gap (Dyeing & Finishing Shed)	Building engineer is required to repair the gap in connections with a suitable method.	6-weeks
24	Bolt missing and connection gap (Dyeing & Finishing Shed)	Install the missing bolt where necessary.	6-weeks
25	Loose cable bracing (Dyeing & Finishing Shed)	The factory is required to tighten the loose bracings for transferring the lateral loads properly.	6-weeks
26	Lack of Lateral Stability (Finishing Shed Unit-2)	The building engineer is required to carry out Engineering Assessment (EA) to check the lateral stability of the structure and prepare full set of design report with necessary remedial actions.	6-weeks
27	Lack of Lateral Stability (Finishing Shed Unit-2)	Complete remedial works where necessary.	6-months

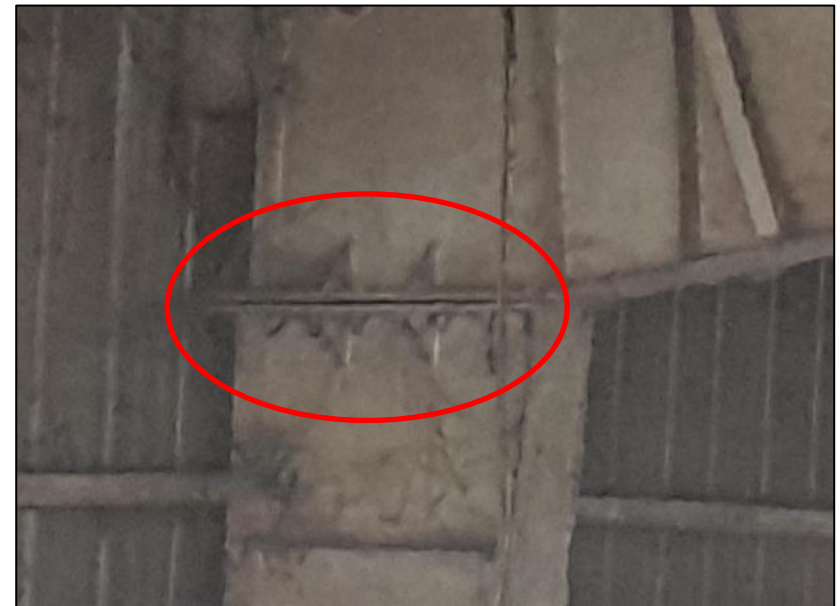
Gap observed in connections

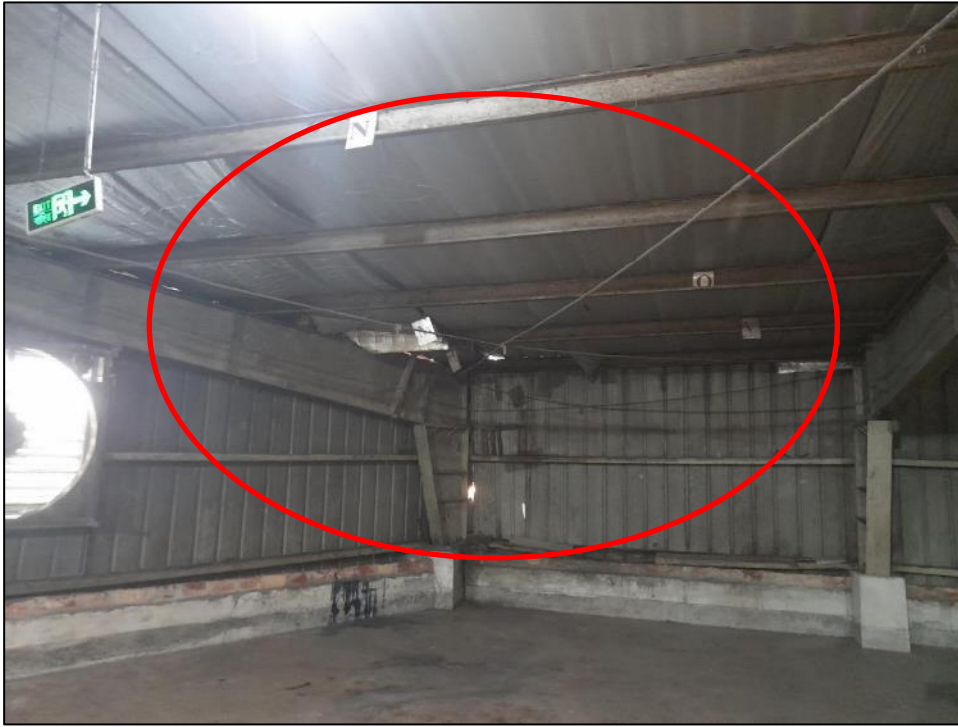
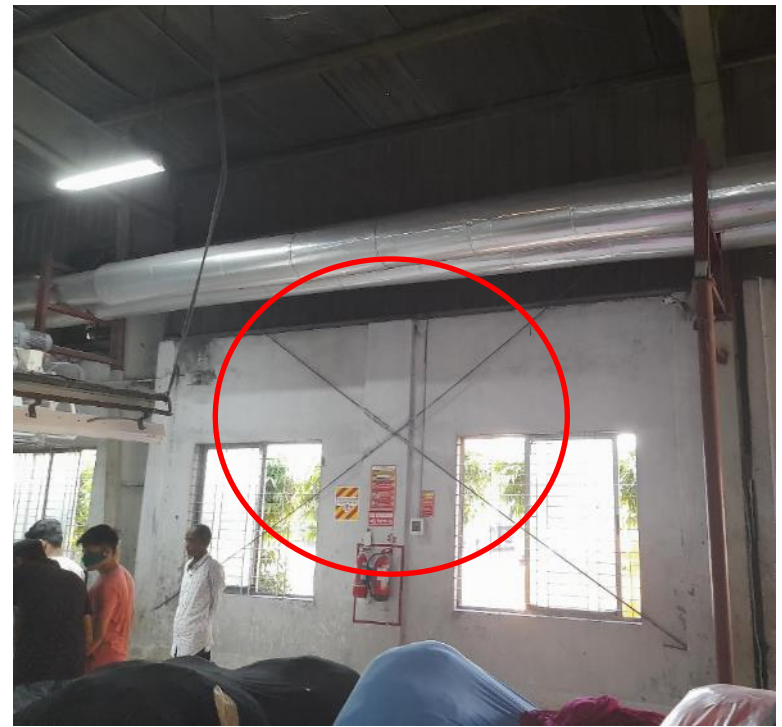
Loose cable bracing (Finishing & Warehouse Shed)

Some wall and roof cable bracing were found loose in Finishing & Warehouse Shed. The factory is required to tighten the loose bracings for transferring the lateral loads properly.

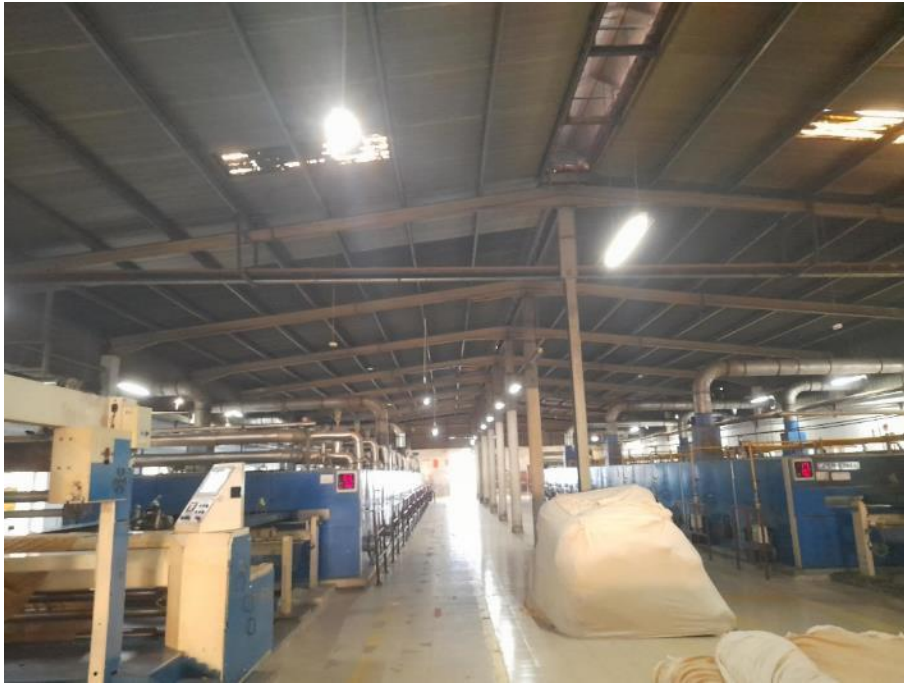
Portal frame along short direction.

Portal frame is provided along short direction. Any compression member along long direction with any lateral bracing was not available. Only roof bracing was provided along short direction therefore, lateral stability along long direction is questionable. The building engineer is required to carry out Engineering Assessment (EA) to check the lateral stability of the structure and prepare full set of design report with necessary remedial actions.

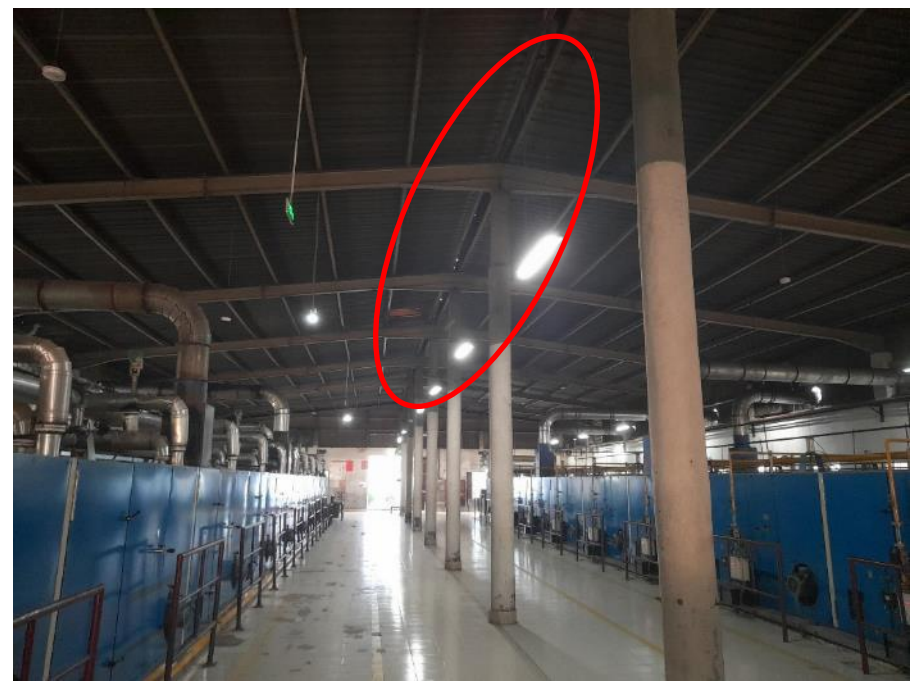
No bracing/Compression strut was provided along the long direction.

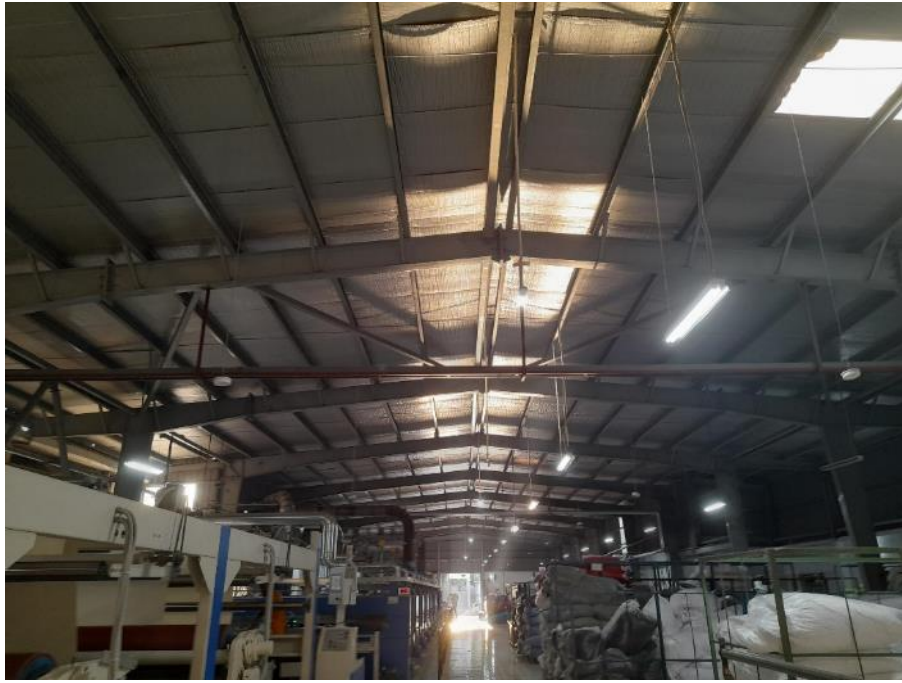
Portal frame along short direction.

Portal frame is provided along short direction. Compression member along with roof and wall bracings were missing in some grids along direction therefore, lateral stability along long direction is questionable. The building engineer is required to carry out Engineering Assessment (EA) to check the lateral stability of the structure and prepare full set of design report with necessary remedial actions.

Item No.	Observation	Recommended Action Plan	Recommended Timeline
28	Lack of Lateral Stability (Finishing Shed Unit-3)	The building engineer is required to carry out Engineering Assessment (EA) to check the lateral stability of the structure and prepare full set of design report with necessary remedial actions.	6-weeks
29	Lack of Lateral Stability (Finishing Shed Unit-3)	Complete remedial works where necessary.	6-months
30	Absence of design documents (Utility Shed-1)	Building engineer is required to prepare a set of design report in compliance with section 1.9.1.1 (part-6, BNBC).	6-weeks
31	Absence of design documents (Utility Shed-1)	Implement remediation work if required.	6-months
32	Corrosion in steel section . (Utility Shed-1)	Factory is required to take necessary actions to protect the steel members from corrosion.	6-weeks

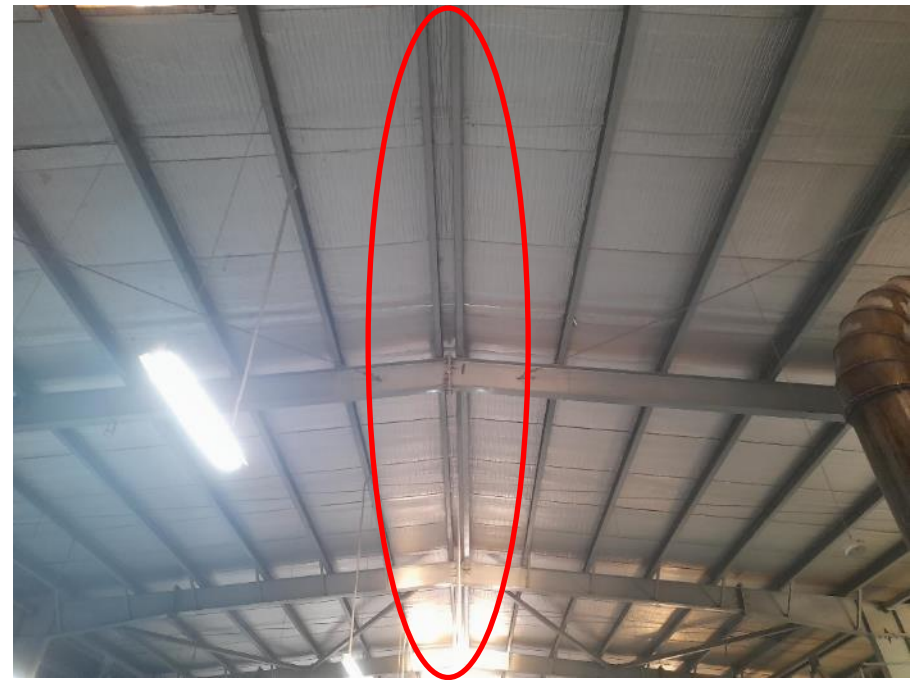
Bracing/Compression strut were missing in some grids along the long direction.
