Sparkle Knit Composite Limited

Kabirpur, Savar, Dhaka
(24.015723, 90.248490)
08 October 2023

Observations

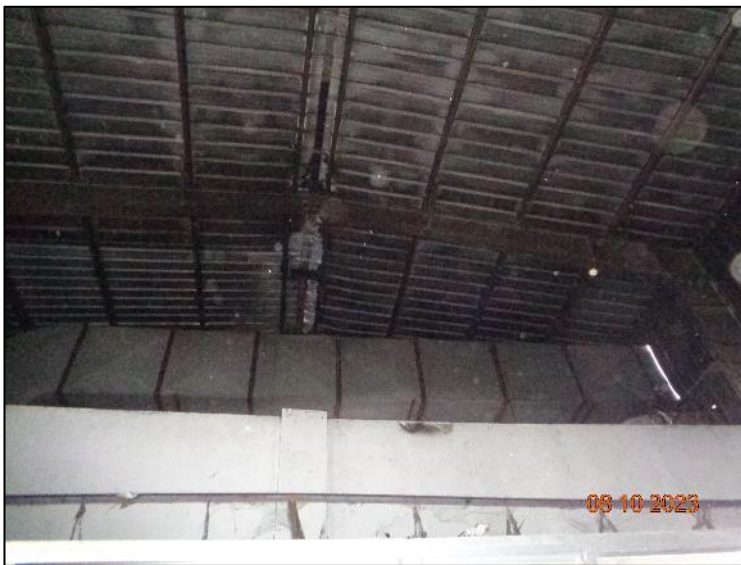
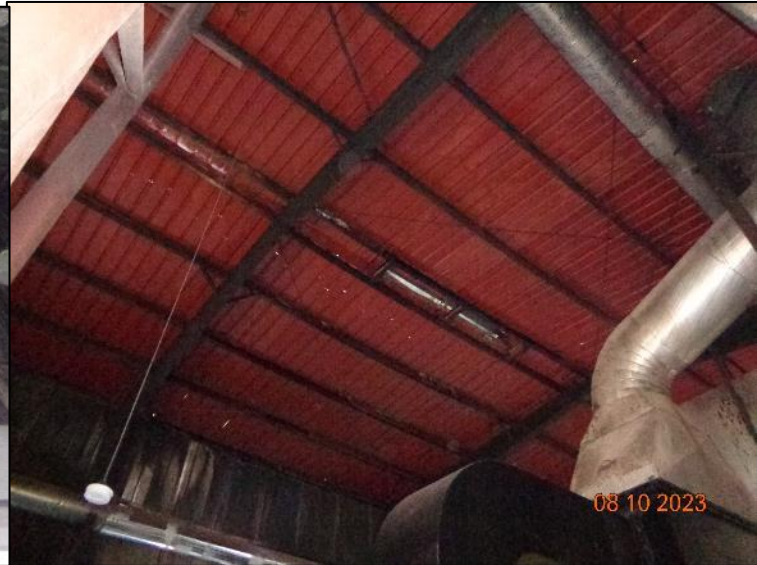
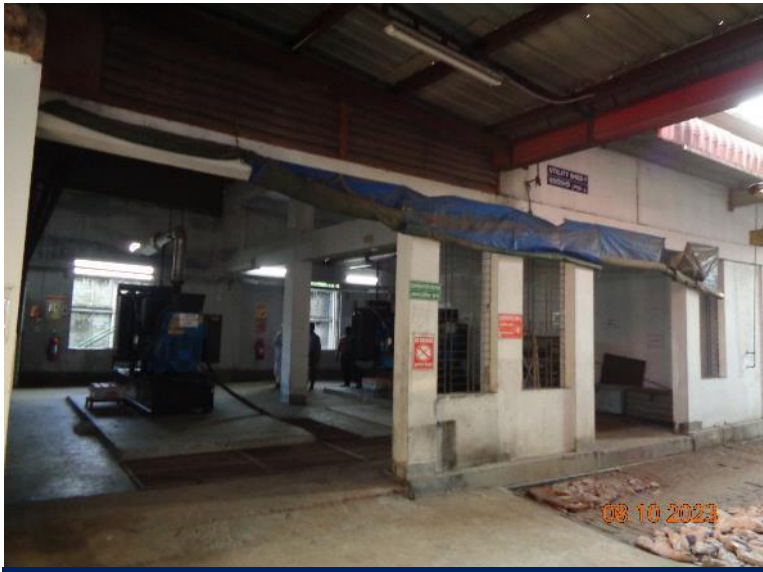
Steel Part

Absence of design documents

During inspection, only as-built drawing was available for the Utility Shed-1. As per BNBC, every building or structure designed shall have its design documents prepared in accordance with the provision of Section 1.9.1. The design document shall include a design report, and a set of structural drawings, which shall be prepared in compliance with section 1.9.1.1 and section 1.9.1.2 as per BNBC. At the time of inspection, design report was not available which is required to be prepared in compliance with section 1.9.1.1 (part-6, BNBC).

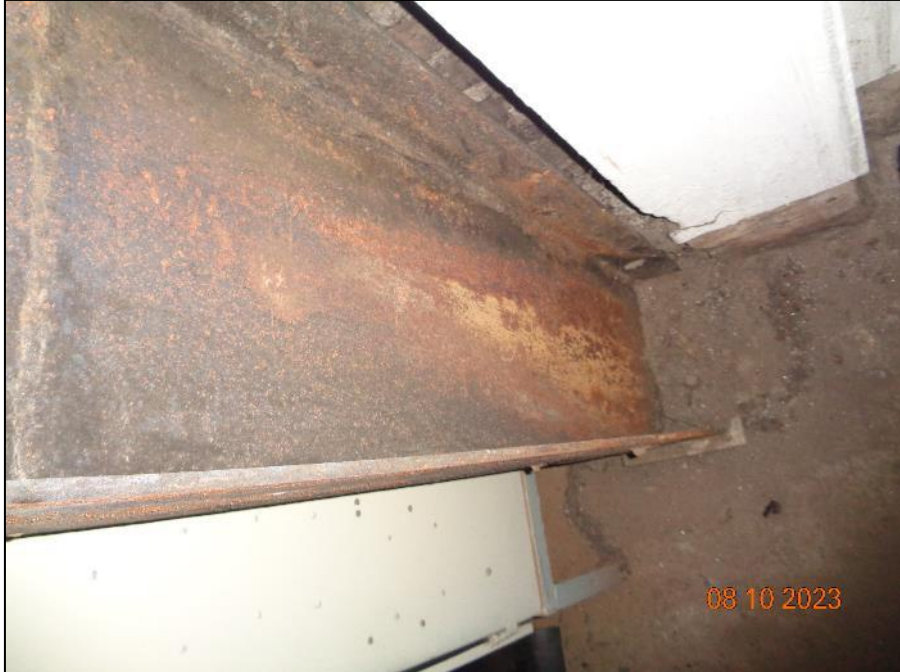
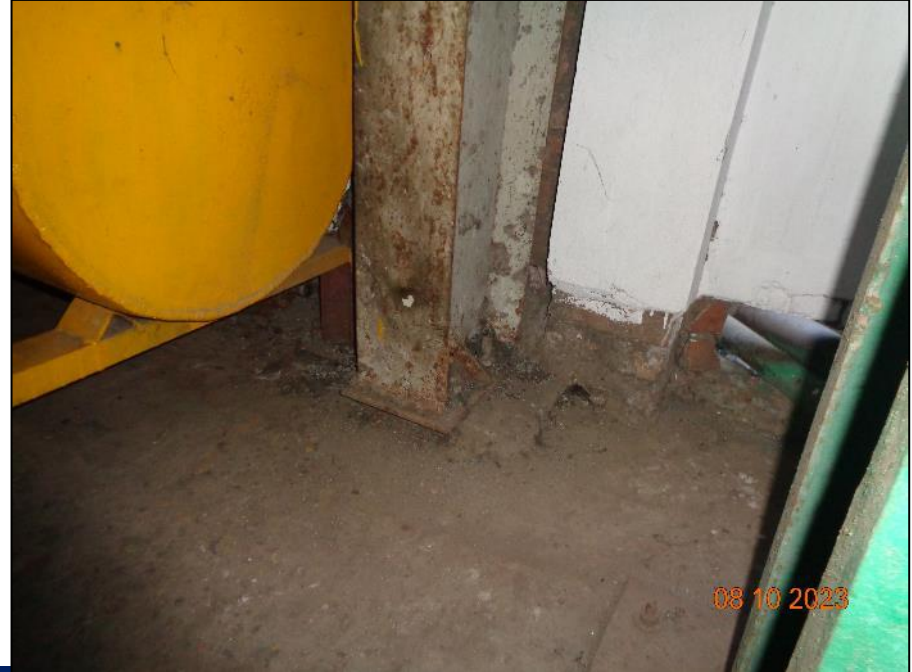
Corrosion in steel section

During inspection, corrosion was observed in steel section. Factory engineer is required to take necessary measures to prevent the corrosion in steel sections.

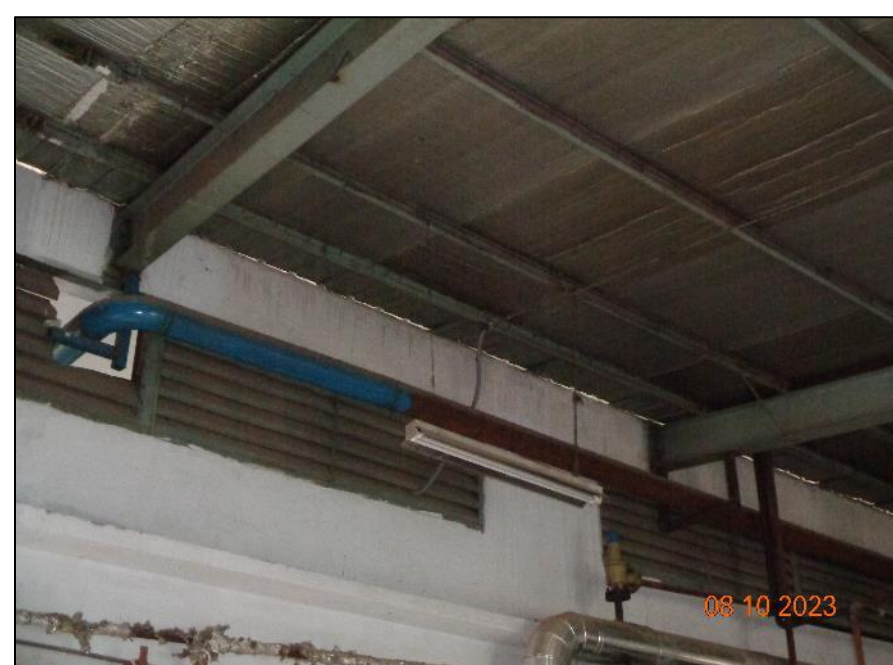
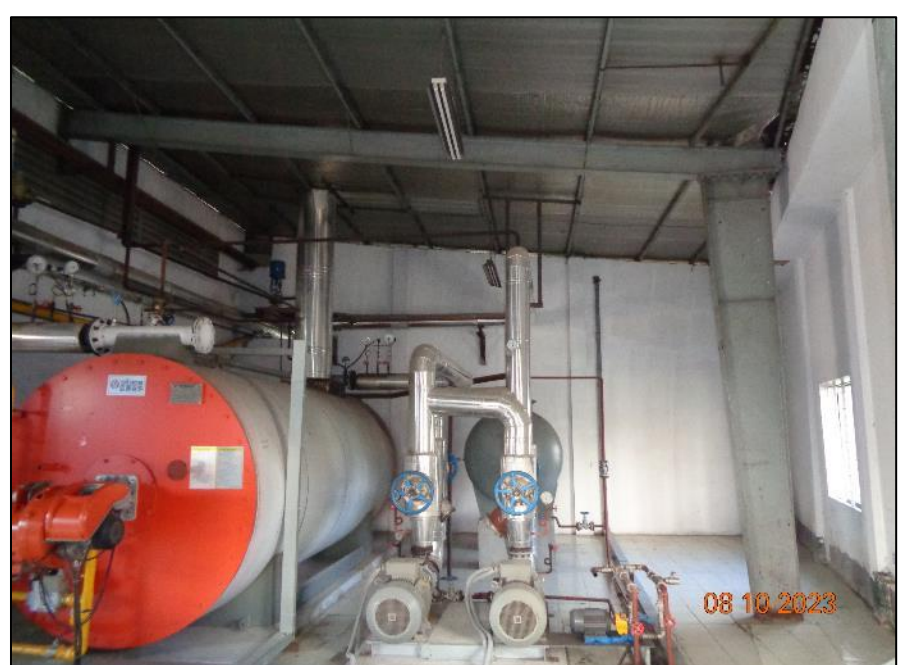
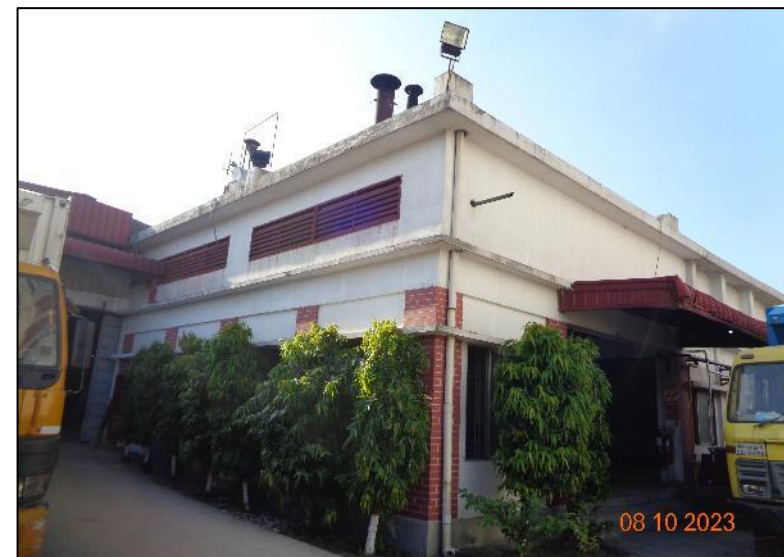
Steel Part

Absence of design documents

During inspection, only as-built drawing was available for the Utility Shed-2. As per BNBC, every building or structure designed shall have its design documents prepared in accordance with the provision of Section 1.9.1. The design document shall include a design report, and a set of structural drawings, which shall be prepared in compliance with section 1.9.1.1 and section 1.9.1.2 as per BNBC. At the time of inspection, design report was not available which is required to be prepared in compliance with section 1.9.1.1 (part-6, BNBC).

Item No.	Observation	Recommended Action Plan	Recommended Timeline
33	Absence of design documents (Utility Shed-2)	Building engineer is required to prepare a set of design report in compliance with section 1.9.1.1 (part-6, BNBC).	6-weeks
34	Absence of design documents (Utility Shed-2)	Implement remediation work if required.	6-months
35	Corrosion in steel section . (Utility Shed-2)	Factory is required to take necessary actions to protect the steel members from corrosion.	6-weeks
36	Absence of design documents (Transformer Room-1)	Building engineer is required to prepare a set of design report in compliance with section 1.9.1.1 (part-6, BNBC).	6-weeks
37	Absence of design documents (Transformer Room-1)	Implement remediation work if required.	6-months

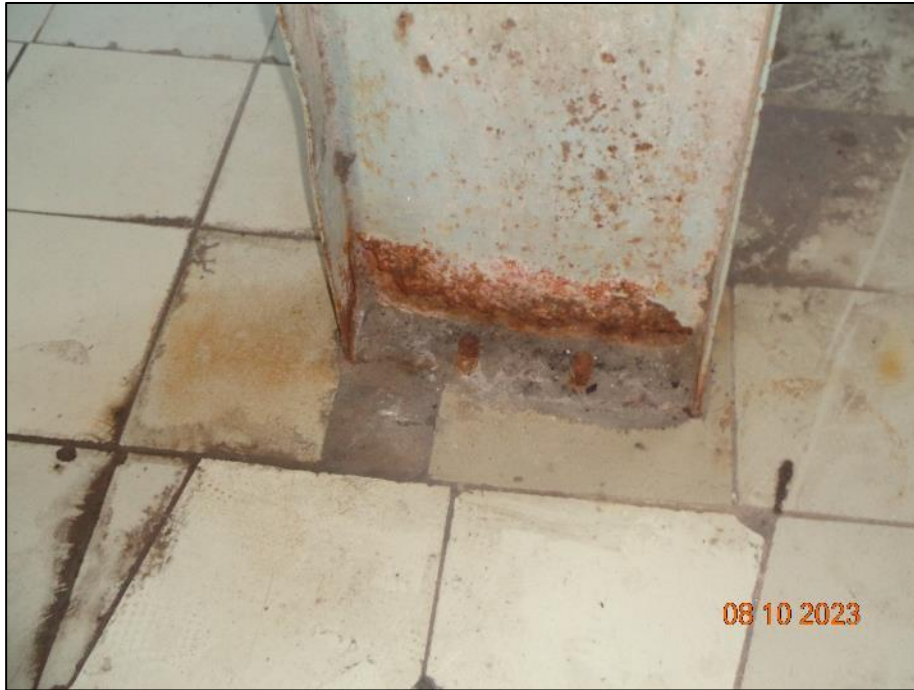
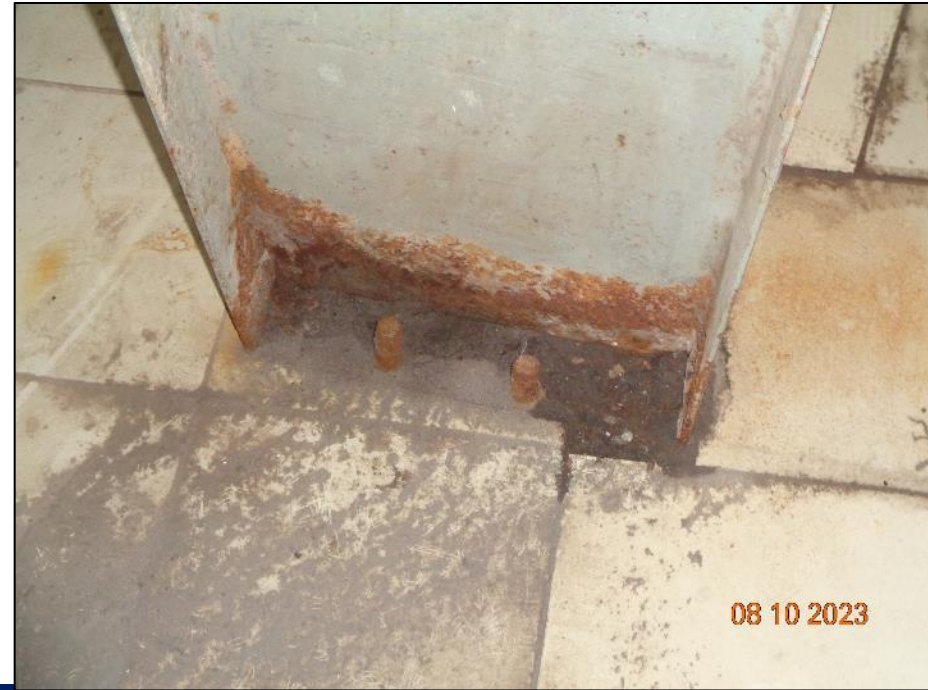
Corrosion in steel section

During inspection, corrosion was observed in steel section. Factory engineer is required to take necessary measures to prevent the corrosion in steel sections.

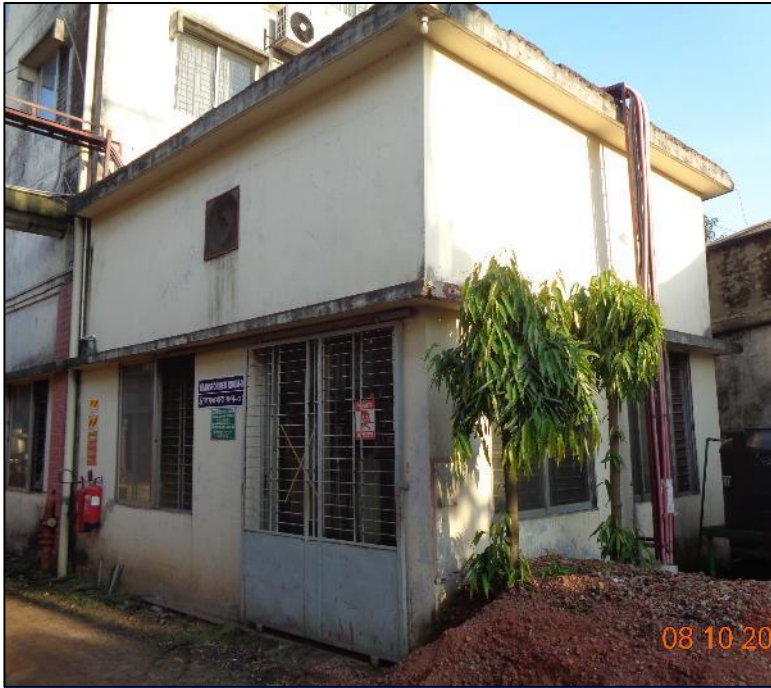
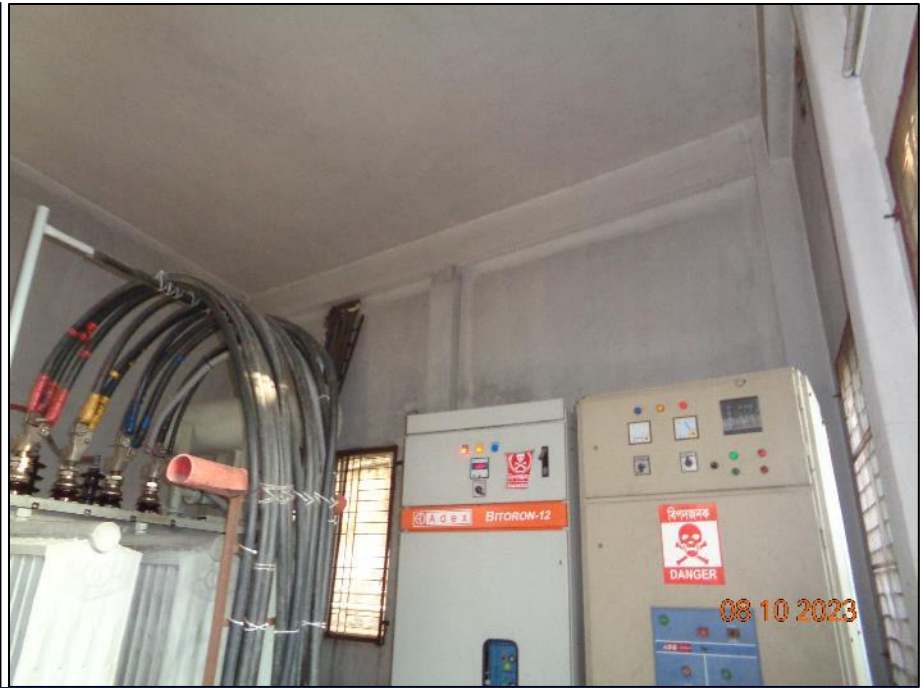
Transformer Room-01

Absence of design documents

During inspection, only as-built drawing was available for the Transformer Room-1. As per BNBC, every building or structure designed shall have its design documents prepared in accordance with the provision of Section 1.9.1. The design document shall include a design report, and a set of structural drawings, which shall be prepared in compliance with section 1.9.1.1 and section 1.9.1.2 as per BNBC. At the time of inspection, design report was not available which is required to be prepared in compliance with section 1.9.1.1 (part-6, BNBC).

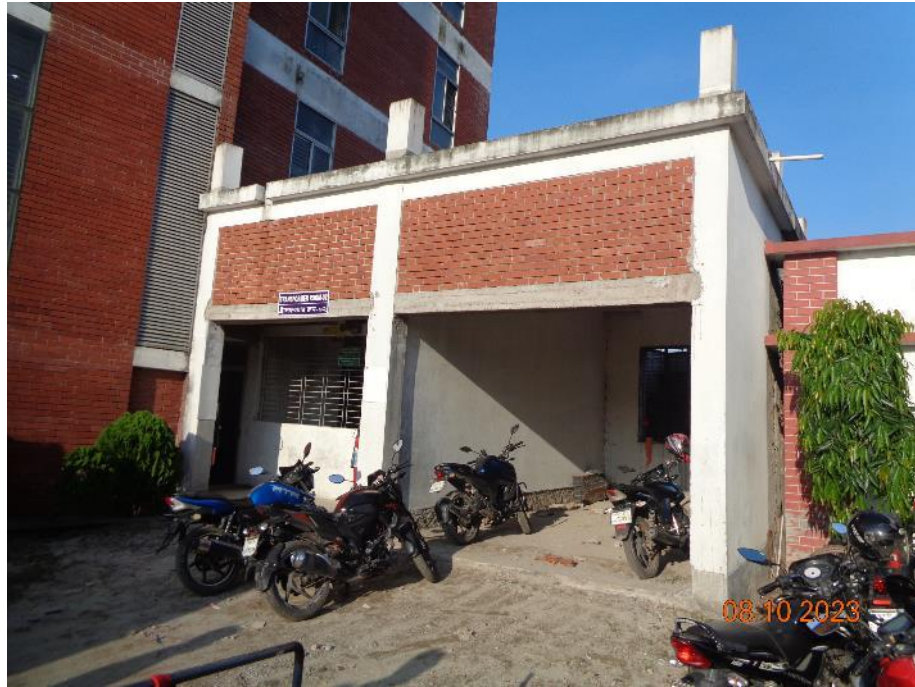
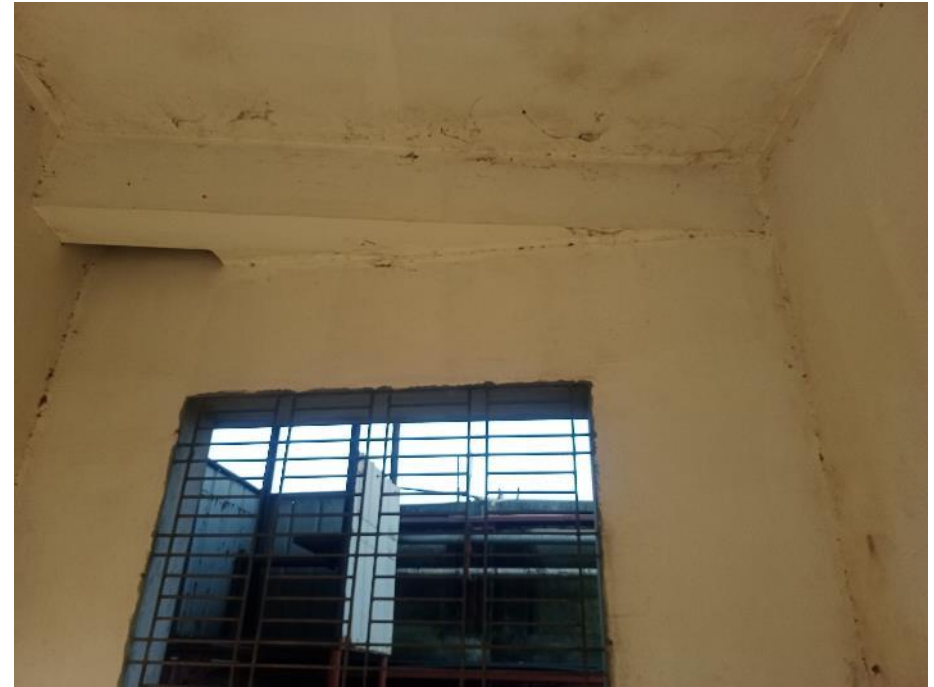
Transformer Room-02

Absence of design documents

During inspection, only as-built drawing was available for the Transformer Room-2. As per BNBC, every building or structure designed shall have its design documents prepared in accordance with the provision of Section 1.9.1. The design document shall include a design report, and a set of structural drawings, which shall be prepared in compliance with section 1.9.1.1 and section 1.9.1.2 as per BNBC. At the time of inspection, design report was not available which is required to be prepared in compliance with section 1.9.1.1 (part-6, BNBC).

Item No.	Observation	Recommended Action Plan	Recommended Timeline
38	Absence of design documents (Transformer Room-2)	Building engineer is required to prepare a set of design report in compliance with section 1.9.1.1 (part-6, BNBC).	6-weeks
39	Absence of design documents (Transformer Room-2)	Implement remediation work if required.	6-months
40	Absence of design documents (ETP)	Building engineer is required to prepare a set of design report in compliance with section 1.9.1.1 (part-6, BNBC).	6-weeks
41	Absence of design documents (ETP)	Implement remediation work if required.	6-months
42	Lateral stability system. (Steam Boiler Shed)	Building Engineer is required to confirm the lateral load path & verify the lateral stability of the steel shed.	6-weeks
43	Lateral stability system. (Steam Boiler Shed)	Implement the remediation if required.	6-months

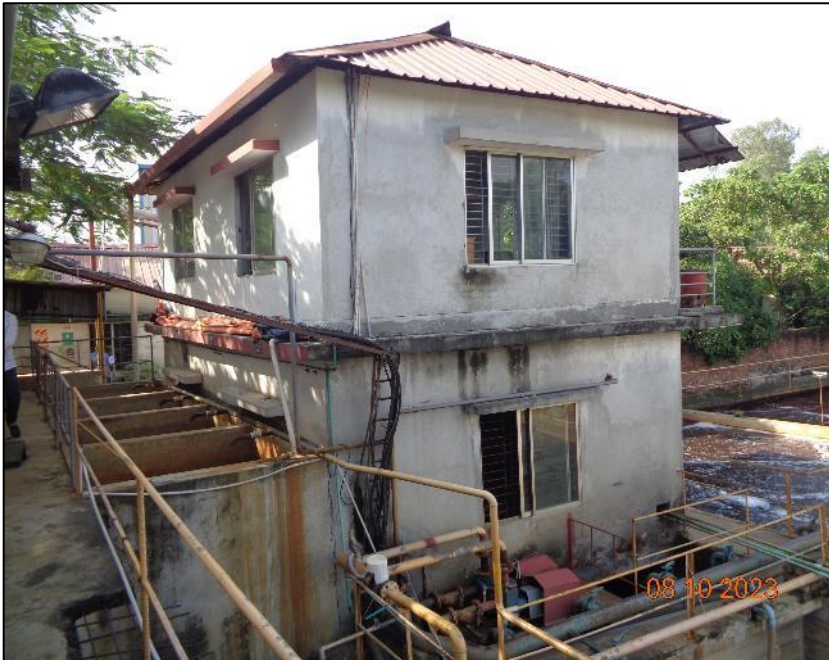
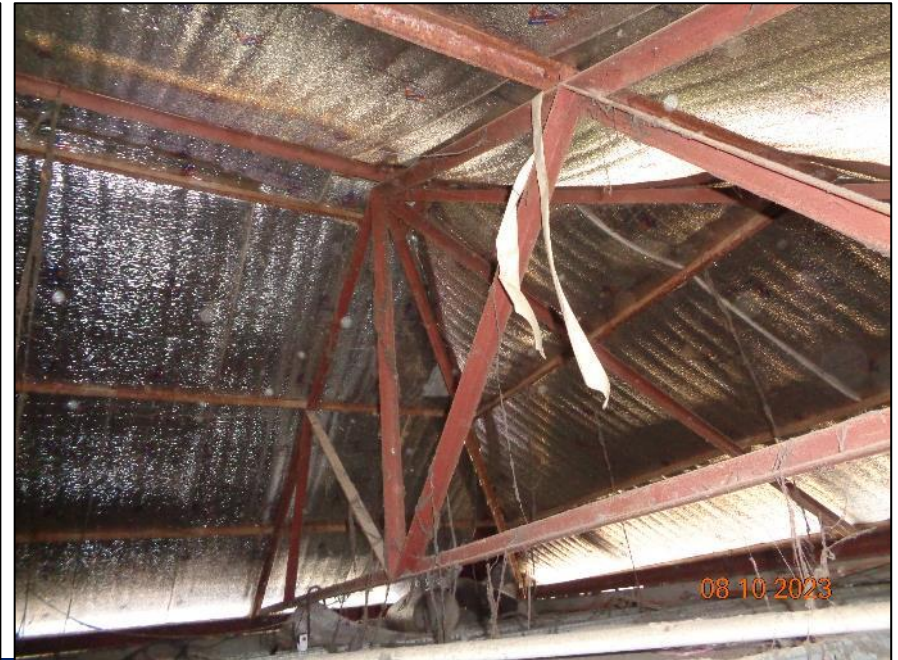
Two Storied ETP

Absence of design documents

During inspection, no documents was available. As per BNBC, every building or structure designed shall have its design documents prepared in accordance with the provision of Section 1.9.1. The design document shall include a design report, and a set of structural drawings, which shall be prepared in compliance with section 1.9.1.1 and section 1.9.1.2 as per BNBC. At the time of inspection, design report was not available which is required to be prepared in compliance with section 1.9.1.1 (part-6, BNBC).

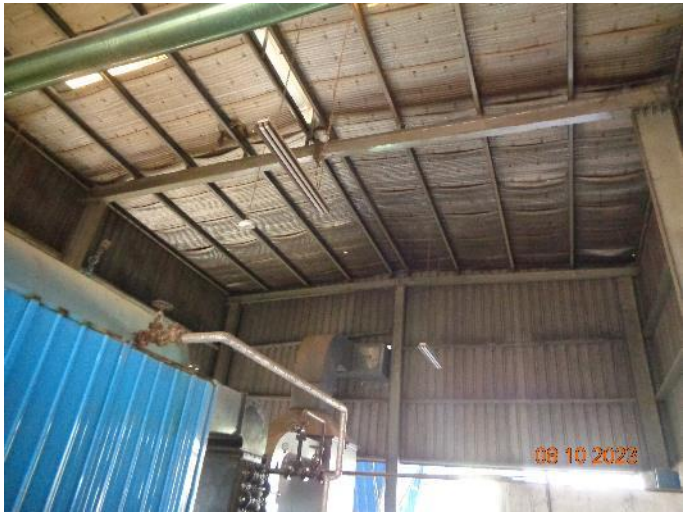
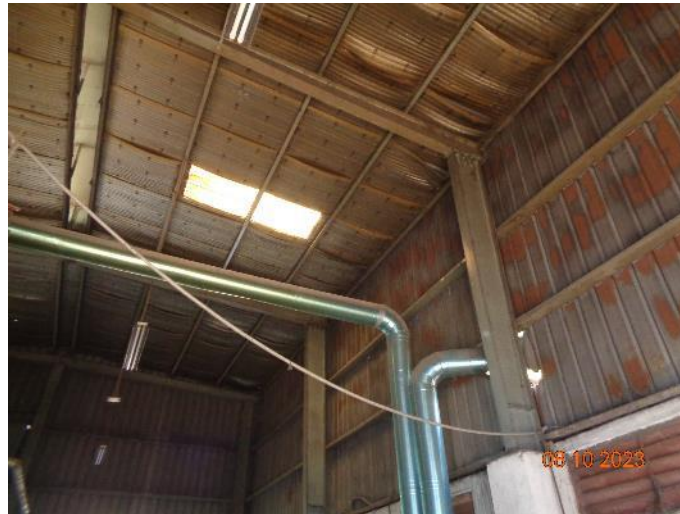
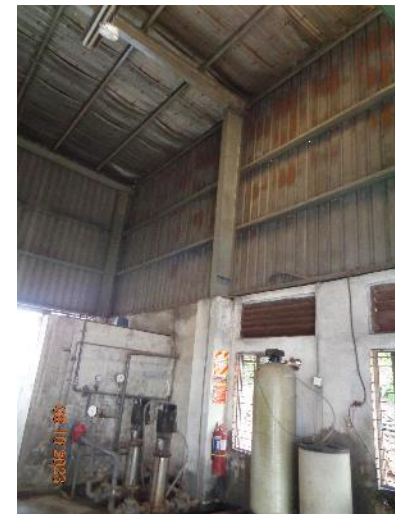
Lateral load transfer media missing at roof level

Lateral load transfer media (compression strut, horizontal & vertical bracing) along the ridge and eave is missing. Building engineer to check the lateral load path and review the stability of the structure accordingly.

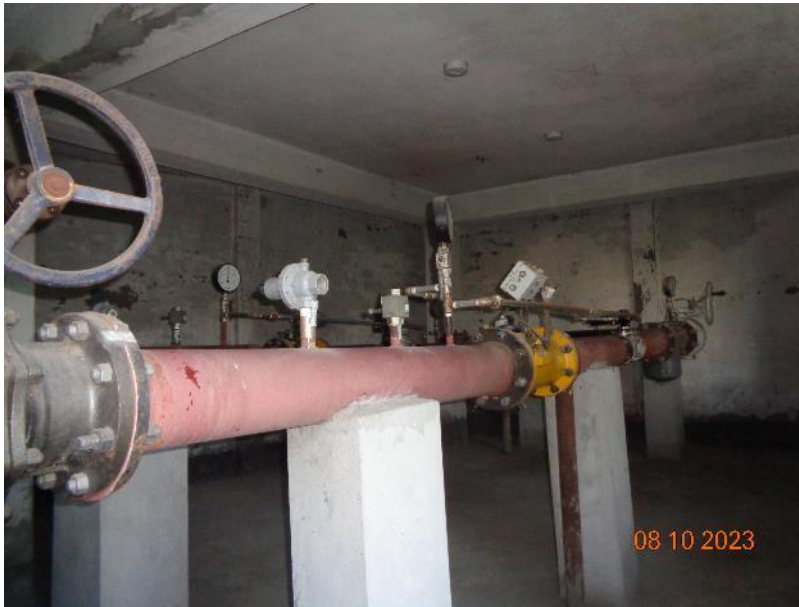
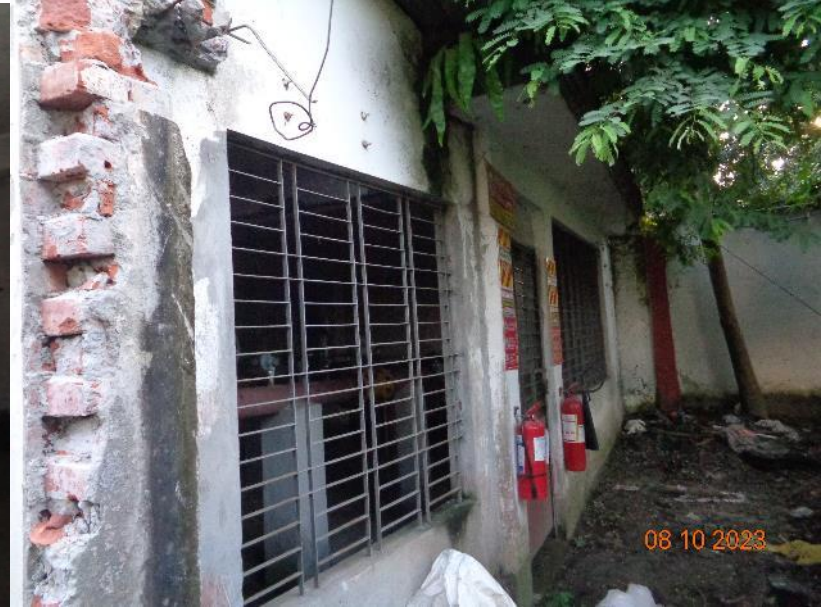
RMS Room

Absence of design documents

During inspection, only as-built drawing was available for the RMS room. As per BNBC, every building or structure designed shall have its design documents prepared in accordance with the provision of Section 1.9.1. The design document shall include a design report, and a set of structural drawings, which shall be prepared in compliance with section 1.9.1.1 and section 1.9.1.2 as per BNBC. At the time of inspection, design report was not available which is required to be prepared in compliance with section 1.9.1.1 (part-6, BNBC).

Item No.	Observation	Recommended Action Plan	Recommended Timeline
44	Absence of design documents (RMS Room)	Building engineer is required to prepare a set of design report in compliance with section 1.9.1.1 (part-6, BNBC).	6-weeks
45	Absence of design documents (RMS Room)	Implement remediation work if required.	6-months
46	Apparently inadequate connection (Wastage Shed)	Building engineer is required to check the connection adequacy for uplift forces as part of EA.	6-weeks
47	Apparently inadequate connection (Wastage Shed)	Implement suggested remediation works.	6-months

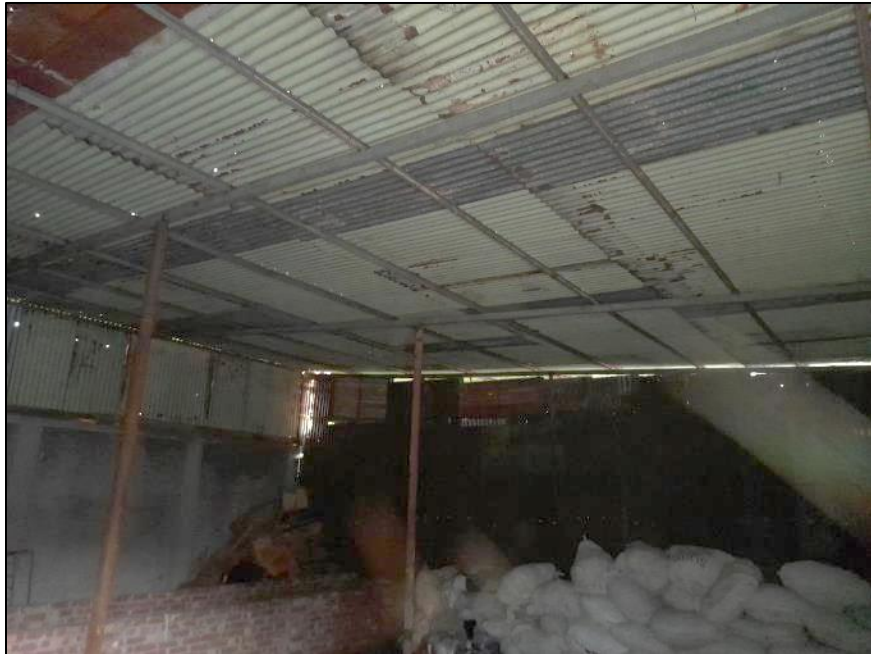
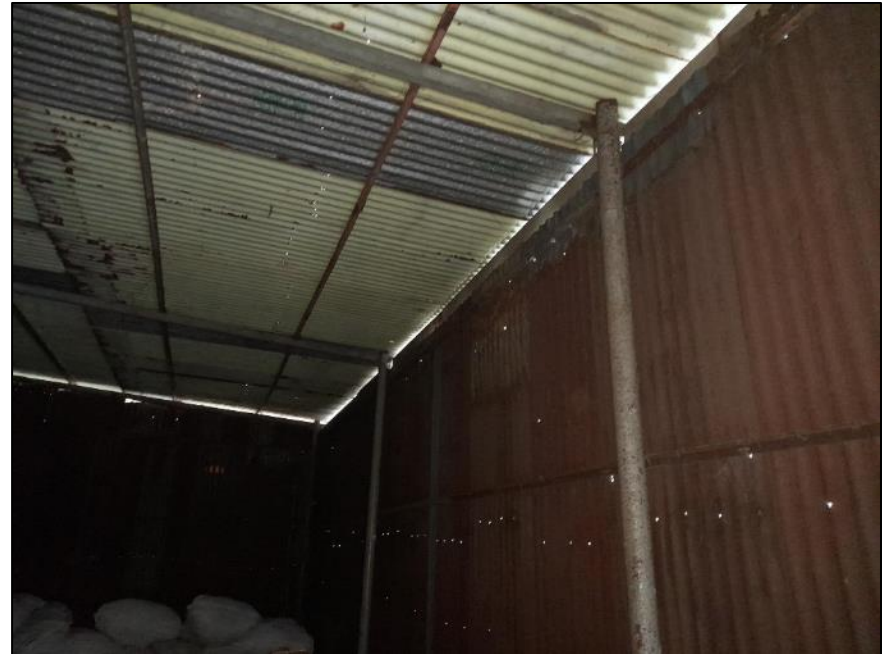
Apparently non engineered shed

Poor connection between steel members

This shed was appeared to be non-engineered due to poor connection and inadequate member size. The building engineer is required to carry out Engineering Assessment (EA) to check the lateral stability & connection adequacy of the structure and prepare full set of design report with necessary remedial actions.
