Cottonex Fashions Limited

19 October 2023

Building Information

Observations

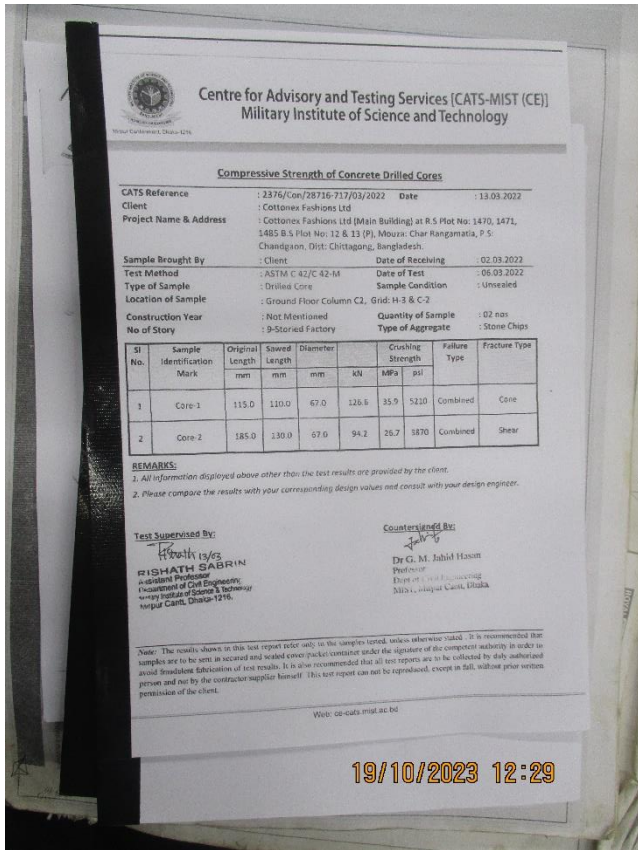
Table 3.1: Equivalent Crushing Strength of Concrete (Column)

4-nos of concrete cores taken from column (5210psi, 3870psi, 5960psi & 5790psi); but two core value (5960psi & 5790psi) used in calculating the equivalent concrete strength.

Also, total 14 sets of cylinder test reports was available on site, but location was not mentioned in the reports.

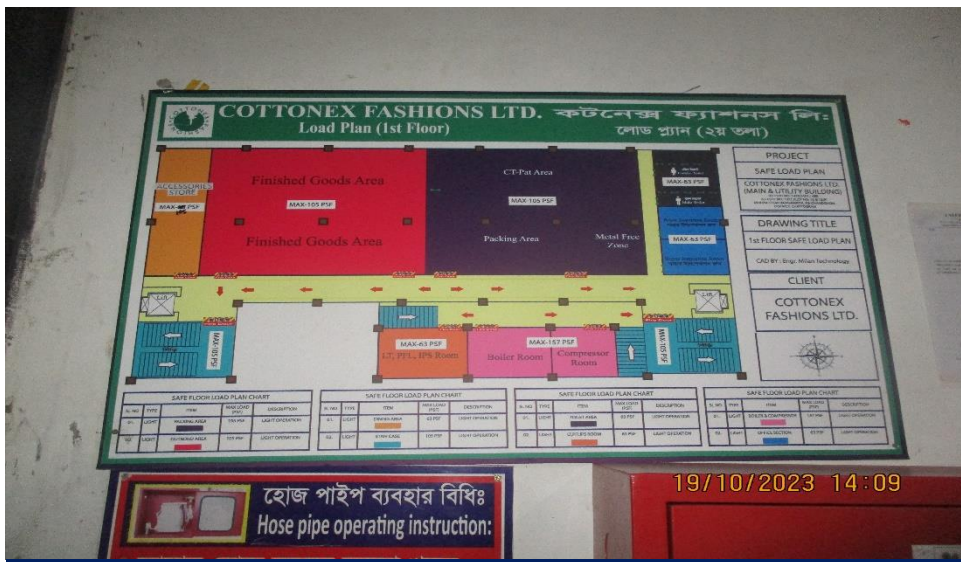
Live load considered 5 kPa on the storage areas which doesn't comply BNBC requirement.

Live load consider 5 kPa on the storage areas

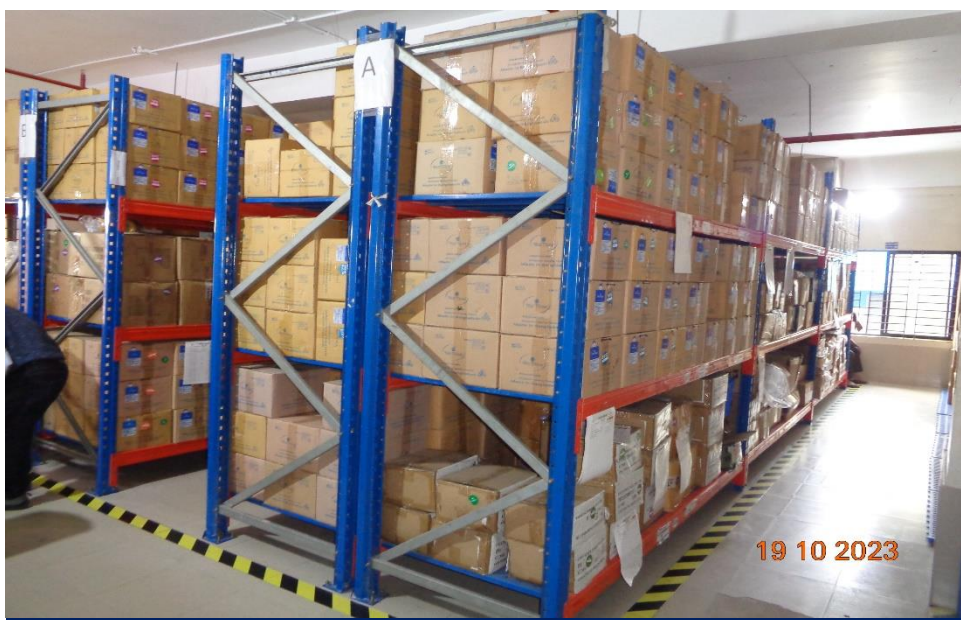
Storage on floor

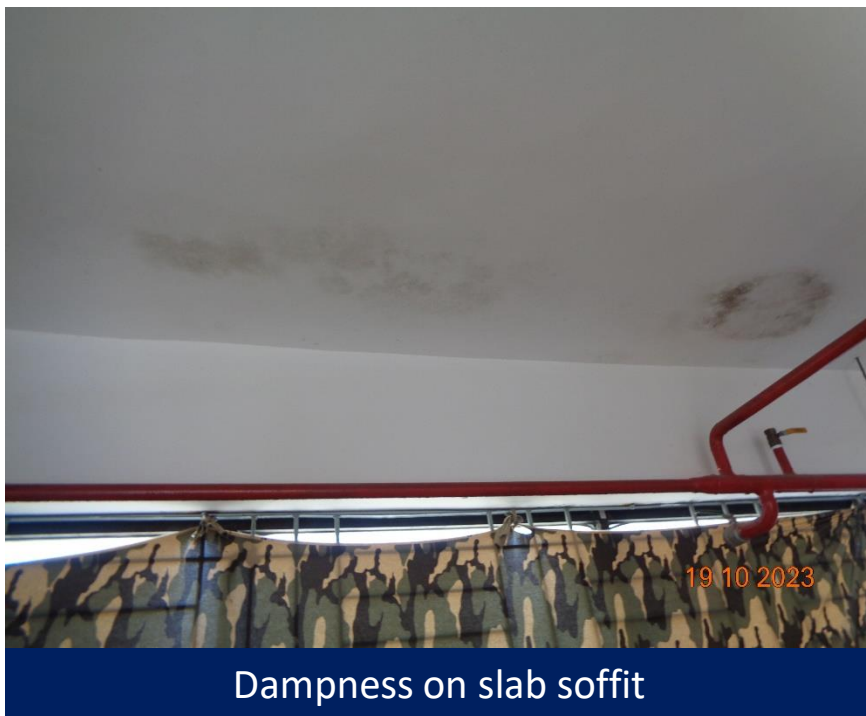
Dampness on the ceiling of the roof floor was observed. Building engineer is required to seal the source of water and repair the damp areas with suitable methods.

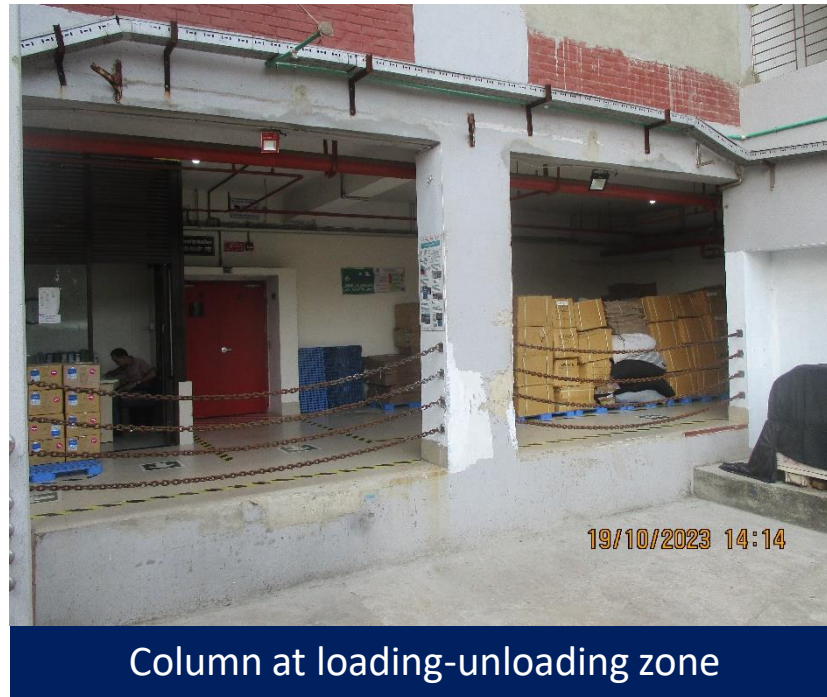
Column at loading-unloading zone

Column adjacent to the loading-unloading area is susceptible to vehicle impact. The building engineer is required to provide separate barrier and signage to avoid possible vehicle impact on column.

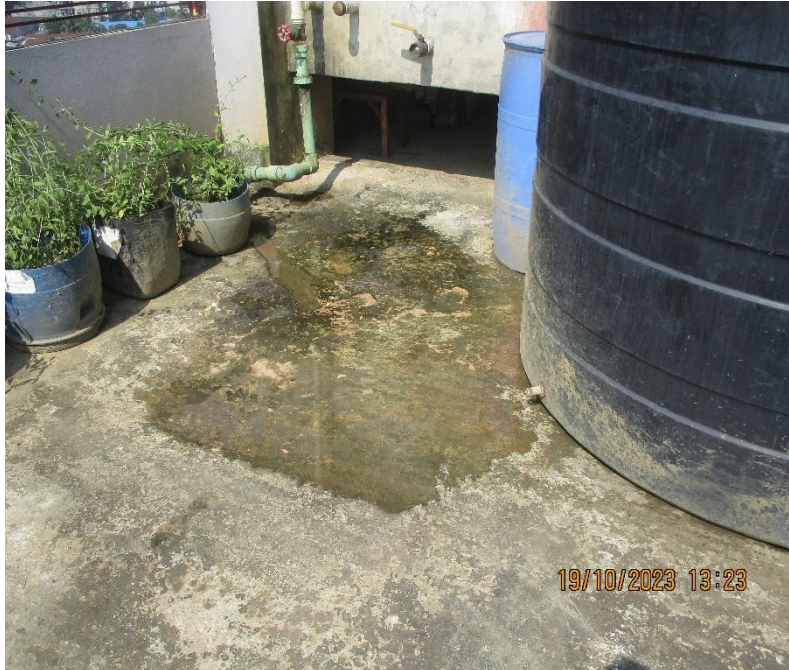
Water ponding on the roof

The factory is required to improve roof drainage system with adequate slope and provide sufficient water outlets to drain out water.

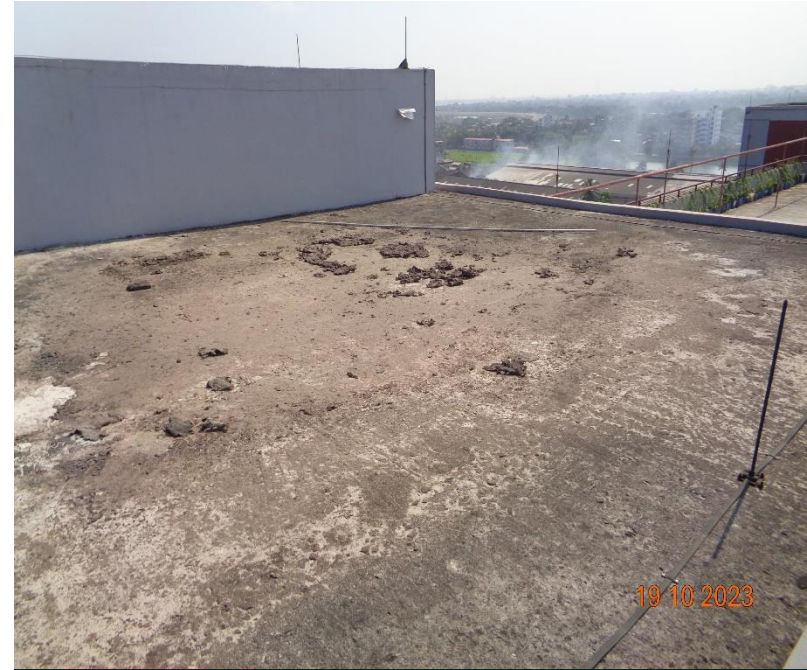
Signage of water ponding on the roof

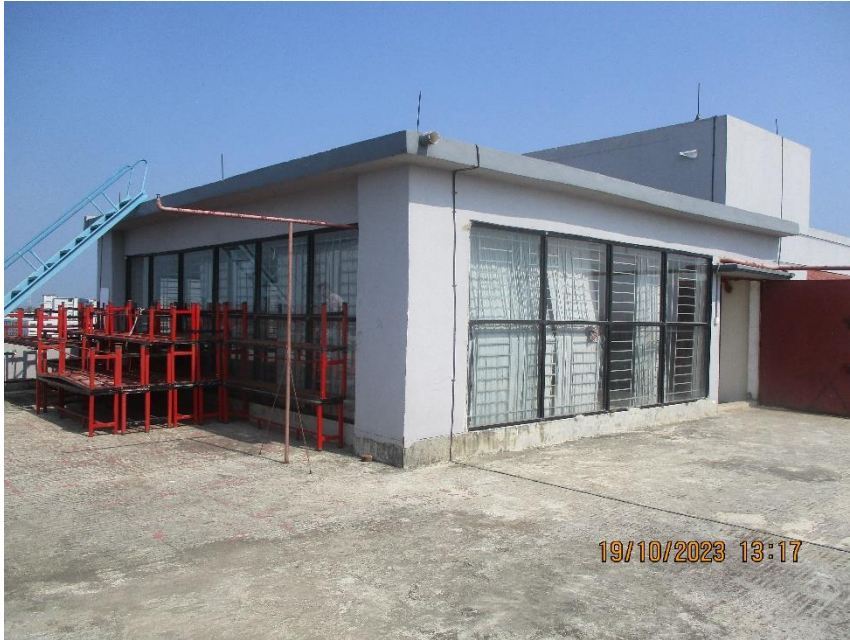
Falling hazard from stair roof top

Falling hazard observed in the stair roof top. Building engineer is required to take necessary measures to avoid possible falling hazard.

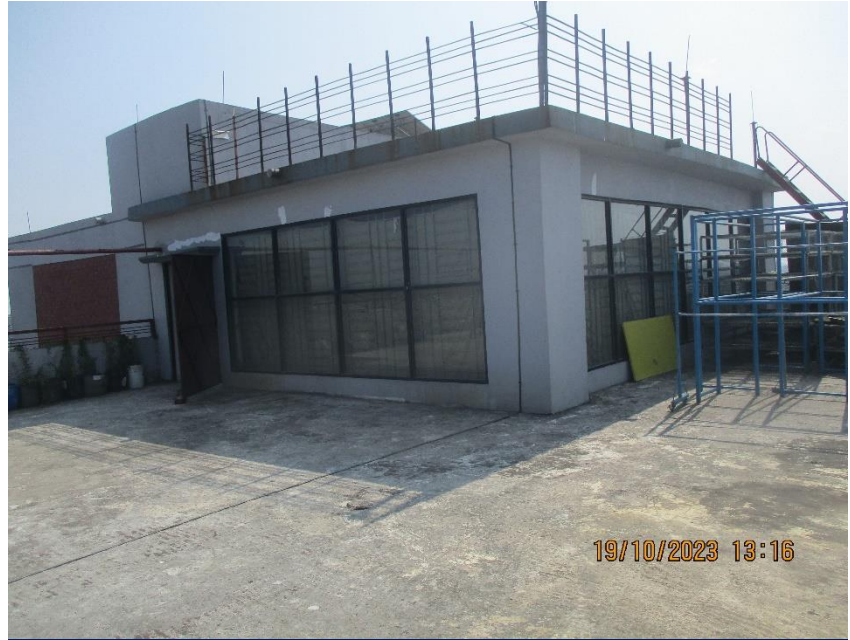
Falling hazard from stair roof top

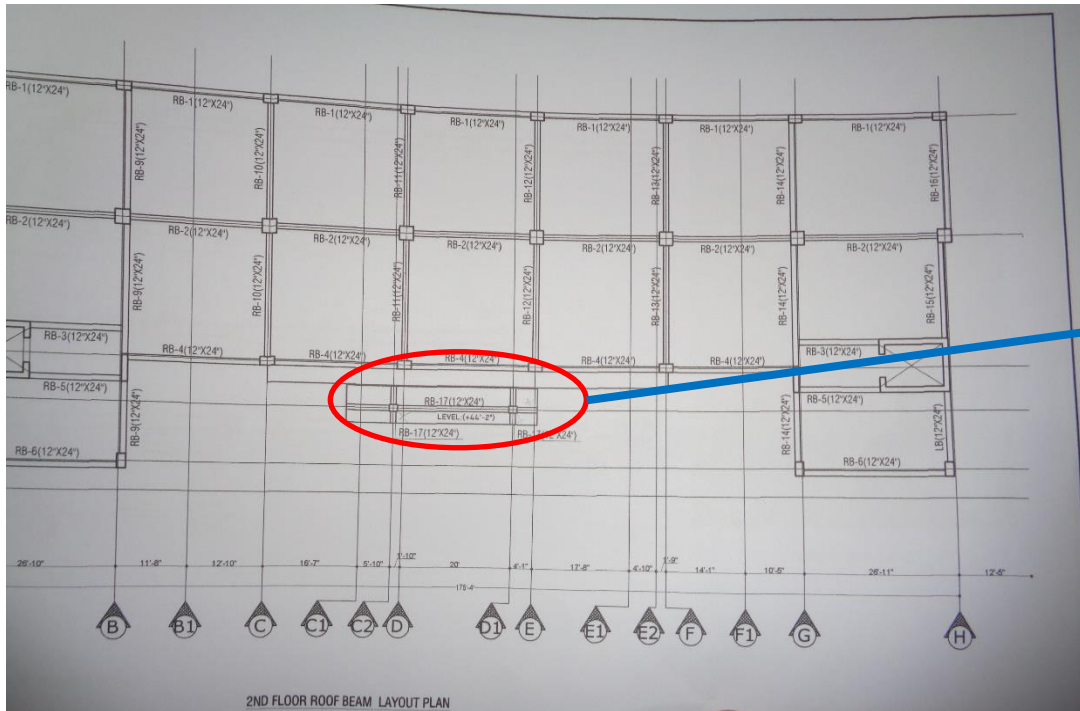
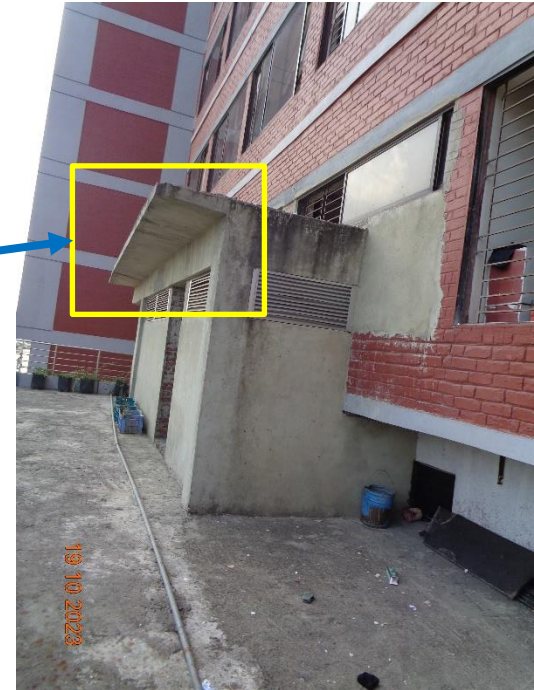
Marked beams layout not matched with on-site condition

Cantilever beams shown in drawing of utility building at stair roof top, but not found on site.
 Building engineer is required to confirm the location of the beams and update the drawings.
