# Aspire Garments Limited (Extension)

491 Dhalla, Singair, manikganj

5 December 2023

**Fabrics and Accessories Shed** is a single storied steel shed.

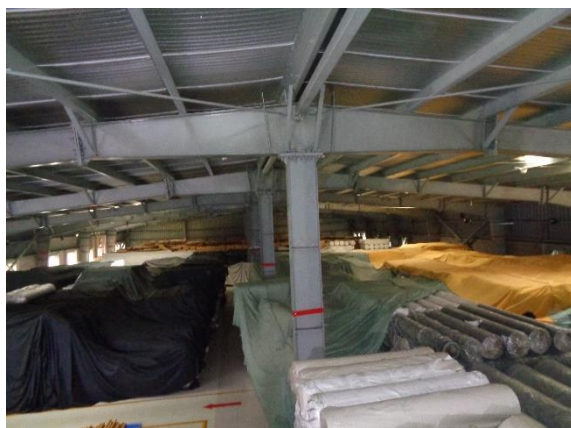
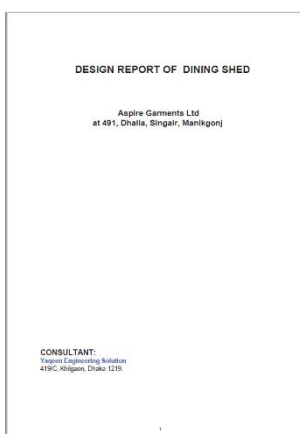
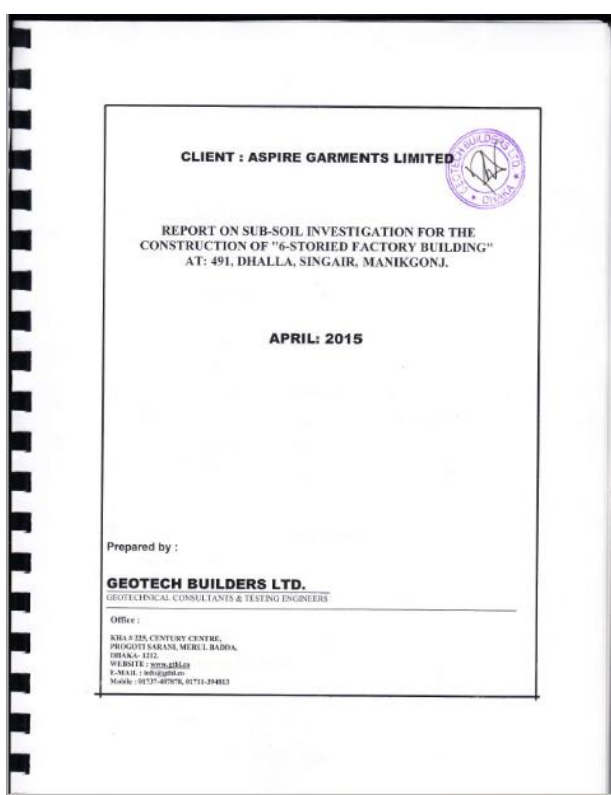
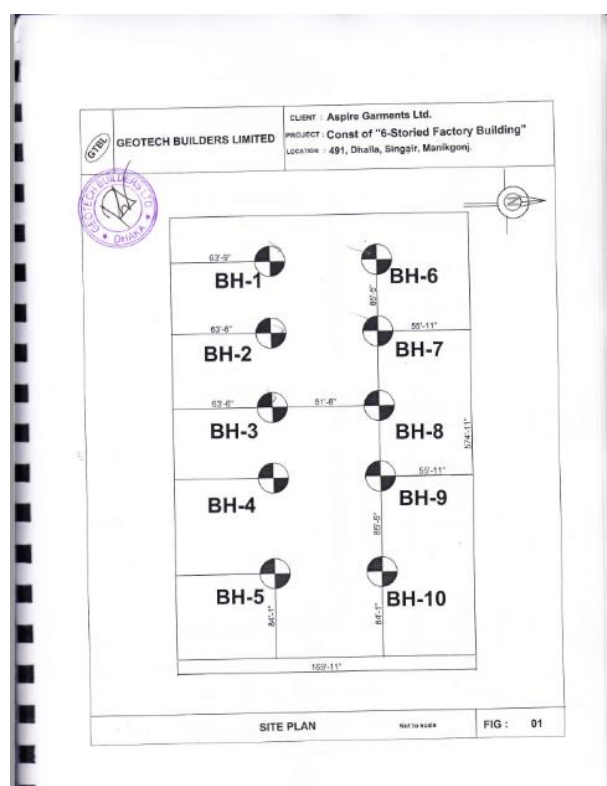
### Observation-1: Design report need to be review against lateral loading

**Description:** Design report was found available for the structure considered lateral forces for the structural members and connection adequacy. The seismic design category has not been mentioned in the design report. A soil test report for a six storied factory building has been provided. The borehole layout does not represent the Fabrics and Accessories Shed. Additionally, the ultimate bearing capacity of the soil for the footing foundation has been considered 3.81ksf. But no calculation has been provided against the consideration. However, the prepared design documents need to be checked against lateral loads following BNBC 2020 by RSC. Submit the design documents including software-based analysis model to the RSC for detail review.

| Observation | Action Plan | Timeline |
|---|---|---|
| Prepared design report needs to be reviewed against lateral loadings. | Prepared design report to be checked against lateral loads following BNBC 2020 by RSC. Submit the design documents including software-based analysis model to the RSC for detail review. | within 6 weeks |
| | Carry-out remediation work if required. | within 6 months |

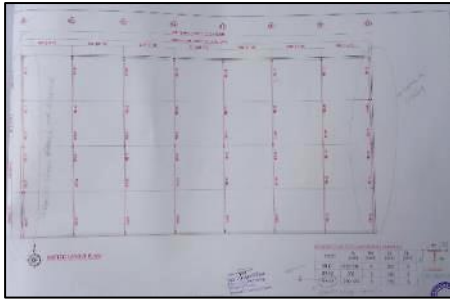
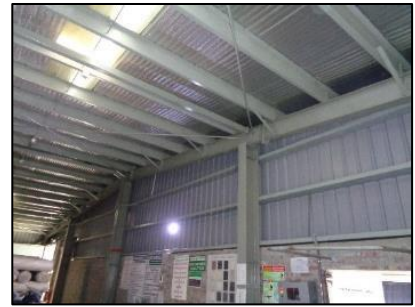
\* Regular shape found.

Uniform shape rafter at gable

**Description:** During inspection, mismatches were found between onsite condition and provided hard copy of the as-built drawing. The shape of the rafter R3 has been shown tapered in drawing but at site condition, shape of rafter was found uniform shape. The web depth for the R3 rafter was found 310mm. The vertical bracing has been shown double angle 2L-05X50X5mm but at site the vertical bracing was found pipe of 140mm dia. Also, the roof bracing has been shown double angle 2L-05X50X5mm but at site the roof bracing was found 25mm dia re-bar and 25mm dia cable. The layout of the compression strut does not match with the between provided as-built drawing and actual site condition.

The construction drawing is re-presentable with site condition with the few mismatches. Building engineer is required to survey the whole structure and prepare accurate as-built drawing.

| Observation | Action Plan | Timeline |
|---|---|---|
| Improper as-built drawing | The building engineer is required to survey the full structure and produce accurate as-built drawings. | within 6 weeks |

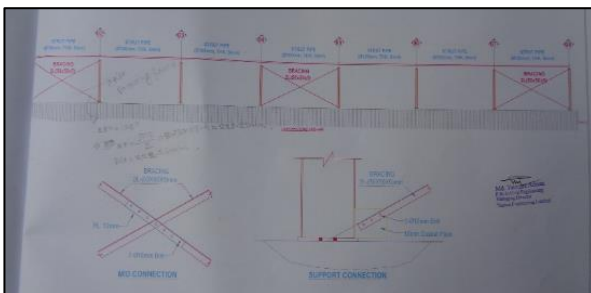
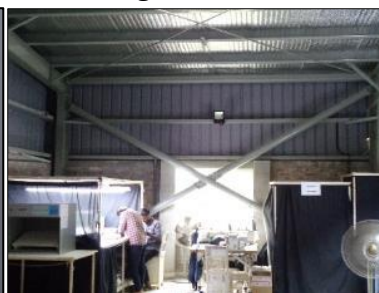
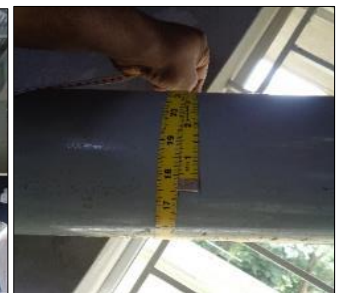
Vertical Bracing- Steel pipe

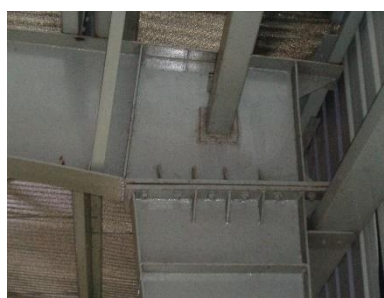
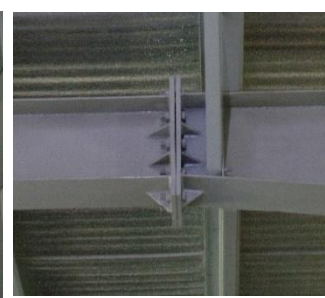
**Description:** Significant gaps observed at column-rafter and rafter-rafter joints at several location. Factory engineer is required to carry out suitable remedial works.

| Observation | Action Plan | Timeline |
|---|---|---|
| Connection gap at several location. | Identify the locations and carryout suitable repair works where necessary. | within 6 weeks |
