# B2B Excellence Ltd (Extension 2)

Mirzapur Purbapara, 8 No Mirzapur Mowza, Mirzapur, Gazipur  
(24.089050, 90.356431)

10 December 2023

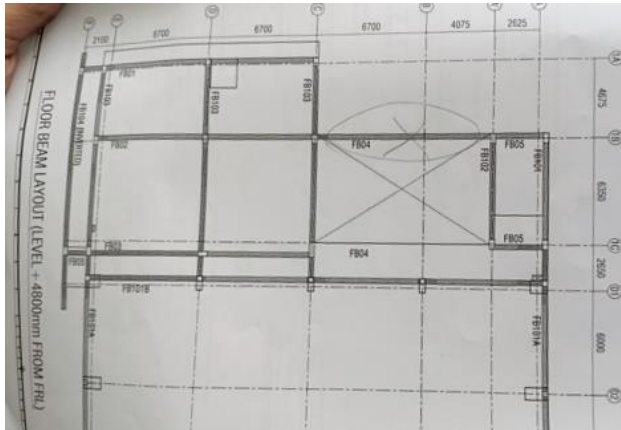
Beam layout plan at +4.8 m level

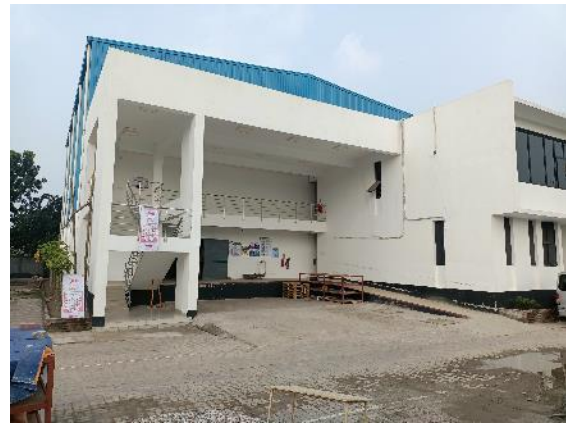
No beam at +4.8 m level

**Description:** At front beam was found missing in first floor level. The building engineer is required to update the as-built drawing correcting the beam layout and submit to RSC.

| Items No. | Observation | Action Plan | Timeline |
|---|---|---|---|
| 1. | Mismatch in as-built drawing. (Warehouse Building) | The building engineer is required to update as-built drawing with necessary connection details. | within 6 weeks |

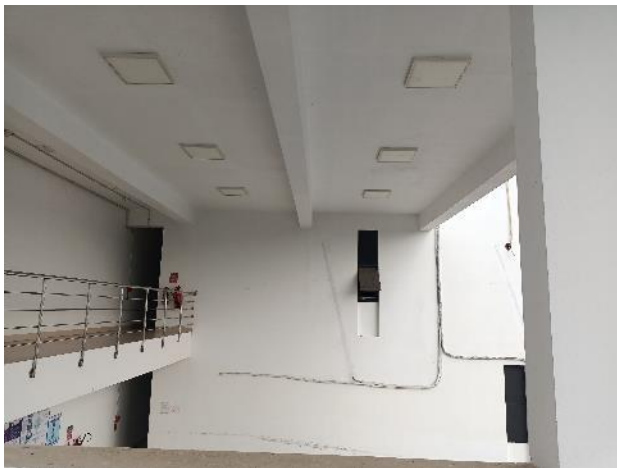
RC Part

**Description:** As per BNBC, every building or structure designed shall have its design documents prepared in accordance with the provision of Section 1.9.1. The design document shall include a design report, and a set of structural drawings, which shall be prepared in compliance with section 1.9.1.1 and section 1.9.1.2 as per BNBC. At the time of inspection, design report was not available which is required to be prepared in compliance with BNBC 2020.

| Items No. | Observation | Action Plan | Timeline |
|---|---|---|---|
| 2. | Absence of design documents. (Warehouse Building) | Building is required to prepare a set of design report in compliance with BNBC. | within 6 weeks |

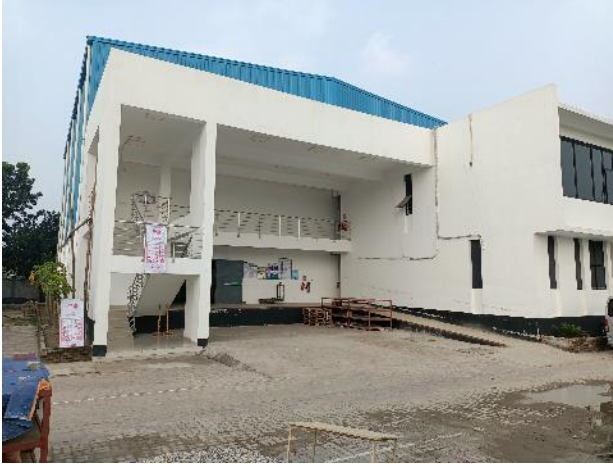
Vehicle impact risk on column

**Description:** Columns on loading/unloading and ramp areas are susceptible to vehicle/trolley impact. The building engineer is required to take necessary action to provide barrier around the column to avoid vehicle/trolley impact in the columns.

| Items No. | Observation | Action Plan | Timeline |
|---|---|---|---|
| 4. | Column susceptible to vehicle/trolley impact. (Warehouse Building) | The building engineer is required to take necessary action to provide barriers around the column to avoid vehicle/trolley impact in the columns. | within 6 weeks |

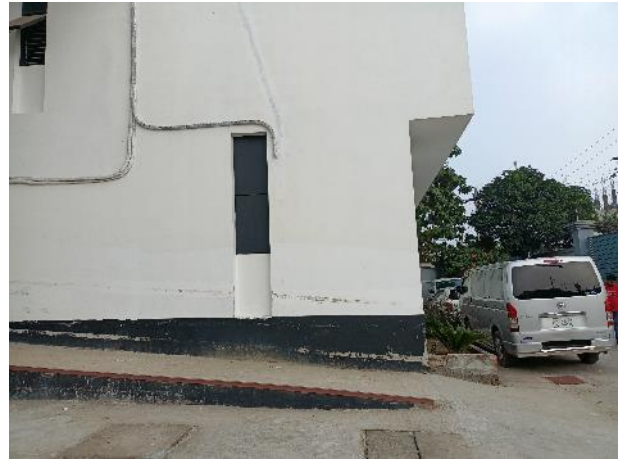
Trolley impact on column

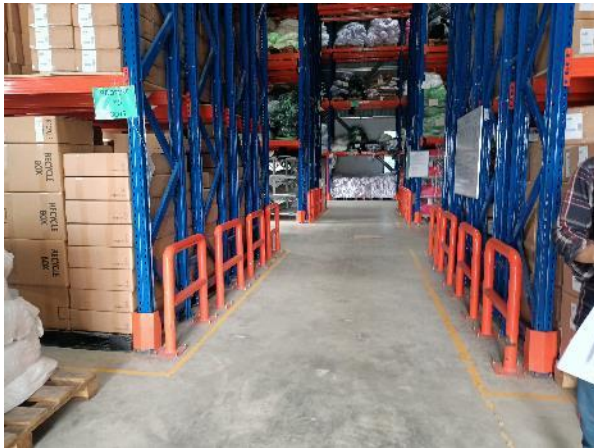
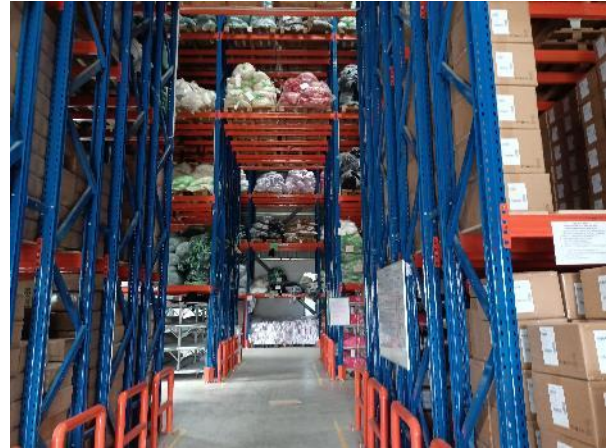
Racking on floor

**Description:** Almost 6 m height racking system was found on ground floor at shed section. The stability checks of the racking system required to be reviewed by RSC.

| Items No. | Observation | Action Plan | Timeline |
|---|---|---|---|
| 5. | Almost 6 m height racking system. (Warehouse Building) | The stability checks of the racking system required to be reviewed by RSC. | within 6 weeks |

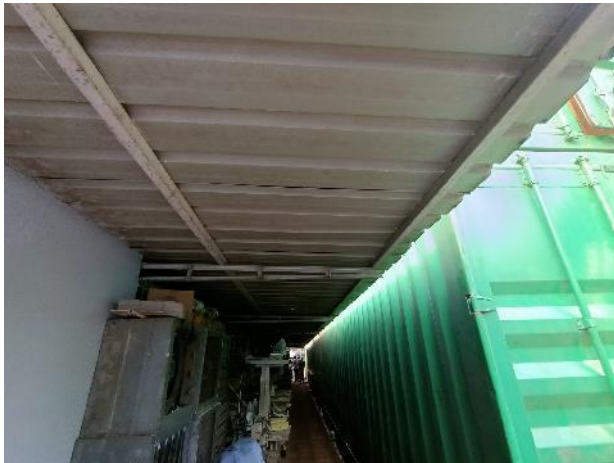
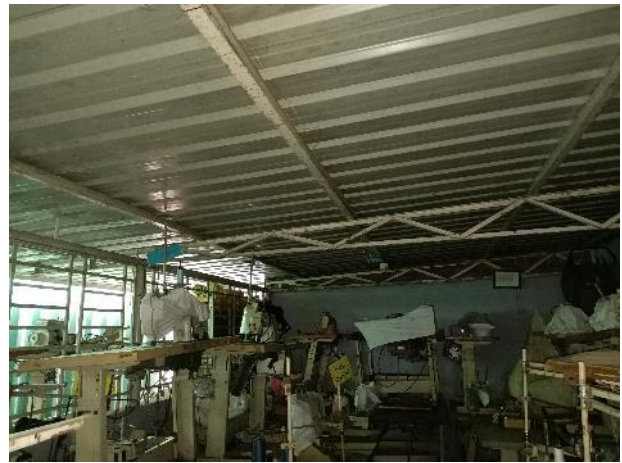
Idle Machine Shed

**Description:** Structural and architectural drawings were not found for the Idle Machine Shed. The building engineer is required to survey the structure and prepare a full set of as-built drawings in compliance with BNBC.

| Items No. | Observation | Action Plan | Timeline |
|---|---|---|---|
| 7. | Lack of drawings. (Idle Machine Shed) | The building engineer is required to survey the whole structure and prepare a full set of as-built drawings with connection details. | within 6 months |

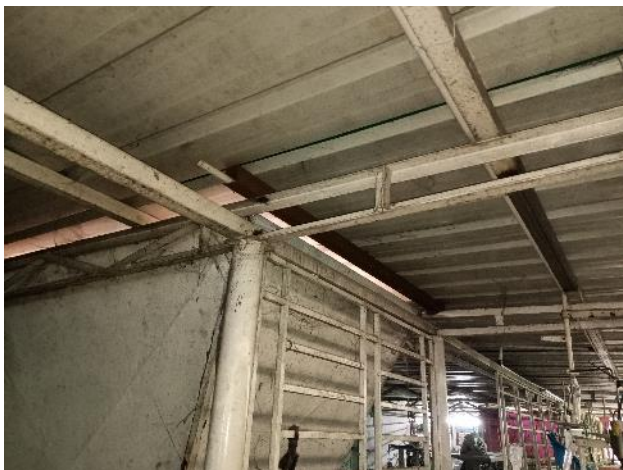
Apparently non-engineered connection

**Description:** Apparently inadequate connections were observed at the lightweight roof of the single storied Sheds. The building engineer is required to check the connection adequacy of the lightweight roof against the uplift pressure of wind.

| Items No. | Observation | Action Plan | Timeline |
|---|---|---|---|
| 8. | Apparently non-engineered connection. (Idle Machine Shed) | Building engineer is required to check the connection of the steel roof for the uplift pressure of wind. | within 6 weeks |
