# RSB Industrial Ltd (Extension)

Plot: 32-34, Sector: 04, Road: 04, CEPZ, Chattogram  
(22.282693, 91.774712)  
12 October 2023

# Building Information

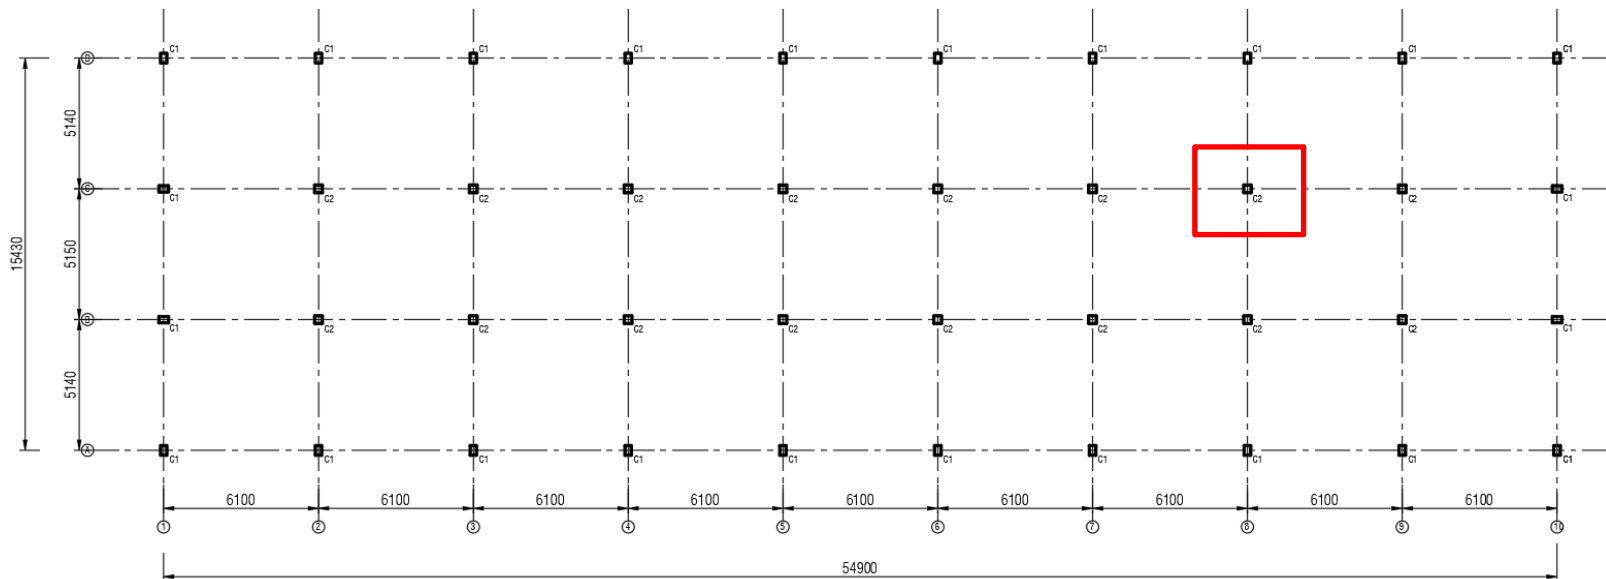
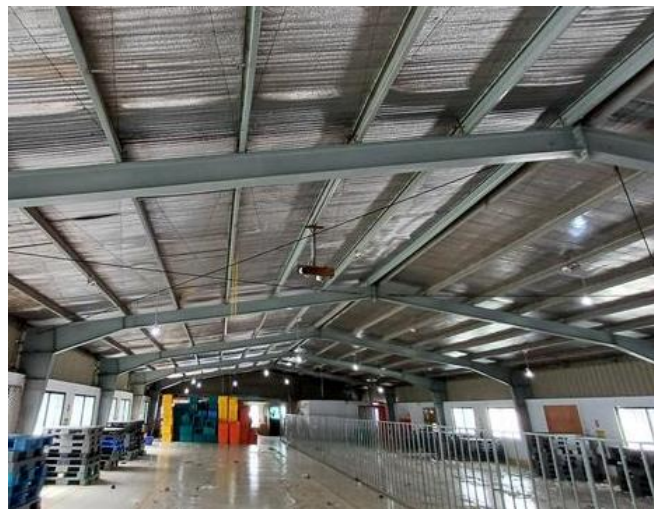
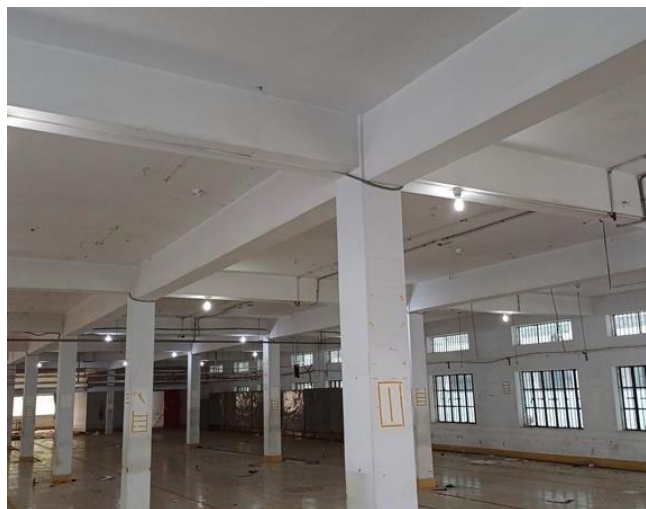
Column layout plan

**High stress in column**

live load considered 2 kPa

Cursory calculation indicates that columns in the marked area found stresses above the normal design limit considering NTPA live load requirements. Live load considered on typical floor 2 kPa. Building engineer is required to review the design, load and column stresses.

| Item No. | Observation | Recommended Action Plan | Recommended Timeline |
|---|---|---|---|
| 01 | High stress in column. (RSB Building no. 02) | Maintain floor live load within 2 kPa until finalization of allowable floor load plan and completion of remedial works (if required). | Immediate |
| 02 | High stress in column. (RSB Building no. 02) | The building engineer is required to conduct Detail Engineering Assessment (DEA) to review the design, load and column stresses. Prepare a set of floor live load plan based on foundation, column & floor capacity of the building. | 6-weeks |
| 03 | High stress in column. (RSB Building no. 02) | Carry out suggested remedial works. Implement load management system (post allowable floor live load plan on each floor level, mark storage height & areas and maintain floor loading accordingly). | 6-months |

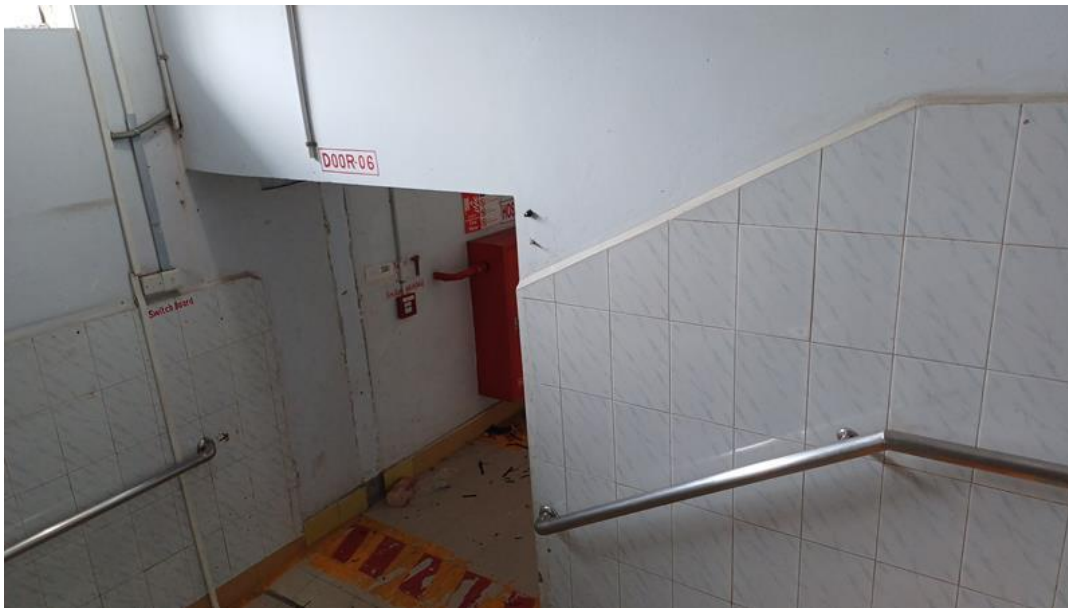
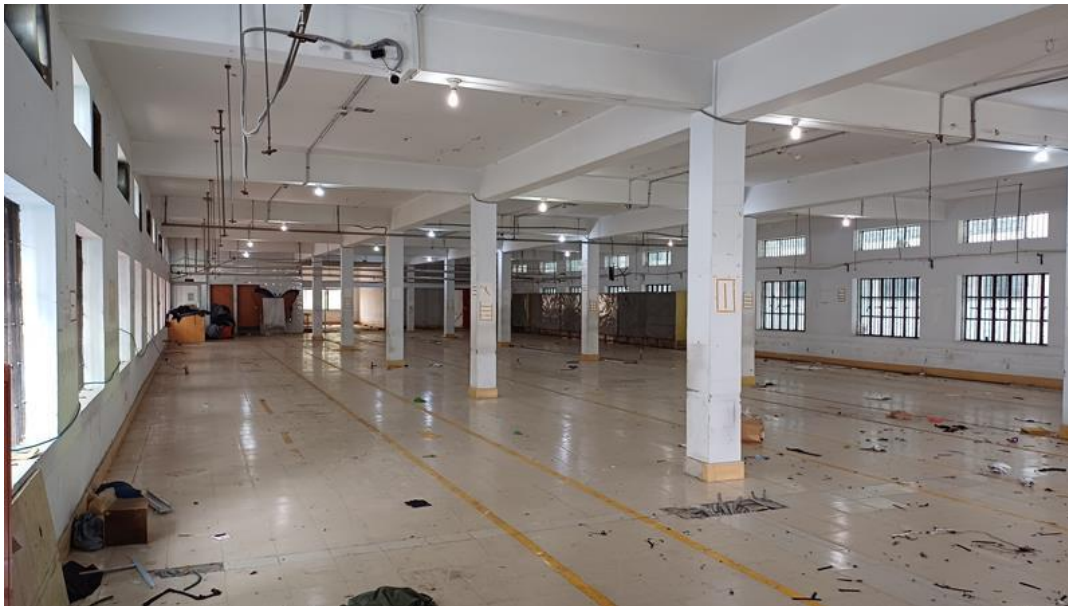
No load plan observed

During inspection, no load plan was found on floors. Building engineer is required to produce load plan as part of EA and actively implement floor loading plan by posting on each floor and maintaining loadings.

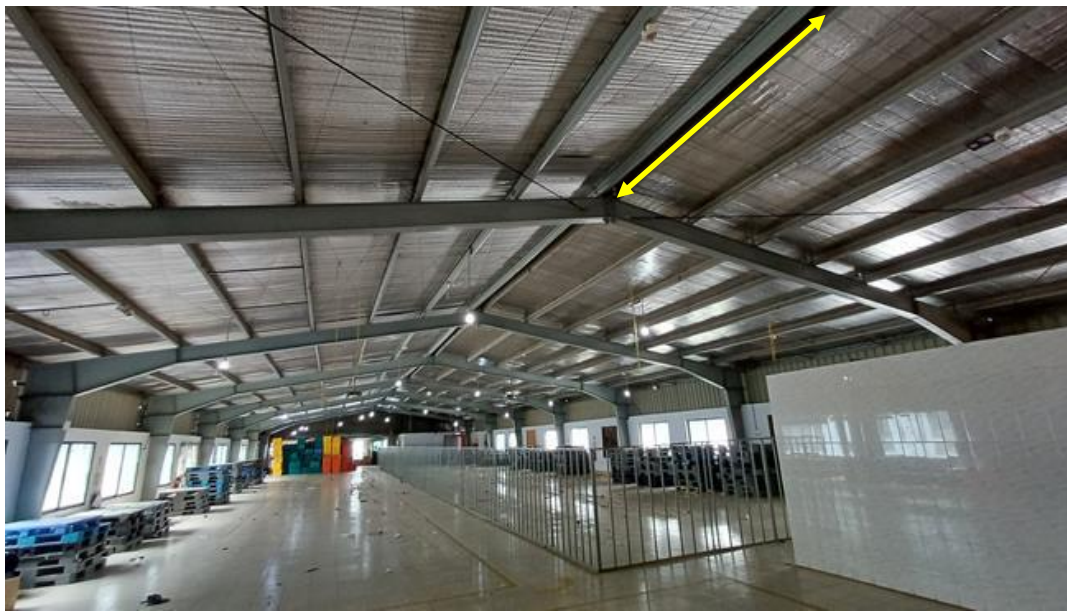
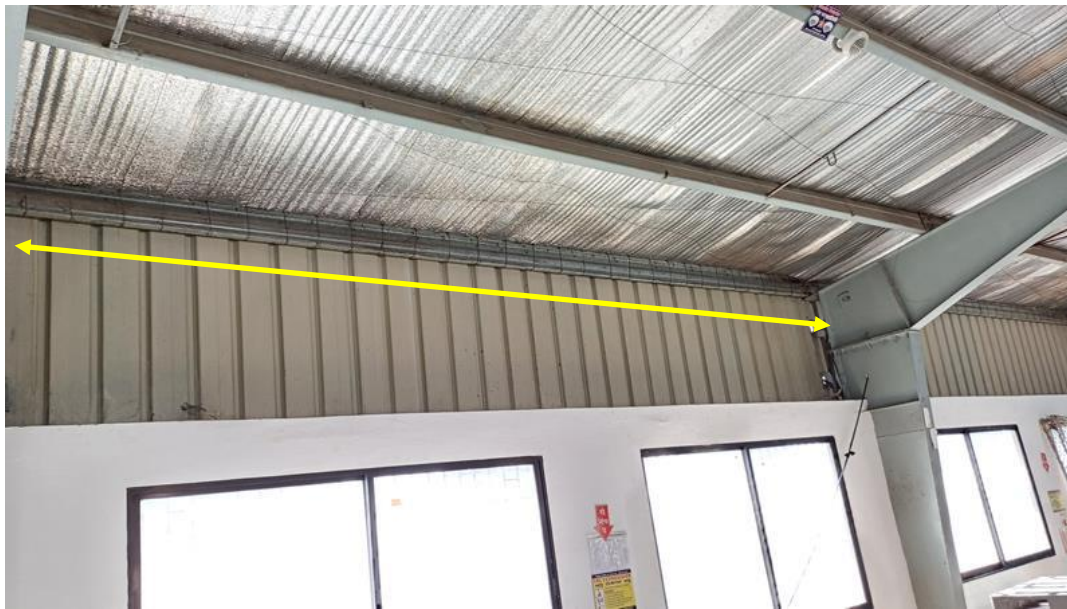
No load transfer media provided

# Incomplete lateral stability system

During inspection, roof bracing were found at some locations, but load transfer media was not provided from frame to frame to transfer the lateral loads. Therefore, lateral stability system of the steel frame is apparently incomplete. Building engineer is required to check the stability of the structure against lateral forces.

| Item No. | Observation | Recommended Action Plan | Recommended Timeline |
|---|---|---|---|
| 04 | Incomplete lateral stability system. (RSB Building no. 02) | Building engineer is required to check the stability of the structure for lateral loading. | 6-weeks |
| 05 | Incomplete lateral stability system. (RSB Building no. 02) | Carry out suggested remedial works if required. | 6-months |

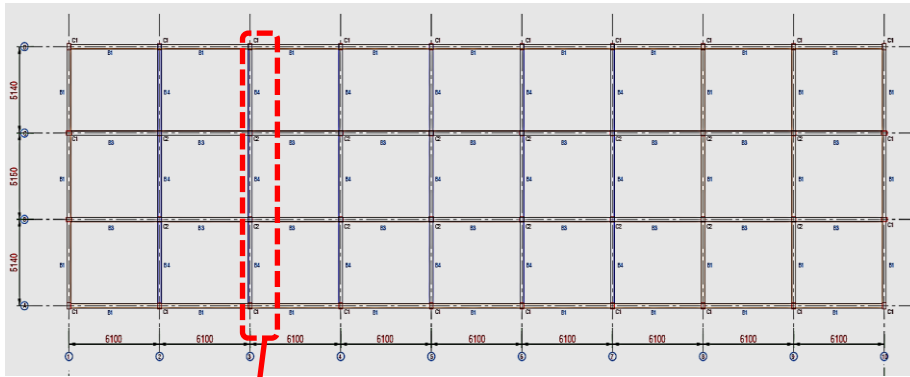
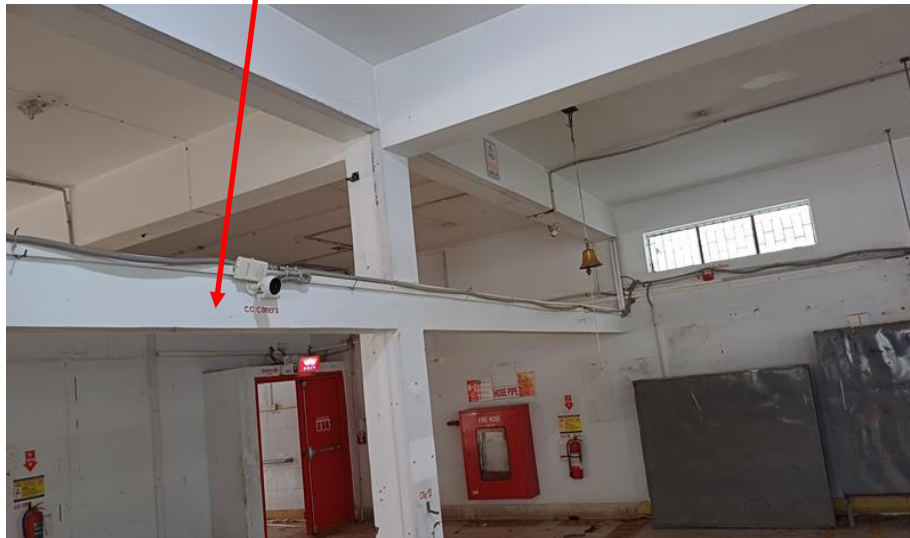
Tie beam at First floor was not shown in the as-built drawing.

Building engineer is required to update the drawing as per actual site condition and submit it to RSC for further review.

| Item No. | Observation | Recommended Action Plan | Recommended Timeline |
|---|---|---|---|
| 06 | Discrepancies and missing information in as-built drawing. (RSB Building no. 02) | Building engineer is required to update the drawings as per actual site condition and submit it to RSC for further review. | 6-weeks |

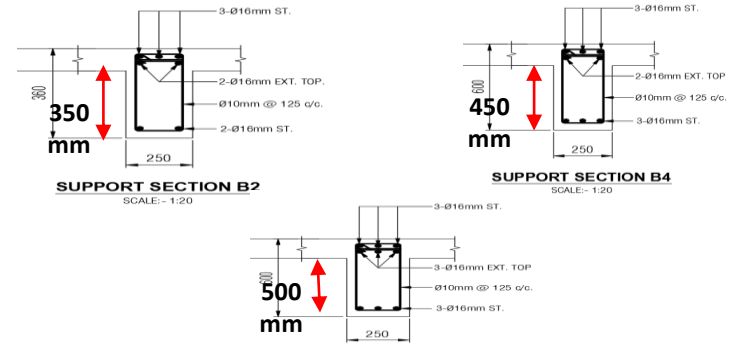
Discrepancy found in beam depths at several locations (both in 1<sup>st</sup> Floor and Ground Floor). Down stand depth in B-2 beam found 350 instead of 235, for B-3, 500 instead of 475 and in B-4, 450 instead of 475.

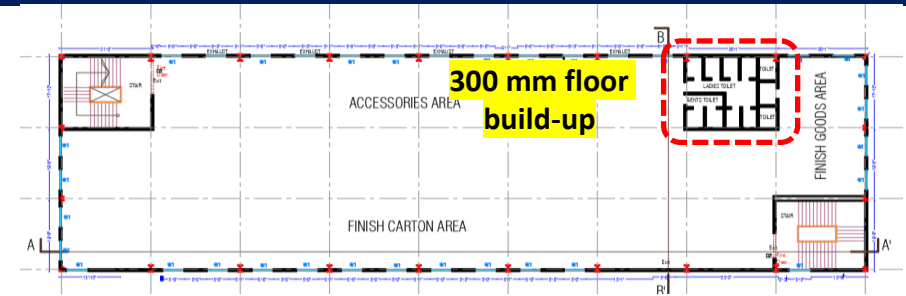
300mm floor build-up found in toilet zone of 3<sup>rd</sup> floor which is not mentioned in the as-built drawings

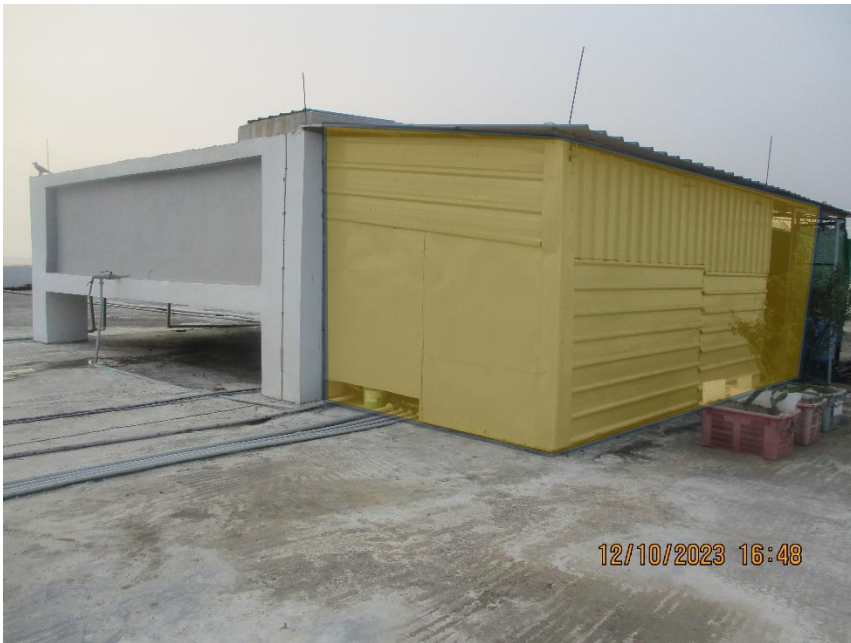
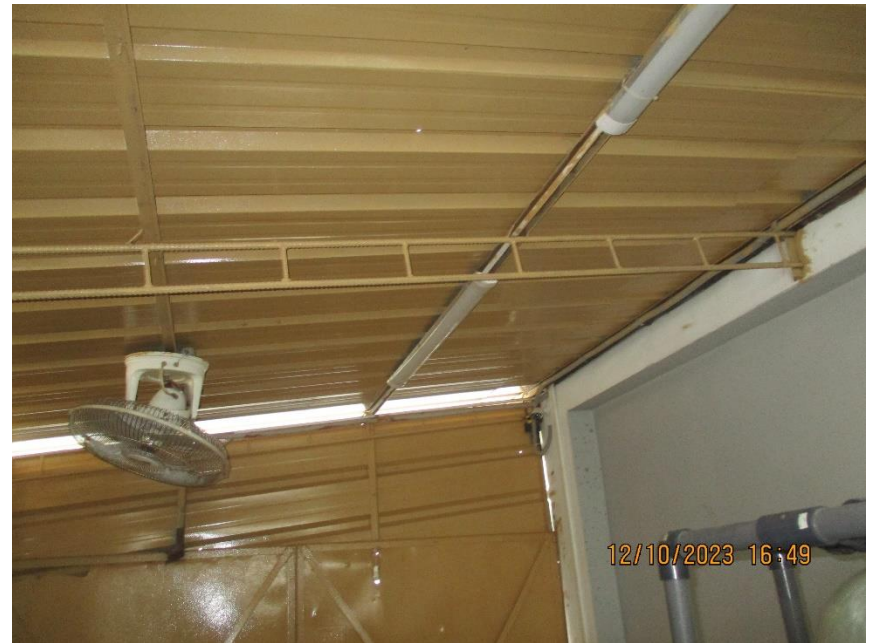
## **Non-engineered RO Shed**

Non-engineered RO shed was observed on the roof.  
Building engineer is required to check the stability of the uplift forces.

| Item No. | Observation | Recommended Action Plan | Recommended Timeline |
|---|---|---|---|
| 10 | Non-engineered RO Shed. (RSB Building no. 03) | Building engineer is required to check the stability against the uplift forces. | 6-weeks |

| Item No. | Observation | Recommended Action Plan | Recommended Timeline |
|---|---|---|---|
| 11 | Non-engineered RO Shed. (RSB Building no. 03) | Carryout remedial works where required. | 6-months |

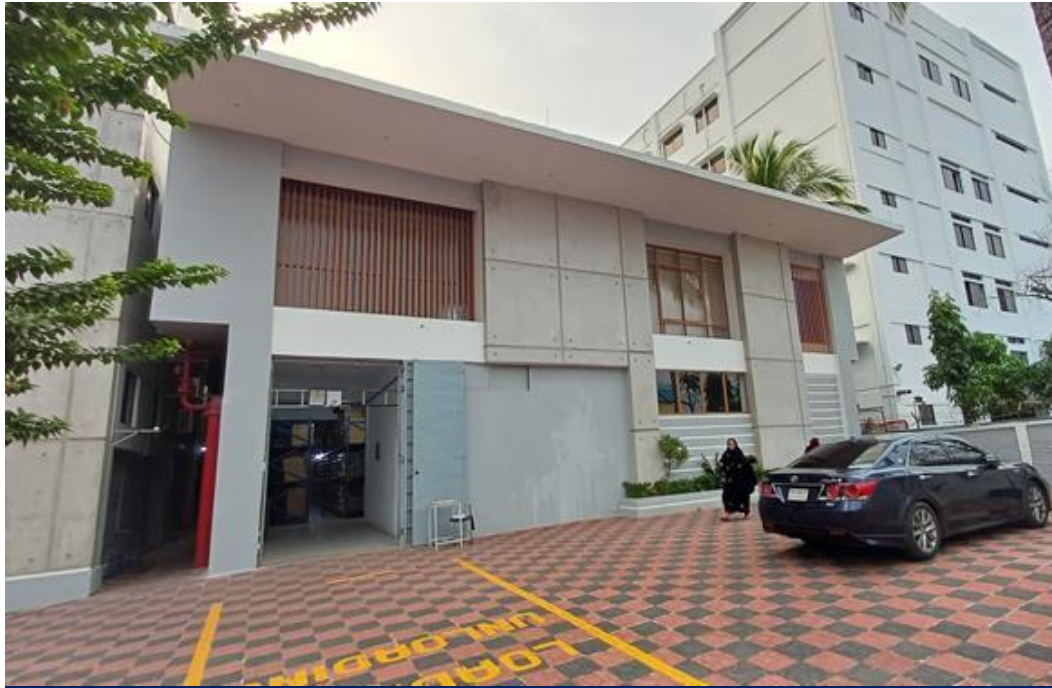
Building-04

# Absence of design documents

As per BNBC, every building or structure designed shall have its design documents prepared in accordance with the provision of Section 1.9.1. The design document shall include a design report, and a set of structural drawings, which shall be prepared in compliance with section 1.9.1.1 and section 1.9.1.2 as per BNBC. At the time of inspection, design documents (including design report, load plan and material test reports) were not available which are required to be prepared in compliance with section 1.9.1 (part-6, BNBC).

| Item No. | Observation | Recommended Action Plan | Recommended Timeline |
|---|---|---|---|
| 12 | Absence of design documents. (RSB Building no. 04) | Building engineer is required to prepare design documents (including design report, load plan and material test reports) in compliance with section 1.9.1 (part-6, BNBC). | 6-weeks |
| 13 | Absence of design documents. (RSB Building no. 04) | Carry out suggested remedial works. | 6-months |

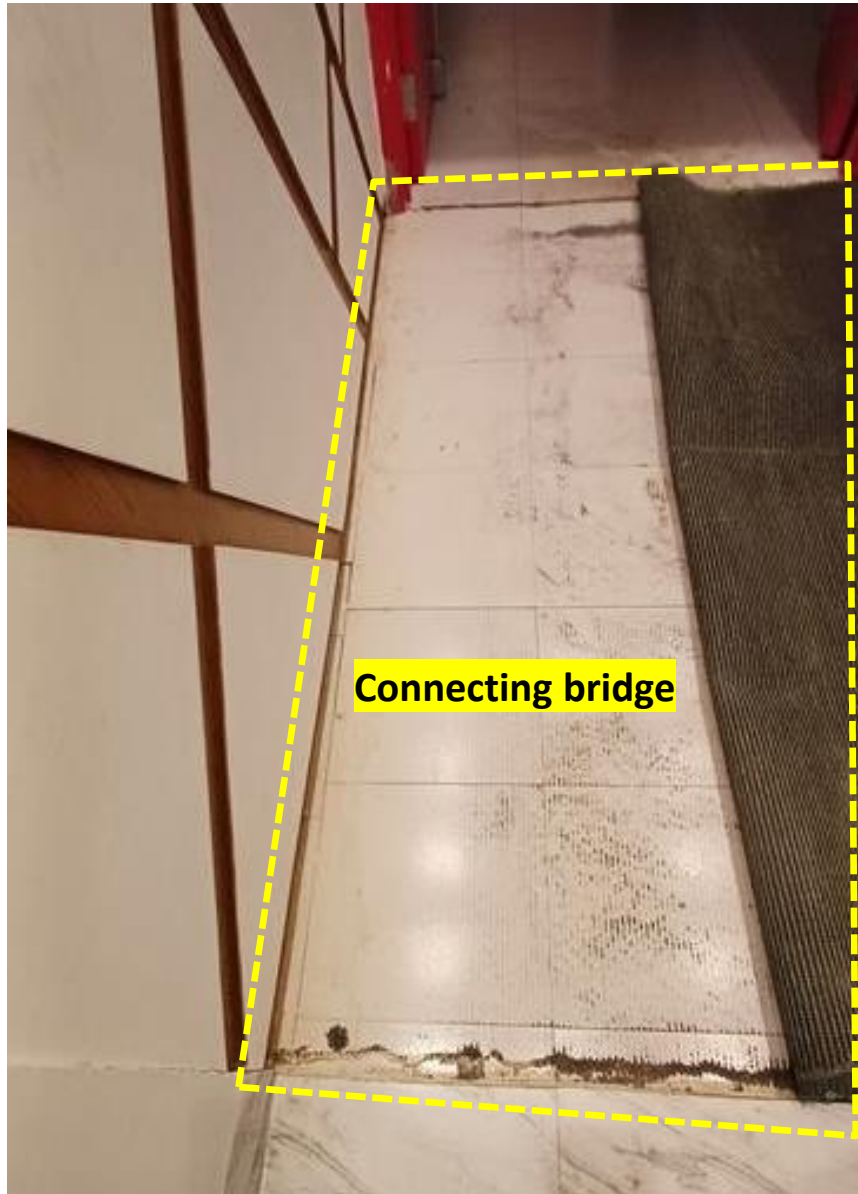
During inspection, connecting bridge found between building-03 and building-04 which is not shown in the as-built drawings. The bridge is connected with building-04. Building engineer is required to update the design documents as per actual site condition and submit it to RSC for further review.

| Item No. | Observation | Recommended Action Plan | Recommended Timeline |
|---|---|---|---|
| 14 | Missing information in as-built drawings. (RSB Building no. 04) | Building engineer is required to update the drawings as per actual site condition and submit it to RSC for further review. | 6-weeks |
| 15 | Missing information in as-built drawings. (RSB Building no. 04) | Carry out suggested remedial works. | 6-weeks |

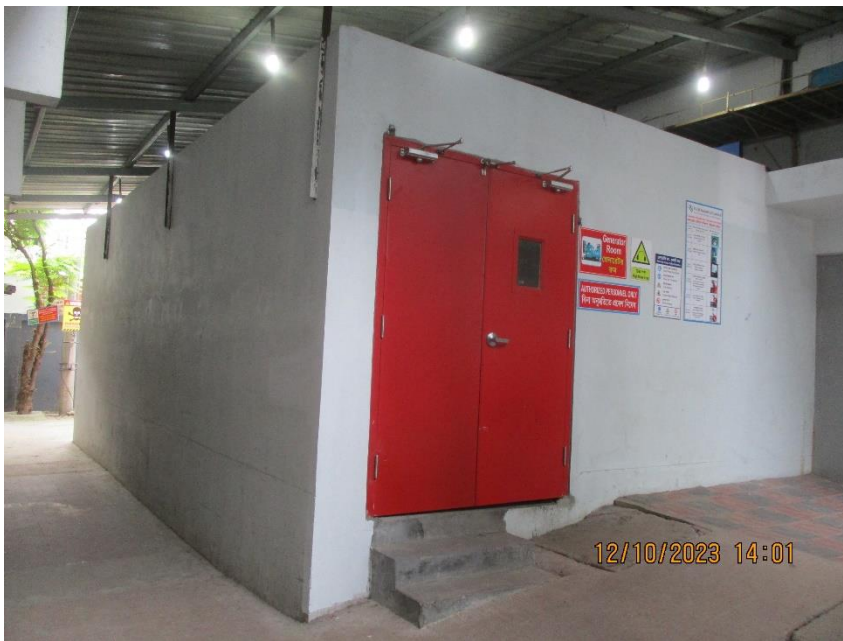
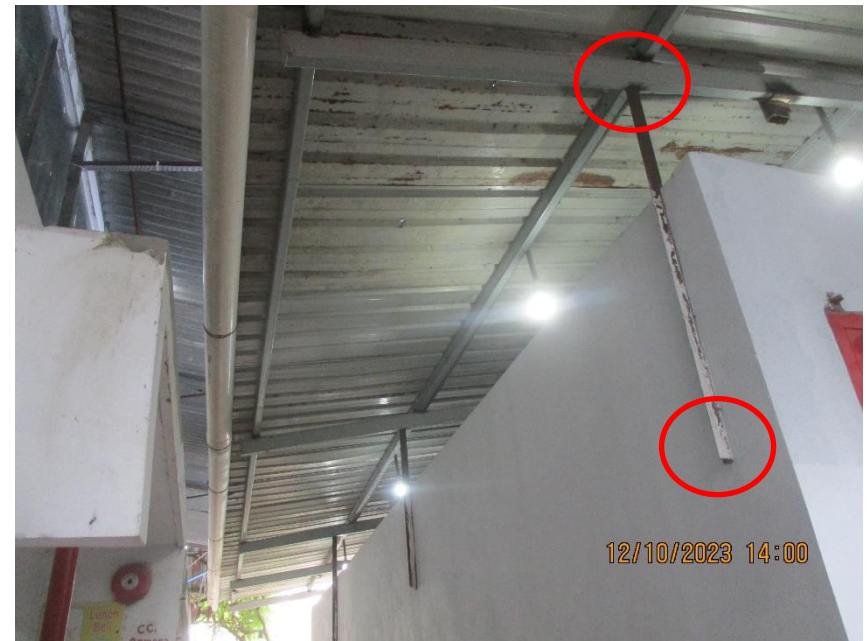
Generator Shed-02

**Apparently inadequate connection against uplift pressure**

Apparently inadequate connection against uplift pressure were observed at the lightweight roof of the single storied shed. The building engineer to check the connection adequacy of the lightweight roof against the uplift pressure of wind and suggest suitable remedial method. Otherwise, replace with an engineered shed.

Non-engineered connection

| Item No. | Observation | Recommended Action Plan | Recommended Timeline |
|---|---|---|---|
| 16 | Apparently inadequate connection against uplift pressure. (Generator Shed-02) | Building engineer is required to check the connection of the steel roof for the uplift pressure of wind. | 6-weeks |
| 17 | Apparently inadequate connection against uplift pressure. (Generator Shed-02) | Complete implementation of remedial works if required. Otherwise replace the sheds with an engineering one. | 6-months |

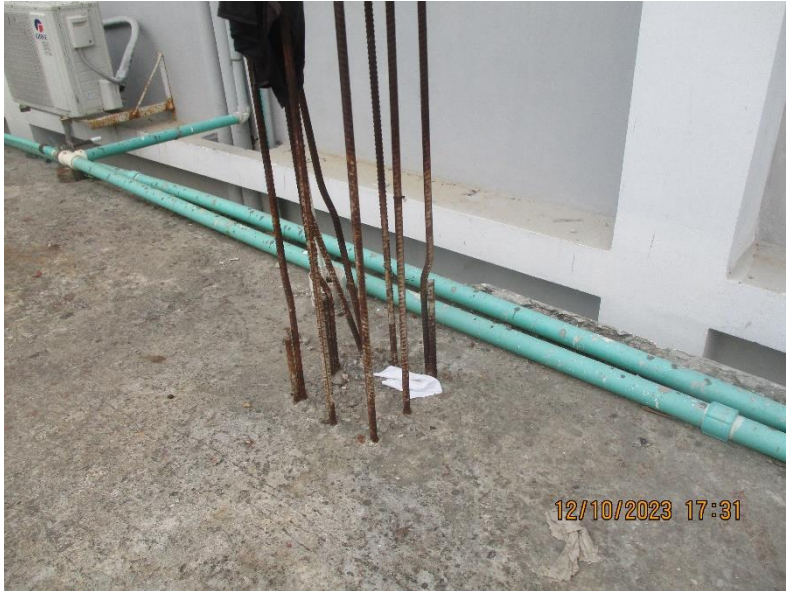
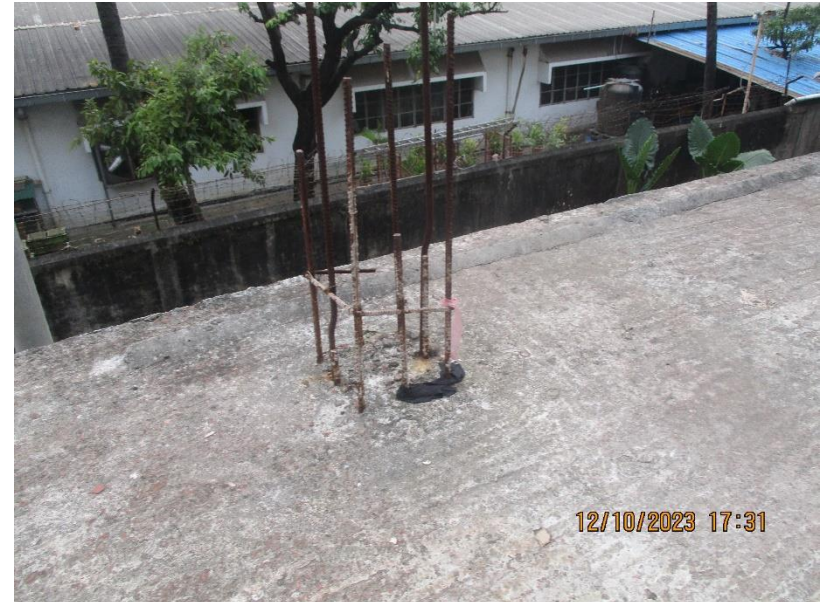
Exposed rebar on roof

Exposed rebar observed on roof which is prone to corrosion. The factory is required to provide anti-corrosive coating on the exposed rebar.

| Item No. | Observation | Recommended Action Plan | Recommended Timeline |
|---|---|---|---|
| 18 | Exposed rebar at roof. (Utility building-02) | The factory is required to provide anti-corrosive coating on the exposed rebar. | 6-months |

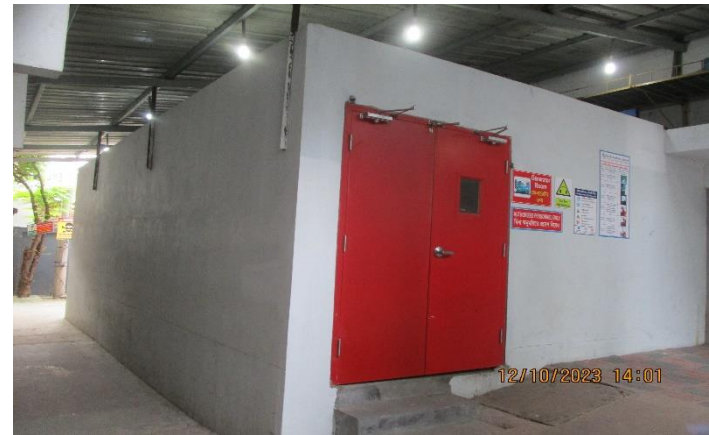
Generator Shed-02

The factory has provided a set of drawings which match partially with the as-built structures. The building engineer is required to survey the whole structure and prepare a full set of as-built drawings in compliance with section 1.9, part 6 of BNBC.

The factory has provided a set of drawings which did not match fully with the as-built structures. The building engineer is required to survey the whole structure and prepare a full set of as-built drawings in compliance with section 1.9, part 6 of BNBC.

| Item No. | Observation | Recommended Action Plan | Recommended Timeline |
|---|---|---|---|
| 19 | Inconsistencies in as built drawings. (Generator Shed-02, Utility building-02, Fire Hydrant Pump Room, Chemical Room, Security Room-02) | Building engineer is required to prepare a full set of structural drawings in compliance with section 1.9.1.2, part-6 of BNBC and submit it to RSC for review. | 6-weeks |
