# Concorde Garments Ltd (Extension)

## Structural Inspection Report

## Building Information

1. **Utility Building:** 4 storied (B+G+3) RC structure.
2. **Warehouse:** Single storied prefabricated steel shed.

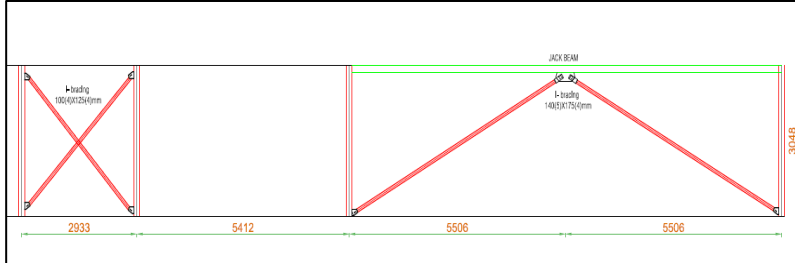
### Observation-1: Discrepancies (RC column instead of steel column) in as-built drawing. (Utility Building)

As per drawing, vertical steel bracing connected to steel column

**Description:** As per available as-built drawing, vertical steel bracing was shown connected to steel column. However, vertical steel bracing was observed connected to steel column in onsite condition. Building engineer is required to update as-built drawing incorporating all structural details of this Building considering existing condition.

| Observation | Action Plan | Timeline |
|---|---|---|
| Discrepancies (RC column instead of steel column) in as-built drawing. (Utility Building) | Building engineer is required to update as-built drawing, structural analysis & design report as per on-site condition. | within 6 weeks |

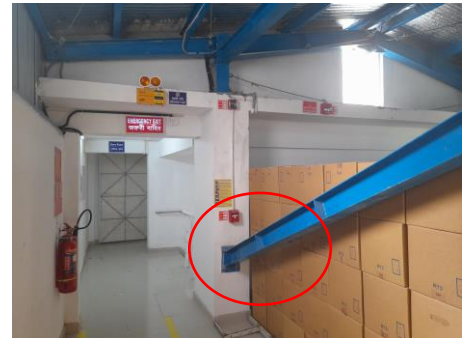
Vertical steel bracing connected to RC column.

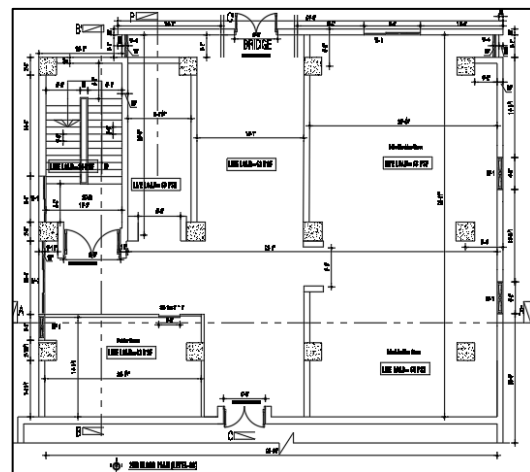
Prepared load plan on 3<sup>rd</sup> floor

### Observation-2: Storage live load does not comply BNBC requirement. (Utility Building)

**Description:** Live load on storage area of 2<sup>nd</sup> floor is considered as 3 kPa in prepared load plan. As per BNBC-2006, live load for light storage areas is required to be considered minimum 6 kPa. Therefore, the factory engineer is required to revise the load plan as per BNBC requirement and check the design accordingly.

| Observation | Action Plan | Timeline |
|---|---|---|
| Storage live load does not comply BNBC requirement. (Utility Building) | Building engineer is required to revise the load plan as per BNBC requirement and check the design accordingly. | within 6 weeks |
| | Implement remediation work if required. | within 6 months |

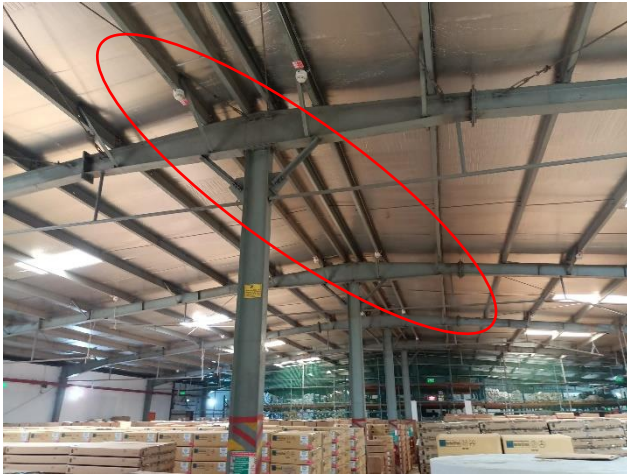
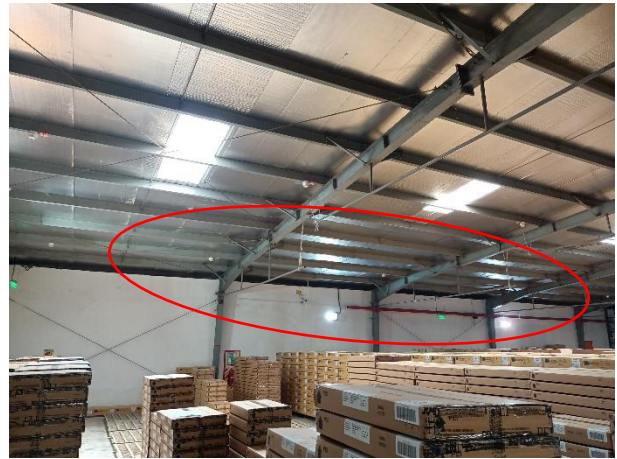
**Observation-3:** Incomplete Lateral Stability System. (Warehouse Shed)

Missing compression strut along long direction

**Description:** Portal frame is provided along short direction. Wall and roof bracing was provided along long direction without compression strut along long direction. Therefore, lateral stability system along long direction is incomplete. The building engineer is required to check the lateral stability system of the structure and suggest necessary alternatives.

| Observation | Action Plan | Timeline |
|---|---|---|
| Incomplete Lateral Stability System. (Warehouse Shed) | The building engineer is required to check the lateral stability system of the structure and prepare design documents with necessary remedial action. | within 6 weeks |
| | Implement remediation work. | within 6 months |
