# INITIAL FIRE SAFETY INSPECTION REPORT

**Pioneer Knitwears (BD) Ltd.(Section-2)(Extension)**

**RSC ID: 24599**

**Date: 23-Nov-2023**

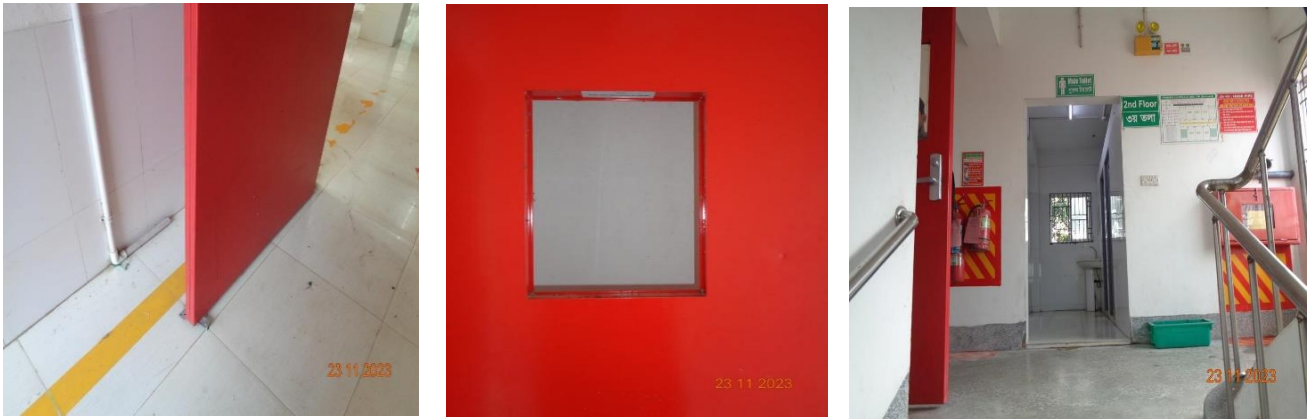
| Sl No. | Category | Findings | Required Action | Remediation Time Frame |
|---|---|---|---|---|
| F-1 | Fire Rated Construction | <p>The exit stairs are not separated from work areas, other spaces on each floor by fire-rated construction due to the following reasons:</p> <ul style="list-style-type: none"> <li>i. Fire doors were not functional properly.</li> <li>ii. Fire doors were found opened with external objects.</li> <li>iii. Vision panel of fire doors were not installed.</li> <li>iv. Unprotected opening was found due to toilet at the stairs.</li> </ul> <p><b>Location:</b> B-6 (Dining Building-2)</p> | <p>Provide minimum 2-hr fire rated construction for buildings 4 storied or more and 1-hr for up to 3 storied. Seal all unprotected openings to separate the exit stairs from work areas and other spaces on all floor levels by 90 minutes for 2 hr. construction and 60 minutes for 1-hr construction. Ensure that the fire rated doors are self-closing and positive latching and that they are provided with fire exit (panic) hardware where serving production floors. If fire rated doors are required to be held open for functional reasons, provide automatic closing devices tied to the fire alarm system.</p> | Within 3 months |
| <p>The first photograph shows a fire door with a significant gap at the bottom, allowing smoke or fire to pass through. The second photograph shows a fire door with a vision panel that is not properly installed or sealed. The third photograph shows a fire door with a fire extinguisher mounted on it, which is not a fire-rated door.</p> | | | | |

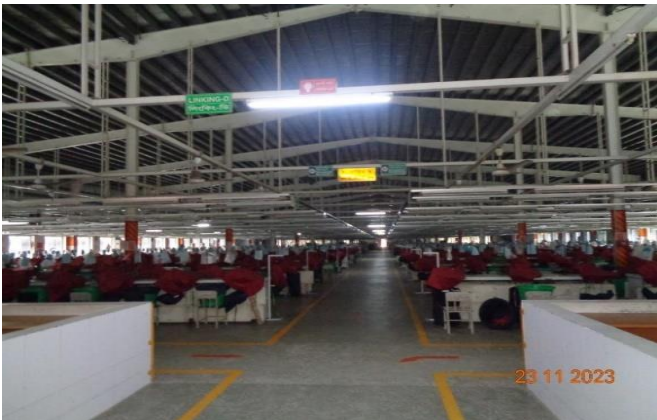
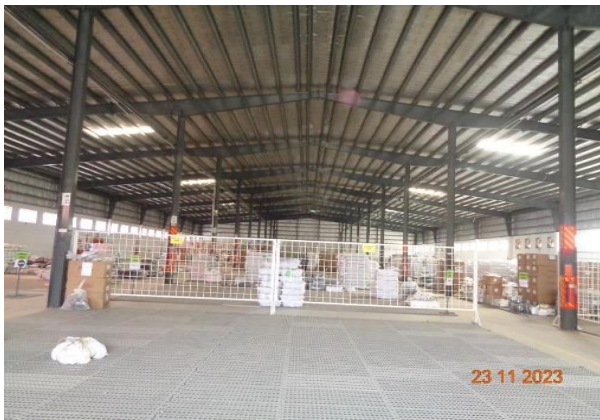
| F-2 | Fire Rated Construction | <p>The main structural elements of the building are constructed by steel which is non-rated and were found in exposed condition without any fire protection. (Interim Structure).</p> <p><b>Located:</b> Shed-5,12,13 and 14.</p> | <p>Interim building shall be type-1 or type-2 construction as per Table 3.2.4 of BNBC-2006. Provide required fire rating on the structural elements by following Section 4.4 and Table 4.4.1 of the RSC Technical Guidelines Standard or Table 3.3.1 and Table 4.1.1 from BNBC Part 4. Consult a qualified fire protection engineer to design the rated construction barriers in between two floors and in structural members.</p> | Within 6 months |

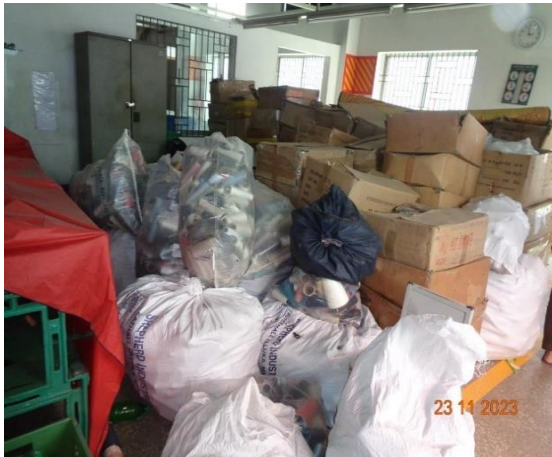
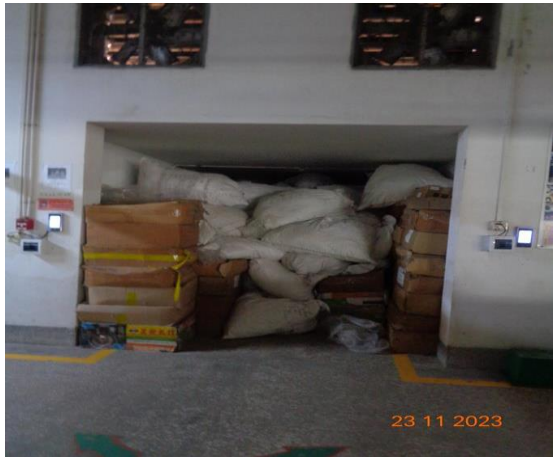
| F-3 | Fire Rated Construction | <p>Areas used for in-process storage of combustible materials are open to the surrounding occupancy.</p> <p><b>Location:</b> Shed-5(Linking Floor C&amp;D).</p> | <p>Provide defined storage areas and limit the storage arrangement as follows: -</p> <ol style="list-style-type: none"> <li>1. General Condition: Maximum height of 2.4m and maximum area of 23m<sup>2</sup>. Separate areas of unenclosed combustible storage by a minimum clear distance of 3m.</li> <li>2. If sprinkler protected: maximum height of 3.66m and maximum area of 93m<sup>2</sup>. Separate areas of unenclosed combustible storage by a minimum clear distance of 3m.</li> </ol> <p>or</p> <ol style="list-style-type: none"> <li>3. Enclose the storage area from the surrounding occupancy with a minimum 1-hour construction.</li> </ol> | Within 3 months |

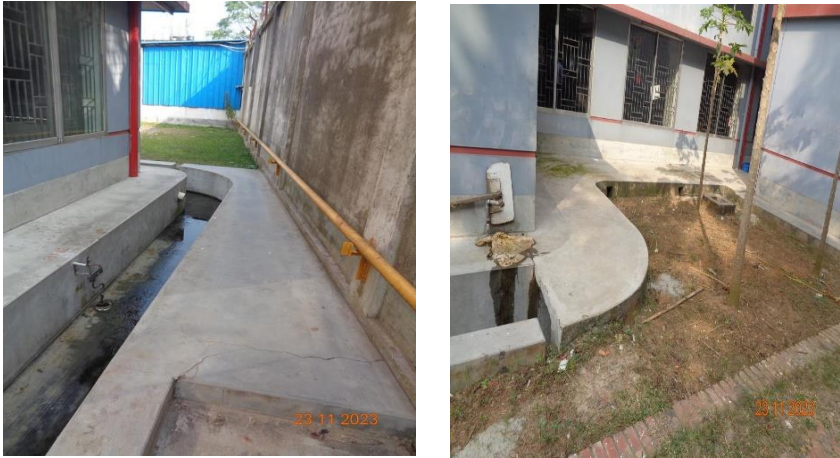
| F-4 | Means of egress | Exit path from Shed-5(Linking Floor C&D) & B-6(Dinning Building-2) is not even and smooth. | Level the exit discharge path to ensure smooth and safe evacuation. | Within 1 month |

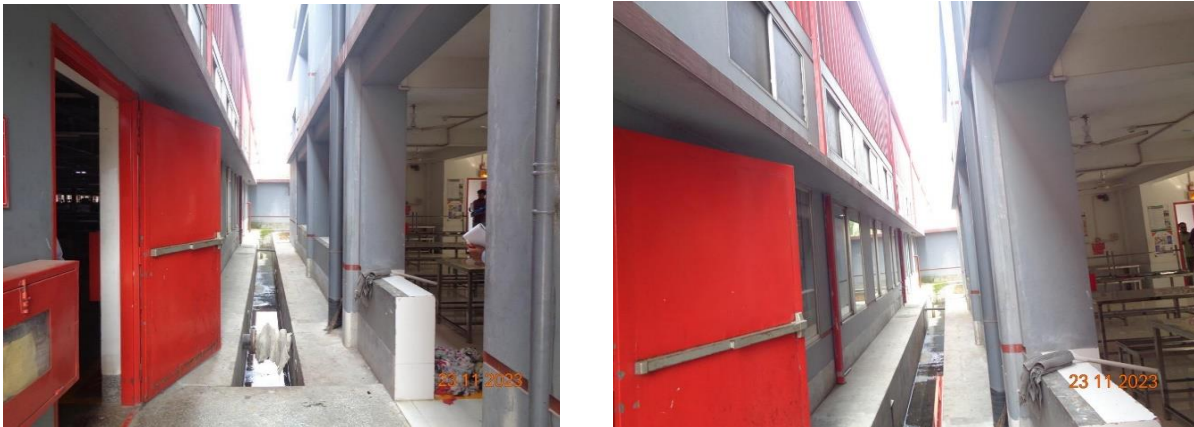
| F-5 | Means of egress | The S/W exit discharge path between Shed-5(Linking Floor C&D) & B-6(Dinning Building-2) is less than 10 ft wide and is not seperated from the building interior due to non rated openings & penetrations. | Seal all penetrations and openings to the interior of the building along the discharge path, up to a height of 10 ft., to provide a minimum 1-hr fire seperation. Alternatively, provide a second remote discharge path to the public way (only include this if feasible). | Within 3 months |

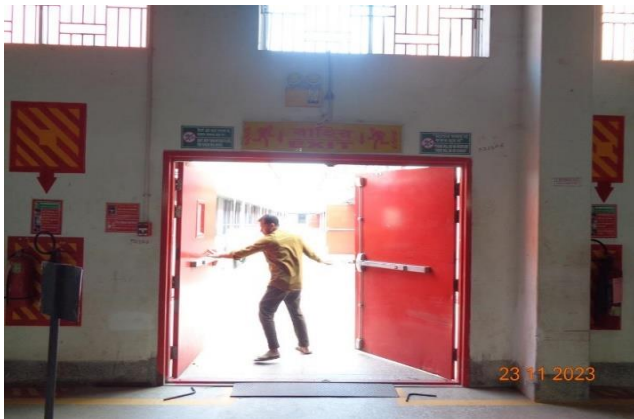
| F-6 | Means of Egress | <p>Headroom on main exits were found less than 6 ft 8 inch.</p> <p><b>Location:</b> Shed- 14 (Yarn Godown).</p> | <p>Headroom on means of egress shall not be less than 6 ft 8 inch.</p> | <p>Within 1 month</p> |

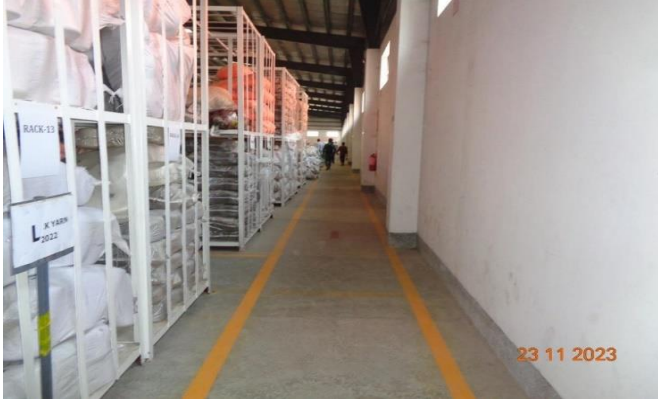
| F-7 | Means of Egress | Travel distance of egress exceeds limit on the Shed- 14 (Yarn Godown). | Reconfigure the egress arrangement or provide an additional exit so that the travel distance for group H occupancies shall not exceed 30m (100ft). | Within 1 month |

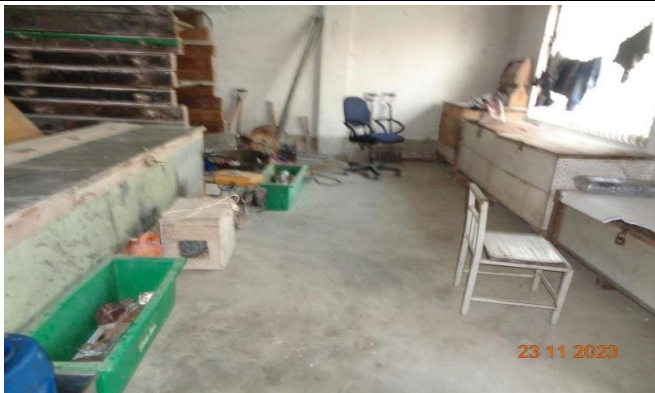
| F-8 | Means of Egress | <p>Aisles marking has not been provided on the floor properly.</p> <p><b>Location:</b> Shed- 13 (Civil Godown)</p> | Provide minimum aisle widths of 36-in and mark properly. | Within 1 months |

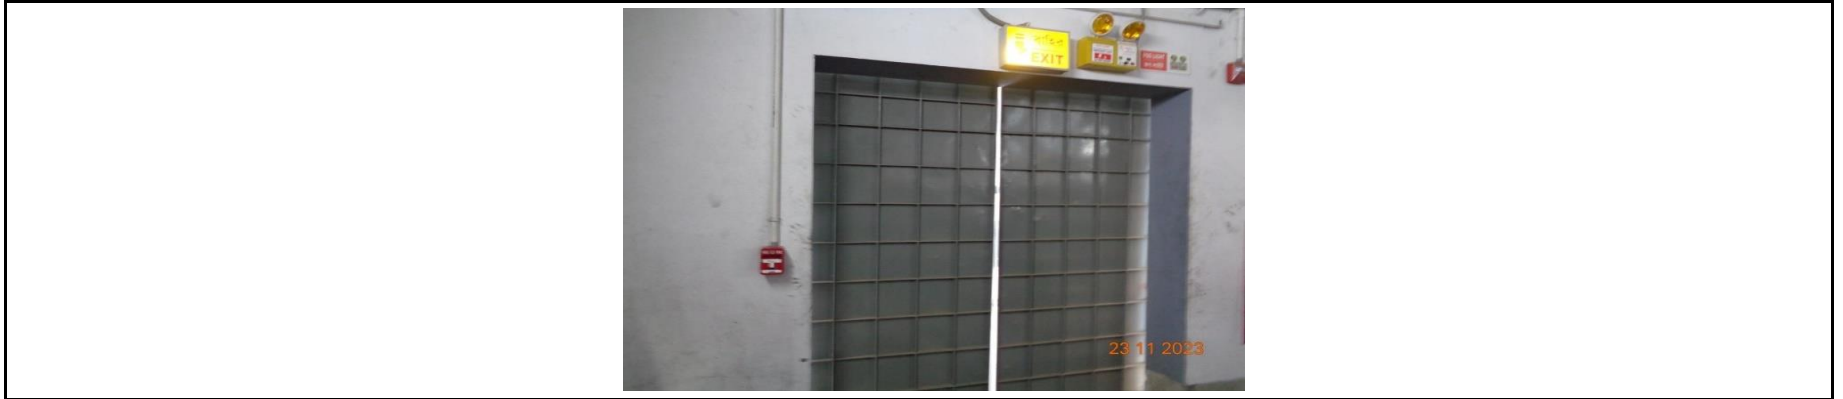
| F-10 | Means of Egress | <p>Sliding doors are provided at building exits.</p> <p><b>Location:</b> Shed- 16 (Diesel Generator):</p> | Replace all collapsible and sliding doors along the means of egress with side-hinged, swinging egress doors. | Within 1 month |

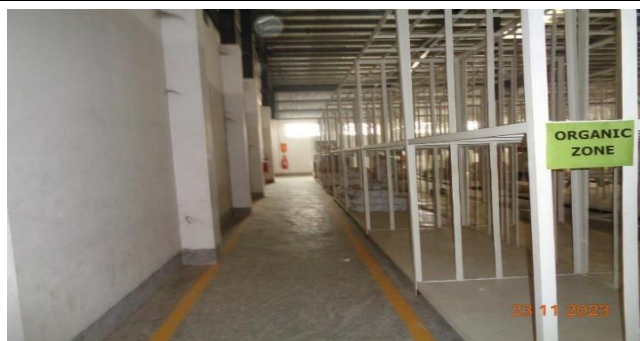
| F-11 | Egress Lighting | <p>The directional signs are not provided where there is a change in direction and where the continuation of the egress path is not obvious.</p> <p>Location: Shed-14</p> | <p>Install illuminated directional signs shall be provided where there is a change in the direction for the path of travel and the direction to an exit is not obvious.</p> | Within 1 month |
