# Trust Knitwear Industries Ltd.(Extended)

Bhabanipur, Gazipur Sadar, Gazipur.

4 December 2023

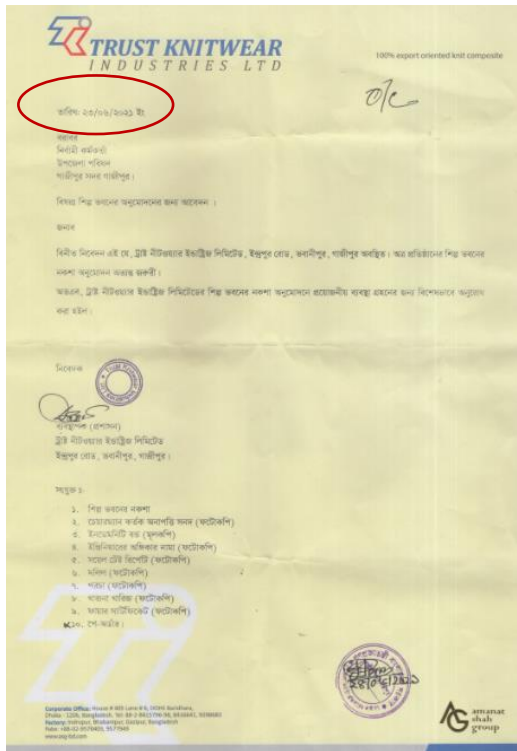
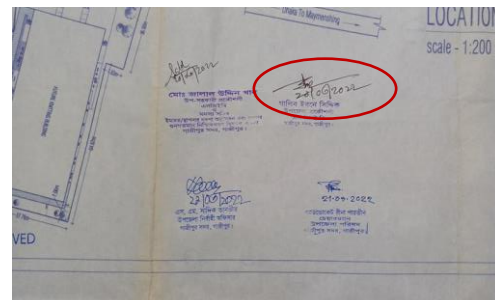
**Observation-1:** Inconsistencies in the design report.

**Description:** The factory got approval from LGED (local authority) on March 2022, but the analysis was done as per BNBC 2006. Building engineer is required to update the design documents as per actual site conditions complying with BNBC 2020.

Also, no information of the foundation was found provided in the as-built drawings. Building engineer is required to incorporate foundation information with adequacy as part of Detailed Engineering Assessment (DEA).

| Observation | Action Plan | Timeline |
|---|---|---|
| Inconsistencies in the design report. | Building engineer is required to update the design documents as per actual site conditions complying with BNBC 2020. | within 6 weeks |
| | Implement remediation work if required. | within 6 months |
| Inconsistencies in the design report. | Building engineer is required to incorporate foundation information with adequacy as part of Detailed Engineering Assessment (DEA). | within 6 weeks |

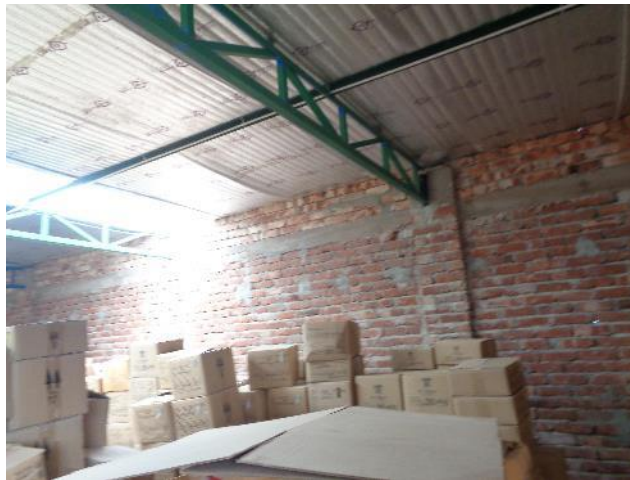
**Observation-2:** Apparently inadequate connection (Leftover storage shed)

**Description:** Roof trusses were found inserted into the brick wall. The building engineer is required to check the connection adequacy of the steel members.

| Observation | Action Plan | Timeline |
|---|---|---|
| Apparently inadequate connection | The building engineer is required to check the connection adequacy of the steel members. | within 6 weeks |
| | Implement remediation work if required. | within 6 months |
