# Northern Fashion (Extension)

Plot 16-18 Dakkin Panishail, EPZ kaliakur road, Kashimpur, Gazipur, Dhaka  
(23.991820, 90.257763)

27 November 2023

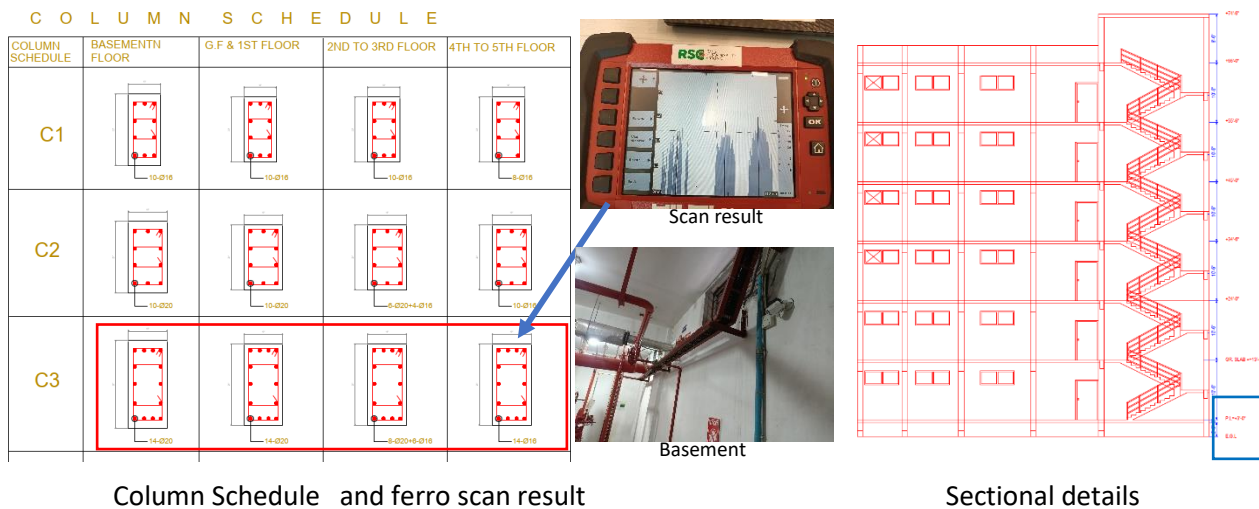
**Observation-01:** Mismatch in as-built drawings. (Building-D: New Warehouse)

**Description:** During inspection, number of rebar at C3 type column not matched. 3 nos of rebars were found at short face instead of 4 nos. Moreover, in the sectional elevation basement floor has not been shown. Building engineer is required to update as-built drawing incorporating all the mismatches.

| Observation | Action Plan | Timeline |
|---|---|---|
| Mismatch in as-built drawings. (Building-D: New Warehouse) | Building engineer is required to update as-built drawing incorporating all mismatches. | within 6 weeks |

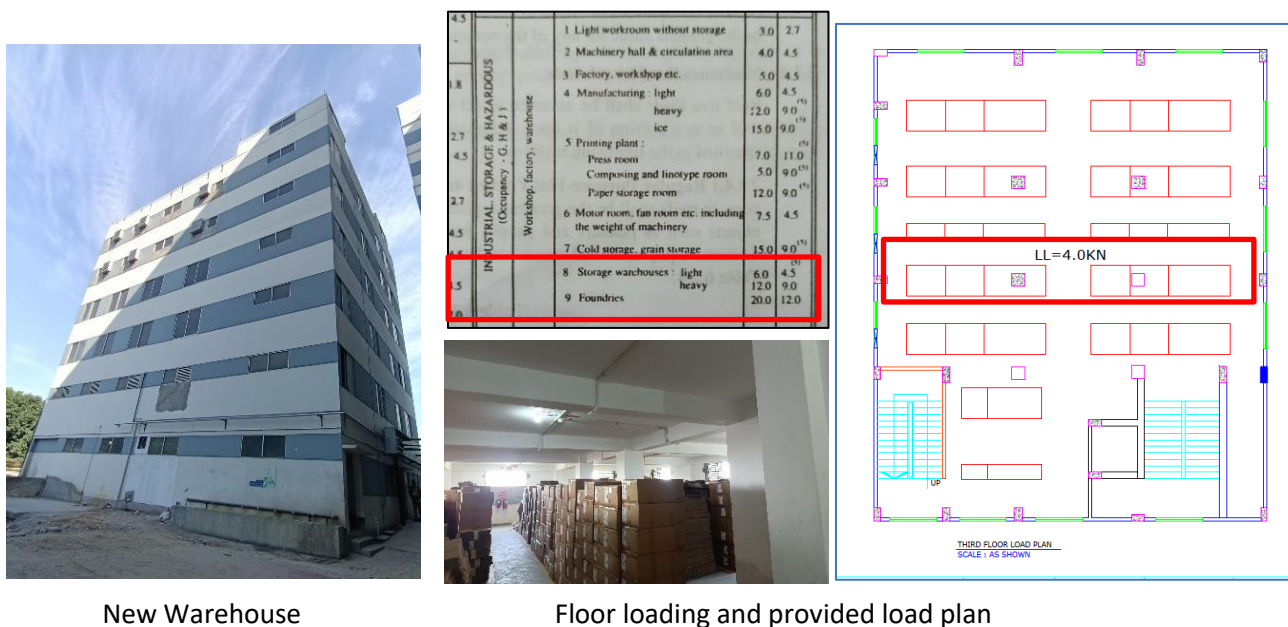
**Observation-02:** Prepared load plan does not comply with BNBC and absence of design documents.  
(Building-D: New Warehouse)

**Description:** The building is being used for a warehouse/store. As per BNBC, the minimum floor live load for light storage is 6 kN/m<sup>2</sup> (125 psf). But as per the load plan, the allowable live load is 4 kN/m<sup>2</sup>. In addition, the load plan has been prepared without having any structural analysis and design. The building engineer is required to prepare design documents based on in-situ material test result.

| Observation | Action Plan | Timeline |
|---|---|---|
| Prepared load plan does not comply with BNBC and absence of design documents. (Building-D: New Warehouse) | Building is required to prepare a set of design report in compliance with BNBC. | within 6 weeks |
| Prepared load plan does not comply with BNBC and absence of design documents. (Building-D: New Warehouse) | Verify in-situ material strength by taking core (min. 4 number 100 mm diameter) from lower tier columns. | within 6 weeks |
| Prepared load plan does not comply with BNBC and absence of design documents. (Building-D: New Warehouse) | The building engineer is required to revise the floor live load plan following BNBC storage live load requirement. | within 6 weeks |
| Prepared load plan does not comply with BNBC and absence of design documents. (Building-D: New Warehouse) | Implement remediation work if required. | within 6 months |
| Prepared load plan does not comply with BNBC and absence of design documents. (Building-D: New Warehouse) | Implement floor load plan. | within 6 months |

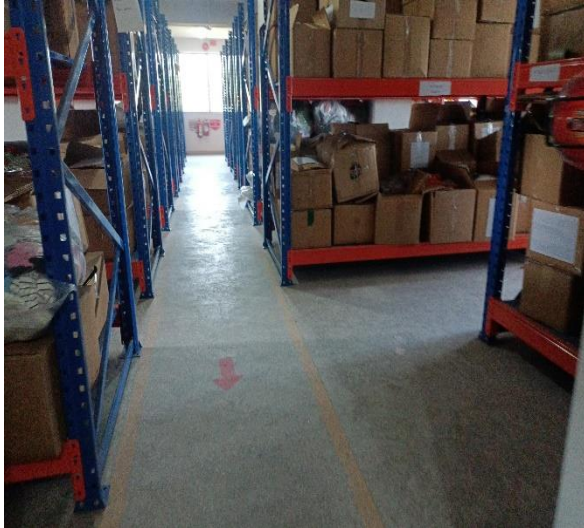
Racks without anchorage

**Description:** Some racks on floors are not anchored or braced to resist lateral (earthquake) forces. The factory is required to anchor/brace all non-structural elements adequately to resist earthquake forces.

| Observation | Action Plan | Timeline |
|---|---|---|
| Non-structural elements not anchored or braced. (Building-D: New Warehouse) | The factory is required to anchor/brace all non-structural elements adequately to resist earthquake forces. | within 6 weeks |

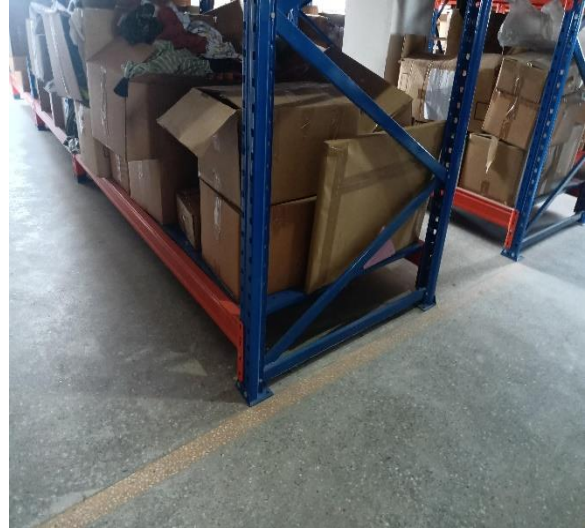
Racks without anchorage
