# Raidha Collection Ltd (Extension)

Zamirdia, Valuka, Mymensingh

2 November 2023

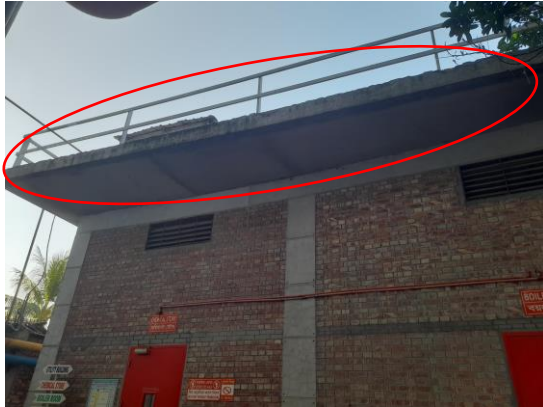
Typical framing system

### Observation-1: Lack of information in as-built drawing. (Utility Building)

**Description:** During inspection, extended cantilever on roof slab was observed in south direction of Utility Building. However, structural detail of this cantilever slab was not available in slab details of structural drawing. The building engineer is required to update as-built drawing incorporating all structural details of this Building.

| Observation | Action Plan | Timeline |
|---|---|---|
| Lack of information in as-built drawing. (Utility Building) | The building engineer is required to update as-built drawing incorporating all structural details of this building. | within 6 weeks |

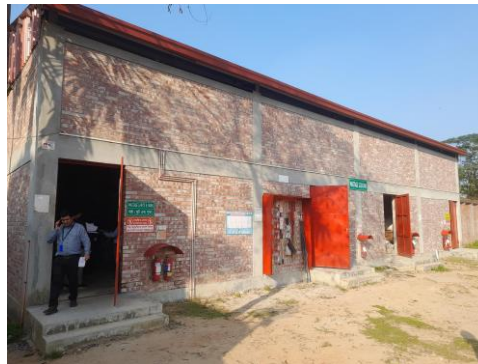
Wastage Godown

### Observation-2: Absence of design documents. (Wastage Godown)

**Description:** As per BNBC, every building or structure designed shall have its design documents prepared in accordance with the provision of Section 1.9.1. The design document shall include a design report, and a set of structural drawings, which shall be prepared in compliance with section 1.9.1.1 and section 1.9.1.2 as per BNBC. At the time of inspection, a design report was not available which is required to be prepared in compliance with section 1.9.1.1 (part-6, BNBC).

| Observation | Action Plan | Timeline |
|---|---|---|
| Absence of design documents. (Wastage Godown) | The building is required to prepare a set of design report in compliance with BNBC. | within 6 weeks |
| Absence of design documents. (Wastage Godown) | Implement remediation work if required. | within 6 months |

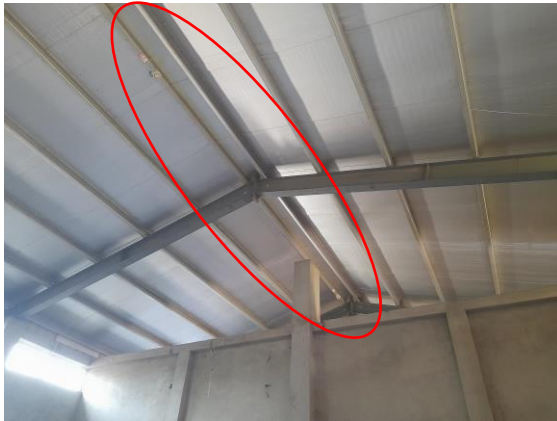
**Observation-3:** Lack of lateral stability of steel rafter. (Wastage Godown)

Missing compression strut

**Description:** Portal frame is provided along short direction. Load transfer media (compression strut) and resisting system (bracing) were not available along long direction. Therefore, lateral stability of steel rafter along long direction is questionable. The building engineer is required to check the lateral stability of the structure.

| Observation | Action Plan | Timeline |
|---|---|---|
| Lack of Lateral Stability of Steel Rafter. (Wastage Godown) | The building engineer is required to check the lateral stability of the steel rafter. | within 6 weeks |
| Lack of Lateral Stability of Steel Rafter. (Wastage Godown) | Implement remediation work if required. | within 6 months |

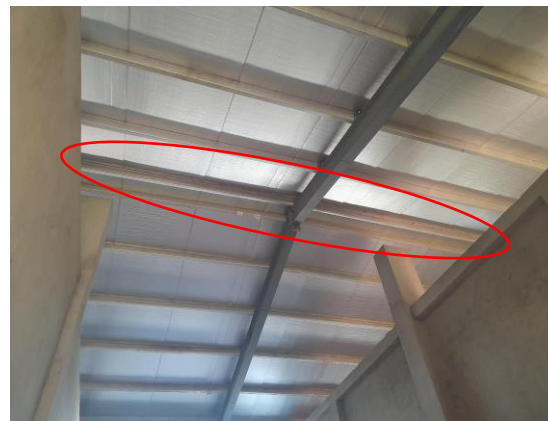
No vertical or Horizontal bracing

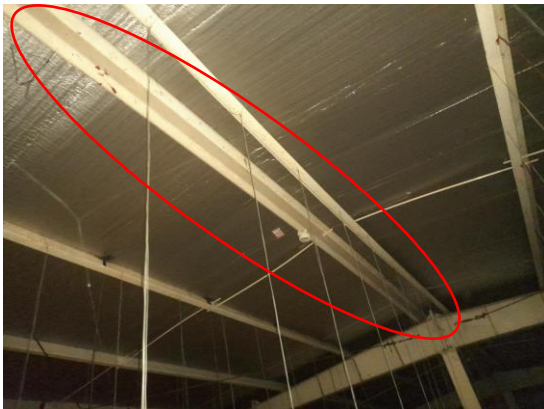
**Observation-4:** Lack of Lateral Stability. (Stoll Shed)

Missing compression strut

**Description:** Portal frame is provided along short direction. Load transfer media (compression strut) was not available along long direction. Therefore, lateral stability system along long direction is incomplete. The building engineer is required to check the lateral stability of the structure.

| Observation | Action Plan | Timeline |
|---|---|---|
| Lack of Lateral Stability. (Stoll Shed) | Building engineer is required to check the lateral stability of the shed. | within 6 weeks |
| Lack of Lateral Stability. (Stoll Shed) | Implement remediation work if required. | within 6 months |

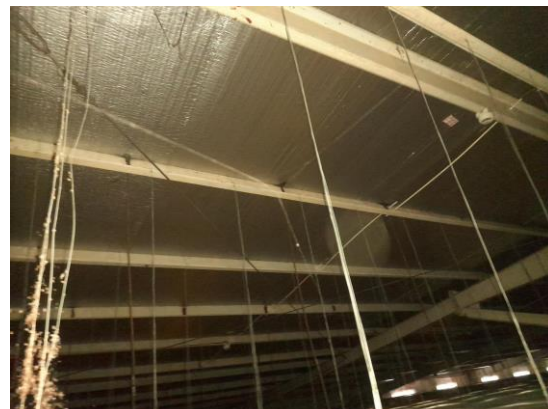
Cable bracing on roof

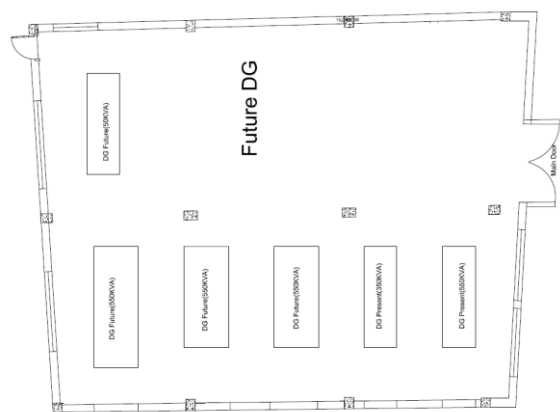
Diesel Generator Building

**Observation-5:** Lack of information in as-built drawing. (Diesel Generator Building)

**Description:** In architectural drawing, roof layout plan and details for existing chiller on roof was not available for Diesel Generator Building. Building engineer is required to update as-built drawing incorporating all structural details of this Building.

| Observation | Action Plan | Timeline |
|---|---|---|
| Lack of information in as-built drawing. (Diesel Generator Building) | Building engineer is required to update as-built drawing incorporating all structural details of this Building. | within 6 weeks |

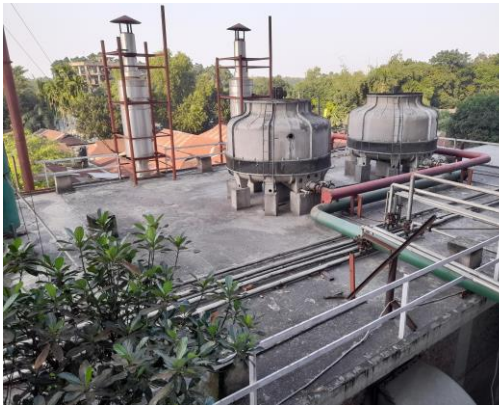
Roop top chiller

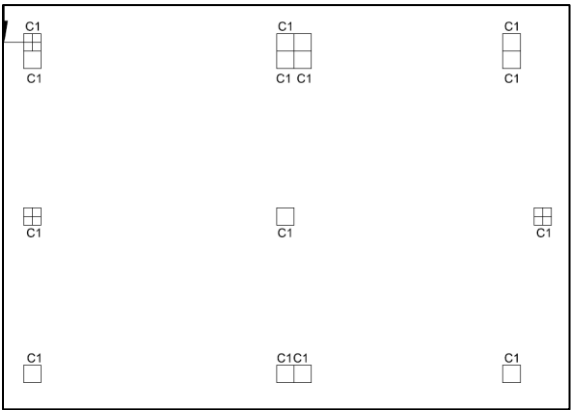
Column layout plan

**Observation-6:** Discrepancies in as-built drawing. (Air Compressor Room)

**Description:** As per the column schedule, the number of rebars of column C1 was shown as 6 nos. However, during the inspection, 4 number of rebar were confirmed by ferro scanning in the column. The building engineer is required to survey the whole structure and update the as-built drawing accordingly.

| Observation | Action Plan | Timeline |
|---|---|---|
| Discrepancies in as-built drawing. (Air Compressor Room) | The building engineer is required to update as-built drawing incorporating all structural details of this building. | within 6 weeks |
