Logos Apparels Ltd. – Unit 2 (Extension)

Telerchala, Mouchak, Kaliakoir, Gazipur

20 December 2023

2. Observations:

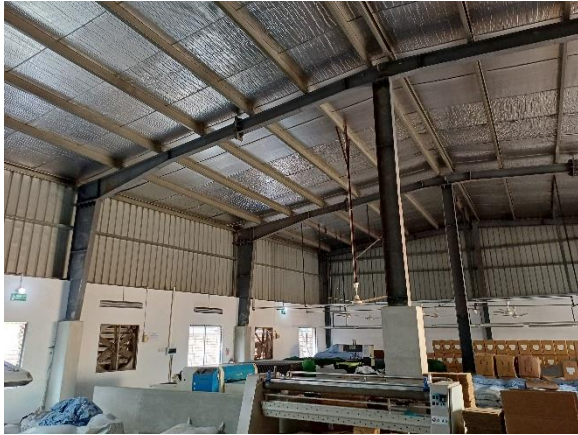
Observation 1: Lack of lateral stability. (Finishing Shed)

Missing wall bracing and roof bracing

Description: Lack of lateral stability system (no compression strut, roof & wall bracing) was observed in the structure. The building engineer is required to carry out Engineering Assessment (EA) to check the lateral stability of the structure and suggest proper remedial actions accordingly. Submit the EA documents to RSC for review.

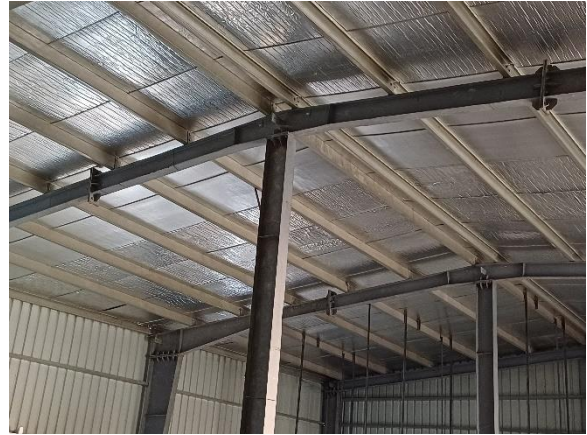
Missing compression strut

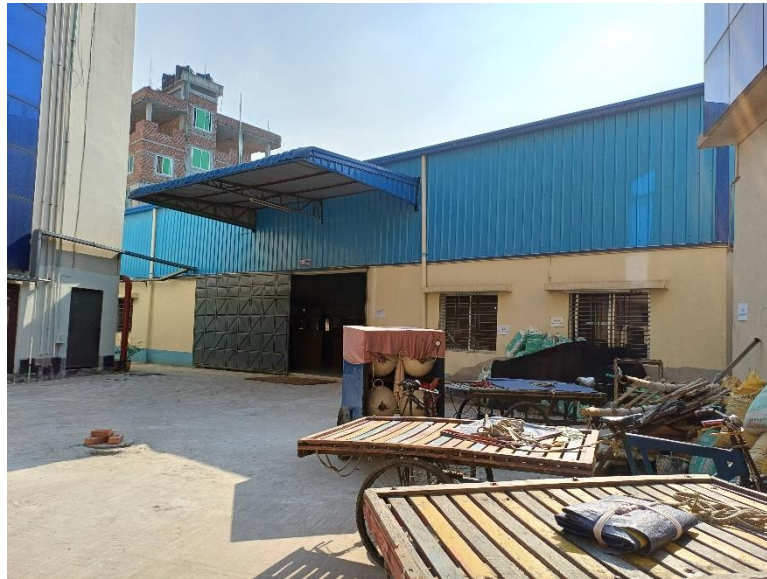
Observation 2: Lack of Geotechnical Investigation Report. (Finishing Shed)

Description: During the inspection, the geotechnical investigation report of the Finishing Shed was not found on-site. The building engineer is required to carry out soil tests according to BNBC requirements and prepare a design report based on the actual soil profile and geologic condition.

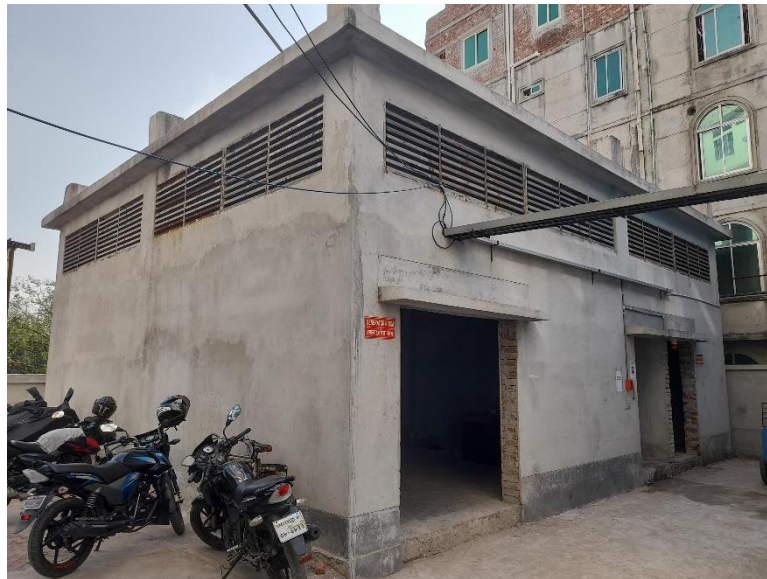
Utility Building

Observation 3: Lack of design documents. (Utility Building)

Description: As per BNBC, every building or structure designed shall have its design documents prepared following the provision of Section 1.9.1. The design document shall include a design report, a set of as-built drawings and load plans which shall be prepared in compliance with section 1.9.1.1 and section 1.9.1.2, part 6 of BNBC. During the inspection, the design report, as-built architectural drawing and load plan were not available on-site. The building engineer is required to prepare a design report and submit it to RSC for review.

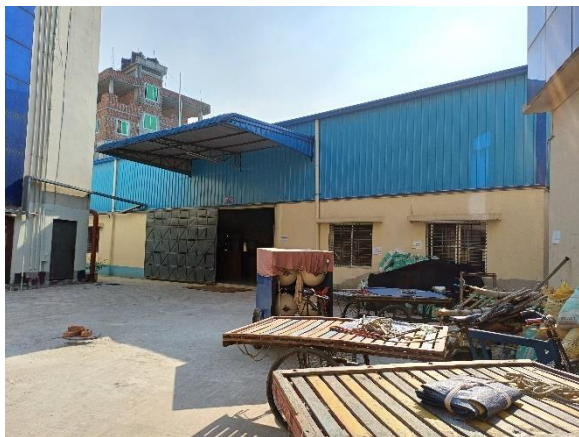
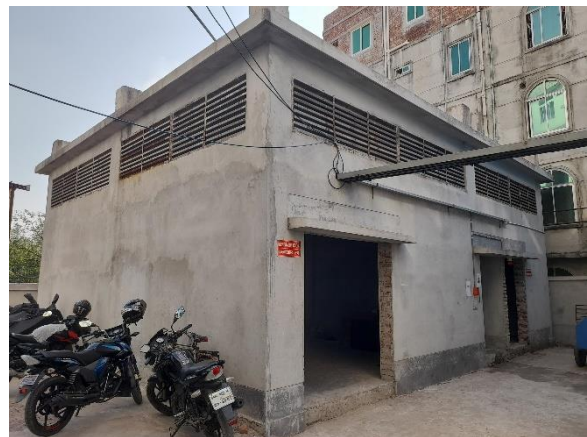
Observation-4: Lack of building permit from local authority. (Finishing Shed & Utility Building)

Description: During the inspection, building permit from the local authority for the Finishing Shed and Utility Building was not found on-site. The factory is required to collect building permits from government-approved local authorities for these structures.
