# Reedisha Knitex Ltd (Extension)

Dhanua, Nayanpor, Sreepur, Gazipur

5 December 2023

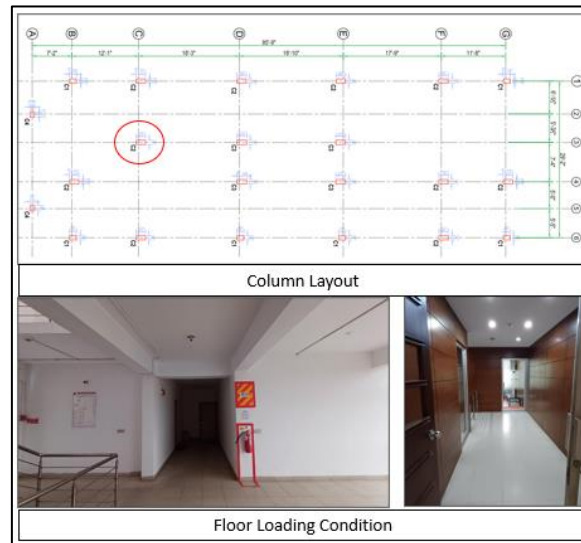
**Observation-1:** Stress in column exceeds normal design limit. (Old Admin Building)

**Description:** The cursory calculation indicates that column stress exceeds the normal design limit considering a typical floor live load of 3kPa, roof live load of 1.5 kPa, and minimum concrete strength based on aggregate type. The building engineer is required to review the design, loads, and column stresses for the marked columns based on in-situ material strength.

| Observation | Action Plan | Timeline |
|---|---|---|
| Stress in column exceeds normal design limit. (Old Admin Building) | Verify in-situ material strength. | within 6 weeks |
| Stress in column exceeds normal design limit. (Old Admin Building) | Building engineer is required to review the design load. | within 6 weeks |
| Stress in column exceeds normal design limit. (Old Admin Building) | Produce and actively manage a loading plan for all floor plates within the factory, considering floor and column capacity. | within 6 weeks |
| Stress in column exceeds normal design limit. (Old Admin Building) | Carry out the suggested remedial works if required. | within 6 months |

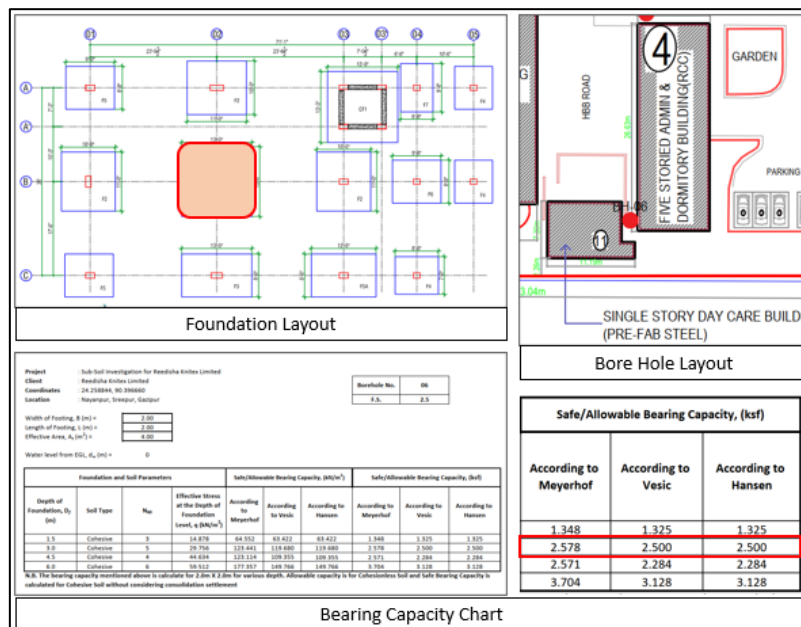
**Observation-2:** Stress in foundation exceeds normal design limit (New Admin Building)

**Description:** Cursors calculation indicates the highlighted foundation is inadequate for bearing. The loading is considered 3kPa for typical floor and allowable bearing capacity of soil is **1.25 tsf (FS: 2.5)** at 2.4 m depth. Building engineer is required to verify in-situ material strength and review the design load and foundation stresses.

| Observation | Action Plan | Timeline |
|---|---|---|
| Stress in foundation exceeds normal design limit (New Admin Building) | Verify in-situ material strength. | within 6 weeks |
| Stress in foundation exceeds normal design limit (New Admin Building) | Building engineer is required to review the design load and foundations stresses. | within 6 weeks |
| Stress in foundation exceeds normal design limit (New Admin Building) | Produce and actively manage a loading plan for all floor plates within the factory, considering floor, column, and foundation capacity. | within 6 weeks |
| Stress in foundation exceeds normal design limit (New Admin Building) | Carry out the suggested remedial works if required. | within 6 months |

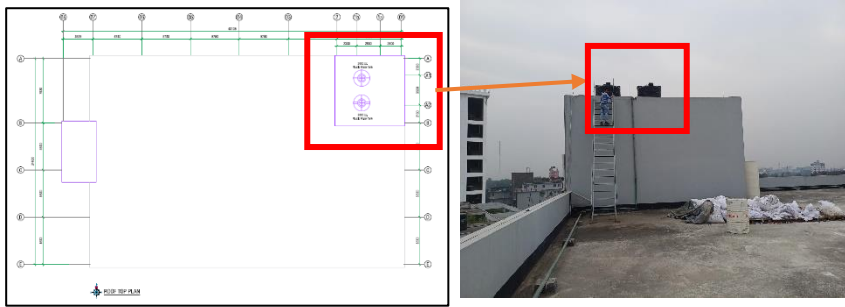
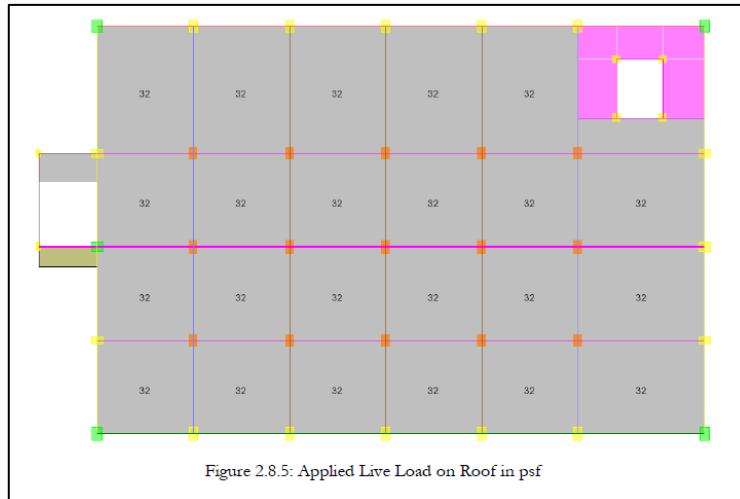
Figure 2.8.5: Applied Live Load on Roof in psf

**Observation-3:** Missing water tank load on FEM model (Printing Building).

**Description:** Two plastic water tanks (capacity of 2000L) were observed on the stair roof. In FEM model water tank load has not been applied on stair roof. Building engineer is required to apply water tank load on stair roof in the FEM model and incorporate the results in the design report.

| Observation | Action Plan | Timeline |
|---|---|---|
| Missing water tank load on FEM model (Printing Building). | Building engineer is required to apply water tank load on stair roof in the FEM model and incorporate the results in the design report. | within 6 weeks |
| Missing water tank load on FEM model (Printing Building). | Carry out remediation work if required. | within 6 months |

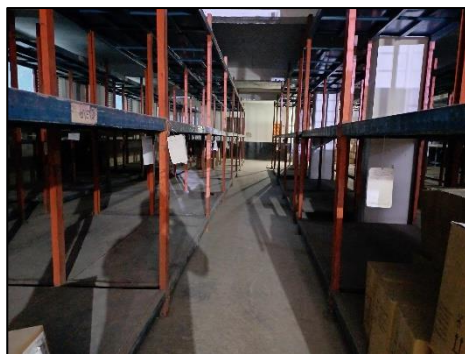
Printing Building storage rack

**Observation-4:** Storage rack without anchorage (Printing Building & General Store Shed ).

**Description:** Racks on different floors are not adequately anchored or braced to resist lateral (earthquake) forces. Building engineer is required to adequately anchor and brace all non-structural elements to resist earthquake forces to comply with the BNBC.

| Observation | Action Plan | Timeline |
|---|---|---|
| Storage rack without anchorage (Printing Building & General Store Shed) | Building engineer is required to adequately anchor and brace all non-structural elements to resist earthquake forces to comply with the BNBC. | within 6 months |

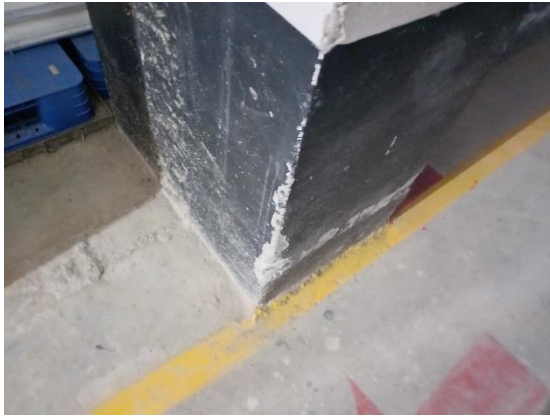
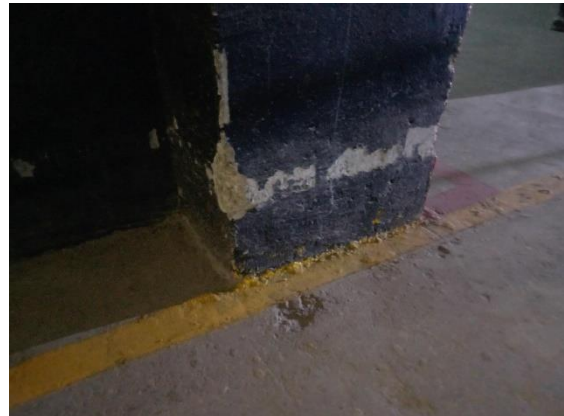
**Observation-5:** Trolley impact on column (Printing Building)

**Description:** Column on several floors has been affected by trolley impact. Factory is required to provide adequate barrier to prevent trolley impact.

| Observation | Action Plan | Timeline |
|---|---|---|
| Trolley impact on column (Printing Building) | Factory is required to provide adequate barrier to prevent trolley impact. | within 6 months |

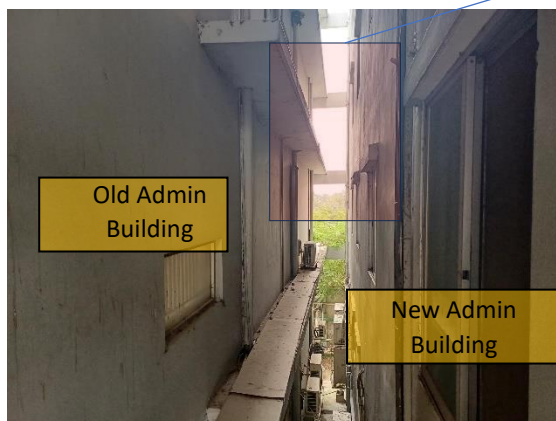
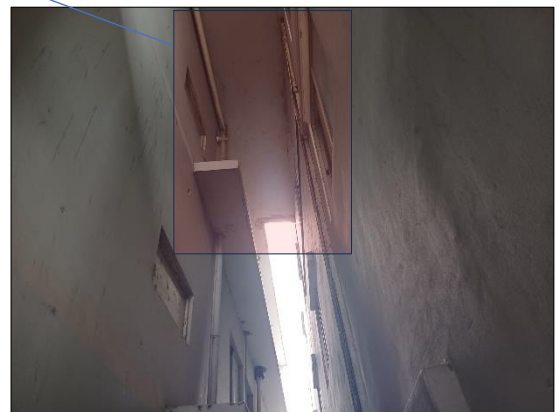
Structural Connection

Beam and slab are connected between Old Admin Building and New Admin Building

**Description:** During inspection it was found that beams and slabs are connected in the new admin building and old admin building. The Building Engineer is required to check the structural integrity of two buildings for the structural connections. Otherwise, separate the connections.

| Observation | Action Plan | Timeline |
|---|---|---|
| Structural connection between two building (Old Admin Building & New Admin Building). | Building Engineer is required to check the structural integrity of two buildings considering the structural connections. Otherwise, separate the structural connections and check the structural integrity separately. | within 6 weeks |

| Structural connection between two building (Old Admin Building & New Admin Building). | Carry out remediation work if required. | within 6 months |

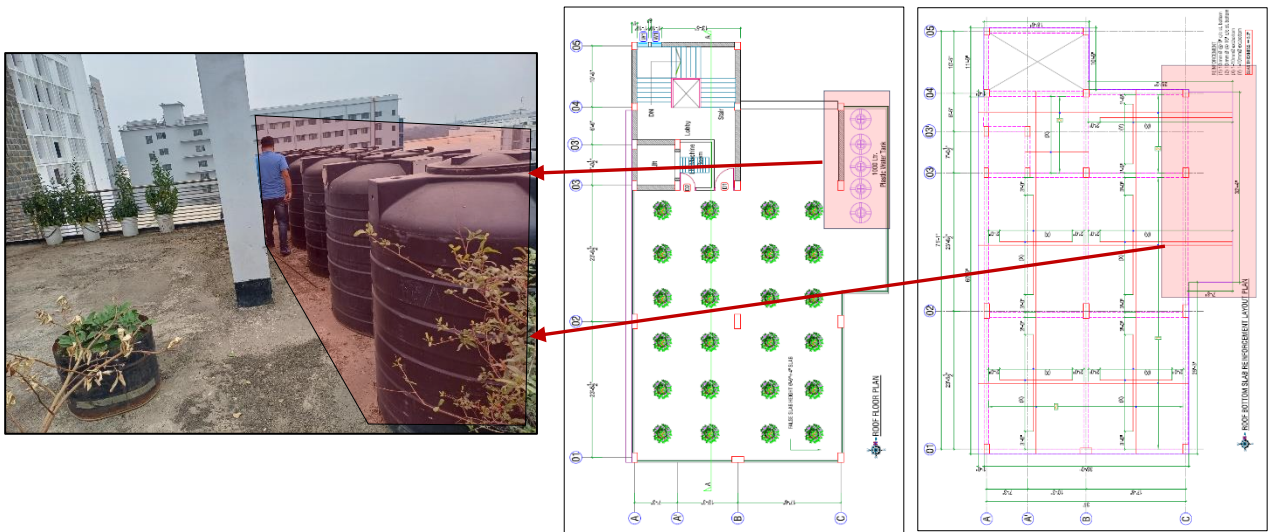
**Observation-7:** Water tank on cantilever slab (New Admin Building).

5 Nos 1000L water tank on roof slab at cantilever portion

**Description:** 5 no's water tank was found on roof slab which was placed on the cantilever portion of the slab. Building Engineer is required to check the slab adequacy of slab for water tank loading.

| Water tank on cantilever slab (New Admin Building). | Building Engineer is required to check the slab adequacy of slab for water tank loading. | within 6 weeks |
| Water tank on cantilever slab (New Admin Building). | Carry out remediation work if required. | within 6 months |

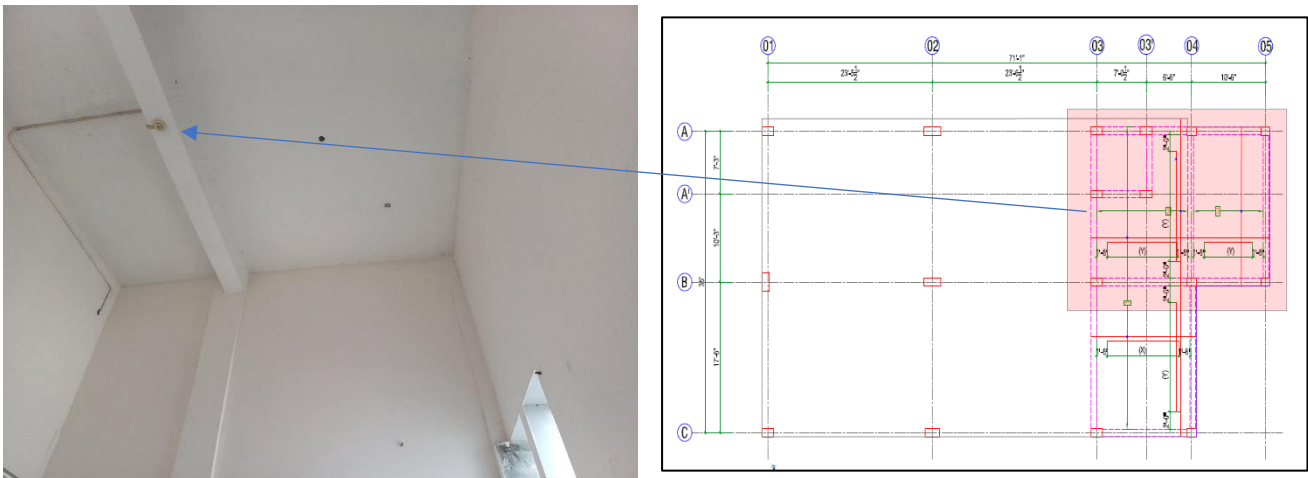
**Observation-8:** Discrepancies in as built drawings (New Admin Building).

**Description:** Beams in stair top are missing in as-built drawings. Building engineer is required to update the as built drawings as per site condition.

| Discrepancies in as built drawings (New Admin Building). | Building engineer is required to update the as built drawings as per site condition. | within 6 weeks |

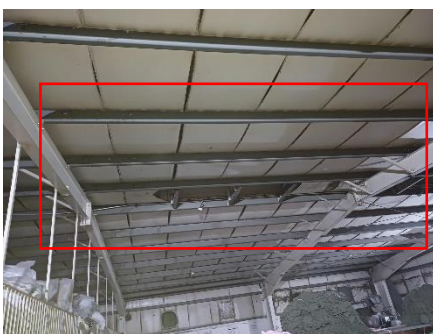
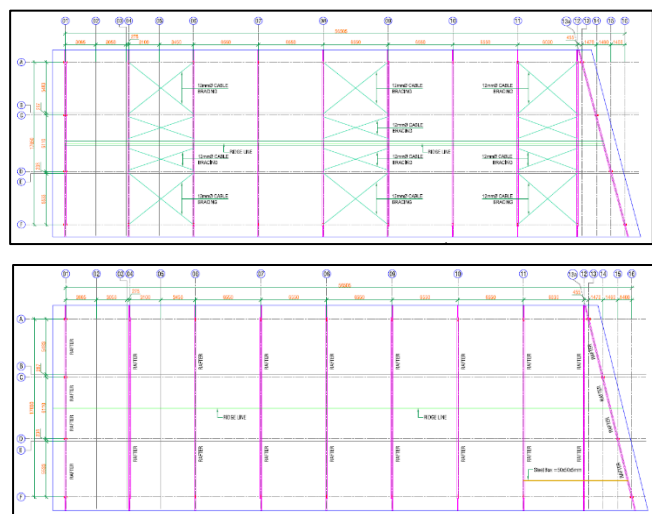
**Observation-10:** Lack of lateral stability system (General Store Shed).

**Description:** Lack of lateral stability system (absence of compression strut member) was observed. The building engineer is required to check the stability system of the structure and suggest proper alternatives accordingly.

| Lack of lateral stability (General Store Shed) | The building engineer is required to check the member, connection & stability system of the structure and suggest proper alternatives accordingly. | within 6 weeks |
| Lack of lateral stability (General Store Shed) | Carry out remediation work if required. | within 6 months |

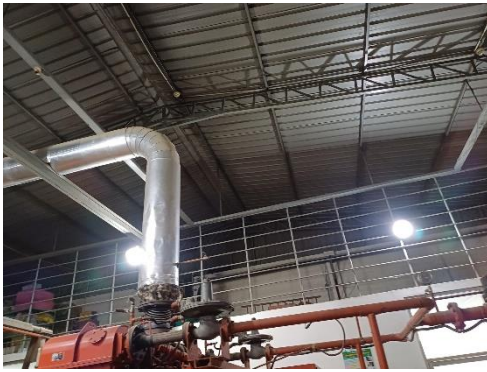
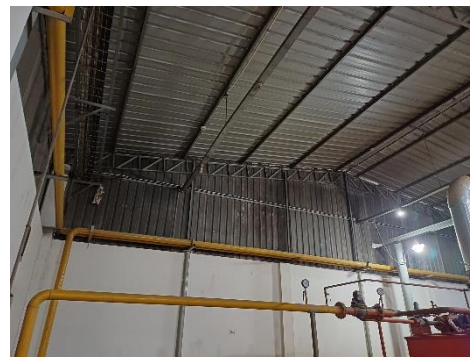
**Observation-11:** Lack of lateral stability system and non-engineered connection (Utility Shed-2).

**Description:** Lack of lateral stability system (strut and bracing), apparent inadequate members and non-engineered connection was observed. The building engineer is required to check the member, connection & stability system of the structure and suggest proper alternatives accordingly.

| Lack of lateral stability system and non-engineered connection (Utility Shed-2). | The building engineer is required to check the member, connection & stability system of the structure and suggest proper alternatives accordingly. | within 6 weeks |
| Lack of lateral stability system and non-engineered connection (Utility Shed-2) | Carry out remediation work if required. | within 6 months |

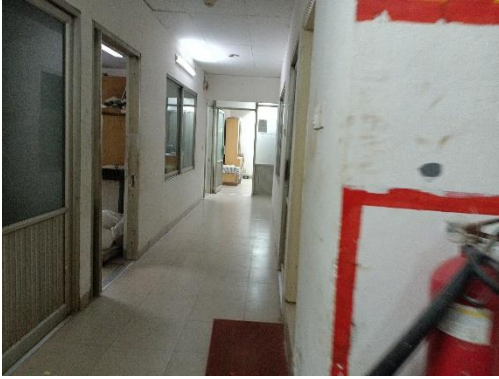
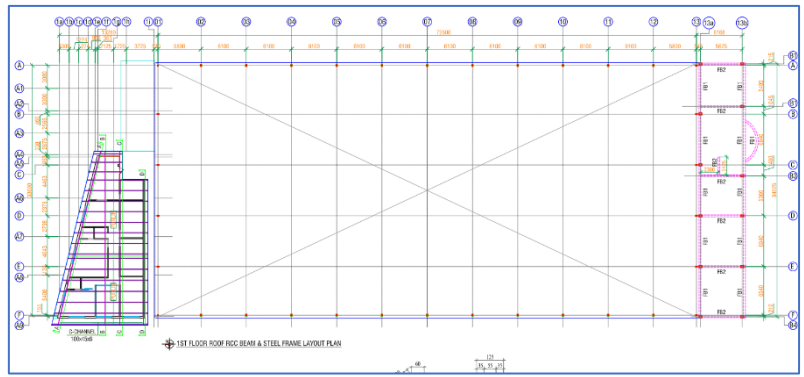
### 1<sup>st</sup> floor (North extension)

**Observation-13:** Lack of information in as-built drawing. (Dyeing Shed-1)

**Description:** No structural details were found for North side extension of 1<sup>st</sup> floor. The building engineer is required to survey the structure and prepare accurate as-built drawings.

| Lack of information in as-built drawing. (Dyeing Shed-1) | The building engineer is required to survey the structure and prepare full set of as-built drawings. | within 6 weeks |

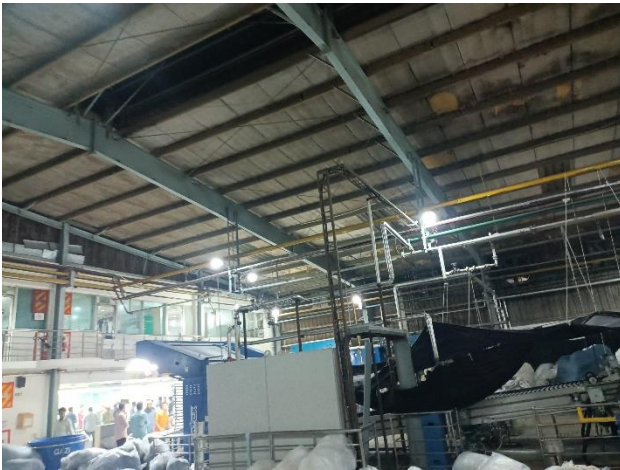
No compression strut on ridge

**Description:** No compression strut was found along the long direction. Only cable bracings were found onsite. So, lateral stability in the long direction is incomplete. The building engineer is required to check the stability system of the existing structure.

| Incomplete lateral stability system. (Dyeing Shed-1) | Building engineer is required to check the lateral stability of the structure. | within 6 weeks |
| Incomplete lateral stability system. (Dyeing Shed-1) | Carry out remediation work if required. | within 6 months |

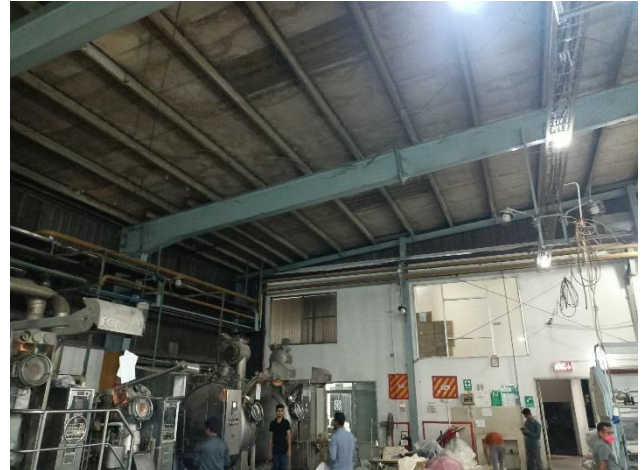
No compression strut on edge

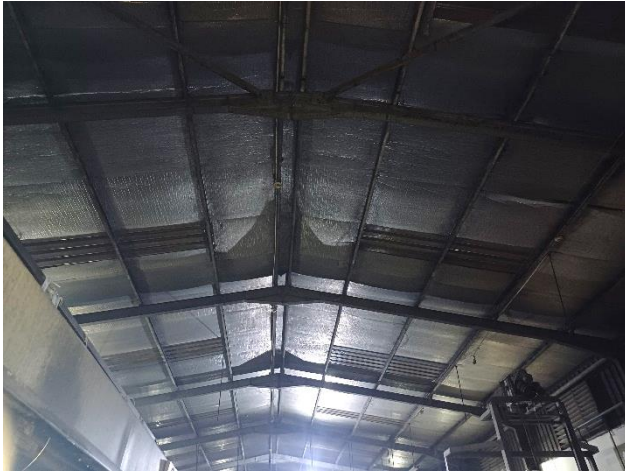
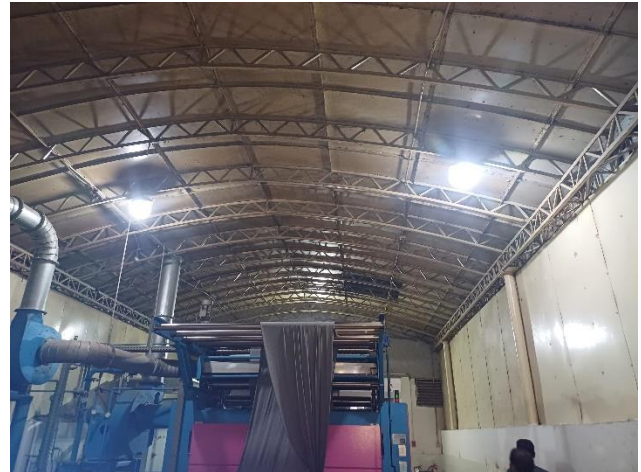
**Observation-15:** Lack of lateral stability system. (Dyeing Shed-2)

**Description:** Load transfer media is not provided at ridge along long direction for this shed. Therefore, the lateral stability system of the roof is apparently incomplete. The building engineer is required to check the stability system of the existing structure.

| Lack of lateral stability system. (Dyeing Shed-2) | Building engineer is required to check the lateral stability of the structure. | within 6 weeks |
| Lack of lateral stability system. (Dyeing Shed-2) | Carry out remediation work if required. | within 6 months |

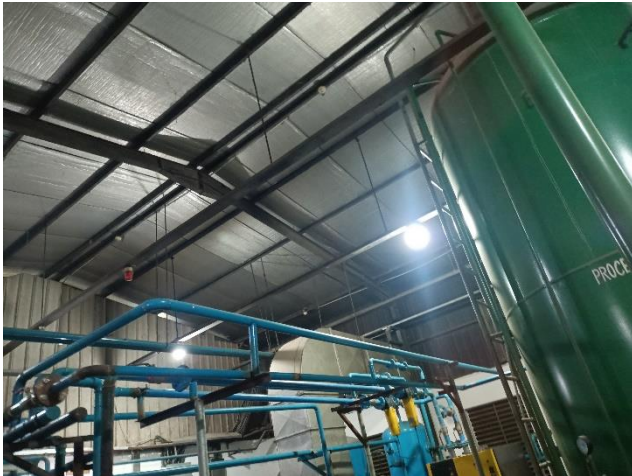
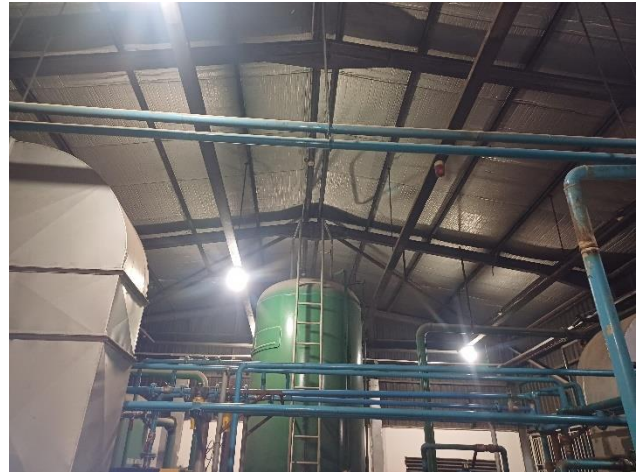
**Observation-17:** Incomplete lateral stability. (Utility Shed)

**Description:** Load transfer media is not provided at ridge along long direction for this shed. Therefore, the lateral stability system of the roof is apparently incomplete. The building engineer is required to check the stability system of the existing structure.

| Incomplete lateral stability. (Utility Shed) | Building engineer is required to check the lateral stability of the structure. | within 6 weeks |
| Incomplete lateral stability. (Utility Shed) | Carry out remediation work if required. | within 6 months |

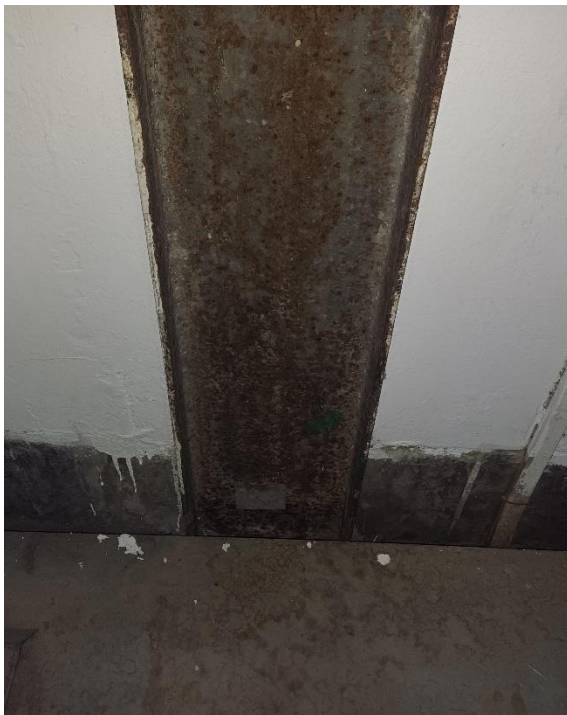
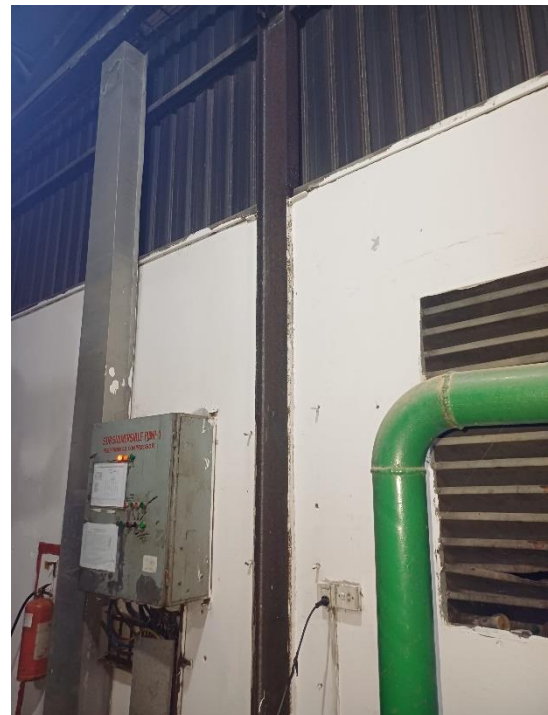
**Observation-18:** Corrosion in steel member. (Utility Shed)

Corrosion

**Description:** Corrosion in steel member was observed in the several locations. The building engineer is required to remove the corrosion and apply anti-corrosive coating to the steel members.

| Corrosion in steel member. (Utility Shed) | Building engineer to remove the corrosion and apply suitable corrosion resistance coating. | within 6 weeks |

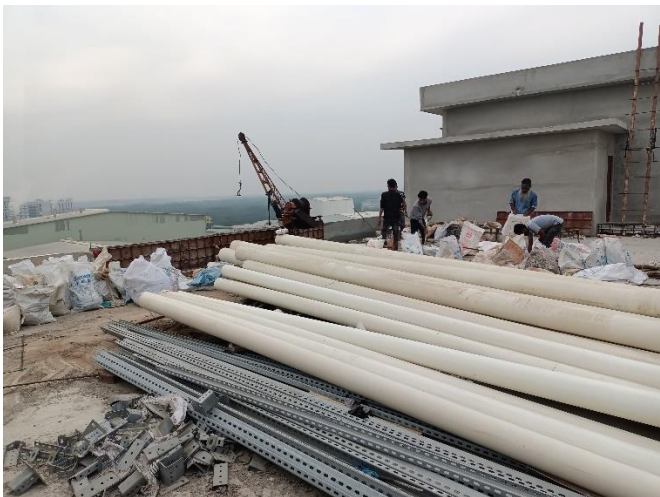
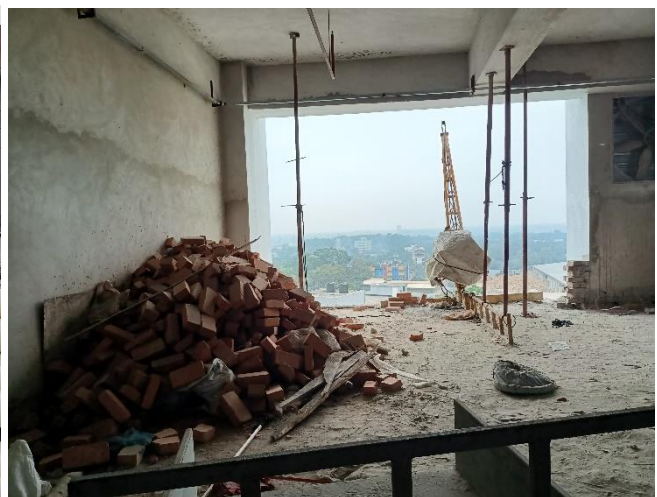
**Observation-20:** Construction Materials on the roof and 8<sup>th</sup> floor. (B+ 8 Storied Building)

Construction Materials & crane

**Description:** Stacking of construction materials and crane were found on the roof. Building engineer is required to remove construction materials from roof and others floor.

| Construction Materials on the roof and 8th floor. (B+ 8 Storied Building) | Building engineer is required to remove construction materials from roof and others floor. | within 6 weeks |

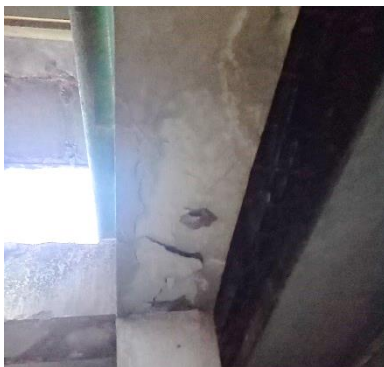
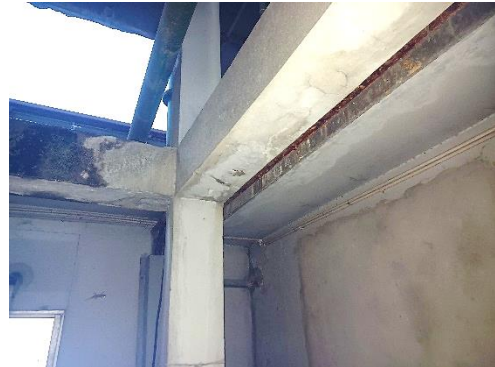
**Observation-22: Cracks under beam soffit. (Cooling Tower)**

Cracks on beam

**Description:** Crack found under beam soffit at North side of cooling tower. Building engineers are required to investigate the reason & extent of crack and prepare an investigation report with proper repair methodology.

| Cracks under beam soffit.<br>(Cooling Tower) | Building engineer is required to investigate the reason & extent of crack and prepare an investigation report with proper repair methodology. | within 6 weeks |
| Cracks under beam soffit.<br>(Cooling Tower) | Carry out remedial works as per investigation report. | within 6 weeks |

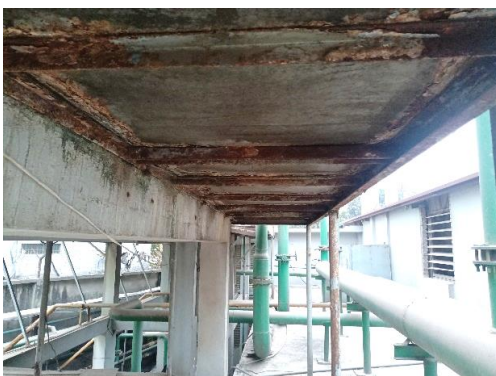
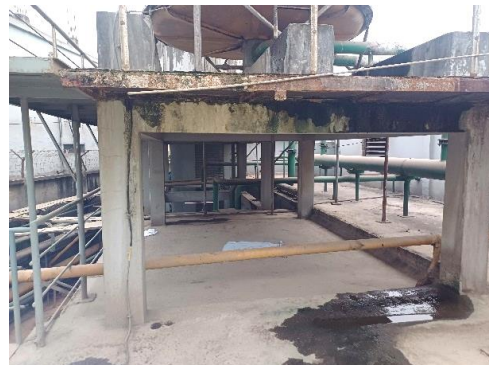
**Observation-23: Severe corrosion in steel member and dampness in RC frame. (Cooling Tower)**

Corrosion

**Description:** Severe corrosion in steel member and dampness were observed in the several locations. The building engineer is required to identify the corrosion & dampness and apply proper remedial measures accordingly.

| Severe corrosion in steel member and dampness in RC frame. (Cooling Tower) | The building engineer is required to identify the corrosion & damp areas and repair them with a suitable method. | within 6 weeks |
