# Eslite Garments (Bangladesh) Co., Ltd

Holding # 1125, Jamirdia, Habirbari, Bhaluka, Mymensingh.

6 December 2023

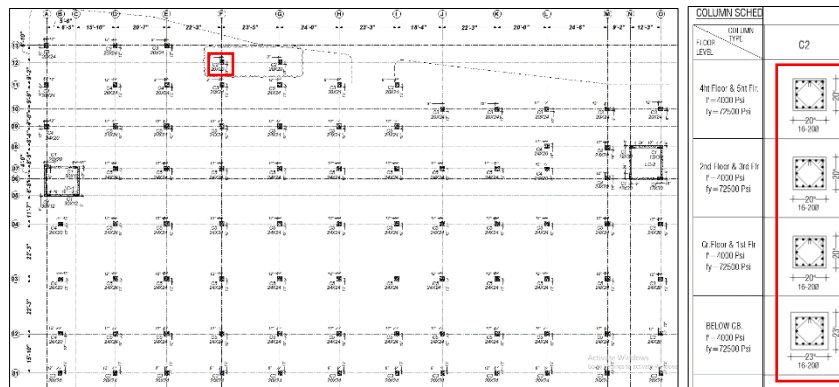
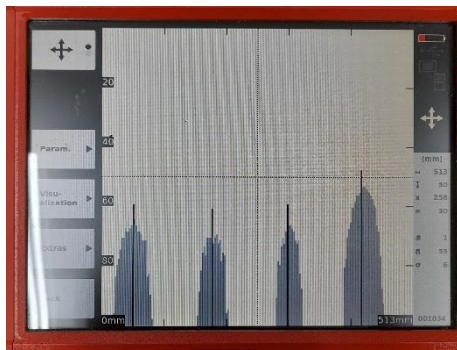
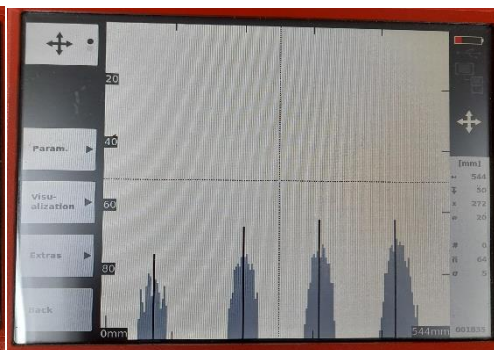
Ferro-scanning at 5<sup>th</sup> floor

**Description:** During inspection, the re-bar of the C2 column was found to be less than the as-built drawing. As per the column schedule, the re-bar has been shown 5 numbers on each face. By the ferro-scanning, at the marked location in column layout, 4 number of re-bars were found in one face of C2 column at 5<sup>th</sup> floor and ground floor.

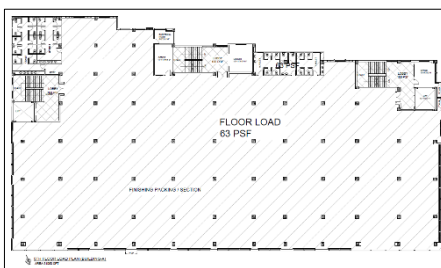
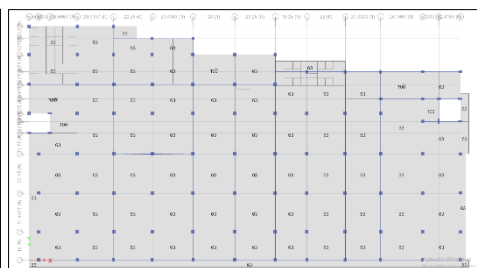
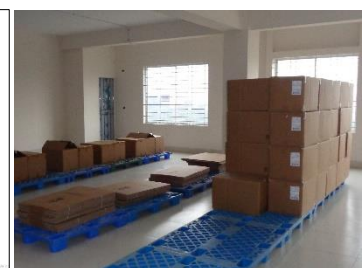
Loading consideration and floor loading at 5<sup>th</sup> floor

Storage loading at 3<sup>rd</sup> floor

**Description:** The 5<sup>th</sup> floor has been proposed for storage. Also, storage loading was also found in some locations of the 5<sup>th</sup> floor. But load plan has been prepared considering 63 psf instead of 126 psf. At 3<sup>rd</sup> floor, storage loading was found, but floor loading has been considered 63psf. In FEA model, 63 psf has been assigned in all the floors. Building engineer is required to revise the design documents considering storage loading as per BNBC.

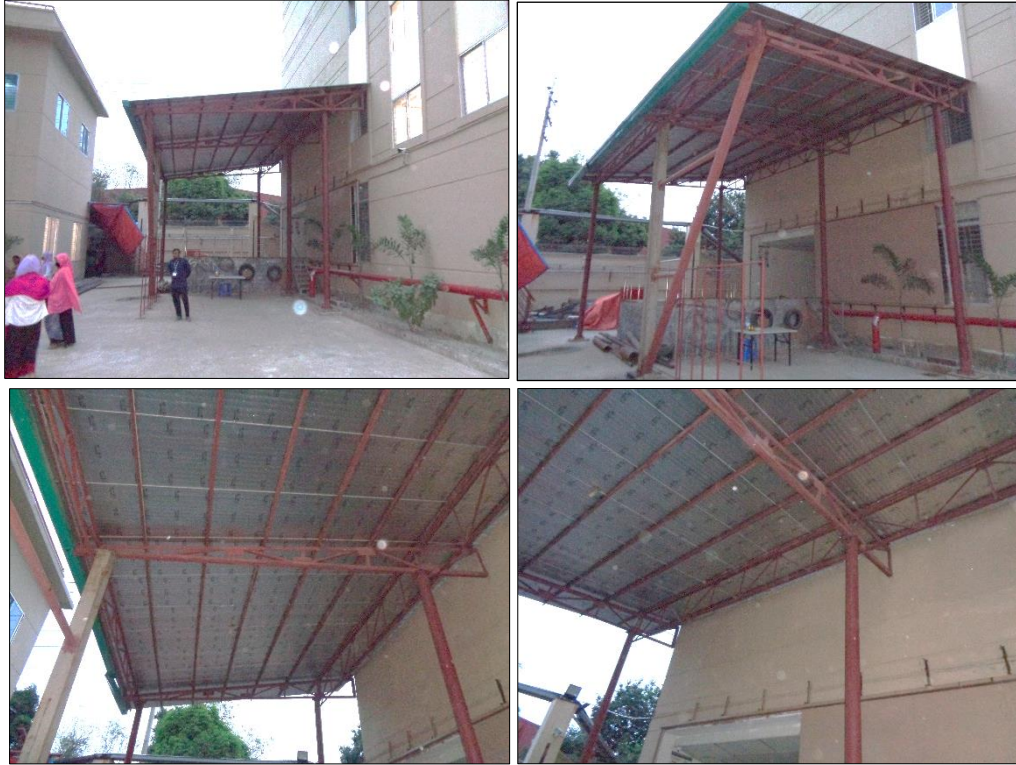
**Observation 3:** Undocumented shed at loading-unloading area (Factory Building)

**Description:** Undocumented shed was found at loading-unloading area of the factory building. The structure is self-supported steel roof truss supported by steel pipe column. Design documents was not available for the structure. The building engineer is required survey the whole structure and prepare the as built drawing. Also building engineer is required to prepare design document for the steel shed.

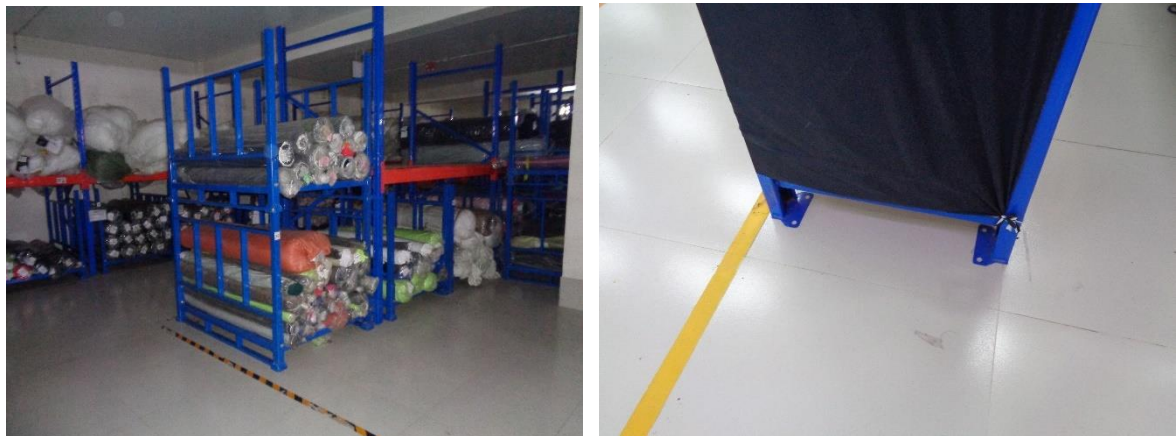
**Observation 4:** Non-structural elements not anchored or braced. (Factory Building)

**Description:** Racks on different floors are not adequately anchored or braced to resist lateral (earthquake) forces. Building is required to adequately anchor and brace all non-structural elements to resist earthquake forces to comply with the BNBC.

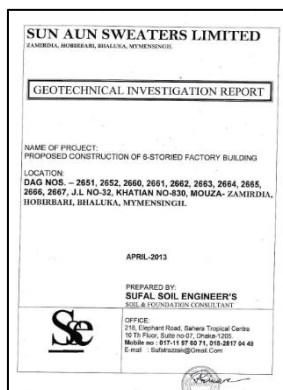
Considering Allowable bearing capacity= 1.50 tsf= 3ksf  
 $DL+LL = 134 \text{ kip}$   
 Required footing area=  $134/3 = 44.7 \text{ ft}^2$   
 Provided footing area=  $9' \times 10' = 90 \text{ ft}^2$   
 $d(\text{provided}) = 12-4 = 8 \text{ in.}$   
 $d(\text{required}), 27 \times 1000 = 1 \times 4 \times \sqrt{3945} \times 2 \times d(44.7 + 4 \times 2 \times)$   
 $d(\text{required}) = 1.7 \text{ inch (OK)}$   
 $A_s(\text{req}) = 0.35 \text{ in}^2/\text{ft}$   
 $A_s(\text{prov.}) = 4.52 \text{ in}^2/\text{ft}$

- Rebar test report found for 16mm dia rod achieving 370 MPa, 20mm dia rod achieving 555MPa; but 500MPa used for column rebar in design report.
- 3 nos concrete core rest report found for column and 1 no. for beam. In the design report, all core test results are considered for concrete strength calculation for column and beam.
- Foundation adequacy check is not provided for all footing.
- Soil test report from which bearing capacity is considered for foundation calculation in design report, is not for dormitory building as per project name and bore layout.

The building engineer is required to collect minimum 4 nos of concrete core from column and beam-slab individually, revise the design report considering concrete strength for each type of structural member individually, revise rebar strength, produce geotechnical investigation report for this structure and revise foundation adequacy check in the design report based on soil investigation report. Submit the revised design report to the RSC for review.

| Observation | Action Plan | Timeline |
|---|---|---|
| Inconsistencies in design report. (Dormitory Building) | The building engineer is required to revise the design report considering concrete strength for each type of structural member individually, revise rebar strength, produce geotechnical investigation report for this structure and revise foundation adequacy check in the design report based on soil investigation report. Submit the revised design report to the RSC for review. | within 6 weeks |

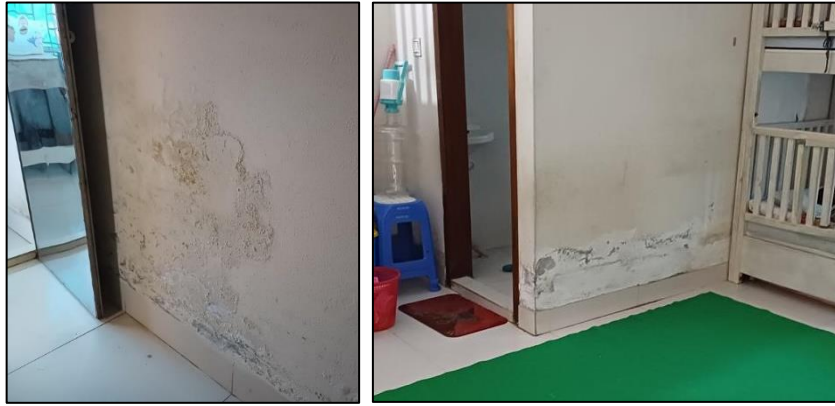
**Observation-6:** Dampness on wall. (Dormitory Building)

**Description:** Dampness found on wall in kitchen and toilet zone wall. The building engineer is required to identify the source of dampness and take remedial measures to repair the wall accordingly.

| Observation | Action Plan | Timeline |
|---|---|---|
| Dampness on wall. (Dormitory Building) | The building engineer is required to identify the source of dampness and take remedial measures to repair the wall accordingly. | within 6 weeks |

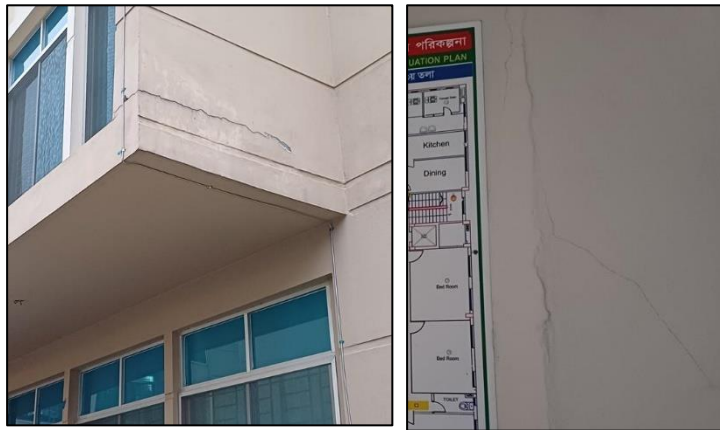
**Observation-7:** Crack on wall. (Dormitory Building)

**Description:** Crack found on façade wall and stair wall. The building engineer is required to identify the reason for the crack and take remedial measures to repair the wall accordingly.

| Observation | Action Plan | Timeline |
|---|---|---|
| Crack on wall. (Dormitory Building) | The building engineer is required to identify the reason for the crack and take remedial measures to repair the wall accordingly. | within 6 weeks |

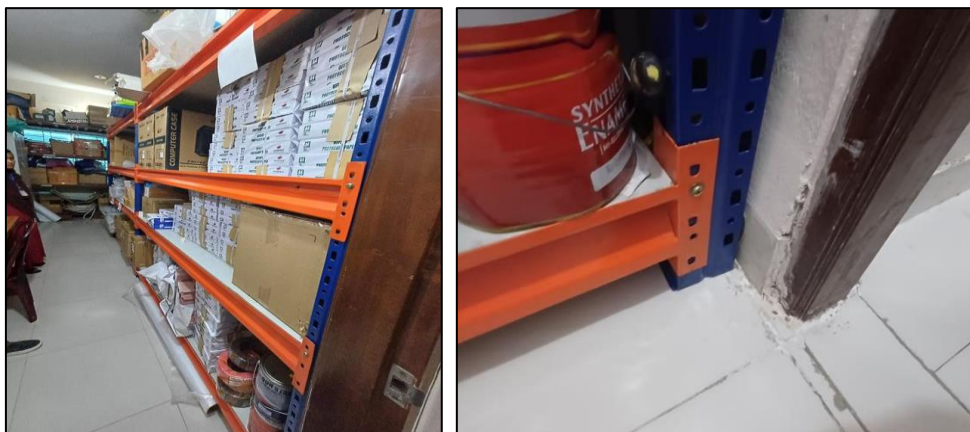
Unbraced storage racks on floors

**Description:** Storage rack found within the building without braced/anchored. Building engineer is required to brace/anchor all non-structural elements.

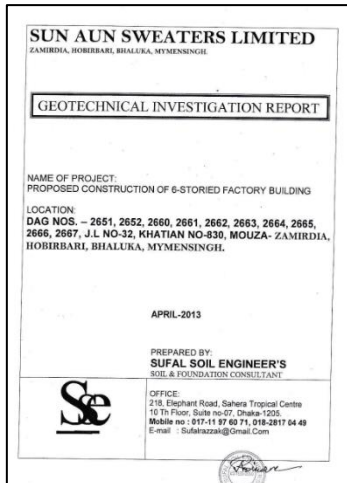
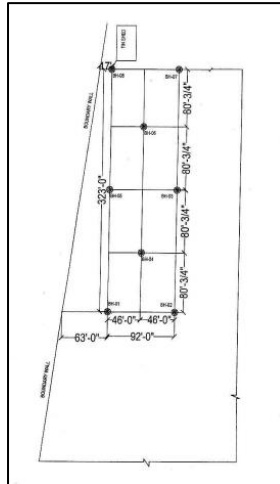
Considering Allowable bearing capacity= 1.50 tsf= 3ksf  
DL+LL= 53kip  
Required footing area=  $53/3 = 17.7 \text{ ft}^2$   
Provided footing area=  $6' \times 6' = 36 \text{ ft}^2$   
 $d(\text{provided}) = 12 - 4 = 8 \text{ in.}$   
 $d(\text{required}), 27 \times 1000 = 1 \times 4 \times \sqrt{3945} \times 2 \times d(17.7 + 17.7 + 2 \times d)$   
 $d(\text{required}) = 1.34 \text{ inch (OK)}$   
 $A_s(\text{req}) = 0.33 \text{ in}^2/\text{ft}$   
 $A_s(\text{prov.}) = 4.62 \text{ in}^2/\text{ft}$

- Foundation adequacy check is not provided for all footing.
- Soil test report from which bearing capacity is considered for foundation calculation in design report, is not for dormitory building as per project name and bore layout.

The building engineer is required to produce geotechnical investigation report for this structure and revise foundation adequacy check in the design report based on soil investigation report. Submit the revised design report to the RSC for review.

| Inconsistencies in design report. (Utility Building) | The building engineer is required to produce geotechnical investigation report for this structure and revise foundation adequacy check in the design report based on soil investigation report. Submit the revised design report to the RSC for review. | within 6 weeks |

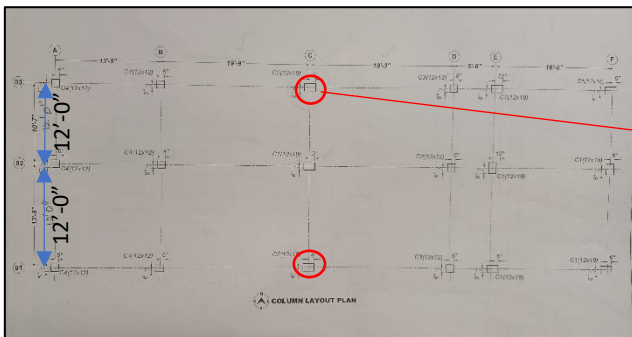
Column layout

**Description:** In as-built drawing, marked column mentioned 12" x 18", but 12" x 15" found on site. Also grid dimension in north-south direction does not match with as-built drawing. The building engineer is required to survey the whole structure and update the as-built drawing.

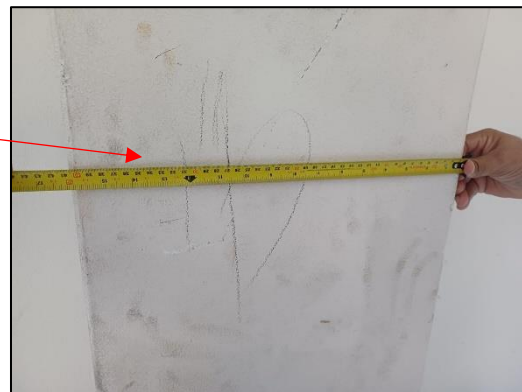
Column size found 12"x15" instead of 12"x18"

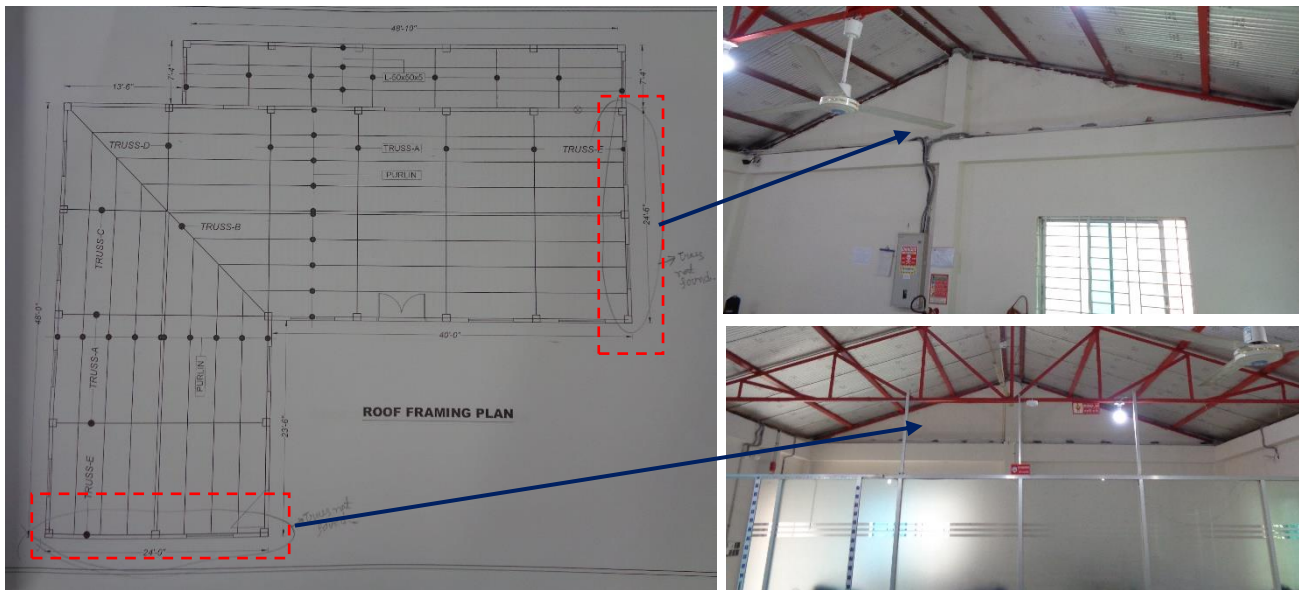
Truss Layout do not match

**Description:** Mismatch was found in the as-built drawing and actual site condition. The truss layout does not match with site conditions. In the as-built drawing, truss has been shown at end gable. But the truss was not found at the end gable at site condition. All the Truss members were found 38X38X5mm. But in the provided drawing two sizes of truss members has been shown- L50X50X5mm & L40X40X5mm. Also, the size of the truss members shown in drawing does not indicate any members. The total number of the vertical members do not match between site condition and drawing. Building engineers is required to survey the whole structure and update the as-built drawing. Revise the design documents based on actual site condition.

| Mismatch in provided as-built drawing. (Canteen Shed) | Building engineer is required to survey the whole structure and update the as-built drawing and as per actual site condition. | within 6 weeks |

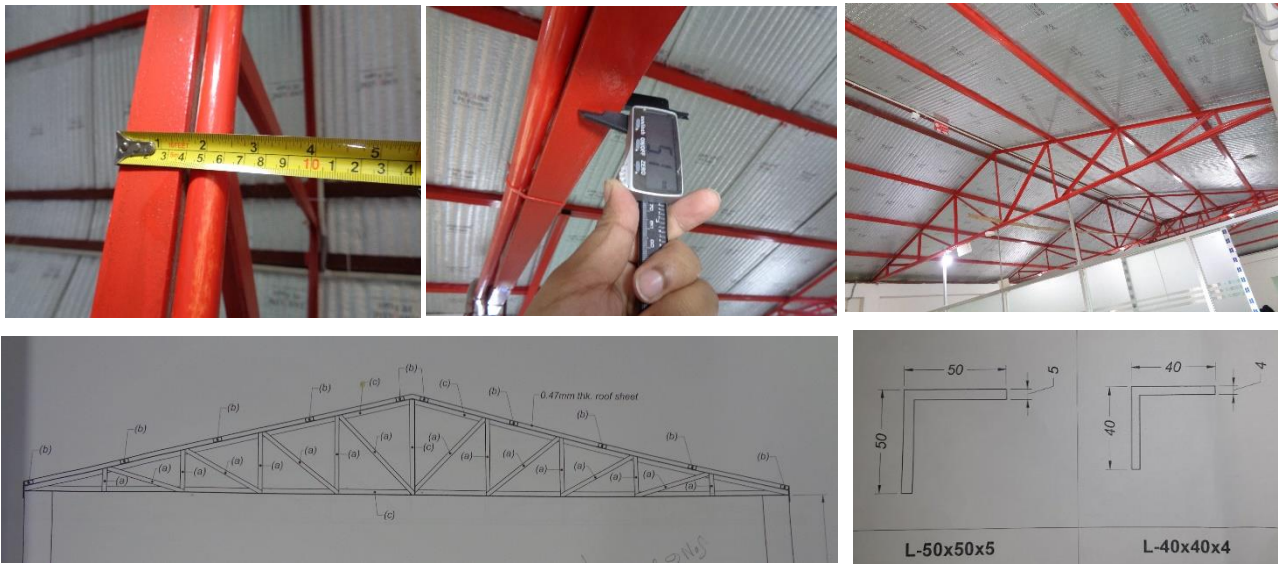
Size of the truss members and number of vertical members mismatch

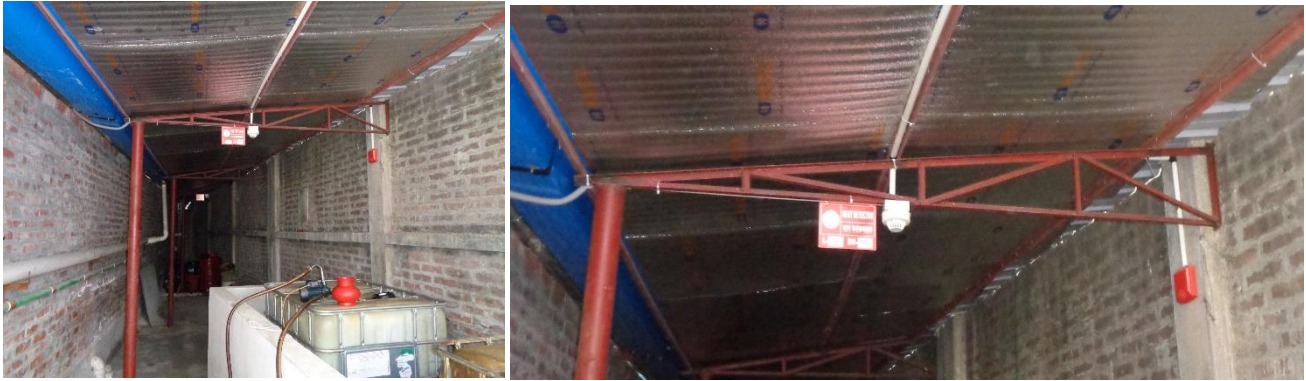
**Observation 12:** Undocumented steel shed. (Diesel store)

**Description:** During inspection, an undocumented diesel store was found adjacent to Canteen shed. The roof of the store is made of steel truss supported by steel pipe column and boundary brick wall. No drawing and design documents were available for the shed. Building engineer is required to survey the structure and prepare accurate as-built drawing including connection details. Also check the adequacy for the connection against the up-lift force.

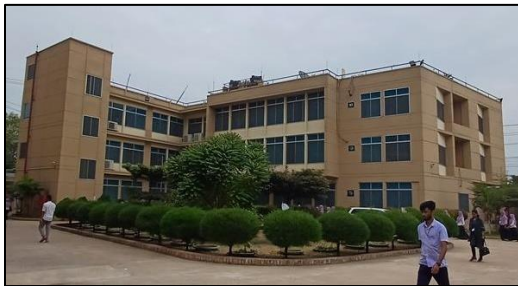
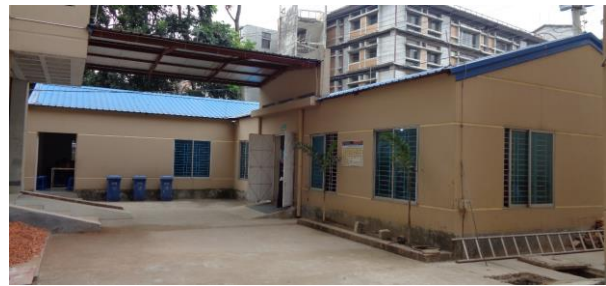
Dormitory Building and Canteen Shed

**Description:** At the time of inspection, building permit drawing was only found for Factory building and Utility Building but not available for rest of the structures. Factory is required to collect the building approval drawing from local authority for Dormitory Building, Canteen Shed, Diesel Store and Security Building
