# Brickland Composite Ltd. (Relocated)

26 December 2023

## Structural Inspection Report

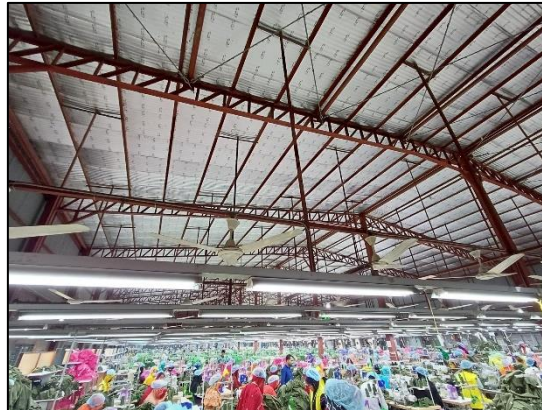
### Observation-1: Lack of design report (Shed-1).

**Description:** As per BNBC, every building should have its design documents in compliance with section 1.9.1 of part 6. During inspection, the design report was not available on site. The building engineer is required to prepare a design report based on in-situ material strength & software-based analysis and in compliance with BNBC 2020 submit it to RSC for review.

| Item No. | Observation | Action Plan | Timeline |
|---|---|---|---|
| 1. | Lack of design report. (Shed-1) | The building engineer is required to prepare a design report based on in-situ material strength & software-based analysis in compliance with BNBC 2020 and submit the documents to RSC for review. | within 6 weeks |
| 2. | Lack of design report. (Shed-1) | Carry out suggested remedial works if required. | within 6 months |

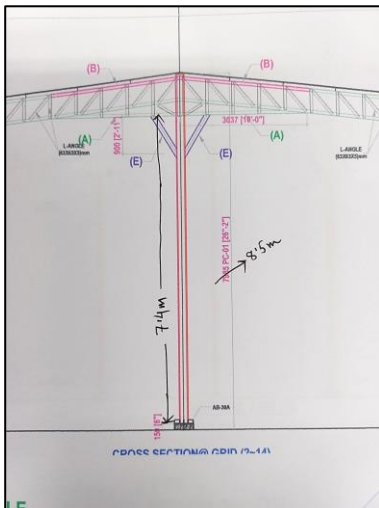
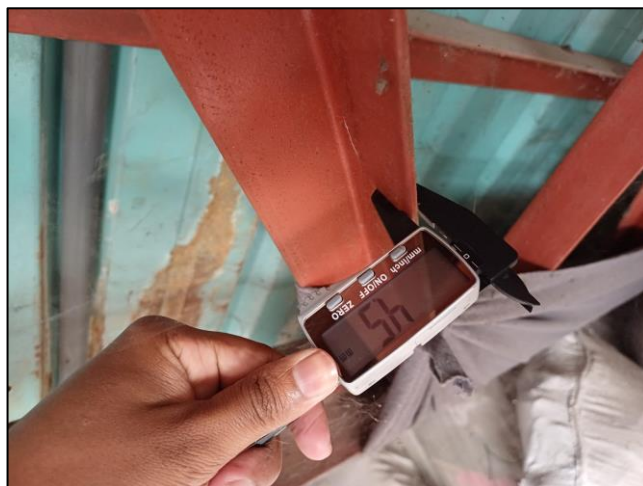
### Observation-2: Discrepancies in as built drawings (Shde-1).

**Description:** During inspection, mismatches were found between onsite condition and as-built drawing. The ridge height was measured 8.5 m instead of 7.4 m. Also, the angle thickness of extension roof truss was measured 4.5mm instead of 5mm. The building engineer is required to survey the full structure and produce accurate as-built drawings.

| Item No. | Observation | Action Plan | Timeline |
|---|---|---|---|
| 3. | Discrepancies in as built drawings. (Shed-1) | The building engineer is required to survey the full structure and produce accurate as-built drawings. | within 6 weeks |

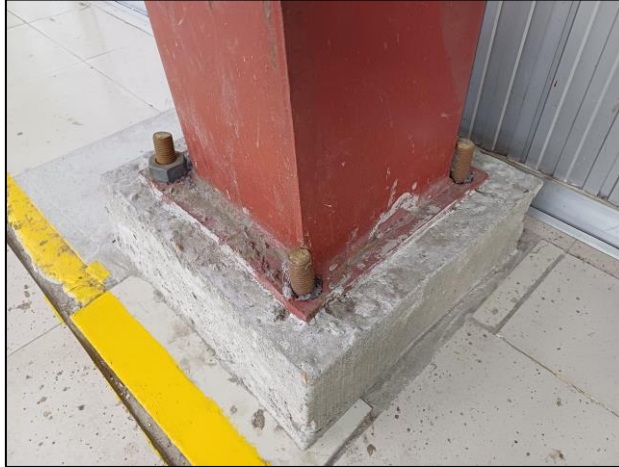
**Observation-3:** Missing anchor bolts (Shed-1).

**Description:** Some of the nuts of anchor bolt were missing. The building engineer to check the connection and install missing nuts.

| Item No. | Observation | Action Plan | Timeline |
|---|---|---|---|
| 4. | Missing anchor bolts nut (Shed-1). | The building engineer is required to install missing nuts. | within 6 weeks |

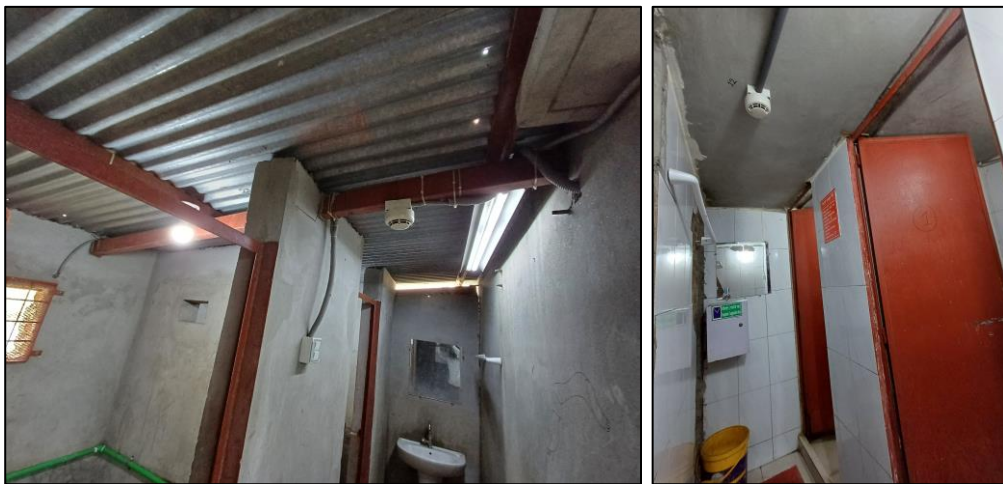
**Observation-4:** Undocumented toilet blocks (Shed-1).

**Description:** Two toilet blocks were found onsite having no structural details. Prepare necessary as-built drawing with connection details for the toilet blocks.

| Item No. | Observation | Action Plan | Timeline |
|---|---|---|---|
| 5. | Undocumented toilet blocks (Shed-1). | The building engineer required to prepare accurate as built drawing with connection details. | within 6 weeks |

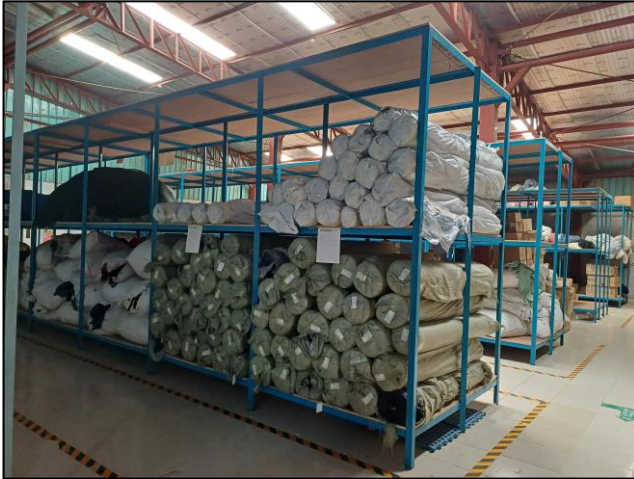
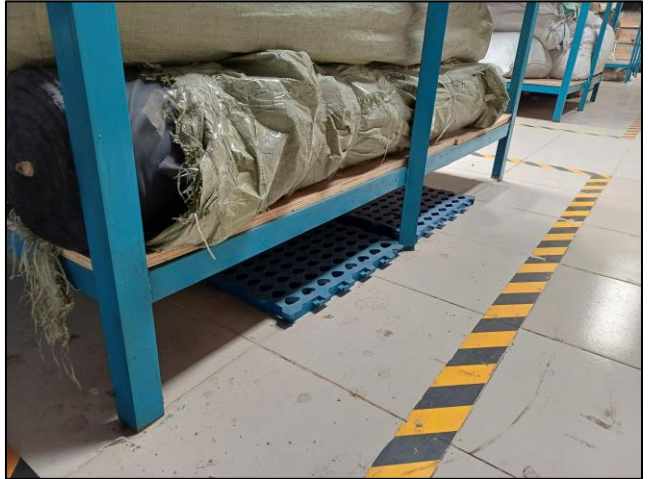
**Observation-5:** Lack of anchorage of storage Rack (Shed-1).

**Description:** Storage racks were found without anchorage. The factory is required to provide anchorage and/or bracing to resist the lateral forces.

| Item No. | Observation | Action Plan | Timeline |
|---|---|---|---|
| 6. | Lack of anchorage of storage Rack (Shed-1). | Provide anchorage and/or bracing to the storage racks to resist the seismic forces. | within 6 months |

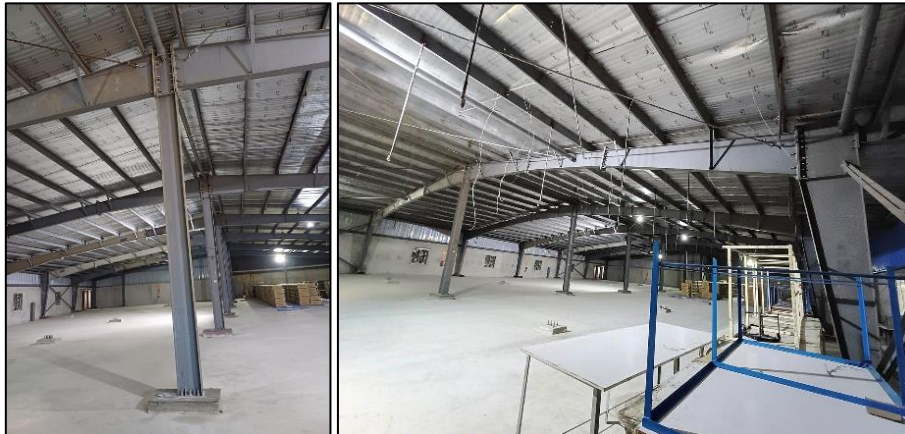
**Observation-6:** Lack of design report (Shed-2).

**Description:** At the time of inspection, only as-built drawings were available, but no design report was available. The building engineer is required to prepare a design report based on in-situ material strength & software-based analysis in compliance with BNBC 2020 and submit it to RSC for review.

| Item No. | Observation | Action Plan | Timeline |
|---|---|---|---|
| 7. | Lack of design report. (Shed-2) | The building engineer is required to prepare a design report based on in-situ material strength & software-based analysis in compliance with BNBC 2020 and submit the documents to RSC for review. | within 6 weeks |
| 8. | Lack of design report. (Shed-2) | Carry out suggested remedial works if required. | within 6 months |
