# ILMEEYAT APPARELS LIMITED (New Building 3)

Jamirdia, Valuka, Mymensingh

28 December 2023

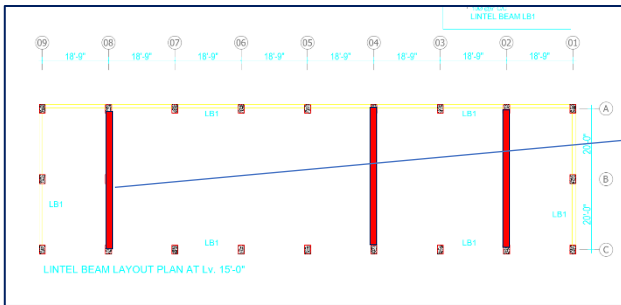
Lintel/tie beam layout plan

### Observation-1: Mismatch in as-built drawing. (Substation & Generator Building)

**Description:** Lintel/tie beam layout does not match with as-built condition. Mismatches are shown in red on the layout. The building engineer is required to update the as-built drawing correcting the tie-beam layout and submitting it to RSC.

| Observation | Action Plan | Timeline |
|---|---|---|
| Mismatch in as-built drawing. (Substation & Generator Building) | Building engineer is required to update as-built drawing incorporating all the mismatches. | within 6 weeks |

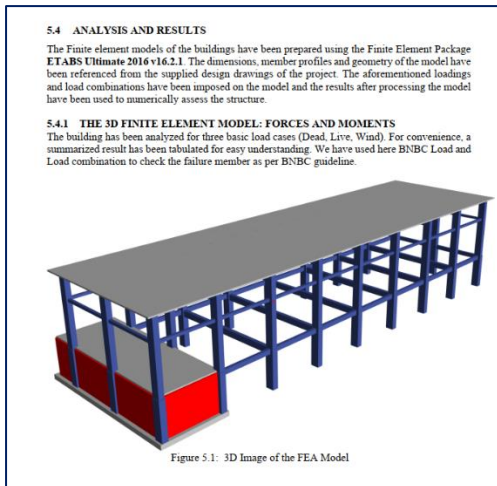
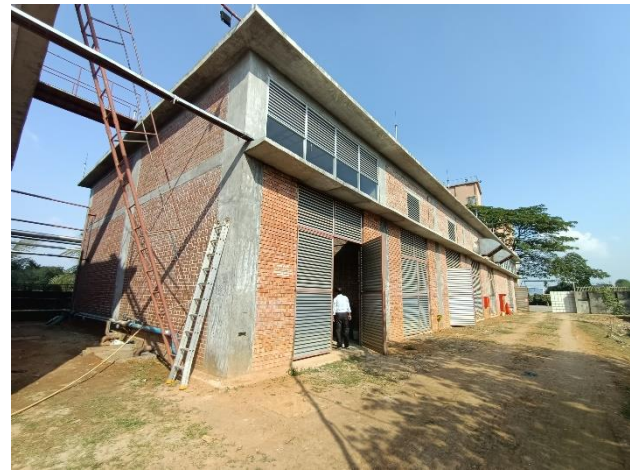
### Observation-2: Design report required to be reviewed by RSC for lateral loading. (Substation & Generator Building)

**Description:** A set of design report was available for the Substation & Generator Building. Design report need to be reviewed against lateral loading.

| Observation | Action Plan | Timeline |
|---|---|---|
| Design report required to be reviewed by RSC for lateral loading. (Substation & Generator Building) | Prepared design report to be checked against lateral loads following BNBC by RSC. | within 6 weeks |
| Design report required to be reviewed by RSC for lateral loading. (Substation & Generator Building) | Implement remediation work if required. | within 6 months |

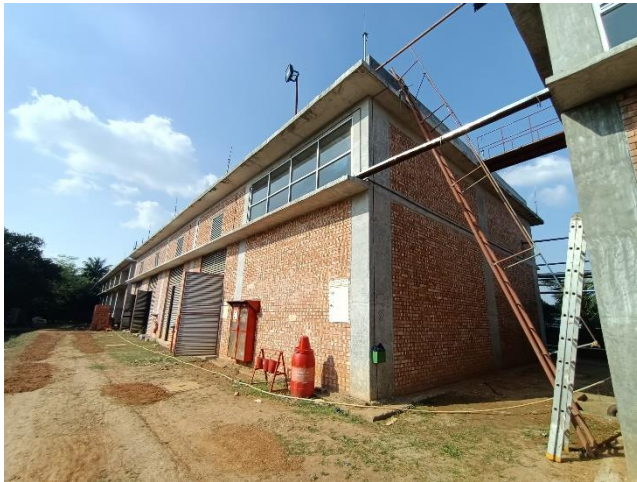
External Steel stair/ladder

**Observation-3:** Apparently non-engineered & undocumented connection bridge and external steel stair. (Substation & Generator Building; Boiler & Compressor Building)

**Description:** Undocumented external steel stair and connection bridge were found in between of these building. The steel stair/ladder and connection bridge seem to be non-engineered. The building engineer is required replace the steel stair and connection bridge with an engineered one.

| Observation | Action Plan | Timeline |
|---|---|---|
| Apparently non-engineered & undocumented connection bridge and external steel stair. (Substation & Generator Building; Boiler & Compressor Building) | The building engineer is required replace the steel stair and connection bridge with an engineered one. | within 6 months |

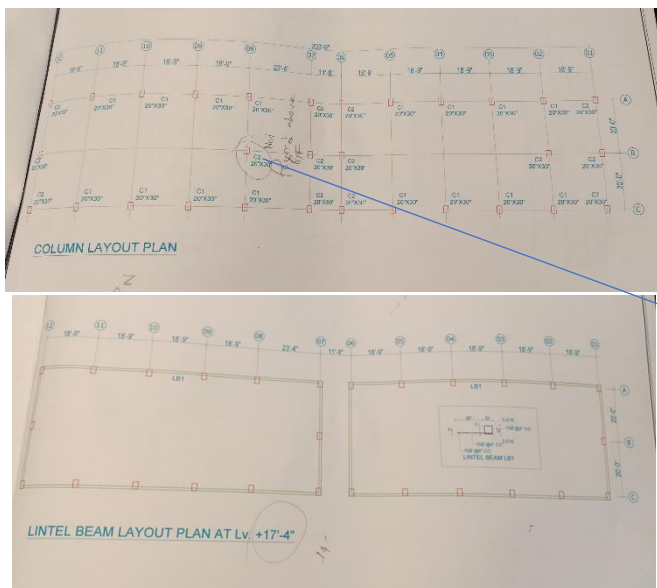
Column/Lintel layout plan

**Observation-4:** Discrepancies in as-built drawing. (Boiler & Compressor Building)

**Description:** C-2 type column on grid 08 does not found above the ground floor. Also, the lintel level was found at +4.3 m level from plinth instead of 5.2 m. The building engineer is required to update the as-built drawing correcting the tie-beam layout and submitting it to RSC.

| Observation | Action Plan | Timeline |
|---|---|---|
| Discrepancies in as-built drawing. (Boiler & Compressor Building) | Building engineer is required to update as-built drawing incorporating all the mismatches. | within 6 weeks |

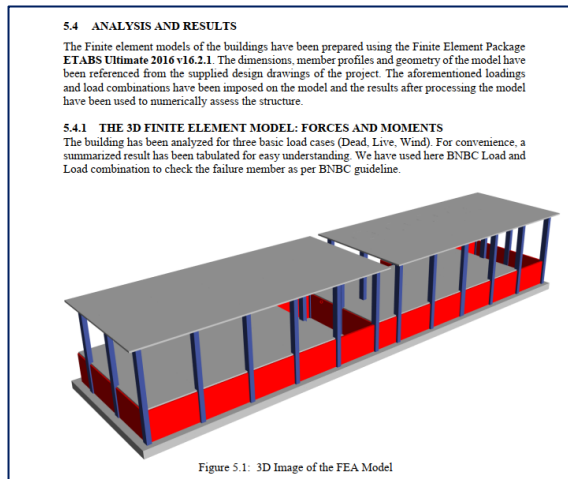
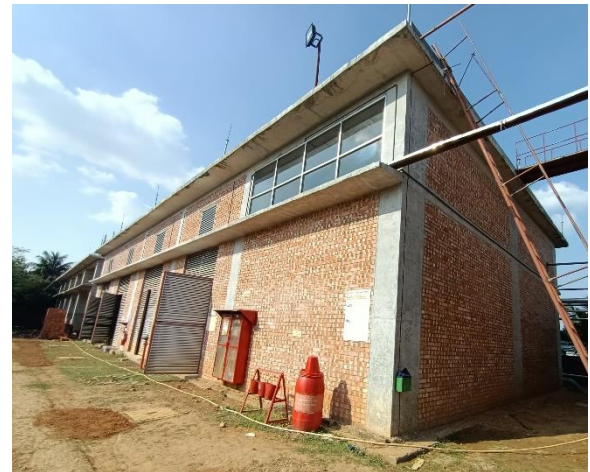
**Observation-5: Design report required to be reviewed by RSC for lateral loading. (Boiler & Compressor Building)**

**Description:** A set of design report was available for the Substation & Generator Building. Design report need to be reviewed against lateral loading.

| Observation | Action Plan | Timeline |
|---|---|---|
| Design report required to be reviewed by RSC for lateral loading. (Boiler & Compressor Building) | Prepared design report to be checked against lateral loads following BNBC by RSC. | within 6 weeks |
| Design report required to be reviewed by RSC for lateral loading. (Boiler & Compressor Building) | Implement remediation work if required. | within 6 months |

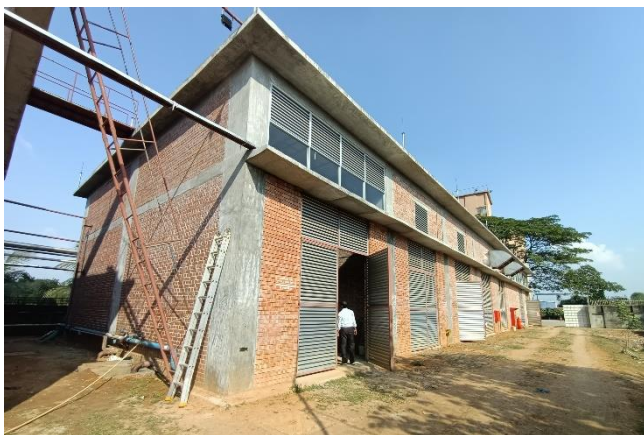
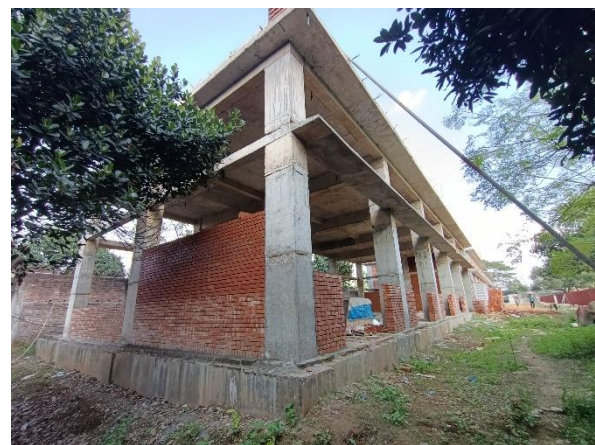
**Observation-6: Lack of building approval from local authority. (Substation & Generator Building; Boiler & Compressor Building)**

**Description:** At the time of inspection, no approval drawing from local authority was available for the above-mentioned structures. Building engineer is required to seek approval from the local authority.

| Observation | Action Plan | Timeline |
|---|---|---|
| Lack of building approval from local authority. (Substation & Generator Building; Boiler & Compressor Building) | Building engineer is required to seek and collect approval from the local authority. | within 6 months |
