Mark Sweater Limited. (Extension)

Surabari, Kashimpur, Gazipur Sadar, Gazipur.

24 December 2023

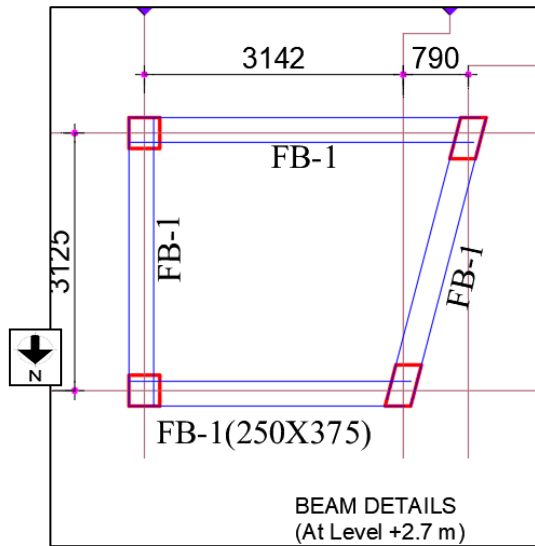
Beam Layout plan

Observation-1: Discrepancies in as-built structural drawings (Buiding-4 (ETP Building)).

Description: During the inspection, an additional floor beam was observed in the ground floor roof slab which was not shown in the as-built structural drawing. In addition, no elevation view was incorporated in the available architectural drawing. The building engineer is required to survey the full structure and produce accurate as-built drawings.

| Observation | Action Plan | Timeline |
|---|--|---|
| Discrepancies in as-built structural drawings. (Building-4 (ETP Building)) | The building engineer is required to survey the full structure and produce accurate as-built drawings. | within 6 weeks |

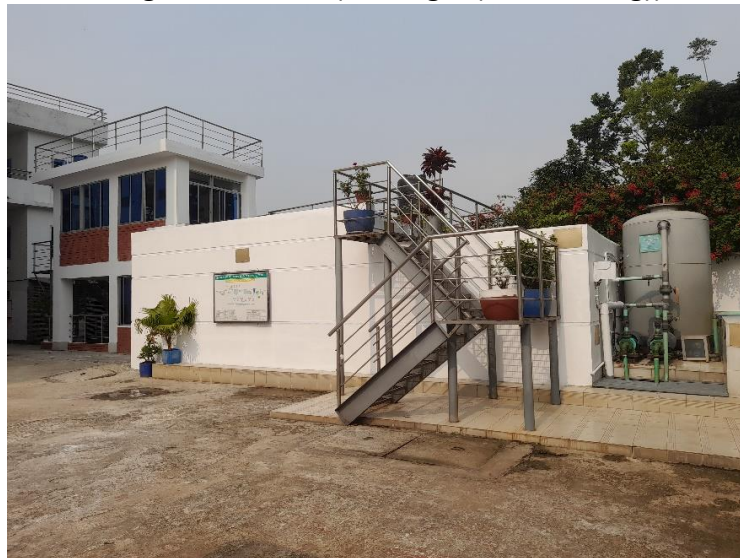
Observation-2: Absence of design documents (Buiding-4 (ETP Building)).

Description: As per BNBC, every building or structure designed shall have its design documents prepared following the provision of Section 1.9.1. The design document shall include a design report, and a set of structural drawings, which shall be prepared in compliance with section 1.9.1.1 and section 1.9.1.2 as per BNBC. At the time of inspection, a design report was not available which is required to be prepared in compliance with BNBC.

| Observation | Action Plan | Timeline |
|---|--|---|
| Absence of design documents. (Building-4 (ETP Building)) | Building is required to prepare a set of design reports in compliance with BNBC. | within 6 weeks |
| | Implement remediation work if required. | within 6 months |

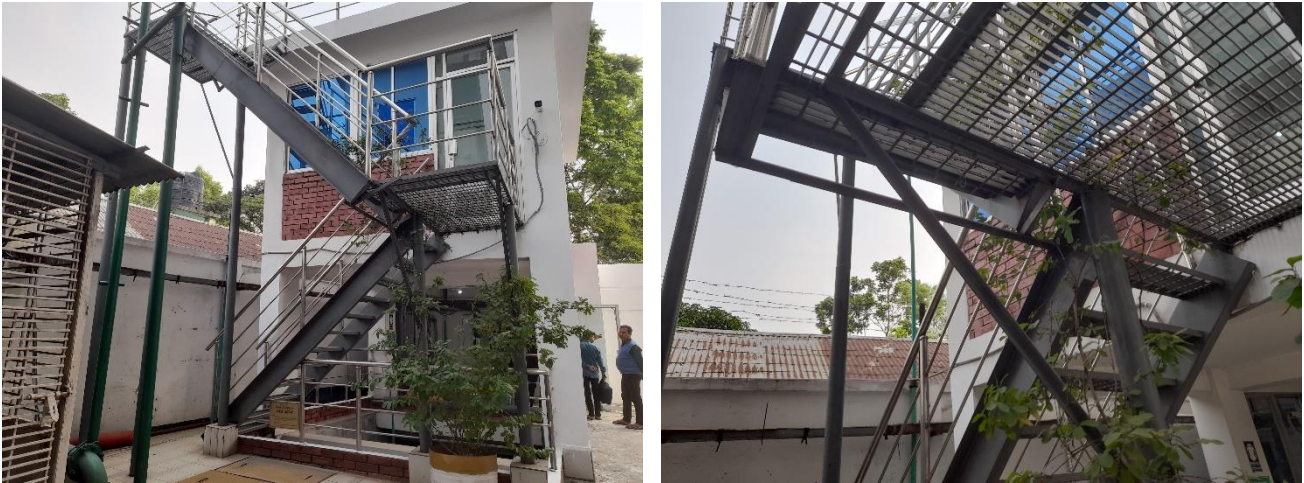
Observation-6: Inadequate steel stair Buiding-4 (ETP Building).

Inadequate connection

Description: There is an external steel stair from the Ground to the 1st floor which was poorly embedded in RC beam of Buiding-4 (ETP Building). Therefore, the connection of steel members to RC beams appeared to be inadequate. The building engineer is required to check the connection adequacy of the steel stairs as part of EA.

| Observation | Action Plan | Timeline |
|---|--|---|
| Inadequate steel stairs. (Building-4 (ETP Building)) | The building engineer is required to check the connection adequacy of the steel stair as part of EA. | within 6 weeks |
| | Carry out suggested remedial works if required. | within 6 months |

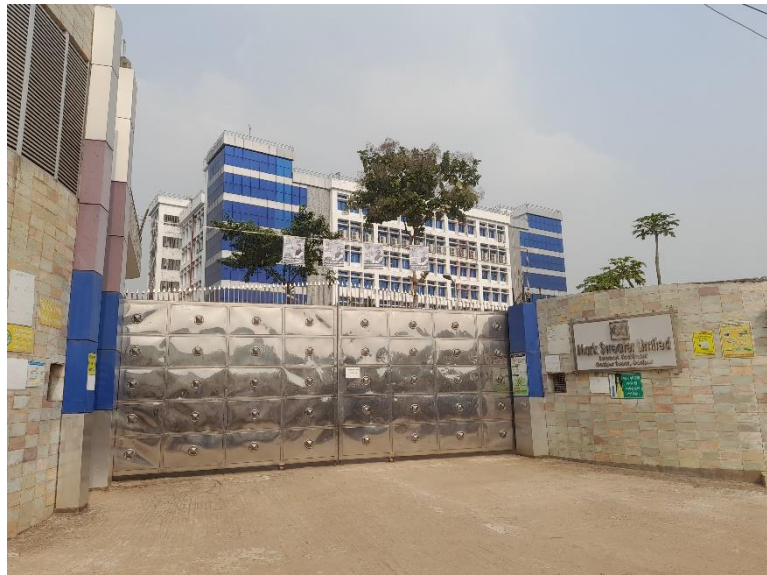
Observation-4: Absence of approval drawing from Local Authority (Buiding-4 (ETP Building), Building-5 (RMS Building), Shed-1 (Wastage shed), Shed-2 (Wastage Shed-2), and Shed-3 (Parking shed)).

Description: During the inspection, no building permit drawing was available for Buiding-4 (ETP Building), Building-5 (RMS Building), Shed-1 (Wastage shed), Shed-2 (Wastage Shed-2), and Shed-3 (Parking shed). The building engineer is required to get approval for all structures from the local authority for the structures.

| Observation | Action Plan | Timeline |
|---|--|---|
| Absence of approval drawing from local authority. (Building-4 (ETP Building), Building-5 (RMS Building), Shed-1 (Wastage shed), Shed-2 (Wastage Shed-2), and Shed-3 (Parking shed)) | The building engineer is required to get approval from the local authority for the structure. | within 6 months |

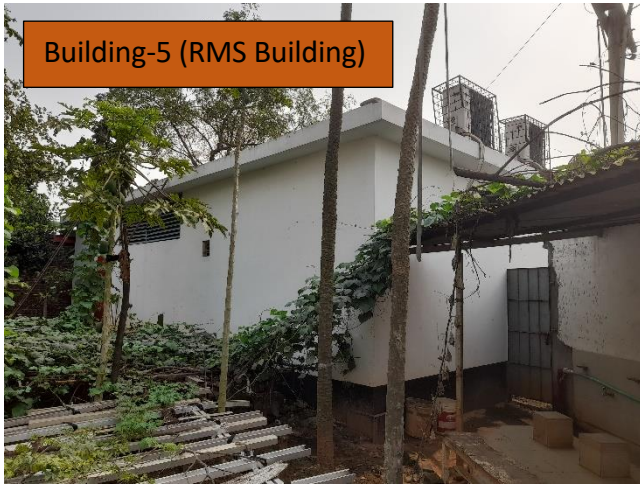
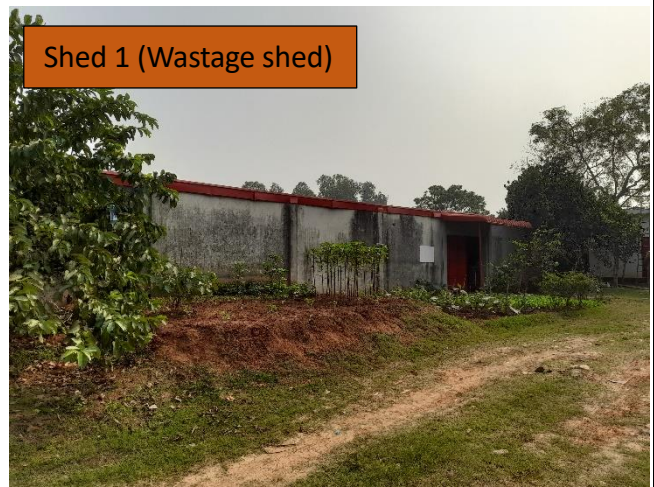
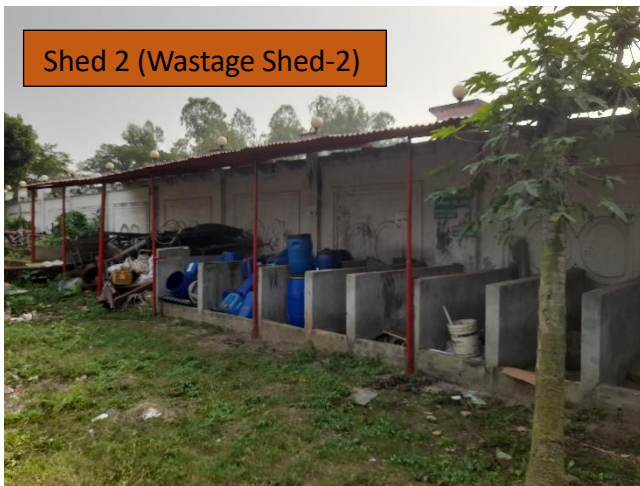
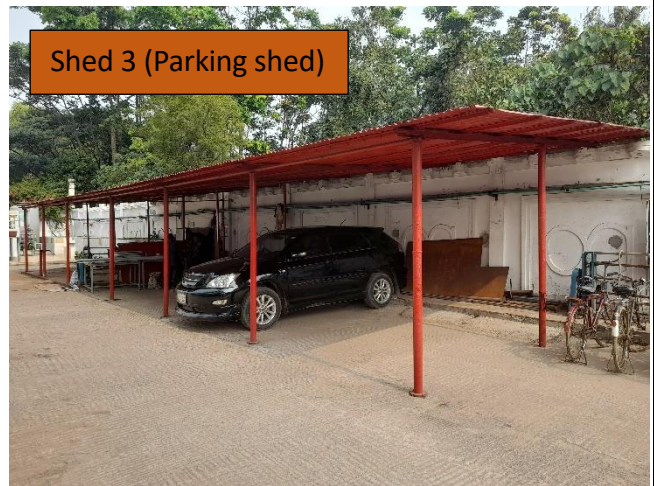
Observation-07: Lack of as-built drawing. (Building-5 (RMS Building), Shed-1 (Wastage shed), Shed-2 (Wastage Shed-2), and Shed-3 (Parking shed)).

Description: During inspection, no as-built drawings were available for (Building-5 (RMS Building), Shed-1 (Wastage shed), Shed-2 (Wastage Shed-2), and Shed-3 (Parking shed)). The building engineer is required to survey the full structure and produce accurate as-built drawings.

| Observation | Action Plan | Timeline |
|---|--|---|
| Lack of as-built drawing. (Building-5 (RMS Building), Shed-1 (Wastage shed), Shed-2 (Wastage Shed-2), and Shed-3 (Parking shed)). | The building engineer is required to survey the full structure and produce accurate as-built drawings. | within 6 weeks |

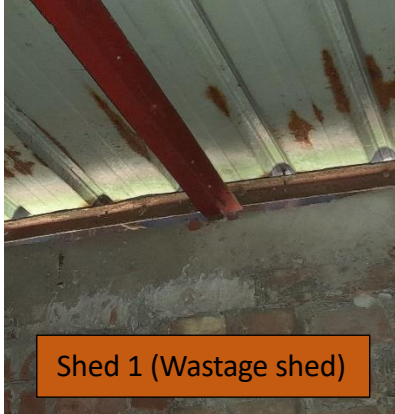
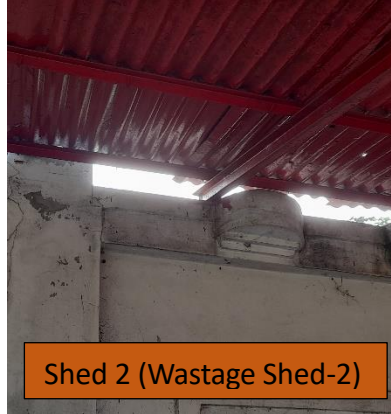
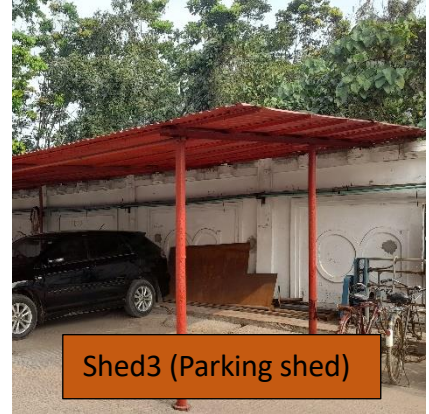
Observation-08: Apparently inadequate connection. (Shed-1 (Wastage shed), Shed-2 (Wastage Shed-2), and Shed-3 (Parking shed))

Apparently inadequate connection

Description: Apparently inadequate connections between column and truss members were observed on (Shed-1 (Wastage shed), Shed-2 (Wastage Shed-2), and Shed-3 (Parking shed)). The building engineer is required to check the connection adequacy of the lightweight roof against uplift wind pressure.

| Observation | Action Plan | Timeline |
|---|--|---|
| Inadequate connection. (Shed-1 (Wastage shed), Shed-2 (Wastage Shed-2), and Shed-3 (Parking shed)). | The building engineer is required to check the connection adequacy of the lightweight roof against uplift wind pressure. | within 6 months |
| | Carry out remediation work if required. | within 6 weeks |
