# Dana Sweater Industries Ltd (New)

Holding No-97, Shoildubi, Kashimpur, Gazipur.

18 December 2023

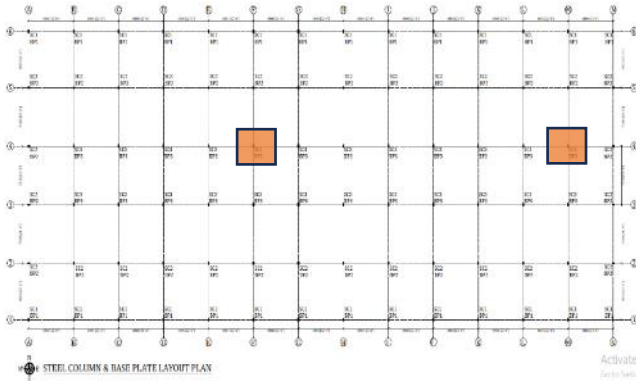
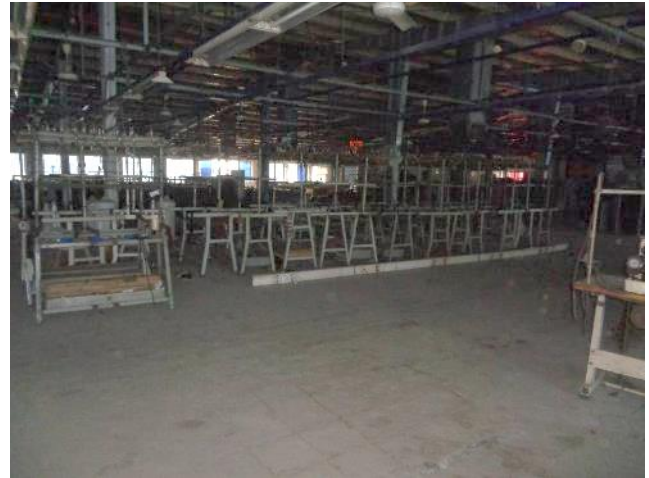
**Observation-1:** High stress in ground floor columns that required immediate design review (Production Building-1).

**Description:** Cursory calculation indicates high stress in ground floor columns (marked above) considering prepared live load 4 kPa for typical floor and minimum steel strength. The building engineer is immediately required to carry out a Detailed Engineering Assessment (DEA) for the structure. Also, maintain live load 2 kPa on 1<sup>st</sup> floor until the DEA is finalized.

| Observation | Action Plan | Timeline |
|---|---|---|
| High stress in ground floor columns that required immediate design review (Production Building-1) | Factory is required to maintain live load 2 kPa for 1 <sup>st</sup> floor until the DEA is finalized | Immediate |
| High stress in ground floor columns that required immediate design review (Production Building-1) | The building engineer is immediately required to carry out a Detailed Engineering Assessment (DEA) for the structure. | within 6 weeks |
| High stress in ground floor columns that required immediate design review (Production Building-1) | Implement remediation work if required. | within 6 months |
| High stress in ground floor columns that required immediate design review (Production Building-1) | Implement floor load plan. | within 6 months |

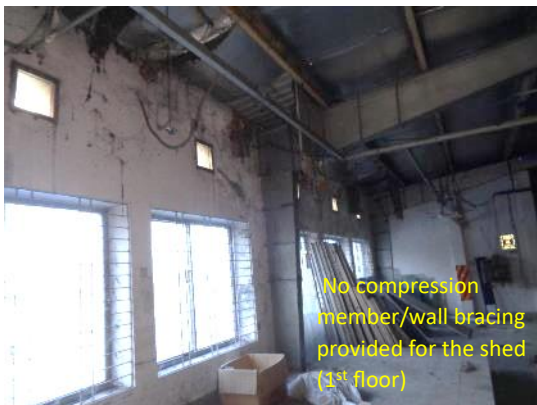
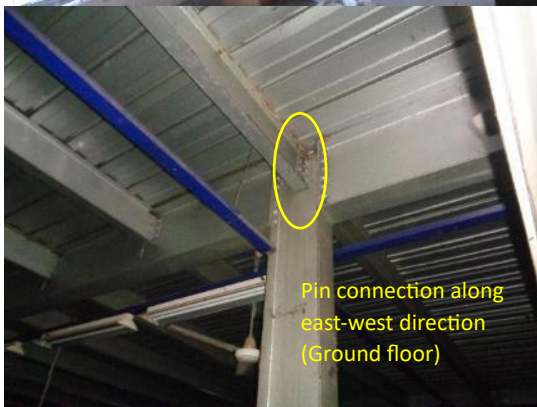
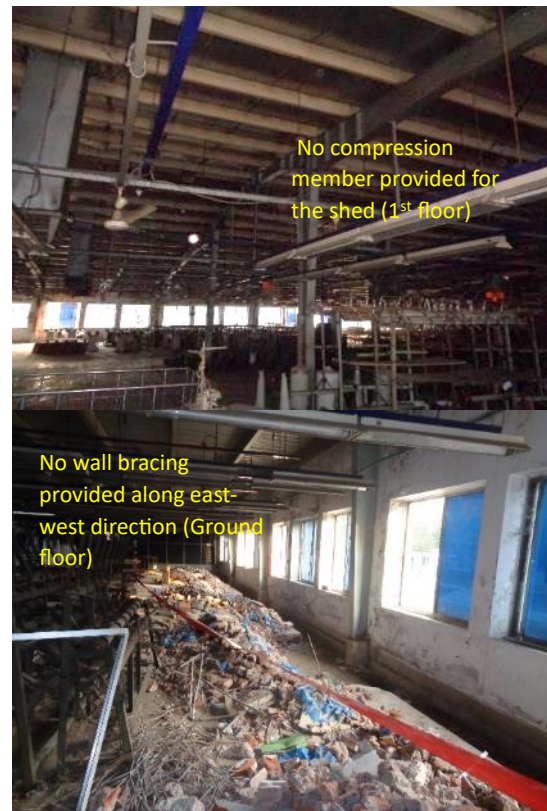
**Observation-2:** Lack of lateral stability (Production Building-1)

**Description:** The compression member was absent in the bracing system which may cause inactive lateral stability of the roof. Also, for the ground floor, pin connection is provided along east-west direction, but no vertical bracing is provided. The building engineer is required to check the lateral stability system of the structure and suggest necessary remedial action accordingly.

| Observation | Action Plan | Timeline |
|---|---|---|
| Lack of lateral stability (Production Building-1). | The building engineer is required to check the lateral stability system of the structure and suggest necessary remedial action. | within 6 weeks |

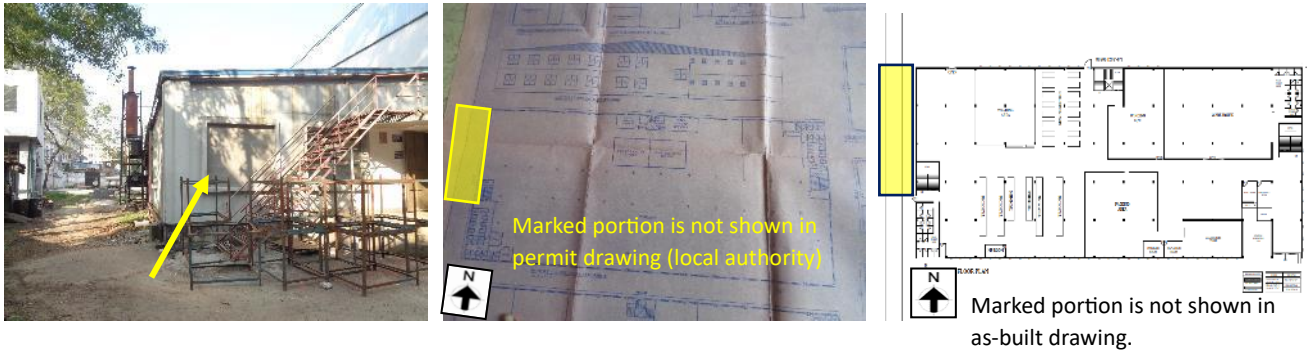
**Observation-3:** Undocumented horizontal expansion at west side (Production Building-1).

**Description:** Undocumented horizontal expansion was found at west side of the structure. The factory is required to collect updated permit drawings from the local authority. The building engineer is required to update the as-built drawing and design report accordingly.

| Observation | Action Plan | Timeline |
|---|---|---|
| Undocumented horizontal expansion at west side (Production Building-1). | The factory is required to collect updated permit drawings from the local authority. | within 6 months |
| Undocumented horizontal expansion at west side (Production Building-1). | The building engineer is required to update the as-built drawing. | within 6 weeks |
| Undocumented horizontal expansion at west side (Production Building-1). | Update design report accordingly. | within 6 weeks |

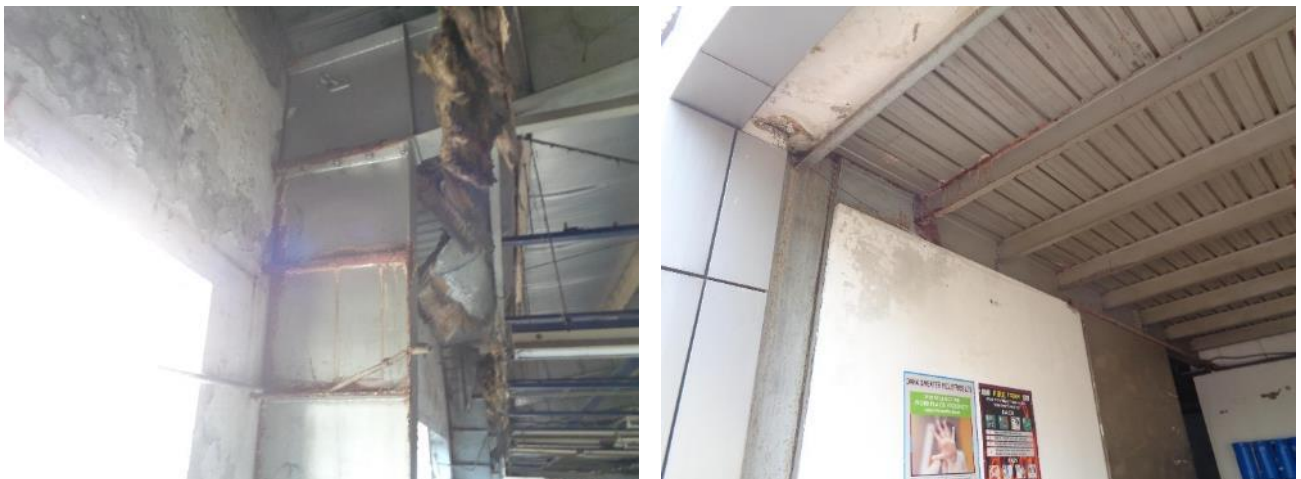
**Observation-4:** Severe corrosion found on steel members (Production Building-1).

**Description:** Severe corrosion was found on steel members. The building engineer is required to provide rust proof paint on steel members.

| Observation | Action Plan | Timeline |
|---|---|---|
| Severe corrosion found on steel members (Production Building-1). | The building engineer is required to remove the corrosion and provide rust proof paint on steel members. | within 6 weeks |

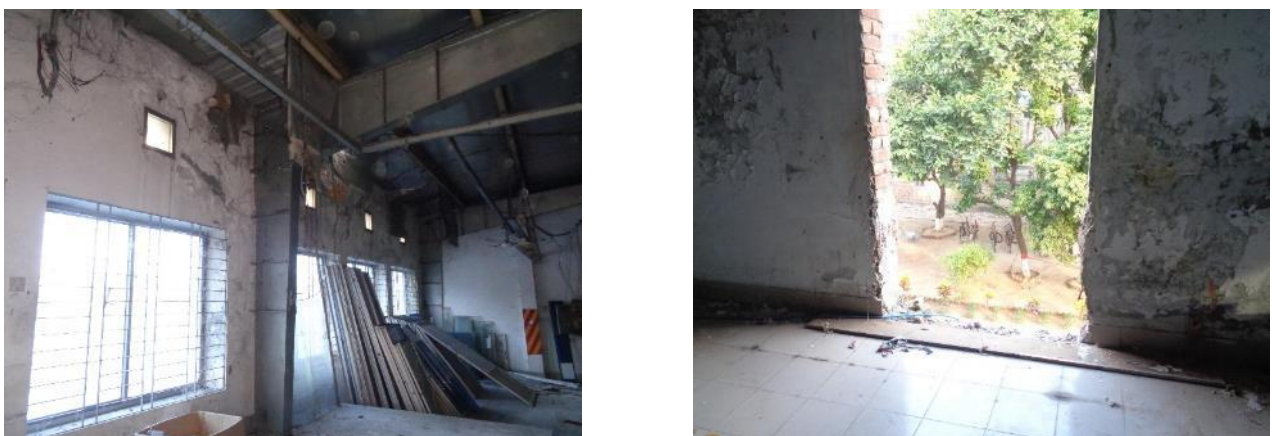
**Observation-5:** Dampness on wall (Production Building-1).

**Description:** Dampness was found on brick wall. The building engineer is required to repair the damp areas.

| Observation | Action Plan | Timeline |
|---|---|---|
| Dampness on wall (Production Building-1). | The building engineer is required to repair the damp areas. | within 6 weeks |

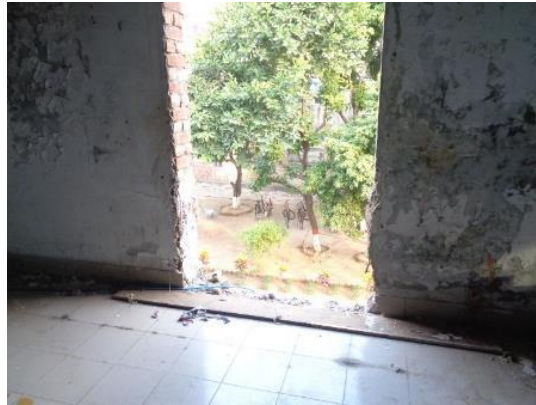
**Observation-6:** Falling hazard at 1<sup>st</sup> floor (Production Building-1).

**Description:** Parapet/railing was not found on the 1st floor. The building engineer is required to provide edge protection to avoid falling hazard.

| Observation | Action Plan | Timeline |
|---|---|---|
| Falling hazard at 1 <sup>st</sup> floor (Production Building-1). | The building engineer is required to provide edge protection to avoid falling hazard. | within 6 weeks |

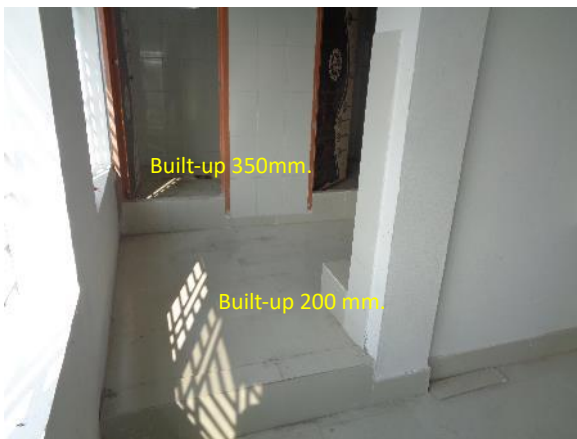
**Observation-7:** Discrepancy in architectural drawing (Production Building-2)

Undocumented toilet built up at second floor.

**Description:** Undocumented floor built-up found at toilet areas. The building engineer is required to update the as-built drawing and analysis model accordingly.

| Observation | Action Plan | Timeline |
|---|---|---|
| Discrepancy in architectural drawing (Production Building-2) | The building engineer is required to update the as-built drawing and analysis model accordingly. | within 6 weeks |

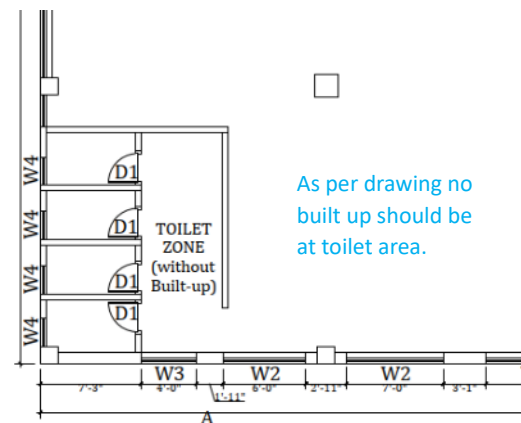
Toilet built up is not shown for typical floor.

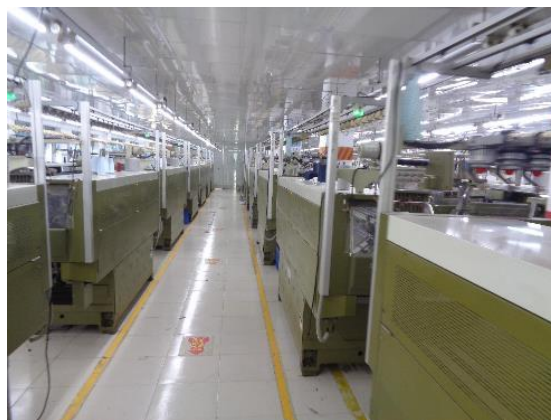
**Observation-8:** Lack of load plan for 1<sup>st</sup> floor (Production Building-2).

**Description:** Load plan for 1<sup>st</sup> floor was not available at the time of inspection. The building engineer is required to produce load plan for 1<sup>st</sup> floor and include in design report.

| Observation | Action Plan | Timeline |
|---|---|---|
| Lack of load plan for 1st floor (Production Building-2). | The building engineer is required to produce load plan based on column & foundation capacity. | within 6 weeks |
| Lack of load plan for 1st floor (Production Building-2). | Implement remediation work if required. | within 6 months |

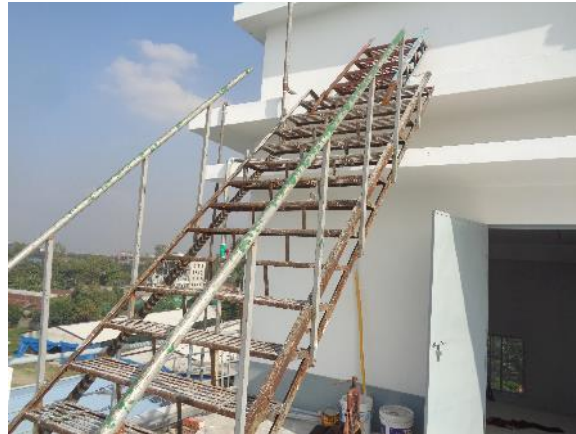
**Observation-9:** Corrosion on steel ladder at roof (Production Building-2)

**Description:** Corrosion was found on steel members. The building engineer is required to provide rust proof paint on steel members.

| Observation | Action Plan | Timeline |
|---|---|---|
| Corrosion on steel ladder at roof (Production Building-2) | The building engineer is required to provide rust proof paint on steel members. | within 6 weeks |

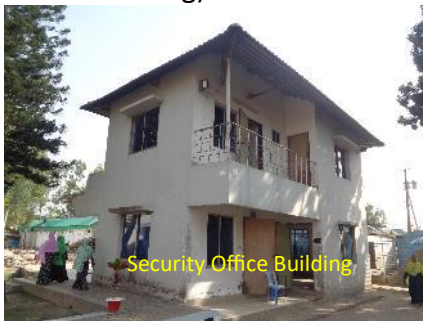
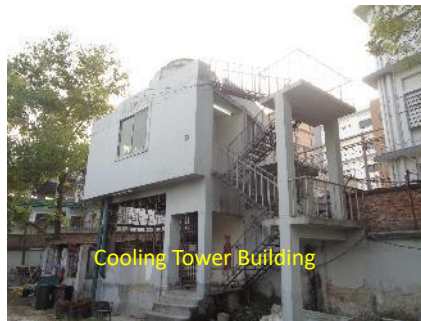
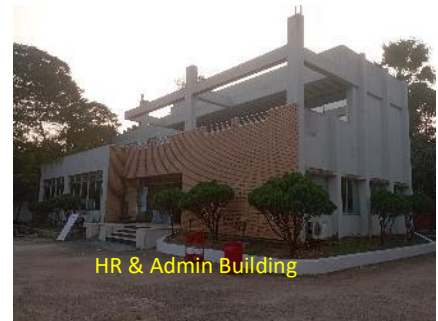
**Observation-10:** Lack of design documents (HR & Admin Building, Security Office Building, Cooling Tower Building).

**Description:** As per BNBC, every building or structure designed shall have its design documents prepared in accordance with the provision of Section 1.9.1. The design document shall include a design report, and a set of structural drawings, which shall be prepared in compliance with section 1.9.1.1 and section 1.9.1.2 as per BNBC. At the time of inspection, design report/as-built drawing was not available. The building engineer is required to prepare a set of as-built drawing and design reports as per 1.9.1 of BNBC.

| Observation | Action Plan | Timeline |
|---|---|---|
| Lack of design documents (HR & Admin Building) | The building engineer is required to prepare a set of as-built drawing and design reports as per 1.9.1 of BNBC. | within 6 weeks |
| Lack of design documents (HR & Admin Building) | Carry out remedial works where required. | within 6 months |
| Lack of design documents (Security Office Building) | The building engineer is required to prepare a set of as-built drawing and design reports as per 1.9.1 of BNBC. | within 6 weeks |
| Lack of design documents (Security Office Building) | Carry out remedial works if required. | within 6 months |
| Lack of design documents (Cooling Tower Building) | The building engineer is required to prepare a set of as-built drawing and design reports as per 1.9.1 of BNBC. | within 6 weeks |
| Lack of design documents (Cooling Tower Building) | Carry out remedial works if required. | within 6 months |

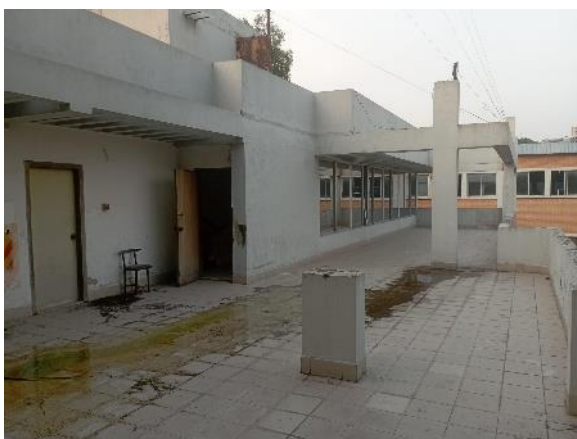
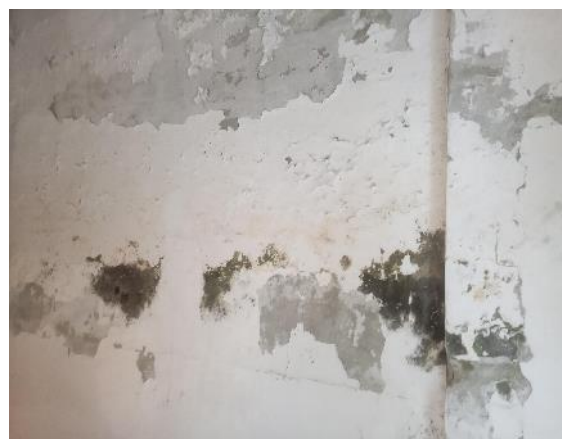
**Observation-11:** Dampness/vegetation on wall/water ponding on roof slab (HR & Admin Building)

**Description:** Dampness/vegetation was found on brick wall. Also, water ponding was found on roof slab. The building engineer is required to repair the damp areas. Also, improve drainage system on roof slab.

| Observation | Action Plan | Timeline |
|---|---|---|
| Dampness/vegetation on wall/Water ponding on roof slab (HR & Admin Building) | The building engineer is required to repair the damp areas. | within 6 weeks |
| Dampness/vegetation on wall/Water ponding on roof slab (HR & Admin Building) | Improve drainage system on roof slab. | within 6 weeks |

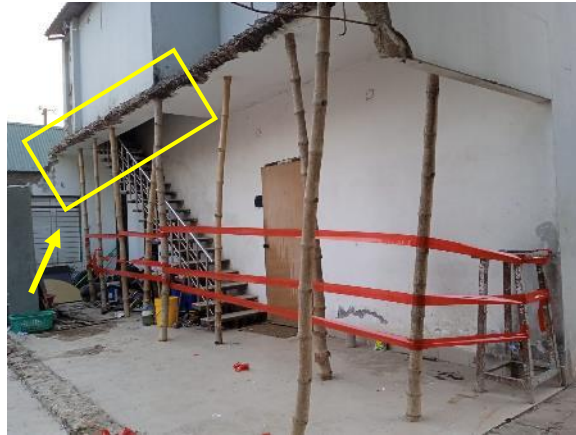
**Observation-12:** Apparently inadequate slab (Security Office Building)

**Description:** Brick wall is supported by a strip of slab only which appeared to be inadequate. The building engineer is required to check the adequacy of the load bearing slab and propose any suitable alternatives.

| Observation | Action Plan | Timeline |
|---|---|---|
| Apparently inadequate slab (Security Office Building) | The building engineer is required to check the adequacy of the load bearing slab and propose any remediation work if required. | within 6 weeks |

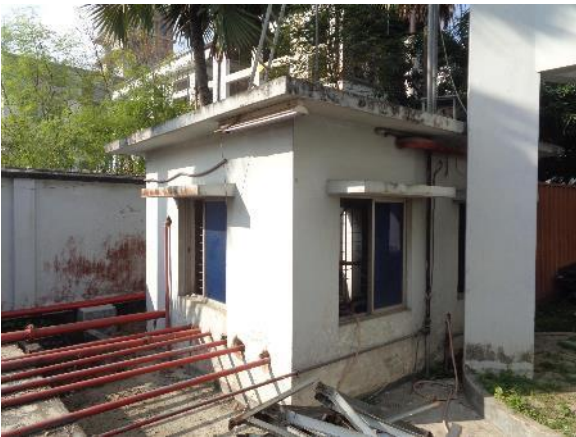
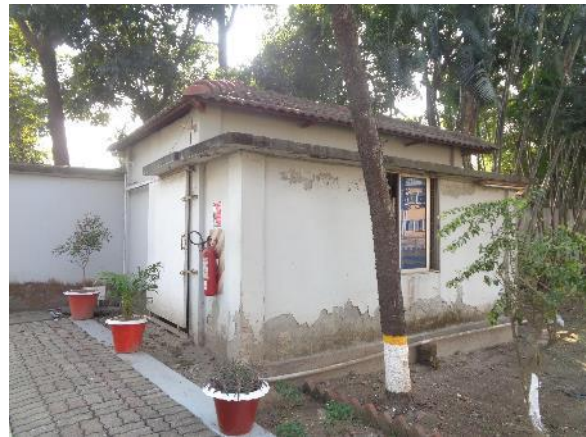
**Observation-13:** Lack of as-built drawing (Pump Room, RMS Room).

**Description:** As-built drawing was not available for the Pump Room and RMS Room. The building engineer is required to produce as-built drawing.

| Observation | Action Plan | Timeline |
|---|---|---|
| Lack of as-built drawing (Pump Room, RMS Room). | The building engineer is required to prepare a set of as-built drawing. | within 6 weeks |
