# LIBERTY KNITWEAR LTD. (Extension)

Ramarbag, Fatullah, Narayanganj.

19 December 2023

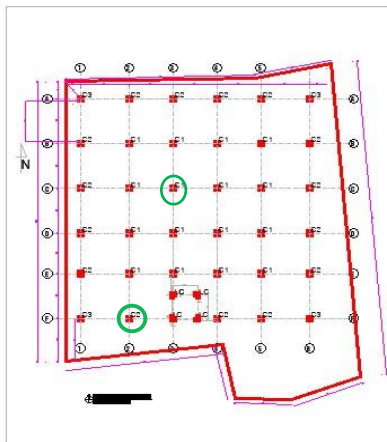
**Observation-1:** Stress in column exceeds normal design limit (ETP Building).

**Description:** The cursory calculation indicates that column stress exceeds the normal design limit considering a typical floor live load of 6kPa/4 kpa for storage, roof live load of 1.5 kPa, and concrete strength of 16.3 MPa. The building engineer is required to review the design, loads, and column stresses for the marked columns based on in-situ material strength.

| Observation | Action Plan | Timeline |
|---|---|---|
| Stress in column exceeds normal design limit (ETP Building) | Building Engineer to review design, loads and column stresses in the area identified above. | within 6 weeks |
| Stress in column exceeds normal design limit (ETP Building) | Verify in-situ concrete stresses by 100mm dia. cores from a minimum 4 no's from lower tier columns. | within 6 weeks |
| Stress in column exceeds normal design limit (ETP Building) | Produce and actively manage a floor live load plan for all floors of the building based on floor, column & foundation capacity. | within 6 weeks |
| Stress in column exceeds normal design limit (ETP Building) | Carry out remedial works where required. | within 6 months |
| Stress in column exceeds normal design limit (ETP Building) | Continue to implement allowable floor load plan. | within 6 months |

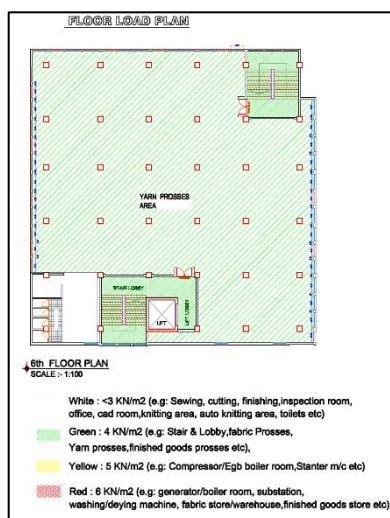
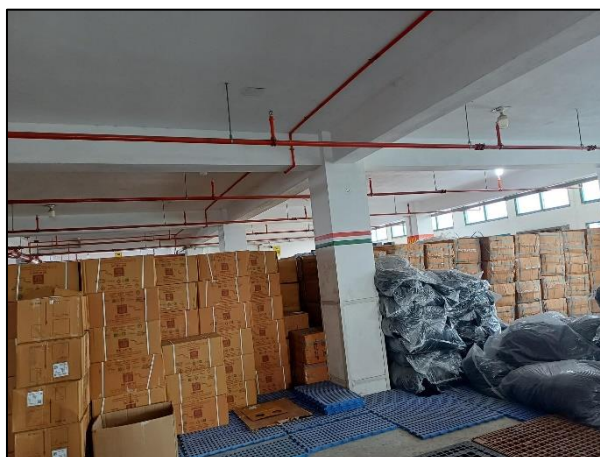
Storage area

**Observation-2:** Storage live load limit does not comply with BNBC requirement (ETP Building).

Prepared load plan for 6th floors. Floor loading considered 4kPa (84 psf) for storage areas.

**Description:** As per BNBC, 6 kPa is required to consider as floor loading for the light storage facilities. During inspection, load plan was found posted considering (84 psf) 4kPa at typical floor storage area. Also, 4 kPa live load considered in design report. However, update the storage live load limit as per BNBC requirement, revise the structural analysis & design accordingly.

| Observation | Action Plan | Timeline |
|---|---|---|
| Storage live load limit does not comply with BNBC requirement. (ETP Building) | Revise storage live load limit as per BNBC requirement, update floor load plan and incorporate the changes in the structural analysis and design report. | within 6 weeks |
| Storage live load limit does not comply with BNBC requirement. (ETP Building) | Building engineer is required to incorporate concrete and rebar strength in FEM model and report based on in-situ material strength. | within 6 months |

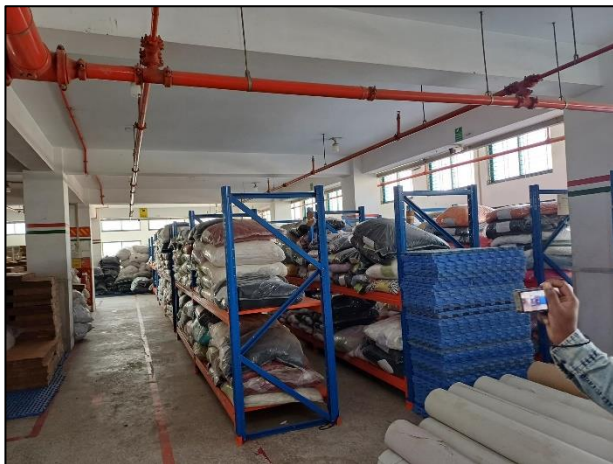
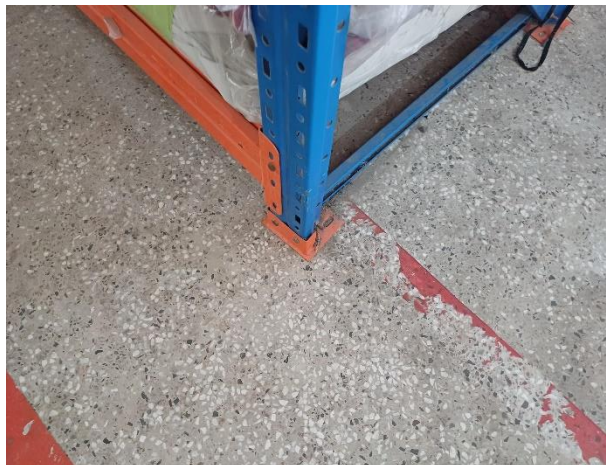
### Observation-4: Storage rack without anchorage (ETP Building).

Storage rack without anchorage

**Description:** Racks on different floors are not adequately anchored or braced to resist lateral (earthquake) forces. The building engineer is required to adequately anchor and brace all non-structural elements to resist earthquake forces to comply with the BNBC.

| Observation | Action Plan | Timeline |
|---|---|---|
| Storage rack without anchorage (ETP Building). | Building Engineer is required to adequately anchor and brace all non-structural elements to resist earthquake forces. | within 6 weeks |

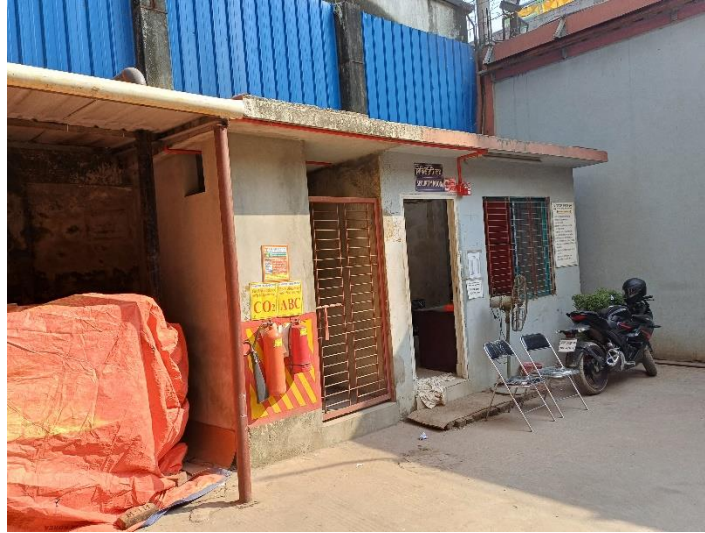
**Observation-5:** Lack of as built drawings (Guard room).

Absence of as built drawings

**Description:** Building engineer is required to prepare a set of as built drawings in compliance with BNBC.

| Observation | Action Plan | Timeline |
|---|---|---|
| Lack of as built drawings (Guard room). | Building engineer is required to prepare a set of as built drawings. | within 6 weeks |

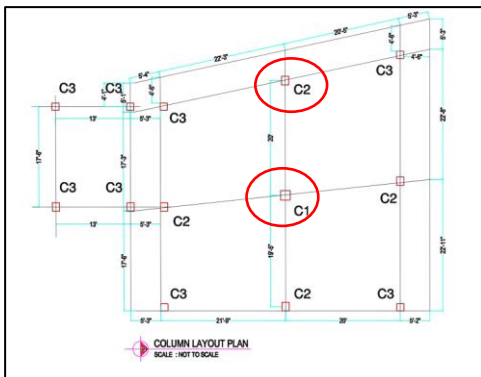
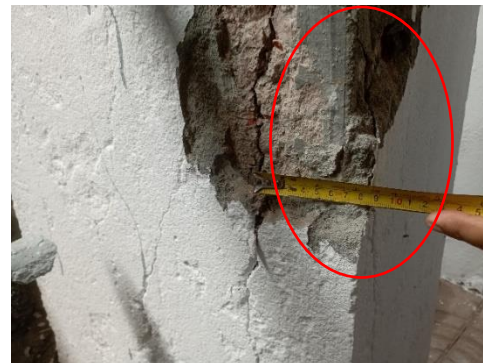
**Observation-6:** Crack in ground floor columns (Canteen Building).

**Description:** Crack was found in marked columns on the ground floor. The factory must immediately engage a consultant to investigate the cracked column. Any safety measures, if required as suggested by the consultant, must be taken immediately to ensure safety. The investigation report along with the repair methodology must be submitted to RSC by December 24, 2023, and the remediation work must be completed within 7 days of receiving acceptance from RSC. Also, carry out a Detailed Engineering Assessment (DEA) of structure based on in-situ material strength. Take concrete cylinder core from ground floor column to determine the in-situ concrete strength.

| Observation | Action Plan | Timeline |
|---|---|---|
| Crack in ground floor columns (Canteen Building). | The factory must immediately engage a consultant to investigate the cracked column. Any safety measures, if required as suggested by the consultant, must be taken immediately to ensure safety. | Immediate |
| Crack in ground floor columns (Canteen Building). | The investigation report along with the repair methodology must be submitted to RSC. | December 24, 2023. |
| Crack in ground floor columns (Canteen Building). | The remediation work for the cracked columns must be completed as per investigation report. | within 6 weeks |
| Crack in ground floor columns (Canteen Building). | Carryout a Details Engineering Assessment (DEA) of the structure. | within 6 weeks |
| Crack in ground floor columns (Canteen Building). | Take concrete cylinder core from ground floor column to determine the in-situ concrete strength. | within 6 weeks |
| Crack in ground floor columns (Canteen Building). | Carry out suggested remedial works for the building from DEA. | within 6 months |

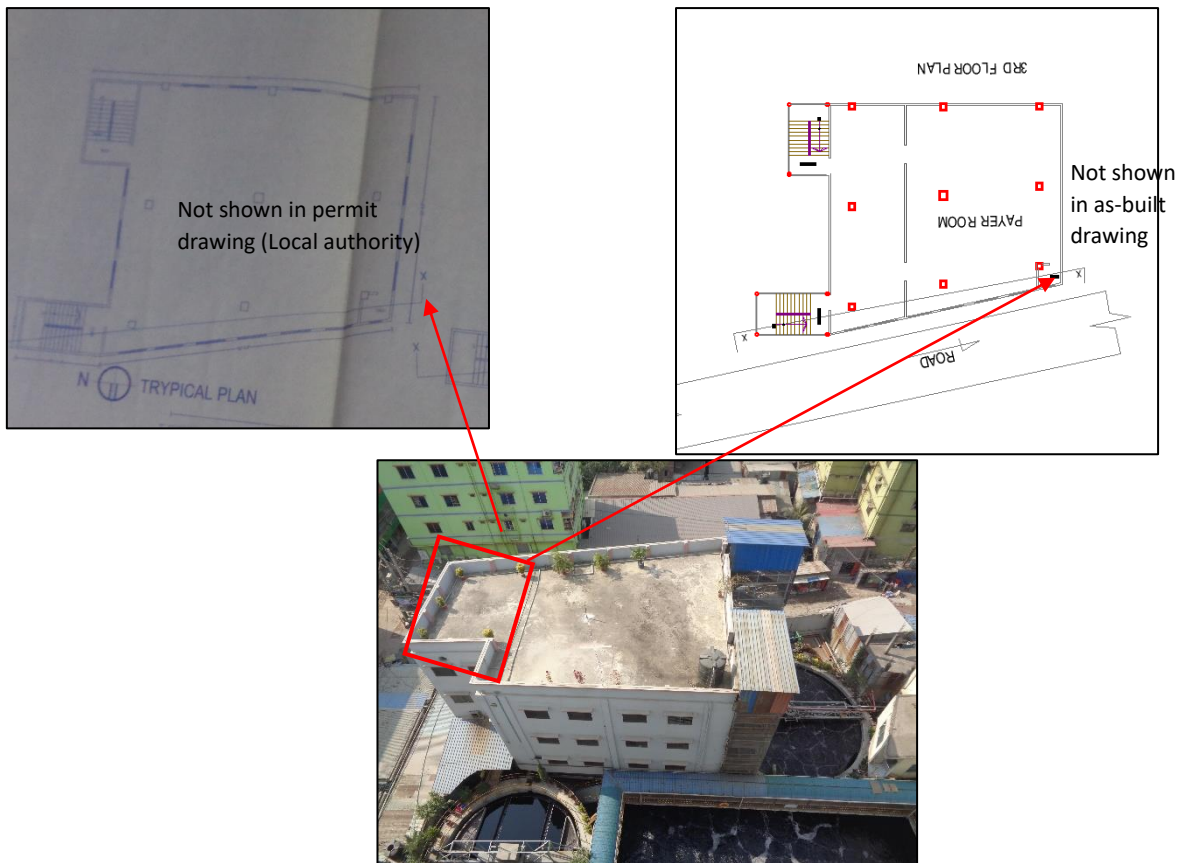
**Observation-7:** Discrepancy in permit drawing and as-built drawing (Canteen Building).

**Description:** Marked portion at south side is not shown in permit drawing (Local authority) and as-built drawing. The factory is required to collect revised permit drawings from the local authority. Also, the building engineer is required to update as-built drawing.

| Observation | Action Plan | Timeline |
|---|---|---|
| Discrepancy in permit drawing and as-built drawing (Canteen Building). | The factory is required to collect revised permit drawings from the local authority. | within 6 months |
| Discrepancy in permit drawing and as-built drawing (Canteen Building). | The building engineer is required to survey the full structure update as-built drawings. | within 6 weeks |

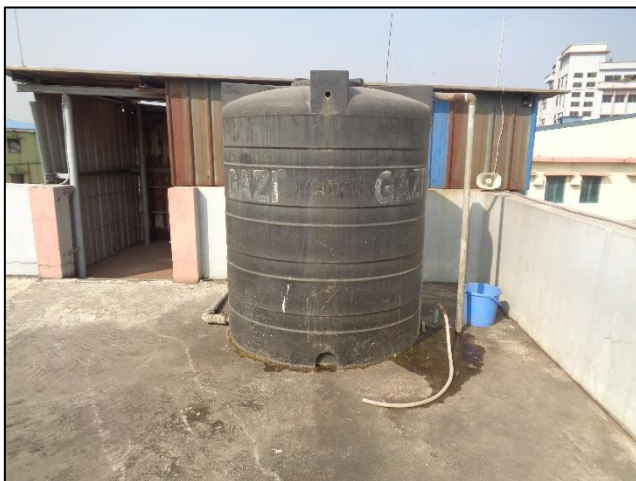
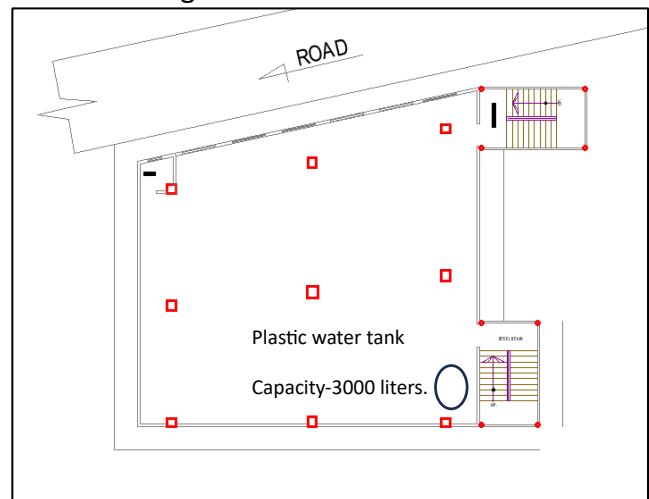
**Description:** A plastic water tank (capacity 3000 liter) found on roof slab which was not shown in as-built drawing. The building engineer is required to update as-built drawing.

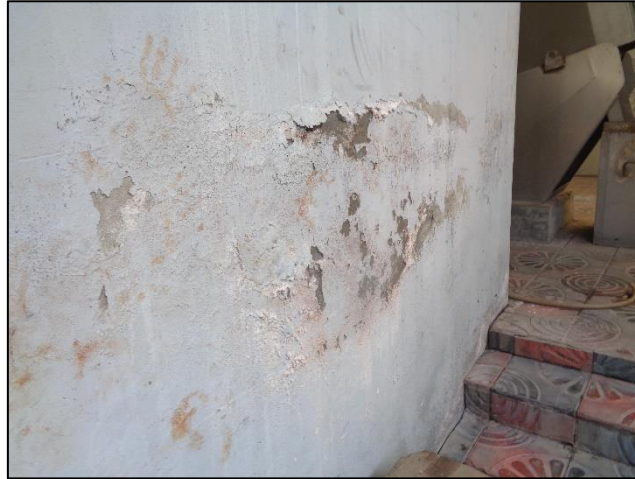
**Observation-8:** Dampness on brick wall at ground floor (Canteen Building).

**Description:** Dampness was found on brick wall on the ground floor. The building engineer is required to identify all damp areas and repair them with a suitable method.

| Observation | Action Plan | Timeline |
|---|---|---|
| Dampness on brick wall at ground floor (Canteen Building). | The building engineer is required to identify all damp areas and repair them with a suitable method. | within 6 weeks |

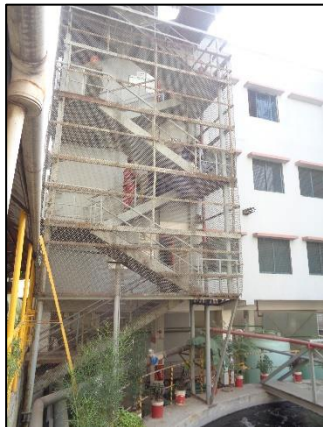
Stair at east side

**Observation-9:** Lack of lateral stability of steel stair (Canteen Building).

**Description:** No bracing system was found on any of the steel stairs. The building engineer is required to check the lateral stability of steel stairs as part of EA.

| Observation | Action Plan | Timeline |
|---|---|---|
| Lack of lateral stability of steel stair (Canteen Building). | The building engineer is required to check the lateral stability of steel stairs as part of EA. | within 6 weeks |
| Lack of lateral stability of steel stair (Canteen Building). | Carry out suggested remedial works if required. | within 6 months |

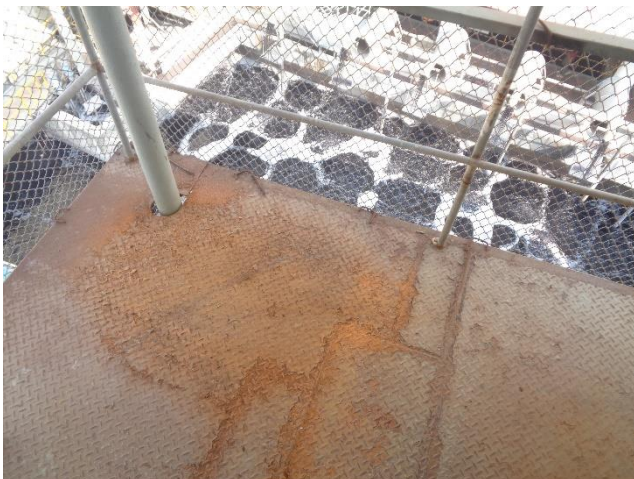
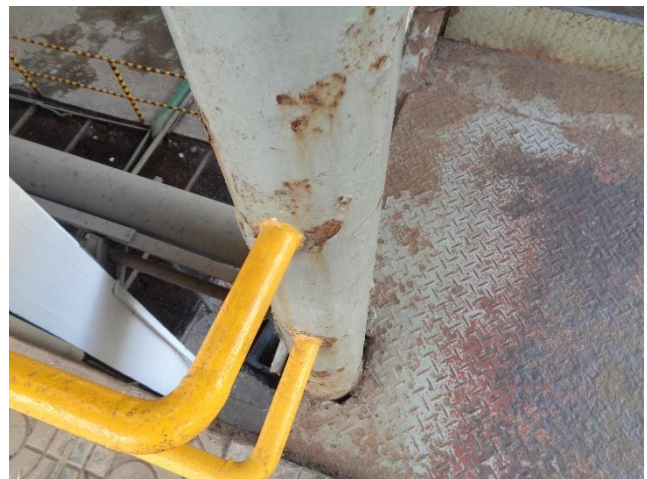
**Observation-10:** Severe corrosion on steel members at steel stairs (Canteen Building).

**Description:** Severe corrosion was found on steel members at both steel stairs. The building engineer is required to remove the corrosion from the steel members and apply rust proof paint.

| Observation | Action Plan | Timeline |
|---|---|---|
| Severe corrosion on steel members at steel stairs (Canteen Building). | The building engineer is required to remove the corrosion from the steel members and apply rust proof paint. | within 6 weeks |
