# Apparels Village Ltd. (Shirts) - New Building 2

37, Khagan, Birulia-1340, Dhaka, Bangladesh

2 January 2024

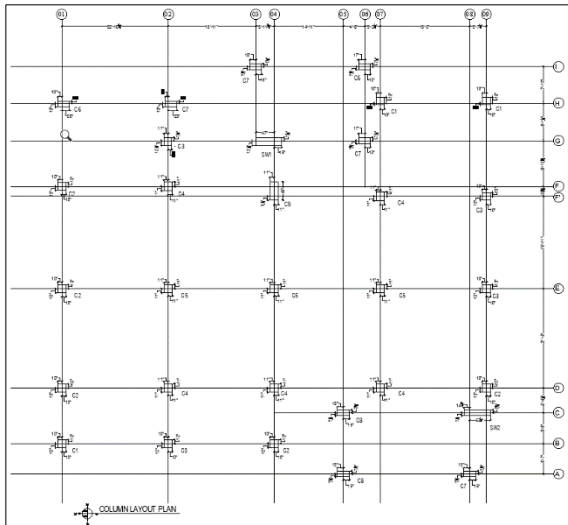
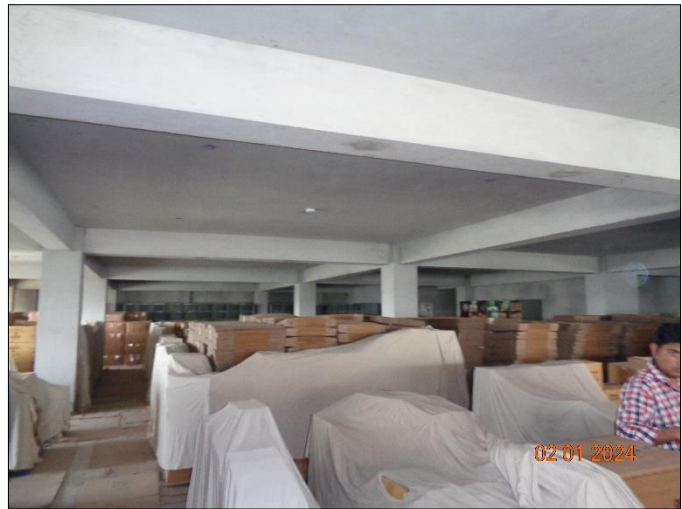
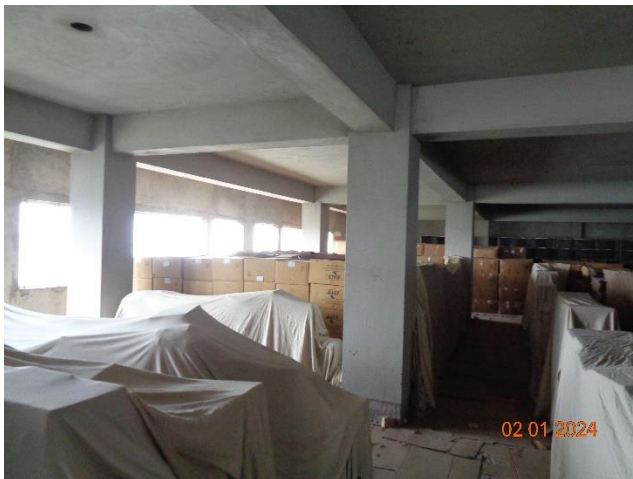
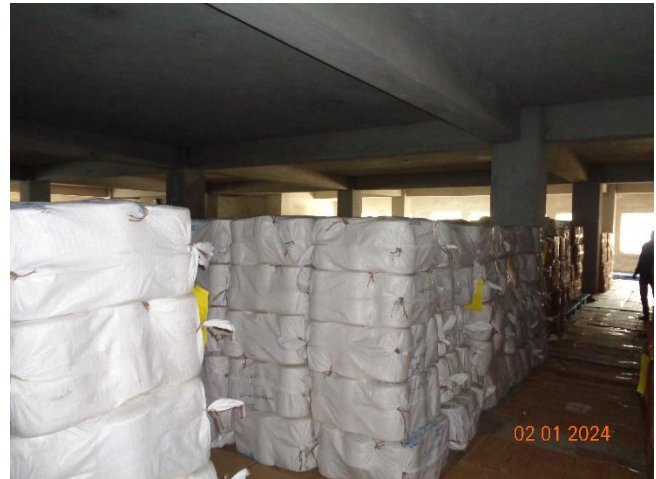
Column Layout plan and floor loading

### Observation-1: Stress in the column exceeds normal design limit. Building-8 (Warehouse-2)

**Description:** The cursory calculation indicates that column stress exceeds the normal design limit considering a typical floor live load of 6kPa, roof live load of 1.5 kPa, and concrete strength of 16.31 MPa and tensile re-bar strength 413MPa.

The building engineer is required to verify in-situ concrete stresses either by concrete cores (100mm dia. cores from column and floor based on material types) or existing cylinder strength data. Building Engineer is required to review design, loads and columns stresses based on in-situ concrete strength following recent building code.

During inspection, the load plan was not available. Building engineers is required to produce and actively manage a loading plan for all floor plates within the factory considering floor, column and foundation capacity.

| SL. No. | Observation | Action Plan | Timeline |
|---|---|---|---|
| 1. | Stress in the column exceeds normal design limit. Building-8 (Warehouse-2) | Building Engineer to review design, loads and column stresses. | within 6 weeks |
| 2. | Stress in the column exceeds normal design limit. Building-8 (Warehouse-2) | Verify in-situ concrete strength by taking concrete core or adequate cylinder test report from all types of structural members. | within 6 weeks |
| 3. | Stress in the column exceeds normal design limit. Building-8 (Warehouse-2) | Produce and actively manage a loading plan for all floor plates considering floor, column and foundation capacity. | within 6 months |

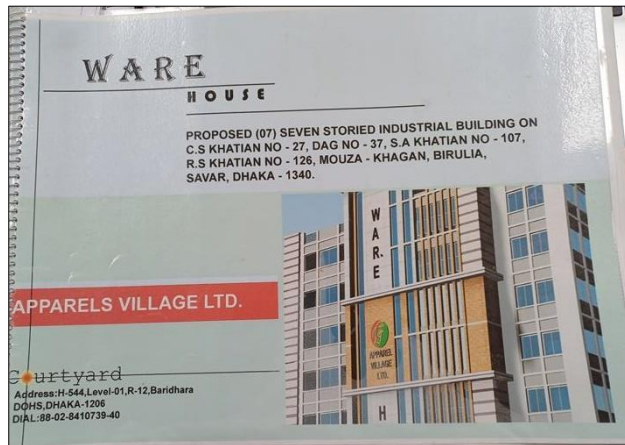
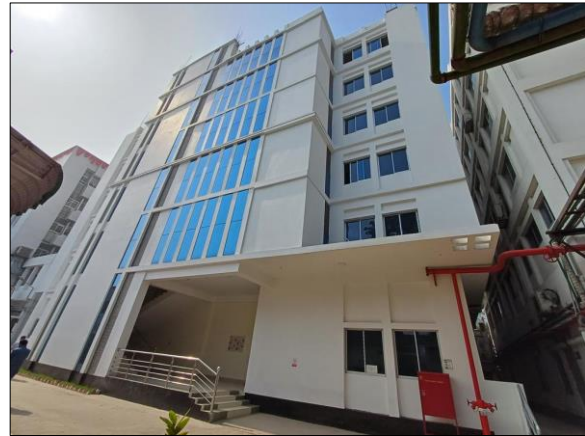
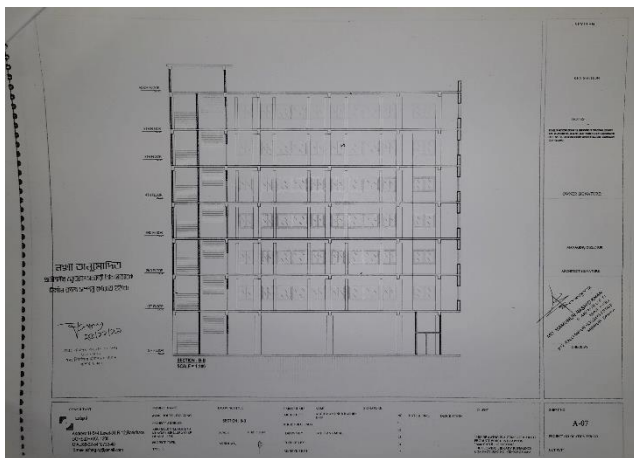
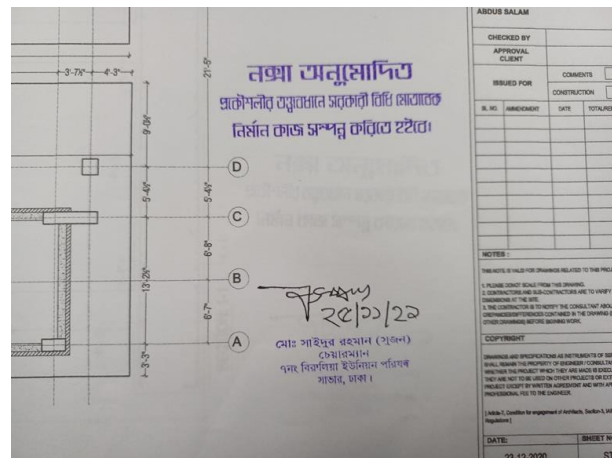
Proposed for the seven storied and constructed up to six storied.

**Observation-2:** Detail Engineering Assessment (DEA) needs to be performed before Future Vertical Extension. Building-8 (Warehouse-2)

**Description:** The building permission layout is for seven storied structure from Birulia union parishad dated 25-Nov-2021. But the construction of the building was started in October 2020 and completed up to six stories in February 2023.

So, there is a possibility of future vertical extension. Building engineer is required to prepare full set of drawing & documents for the seven storied structure prior to commencement of further extension work.

| SL. No. | Observation | Action Plan | Timeline |
|---|---|---|---|
| 6. | Detail Engineering Assessment (DEA) needs to be performed before Future Vertical Extension. Building-8 (Warehouse-2) | Prior to the vertical extension, building engineer is required to produce a Detailed Engineering Assessment (DEA) of the structure according to BNBC and submit it to RSC for review. | within 6 weeks |

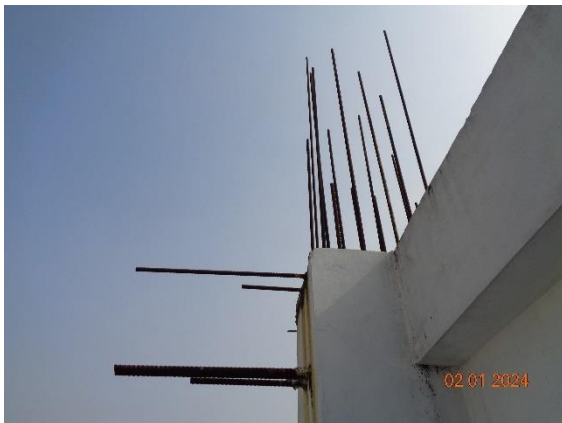
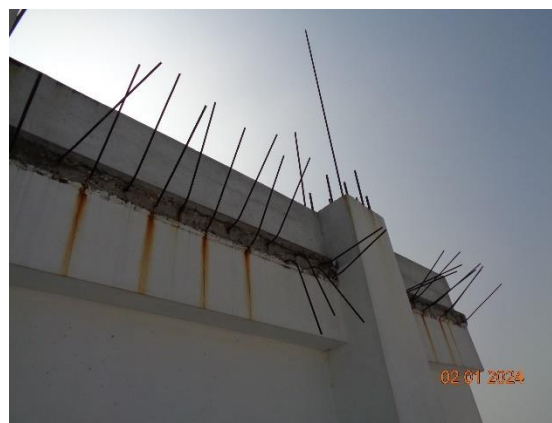
**Observation-3:** Exposed re-bar at roof. Building-8 (Warehouse-2)

**Description:** Exposed reinforcement was found on roof top for columns, beam and slab. Building engineer is required to provide anti-corrosive coating in re-bar to prevent the corrosion in exposed rebar.

| SL. No. | Observation | Action Plan | Timeline |
|---|---|---|---|
| 8. | Exposed re-bar at roof. Building-8 (Warehouse-2) | All exposed reinforcement is to be protected from corrosion which may cause degradation of the concrete. | within 6 months |

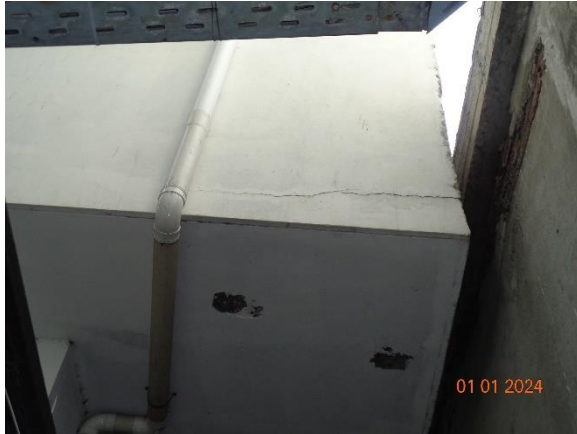
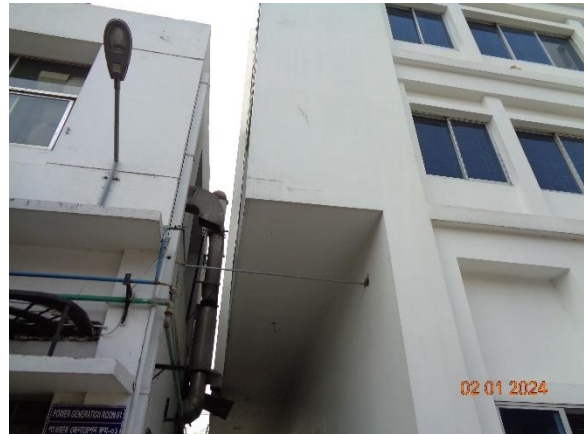
**Observation-4:** Cracks in brick wall supported by cantilever slab. Building-8 (Warehouse-2)

**Description:** During inspection, cracks were found in periphery brick wall supported by cantilever slab. Building engineer is required to investigate the crack considering the deflection of the cantilever slab and carry out suitable repair works.

| SL. No. | Observation | Action Plan | Timeline |
|---|---|---|---|
| 9. | Cracks in brick wall supported by cantilever slab. Building-8 (Warehouse-2) | Building engineer is required to investigate the cause of crack and repair the crack as per recommendation from investigation report. | within 6 weeks |

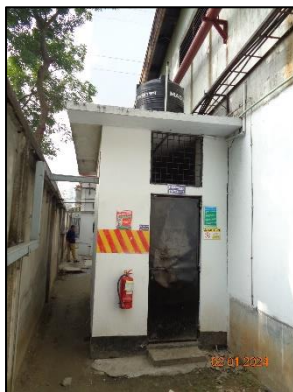
**Observation-5:** Lack of as built drawing (Guard Room, Access Control Room, Ansar Room, RMS Room and Sludge Storage Room).

**Description:** As built drawing of Guard Room, Access Control Room, Ansar Room, RMS Room and Sludge Storage Room were not available on site at the time of inspection. The building engineer required to prepare as built drawing of all these structures.

| SL. No. | Observation | Action Plan | Timeline |
|---|---|---|---|
| 10. | Lack of as built drawing (Guard Room, Access Control Room, Ansar Room, RMS Room and Sludge Storage Room). | The building engineer required to prepare as built drawing of all these structures. | within 6 weeks |

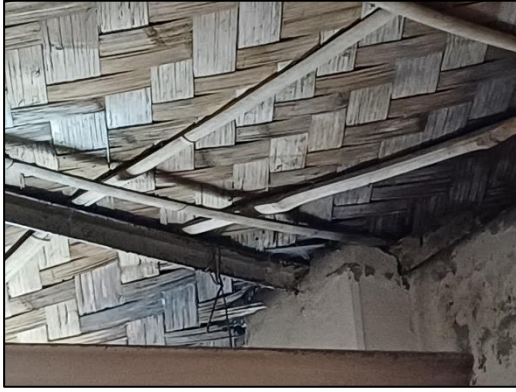
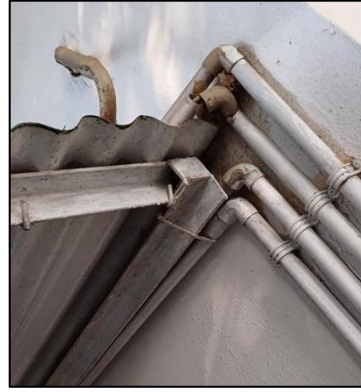
**Observation-6:** Apparently inadequate connection (Ansar Room and RMS Room).

**Description:** Inadequate structural connection details were found in Ansar Room and RMS Room. The Building engineer is required to check the adequacy of the steel connection for uplift forces.

| SL. No. | Observation | Action Plan | Timeline |
|---|---|---|---|
| 11. | Apparently inadequate connection (Ansar Room and RMS Room). | The building engineer is required to check the adequacy of the steel connection for uplift forces. | within 6 weeks |

| 12. | Apparently inadequate connection (Ansar Room and RMS Room). | Carry out remedial work where required. | within 6 months |

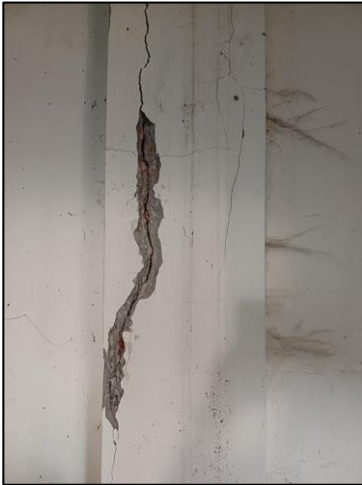
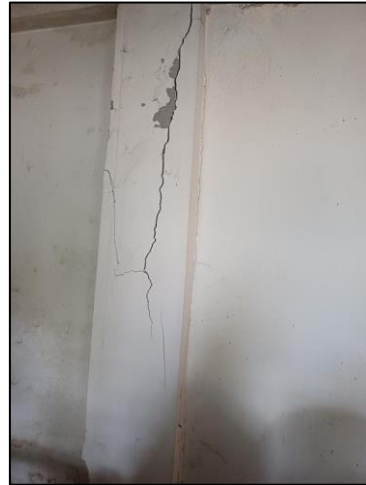
**Observation-7:** Crack on RC column (RMS Room).

**Description:** Crack found in two boundary columns of RMS Room. The building engineer is required to investigate the cause of the crack and repair columns as per recommendation of the investigation report immediately.

| 13. | Crack on RC column (RMS Room). | The building engineer is required to investigate the cause of the crack and repair columns as per recommendation of the investigation report immediately. | Immediate |

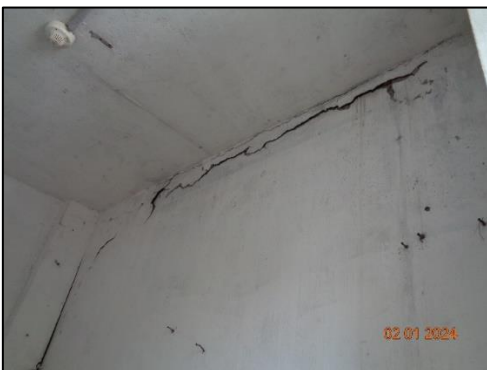
Sludge storage room

**Observation-8:** Crack on wall. (Ansar Room and Sludge storage room).

**Description:** Crack found in the walls of Ansar Room and Sludge storage room. The building engineer is required to investigate the cause of the crack and repair walls as per recommendation of the investigation report.

| 14. | Crack on wall (Ansar Room and Sludge storage room). | The building engineer is required to investigate the cause of the crack and repair walls as per recommendation of the investigation report. | within 6 weeks |

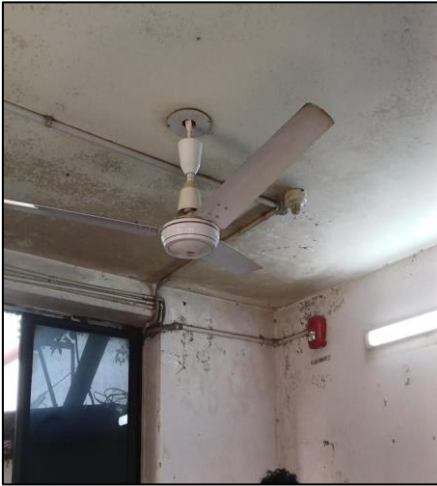
Access control room (dampness on slab)

**Description:** Dampness found on the brick wall of Guard Room, Ansar Room, and Sludge storage room and on slab of Access control room. The building engineer is required to identify the source of dampness and take remedial measures to repair the wall accordingly.

| 15. | Dampness on slab & brick wall (Guard Room, Access control room, Ansar Room, and Sludge storage room). | The building engineer is required to identify the source of dampness and take remedial measures to repair the wall accordingly. | within 6 months |

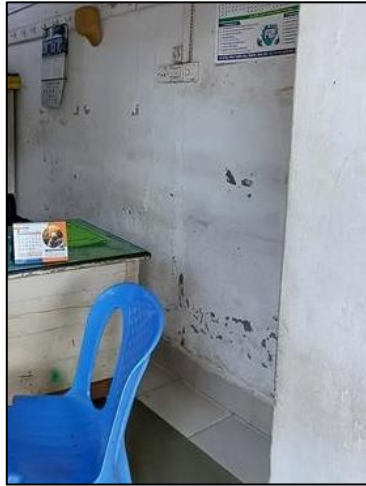
Guard Room (dampness on wall)

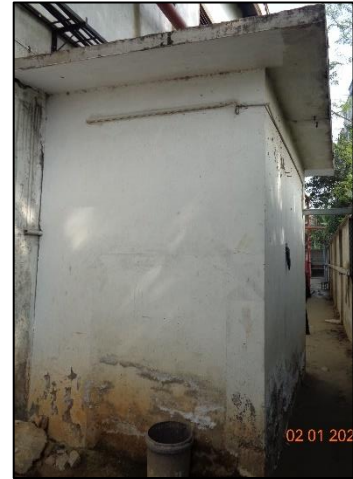
Sludge storage room (dampness on wall)

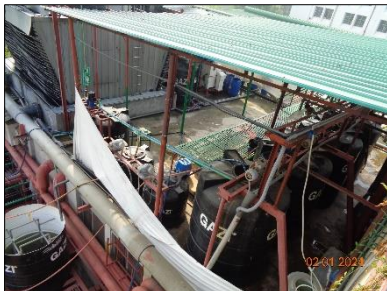
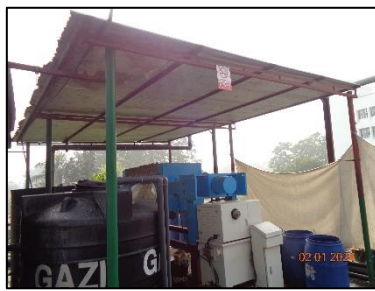
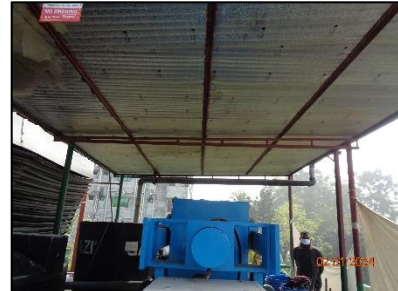
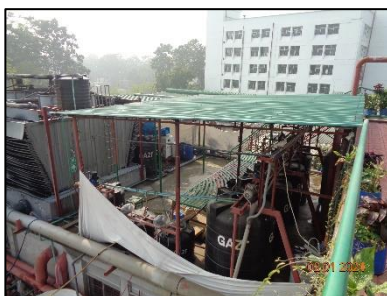
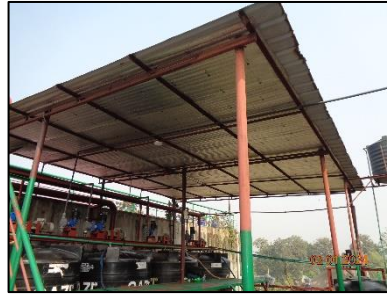
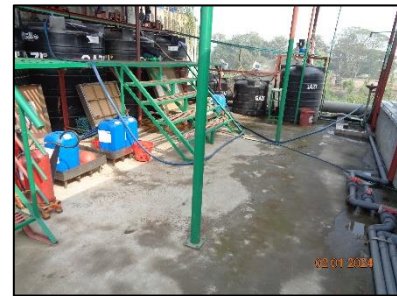
**Observation-10:** The adequacy of connections needs to be verified. Building-9 (ETP Shed)

**Description:** During inspection lightweight sheds were found at 3<sup>rd</sup> floor of the ETP building. Connections between angle and columns appeared to be non-engineered. Building engineer is required to check the connection for the uplift pressure of wind.

| 16. | The adequacy of connections needs to be verified. Building-9 (ETP-Shed) | Building engineer is required to check the connection of the steel shed for the uplift pressure of wind. | within 6 weeks |
| 17. | The adequacy of connections needs to be verified. Building-9 (ETP-Shed) | Carry out remedial work where required. | within 6 months |
