# Winter Dress Limited (Extension)

Gohailbari, Shimulia, Ashulia, Saver, Dhaka-1345.

5 December 2023

## Building Information

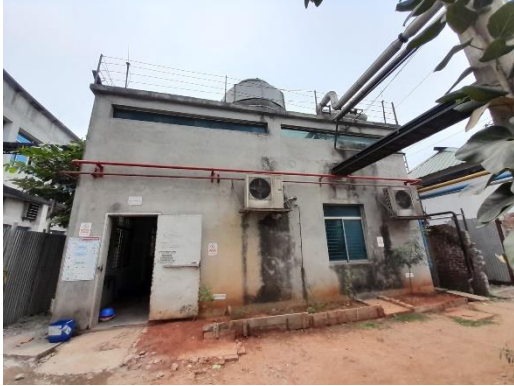
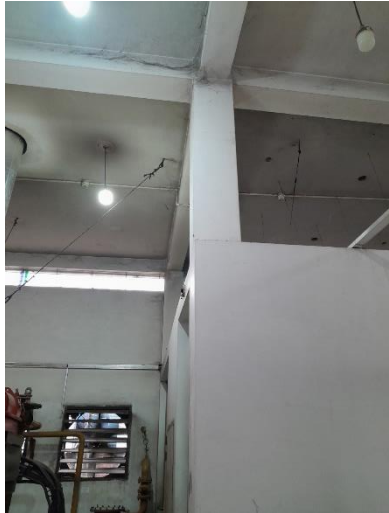
| <b>Observation-1:</b> Absence of design report (Utility Building). | |
| Utility Building | Long columns |
| <b>Description:</b> The design report of the Utility building was not prepared for the Utility Building. Long column adequacy is required to check in the design review. The building engineer is required to prepare a design report following BNBC (part-6, section 1.9.1) | |

| Observation | Action Plan | Timeline |
|---|---|---|
| Absence of design report.<br>(Utility Building). | The building engineer is required to prepare a design report considering BNBC (part-6, Section-1.9.1) | within 6 weeks |
| | The building engineer is required to review the design of the long columns. | within 6 weeks |
| | Carry out suggested remedial works if required. | within 6 months |

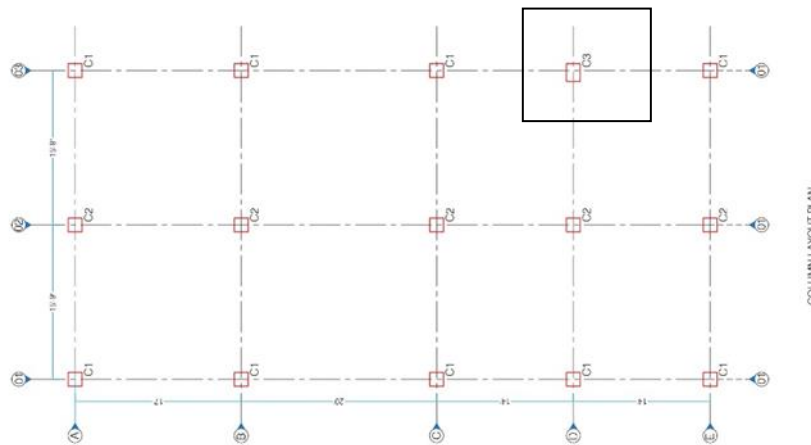
**Observation 2:** Reinforcement and size confirmation of C3 column (Utility Building).

**Description:** The size and reinforcement of the C3 column were not verified due to the site constraint. The building engineer is required to confirm the size and reinforcement of the C3 column.

| Observation | Action Plan | Timeline |
|---|---|---|
| Reinforcement and size confirmation of C3 column<br>(Utility Building). | The building engineer is required to prepare accurate the as-built and confirm the size and rebar of the C3 column. | within 6 weeks |

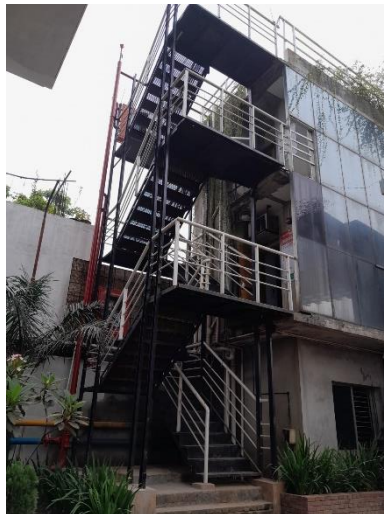
**Observation-3:** Absence of design report. (Fire Control Building).

**Description:** The design report for the Fire Control Building was not prepared. The building engineer is required to prepare a design report following BNBC (part-6, section 1.9.1)

| Observation | Action Plan | Timeline |
|---|---|---|
| Absence of design report. (Fire Control Building). | The building engineer is required to prepare a design report considering BNBC (part-6, Section-1.9.1) | within 6 weeks |
| | Carry out suggested remedial works if required. | within 6 months |

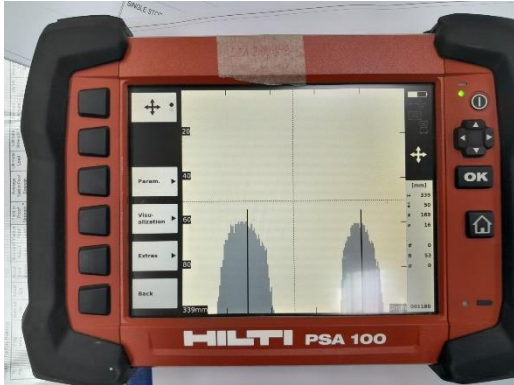
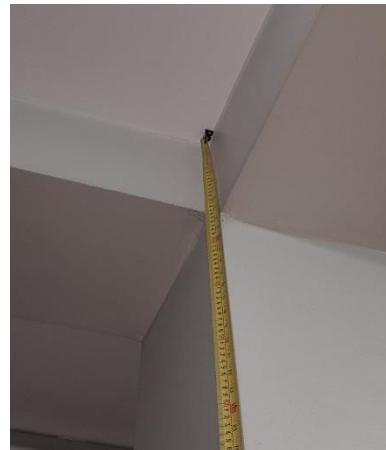
**Observation-4:** Mismatch in as-built drawing. (Fire Control Building)

Number of rebar found 4 instead of 6

Beam size was found 300 mm X 300 mm instead of 300X375 mm.

**Description:** During the inspection, some mismatches were found in the as-built drawing. Column rebar, Beam Size and slab thickness were not matched between the site condition and the as-built drawing.

| Observation | Action Plan | Timeline |
|---|---|---|
| Mismatch in as-built drawing.<br>(Fire Control Building) | The building engineer is required to prepare accurate as-built drawings. | within 6 weeks |

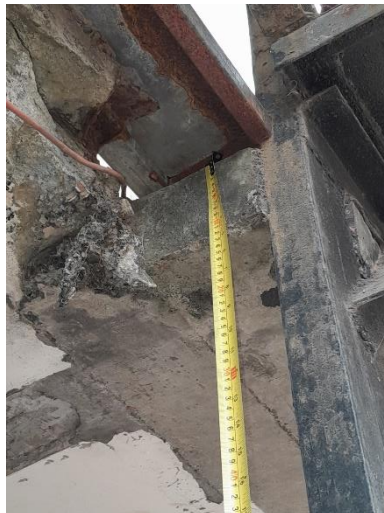
Slab thickness was found 125 mm instead of 175 mm

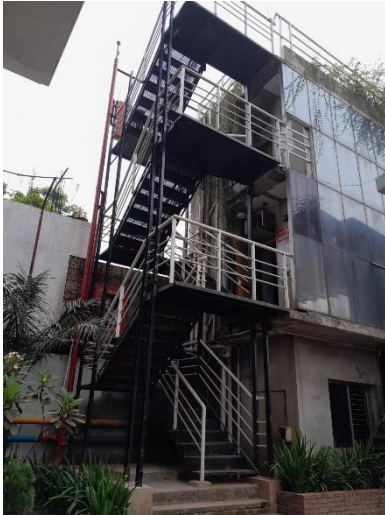
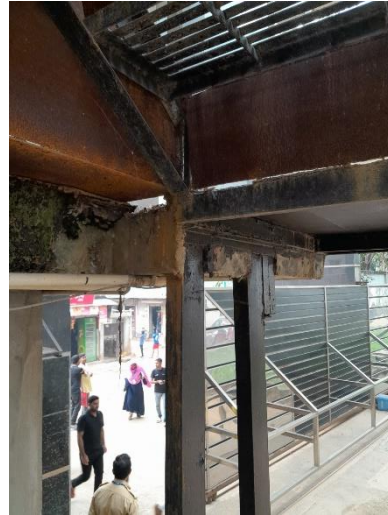
**Observation-5:** Non-engineered steel stair. (Fire Control Building)

Apparently non-engineered steel stair.

**Description:** Apparently non-engineered steel stair (Inadequate member, poor connection details) was observed in the fire control building.

| Observation | Action Plan | Timeline |
|---|---|---|
| Non-engineered steel stair.<br>(Fire Control Building) | The building engineer is required to check the adequacy of the shed | within 6 weeks |
| | Carry out suggested remedial works if required. | within 6 months |

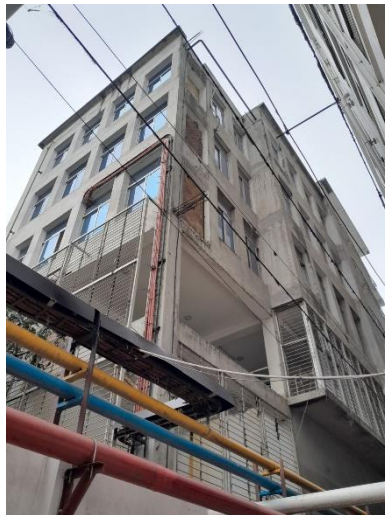
**Observation-6:** Absence of design report. (ETP Building).

**Description:** The design report for the ETP Building was not prepared. The building engineer is required to prepare a design report following BNBC (part-6, section 1.9.1)

| Observation | Action Plan | Timeline |
|---|---|---|
| Absence of design report. (ETP Building). | The building engineer is required to prepare a design report considering BNBC (part-6, Section-1.9.1) | within 6 weeks |
| | Carry out remedial works if necessary. | within 6 months |

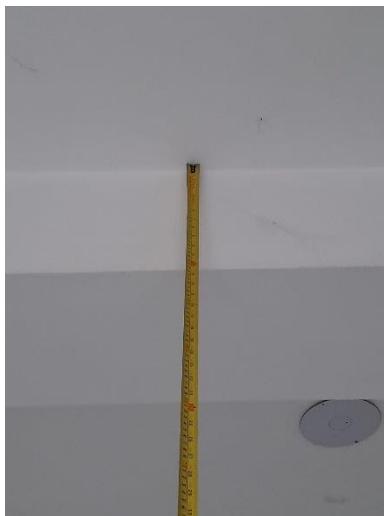
**Observation-7:** Mismatch in as-built drawing. (ETP Building)

**Description:** Beam size was measured 300mm X 300mm instead of 300 mm X 500 mm, Architectural layout not matched with the site condition, Core layout plan not prepared.

| Observation | Action Plan | Timeline |
|---|---|---|
| Mismatch in as-built drawing.<br>(ETP Building) | The building engineer is required to prepare accurate as-built drawings. | within 6 weeks |

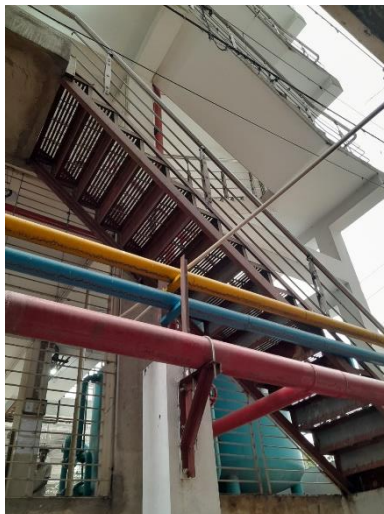
**Observation-8:** Non engineered stair. (ETP Building)

**Description:** Apparently non-engineered steel stair (Inadequate member, poor connection details) was observed in the ETP building.

| Observation | Action Plan | Timeline |
|---|---|---|
| Non-engineered stair. (ETP Building) | The building engineer is required to check the adequacy of the shed | within 6 weeks |
| | Carry out suggested remedial works if required. | within 6 months |

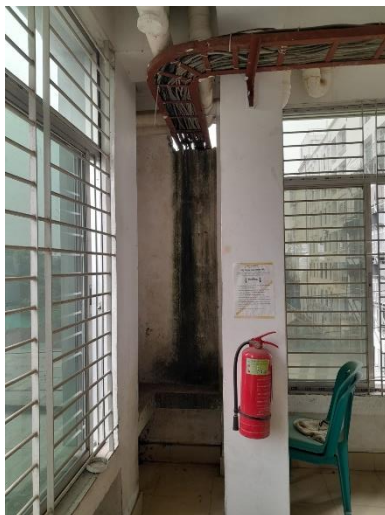
**Observation-9:** Dampness on the building. (ETP Building)

**Description:** Dampness was observed on the ETP building.

| Observation | Action Plan | Timeline |
|---|---|---|
| Dampness on the building.<br>(ETP Building) | The building engineer is required to repair the dampness by a suitable method. | within 6 weeks |

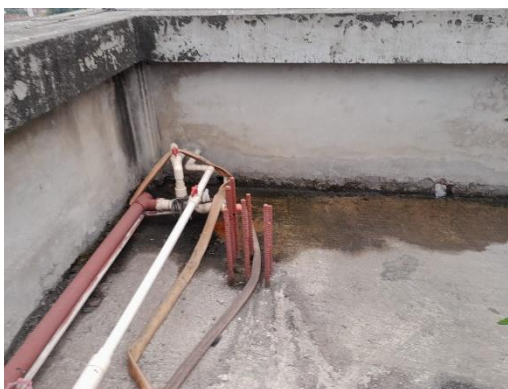
**Observation-10:** Stagnant water on the roof. (ETP Building)

**Description:** Stagnant water was observed on the roof.

| Observation | Action Plan | Timeline |
|---|---|---|
| Stagnant water on the roof.<br>(ETP Building) | The building engineer is required to improve the roof drainage system. | within 6 months |

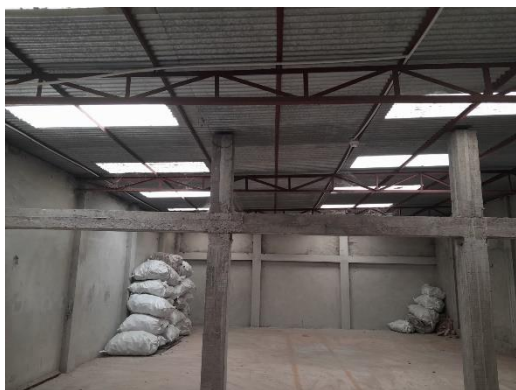
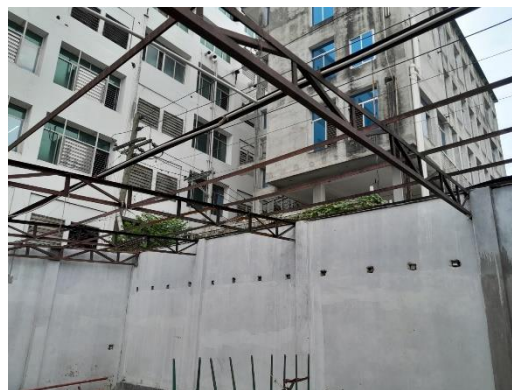
**Observation-11:** Non-engineered shed (Jhut Shed-1 & Jhut Shed-2)

**Description:** Inadequate member size and poor connection details were observed on the Jhut Sheds 1 & 2.

| Observation | Action Plan | Timeline |
|---|---|---|
| Non-engineered shed (Jhut Shed-1 & Jhut Shed-2) | The building engineer is required to check the adequacy of the shed | within 6 weeks |
| | Carry out suggested remedial works if required. | within 6 months |
