# TOKIO MODE LTD (Extension)

98/173, Choydana, National University, Gazipur.

27 November 2023

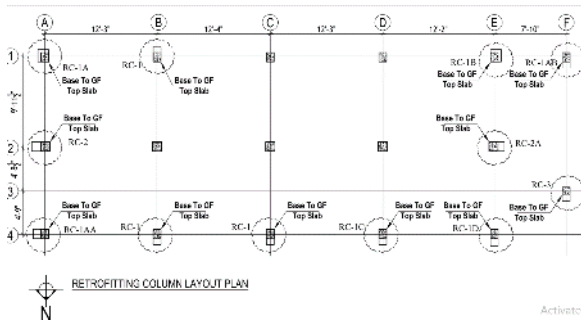
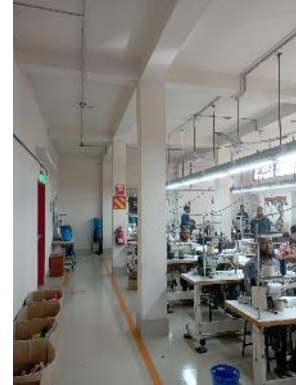
**Observation-1:** Proposed retrofitting work not implemented (Sample & Office building).

**Description:** Retrofitting work is proposed for column and foundation as per the available design report but has not been found implemented on site. The building engineer is required to provide detailed information, for which purpose it requires retrofitting, need to review the design of retrofitting with RSC.

| Observation | Action Plan | Timeline |
|---|---|---|
| Proposed retrofitting work not implemented (Sample & Office Building). | The building engineer is required to submit the retrofitting scheme for further review. | within 6 weeks |
| Proposed retrofitting work not implemented (Sample & Office Building). | Complete all retrofitting work upon getting acceptance from RSC. | within 6 months |

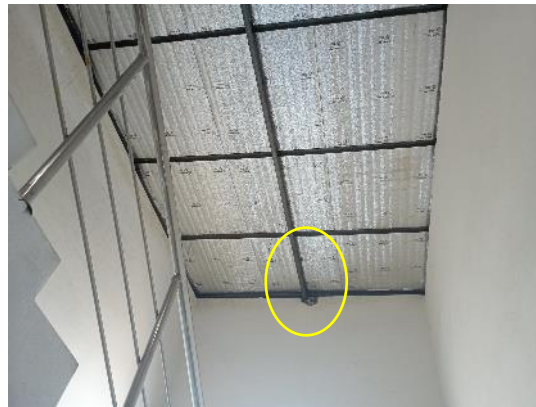
**Observation 2:** Poor anchorage system of stair roof (Sample & Office Building).

**Description:** Anchorage of the steel rafter of the stair roof shed appeared to be poor. The building engineer is required to improve the anchorage system to resist the uplift force.

| Observation | Action Plan | Timeline |
|---|---|---|
| Poor anchorage system of stair roof (Sample & Office Building). | The building engineer is required to improve the anchorage system to resist the uplift force. | within 6 weeks |

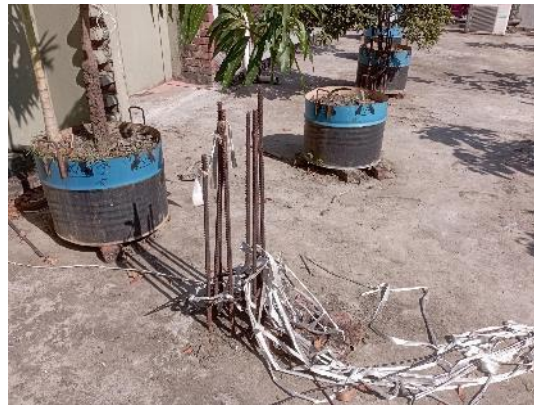
**Observation-3:** Exposed rebar at roof level (Sample & Office Building)

**Description:** Exposed rebar at roof level. The building engineer is required to provide rust proof paint on all exposed rebar.

| Observation | Action Plan | Timeline |
|---|---|---|
| Exposed rebar at roof level (Sample & Office Building) | The building engineer is required to provide rust proof paint on all exposed rebar. | within 6 weeks |

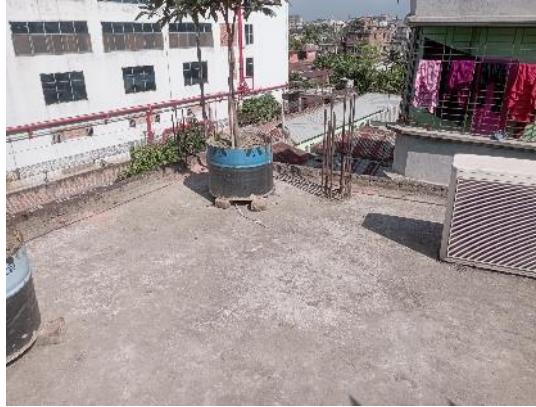
**Observation-4:** Falling hazard at roof level (Sample & Office Building)

**Description:** Parapet/railing not found at roof level. The building engineer is required to provide edge protection to avoid falling hazard.

| Observation | Action Plan | Timeline |
|---|---|---|
| Falling hazard at roof level (Sample & Office Building) | The building engineer is required to provide edge protection to avoid falling hazard. | within 6 weeks |

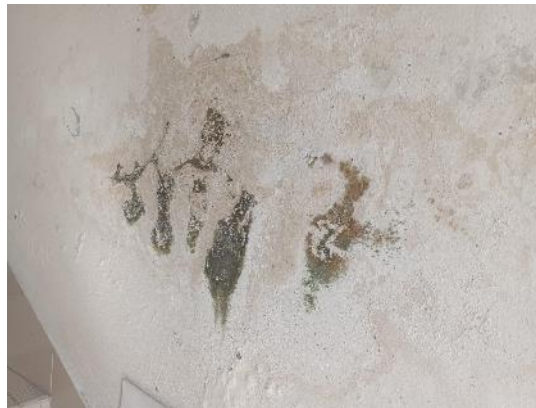
**Observation-5:** Dampness on brick wall (Sample & Office Building).

**Description:** Dampness was found on brick walls at several locations. The building engineer is required to investigate the damp areas and repair with a suitable method.

| Observation | Action Plan | Timeline |
|---|---|---|
| Dampness on brick wall (Sample & Office Building). | The building engineer is required to investigate the damp areas and repair with a suitable method. | within 6 weeks |

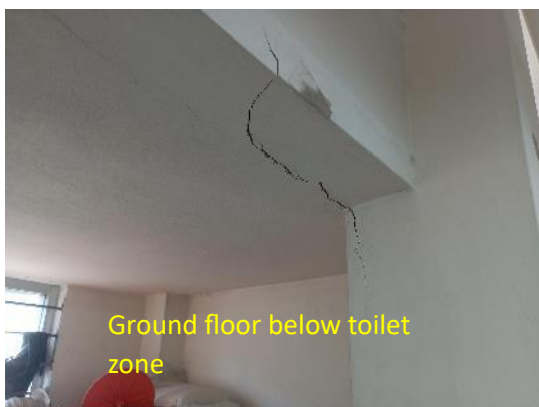
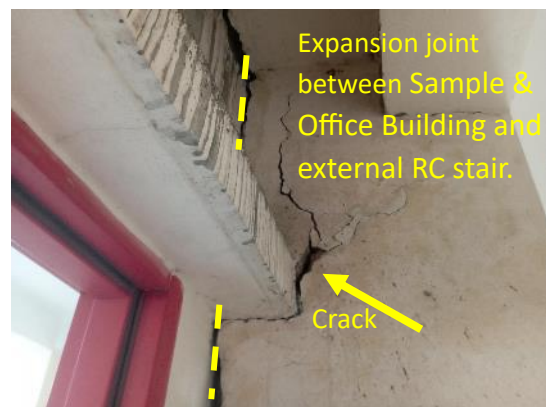
**Observation-6:** Crack on slab soffits, expansion joint (Sample & Office Building)

**Description:** Crack was observed on slab soffits, below the toilet zone at the ground floor, expansion joint near the north stair. The building engineer is required to investigate the reason for the crack and repair as per the investigation report.

| Observation | Action Plan | Timeline |
|---|---|---|
| Crack on slab soffits, expansion (Sample & Office Building) | The building engineer is required to investigate the reason of crack and repair as per investigation report. | within 6 weeks |

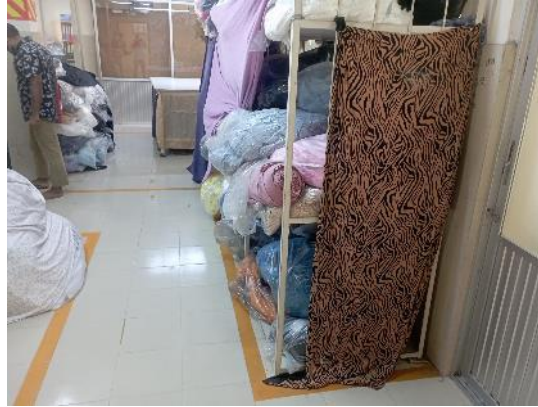
**Observation-7:** Non-structural elements found not anchored/braced (Sample & Office Building)

**Description:** Non-structural elements found not anchored/braced. The building engineer is required to brace/anchor all nonstructural elements including storage racks within the factory.

| Observation | Action Plan | Timeline |
|---|---|---|
| Nonstructural elements found not anchored/braced (Sample & Office Building) | The building engineer is required to anchored/braced all nonstructural elements. | within 6 weeks |

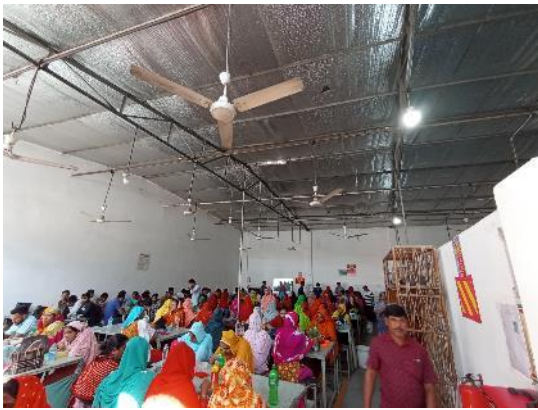
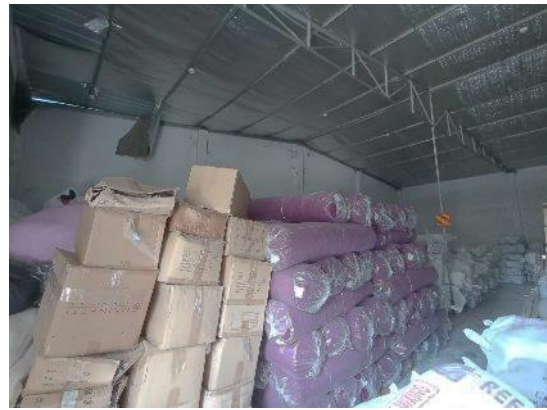
**Observation-8:** Lack of lateral stability (Shed-1).

**Description:** No bracing/compression member is provided to this shed. Also, the steel member size appeared to be undersized. The building engineer is required to check the lateral stability of the shed and prepare a design report.

| Observation | Action Plan | Timeline |
|---|---|---|
| Lack of lateral stability (Shed-1). | The building engineer is required to check the lateral stability of the shed and prepare a design report. | within 6 weeks |
| Lack of lateral stability (Shed-1). | Carry out remedial works where required. | within 6 months |

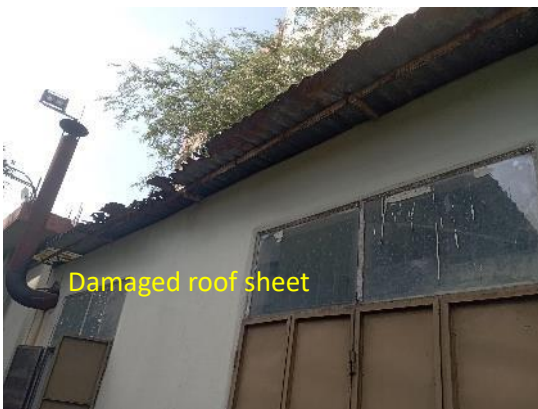
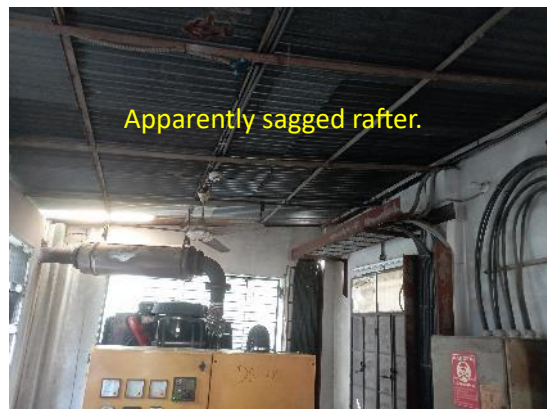
**Observation-9:** Damaged roof sheet/ sagged rafter (Shed-3)

**Description:** Roof sheet was found damaged, and the rafter was found sagged. The building engineer is required to replace the damaged roof sheet and check the capacity of the rafter.

| Observation | Action Plan | Timeline |
|---|---|---|
| Damaged roof sheet/apparently sagged rafter (Shed-3) | The building engineer is required to replace the damaged roof sheet. | within 6 weeks |
| Damaged roof sheet/apparently sagged rafter (Shed-3) | The building engineer is required to check the capacity of the rafter. | within 6 weeks |
| Damaged roof sheet/apparently sagged rafter (Shed-3) | Carry out remedial works where required. | within 6 months |

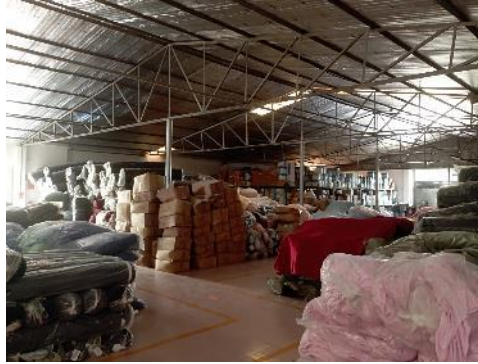
**Observation-10:** Lack of lateral stability of steel part (Shed-4).

**Description:** No bracing/compression member is provided to this shed. The building engineer is required to check the lateral stability of the shed.

| Observation | Action Plan | Timeline |
|---|---|---|
| Lack of lateral stability of steel part (Shed-4). | The building engineer is required to check the lateral stability of the shed. | within 6 weeks |

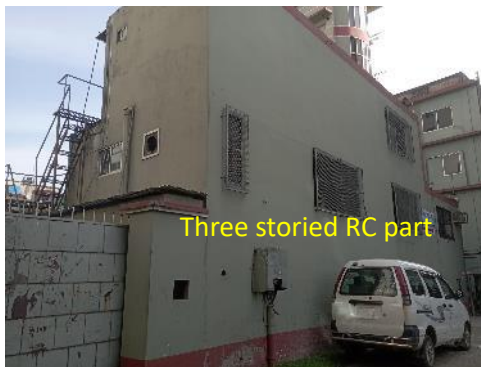
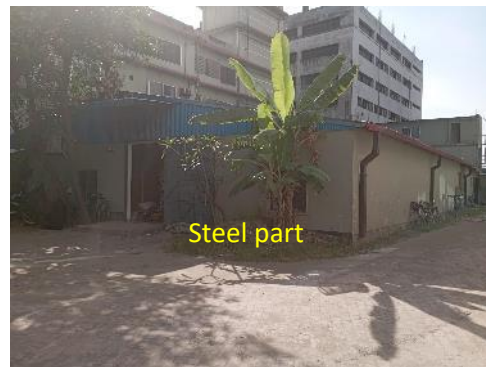
**Observation-11:** Lack of design report/structural drawing/geotechnical investigation report (Shed-4).

**Description:** As per BNBC, every building or structure designed shall have its design documents prepared following the provision of Section 1.9.1. During the inspection, the design report/as-built structural drawing/ geotechnical investigation report was not available on site.

The building engineer is required to carry out a Detailed Engineering Assessment (DEA) including a geotechnical investigation report and prepare a set of structural drawings.

| Observation | Action Plan | Timeline |
|---|---|---|
| Lack of design report/structural drawing/geotechnical investigation report (Shed-4). | The building engineer is required to carry out a Detailed Engineering Assessment (DEA) including a geotechnical investigation report. | within 6 weeks |
| Lack of design report/structural drawing/geotechnical investigation report (Shed-4). | The building engineer is required to prepare a set of as-built structural drawing. | within 6 weeks |
| Lack of design report/structural drawing/geotechnical investigation report (Shed-4). | Carry out remedial works if required. | within 6 months |

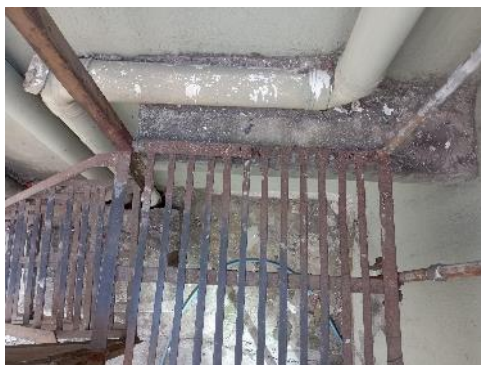
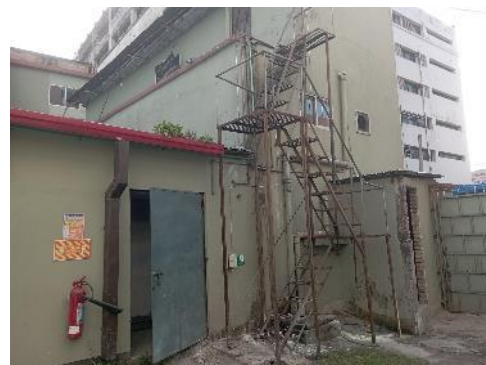
**Observation-12:** Apparently non-engineered steel stair (Shed-4)

**Description:** The steel stair appeared to be non-engineered due to lack of adequate load path/damaged and apparently undersized member. The building engineer is required to replace the damaged members and check the structural adequacy of the steel stair.

| Observation | Action Plan | Timeline |
|---|---|---|
| Apparently non engineered steel stair (Shed-4) | The building engineer is required to replace the damaged members and check the structural adequacy of the steel stair. | within 6 weeks |
| Apparently non engineered steel stair (Shed-4) | Carry out remedial works where required. | within 6 months |

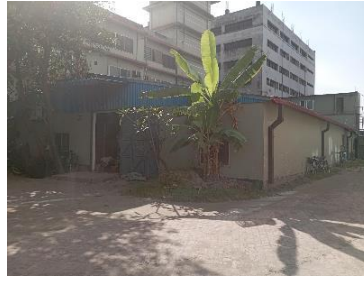
**Observation-13:** Lack of permit drawing from local authority (Shed-4)

**Description:** At the time of inspection permit drawing from local authority was not available. The factory is required to collect the permit drawing from local authority.

| Observation | Action Plan | Timeline |
|---|---|---|
| Lack of permit drawing from local authority (Shed-4) | The factory is required to collect the permit drawing from local authority. | within 6 months |

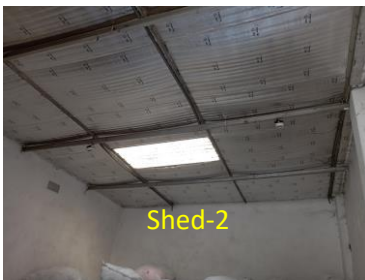
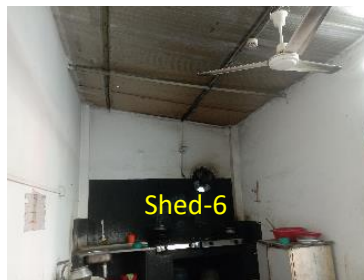
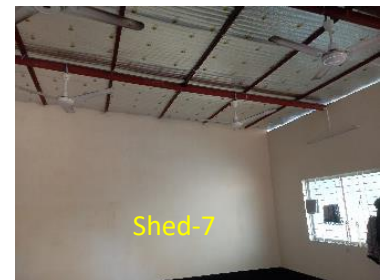
**Observation-14:** Poor anchorage system of steel members (Shed-2, Shed-6, Shed-7).

**Description:** Anchorage of steel rafter of the sheds appeared to be poor. The building engineer is required to improve the anchorage system to resist the uplift force.

| Observation | Action Plan | Timeline |
|---|---|---|
| Poor anchorage system of steel members (Shed-2, Shed-6, Shed-7). | The building engineer is required to improve the anchorage system to resist the uplift force. | within 6 weeks |

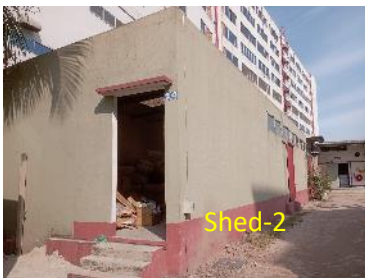
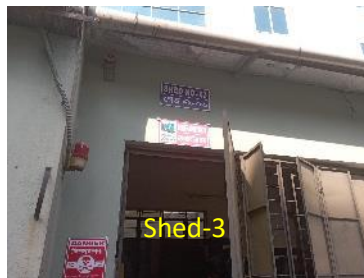
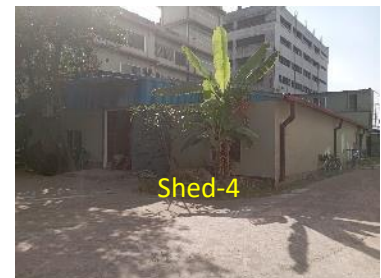
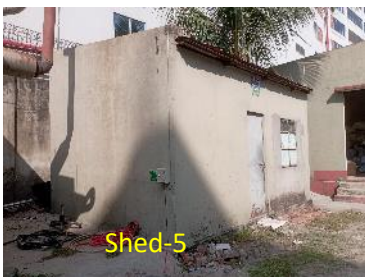
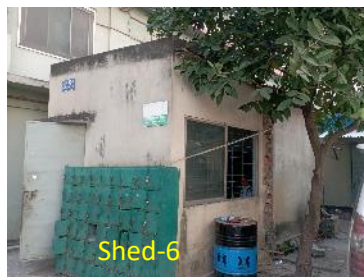
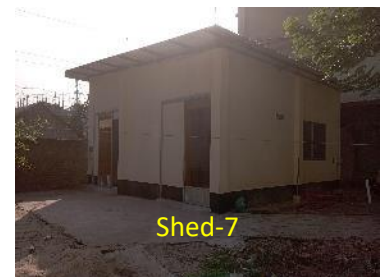
**Observation-15:** Lack of as-built structural drawing (Substation room, Shed-2, Shed-3, Shed-4, Shed-5, Shed-6, Shed-7)

**Description:** At the time of inspection as-built structural drawing was not available for the structures. The building engineer is required to produce as-built structural drawing.

| Observation | Action Plan | Timeline |
|---|---|---|
| Lack of as-built structural drawing (Substation room, Shed-2, Shed-3, Shed-4, Shed-5, Shed-6, Shed-7) | The building engineer is required to produce as-built structural drawing. | within 6 weeks |
