# SP Washing Ltd.

Shirichala, Mohana, Vabanipur, Sadar, Gazipur

10 January 2024

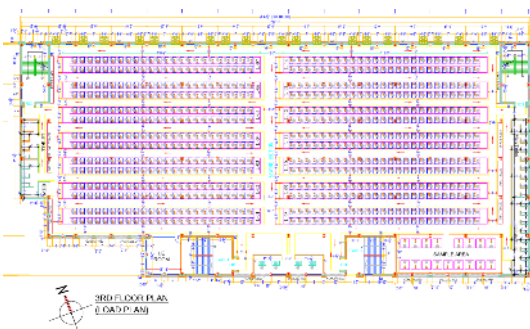
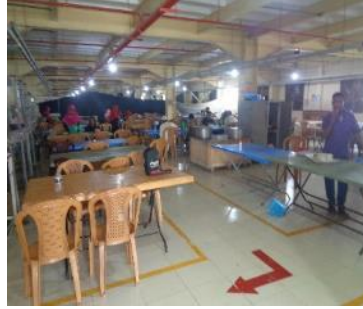
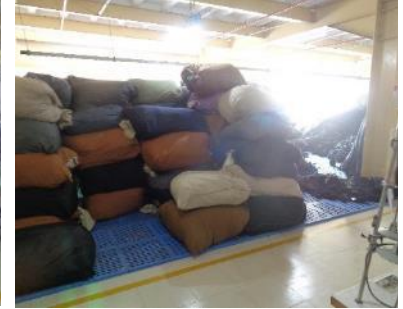
**Observation-1:** Change in floor occupancy (Five storied Main Building).

**Description:** Undesignated dining and storage found on the 3<sup>rd</sup> floor. The building engineer is required to relocate the undesignated dining and storage from that area. Otherwise, revise the load plan and design report as per BNBC and submit to RSC for review.

| Observation | Action Plan | Timeline |
|---|---|---|
| Change in floor occupancy (Five storied Main Building). | The building engineer is required to relocate the undesignated dining and storage from that area. Otherwise revise the load plan and design report as per BNBC and submit to RSC for review. | within 6 weeks |
| Change in floor occupancy (Five storied Main Building). | Implement remediation work if required. | within 6 months |

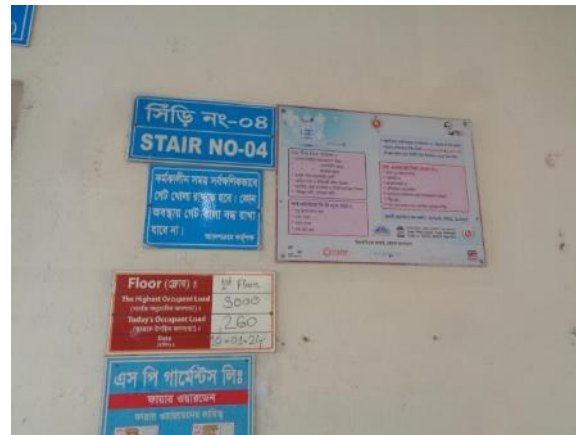
**Observation-2:** Load plan not posted on several floors (Five storied Main Building).

**Description:** The accepted load plan from RSC was not found on several floors. The factory is required to post a load plan at each floor.

| Observation | Action Plan | Timeline |
|---|---|---|
| Load plan not posted on several floors (Five storied Main Building). | The factory is required to post a load plan on each floor. | within 6 weeks |

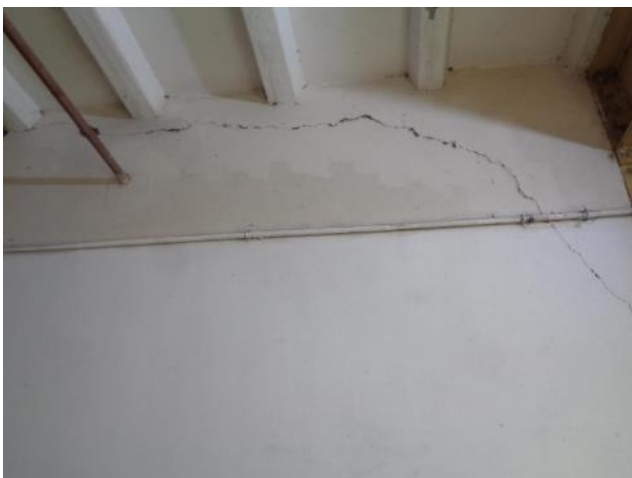
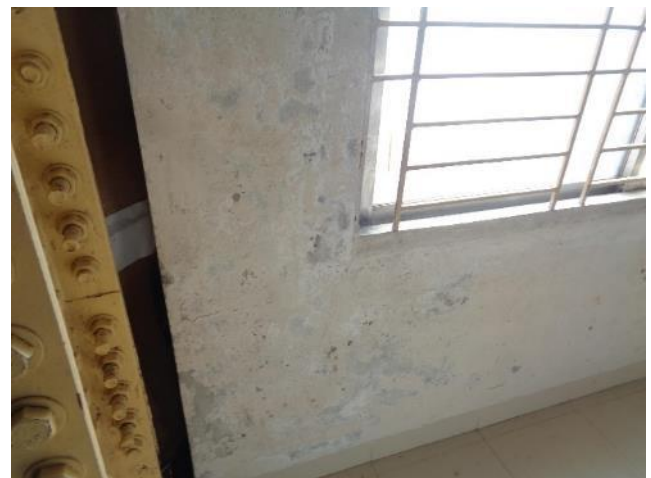
**Observation-3:** Crack and dampness on the brick wall surface (Five storied Main Building).

**Description:** Cracks and dampness were found on the brick wall surface. The building engineer is required to investigate the reason for crack and repair with a suitable method.

| Observation | Action Plan | Timeline |
|---|---|---|
| Crack and dampness on brick wall surface (Five-storied Main Building). | The building engineer is required to investigate the reason for the crack and repair it with a suitable method. | within 6 weeks |

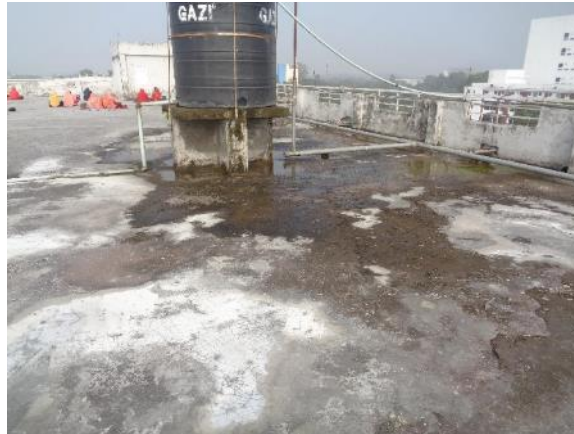
**Observation-4:** Water ponding/vegetation on roof slab (Five-storied Main Building).

**Description:** Water ponding/vegetation was found on the roof slab. The building engineer is required to repair the damp areas with a suitable method and improve the drainage system on the roof slab.

| Observation | Action Plan | Timeline |
|---|---|---|
| Water ponding/vegetation on roof slab (Five-storied Main Building). | The building engineer is required to repair the damp areas with a suitable method and improve the drainage system on the roof slab. | within 6 weeks |

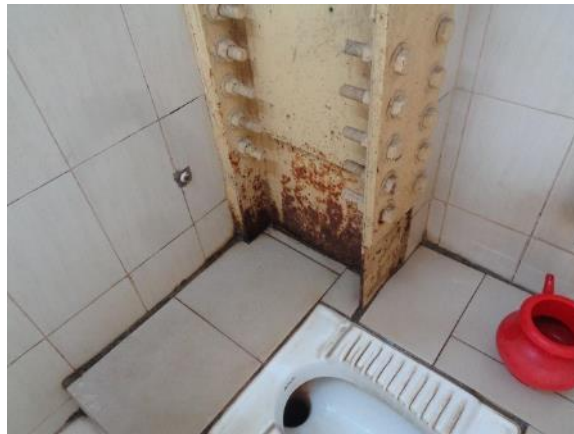
**Observation-5:** Corrosion on steel members (Five-storied Main Building).

**Description:** Severe corrosion was found on steel members at the toilet zone. The building engineer is required to provide rust-proof paint on steel members.

| Observation | Action Plan | Timeline |
|---|---|---|
| Corrosion on steel members (Five-storied Main Building). | The building engineer is required to provide rust-proof paint on steel members. | within 6 weeks |

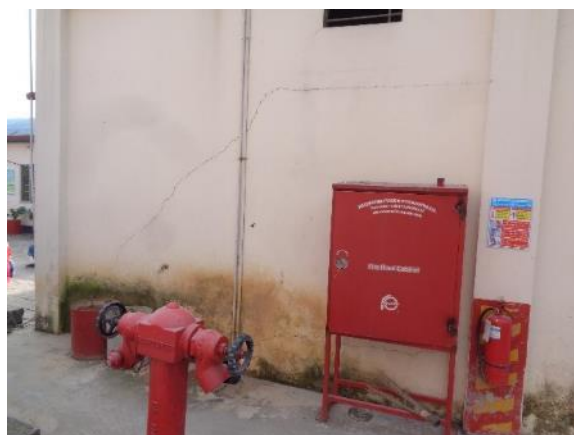
**Observation-6:** Diagonal crack on the brick wall surface (Chemical Store Shed).

**Description:** Diagonal crack on the brick wall surface. The building engineer is required to investigate the reason for the crack including foundation settlement and repair as per the investigation report.

| Observation | Action Plan | Timeline |
|---|---|---|
| Diagonal crack on brick wall surface (Chemical Store Shed). | The building engineer is required to investigate the reason for the crack including foundation settlement and repair as per the investigation report. | within 6 weeks |

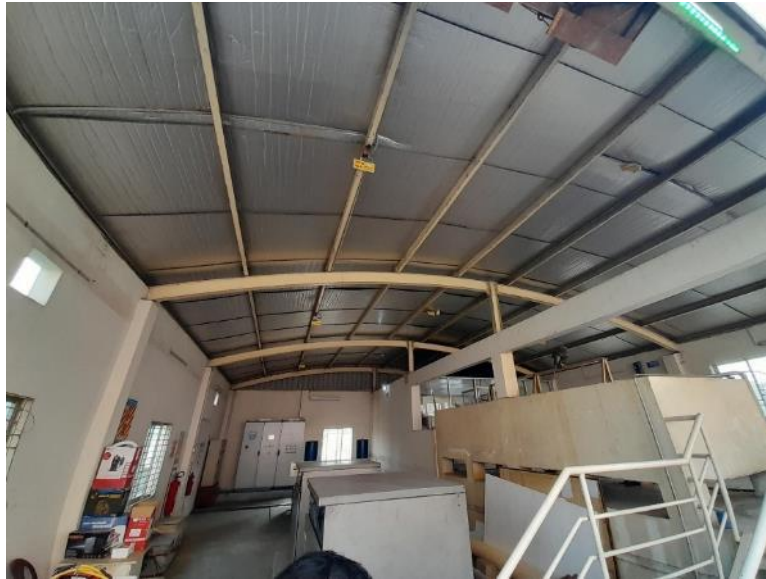
**Observation-7:** Lack of lateral stability (Biological ETP).

**Description:** Compression member/bracing system is not provided for the shed. The building engineer is required to check the lateral stability of the structure and propose a remediation plan.

| Observation | Action Plan | Timeline |
|---|---|---|
| Lack of lateral stability (Biological ETP). | The building engineer is required to check the lateral stability of the structure and propose a remediation plan. | within 6 weeks |
| Lack of lateral stability (Biological ETP). | Implement remediation work if required. | within 6 months |
