# Advanced Composite Textile Ltd

Kashor, Masterbari, Bhaluka, Mymensingh, Bangladesh  
(24.302157N, 90.363604E)

24<sup>th</sup> October 2015

# Observations

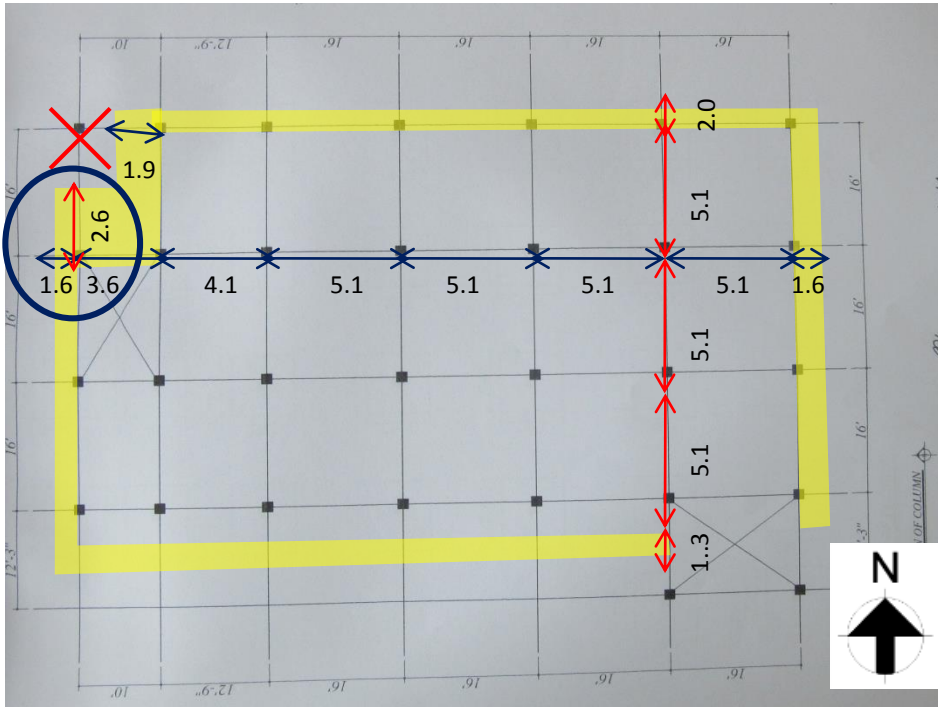
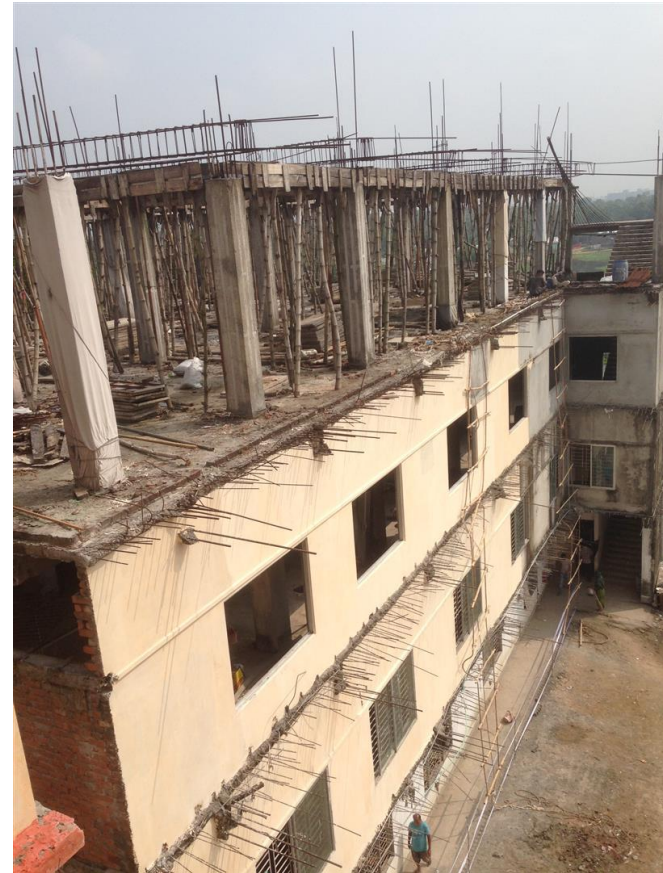
High Stress Levels in Columns

## Observation BLG 1

Outline calculations indicate some columns are highly stressed under their loading conditions particularly if all floors under construction are built up to building permit level (6<sup>th</sup> floor)

| Item No. | Observation | Recommended Action Plan | Recommended Timeline |
|---|---|---|---|
| 1 | High stress levels in columns (B1 and B2) | Factory Engineer to review design, loads and columns stresses in all columns | 6-weeks |
| 2 | High stress levels in columns (B1 and B2) | Factory Engineer to verify insitu concrete strength by taking 100mm diameter cores from 4 columns . Verify grade of steel reinforcement used. | 6-weeks |
| 3 | High stress levels in columns (B1 and B2) | Produce and actively manage a loading plan for all floor plates within the factory giving consideration to floor capacity and column capacity. | 6-weeks |
| 4 | High stress levels in columns (B1 and B2) | Make any structural alterations as advised by Engineer. | 6-months |
| 5 | High stress levels in columns (B1 and B2) | Continue to implement load plan | 6-months |

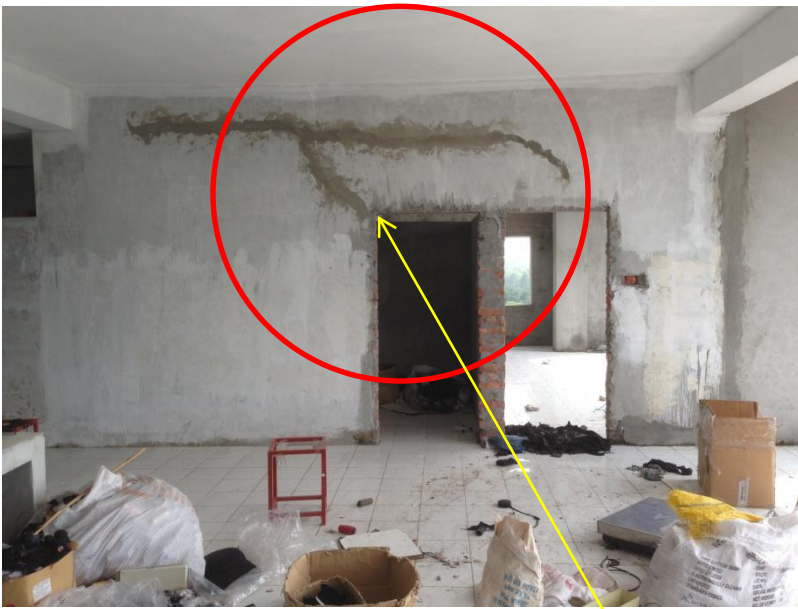
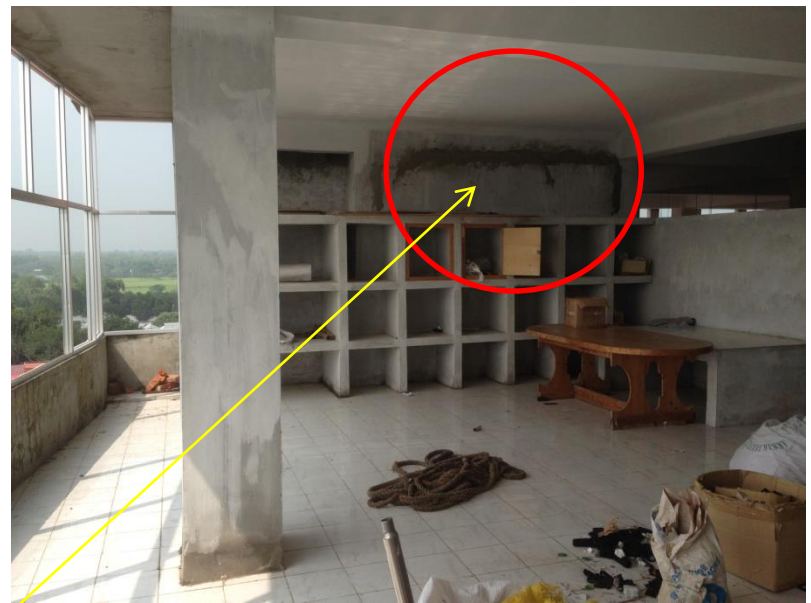
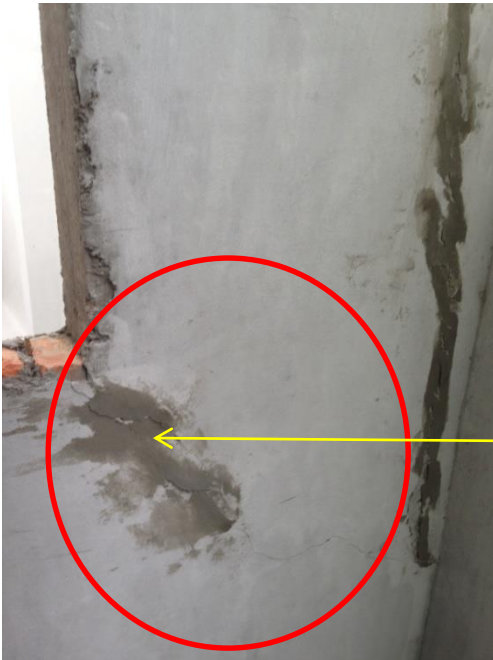
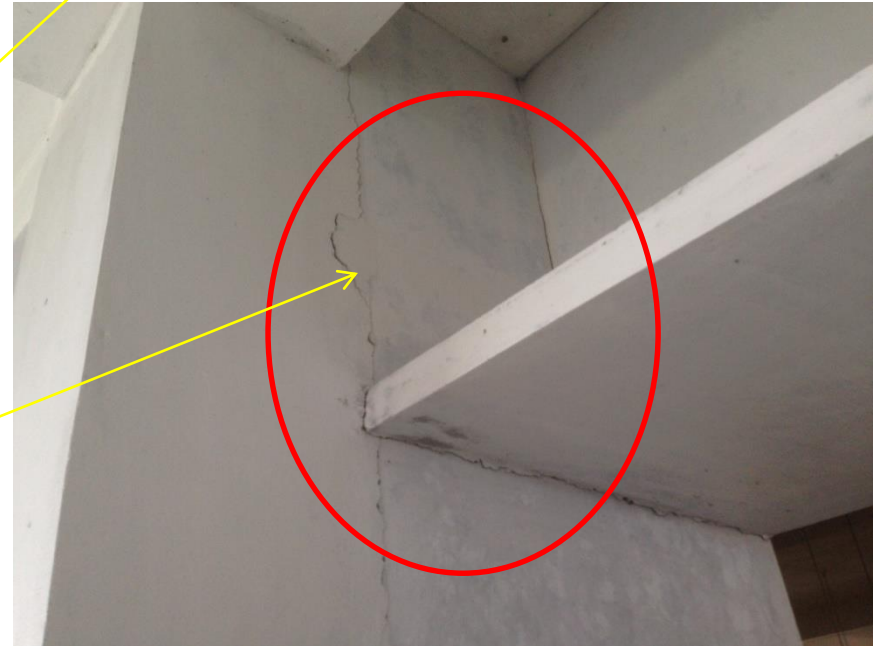
# **Cracking in masonry in various portions of BLG 1**

Cracks on the brick masonry in building 1 was observed in many places

| Item No. | Observation | Recommended Action Plan | Recommended Timeline |
|---|---|---|---|
| 6 | Cracking in masonry in various portions of BLG 1 | Factory Engineer to review design in the area of the cracked walls. Engineer to prove by calculation the adequacy of the masonry to carry the vertical loads. | 6-weeks |
| 7 | Cracking in masonry in various portions of BLG 1 | Engineer to make recommendations for the wall repair/replacement | 6-weeks |
| 8 | Cracking in masonry in various portions of BLG 1 | Carry out the remedial works following the above review | 6-months |

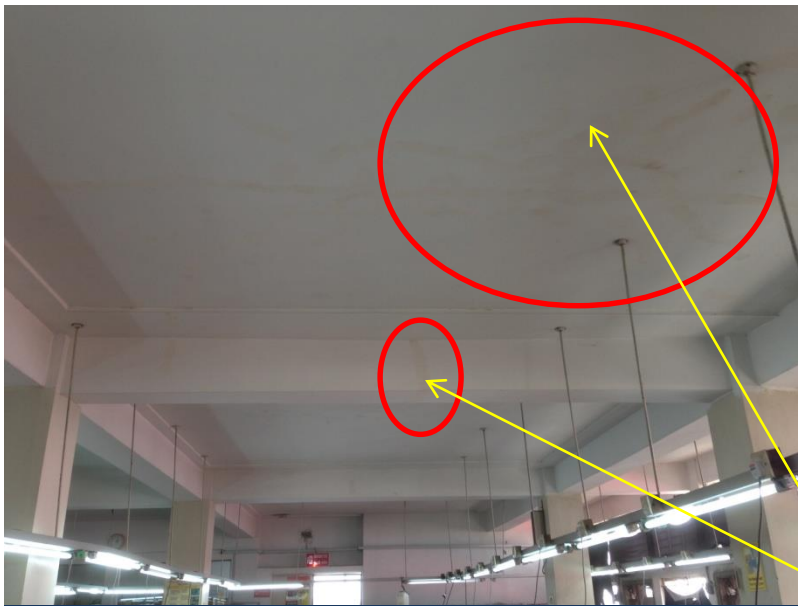
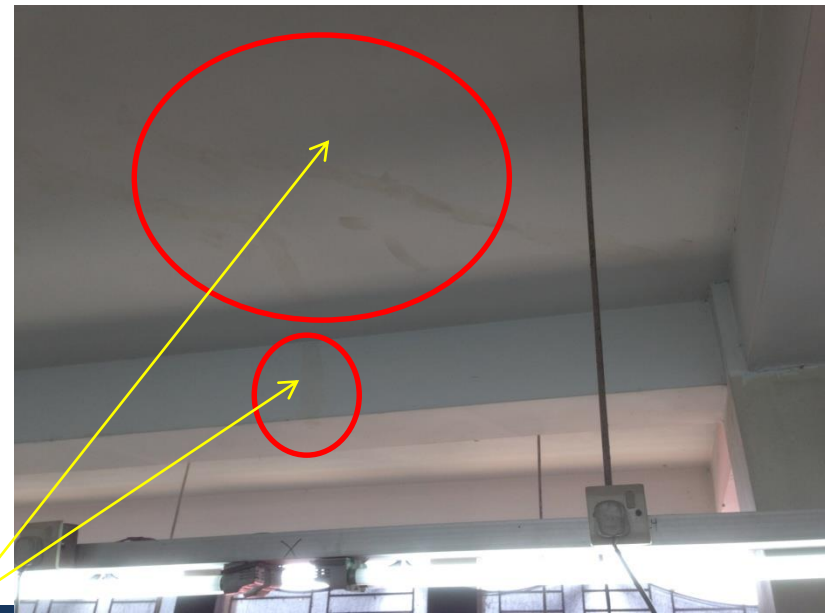
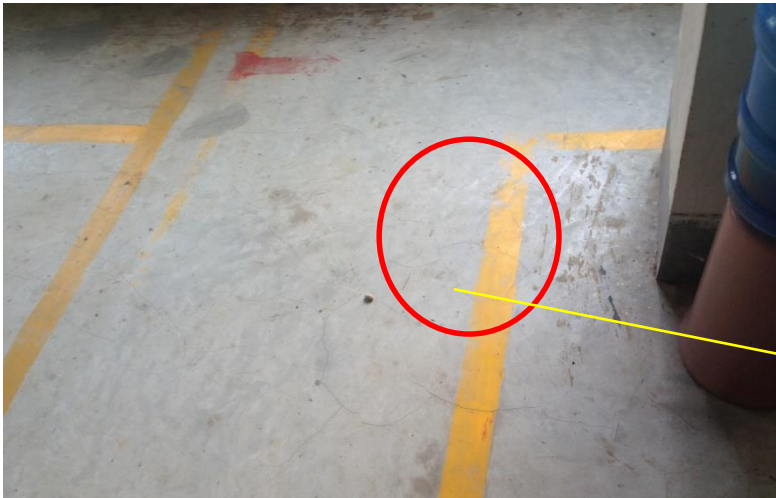
# **Cracking on some beams and slabs (BLG 1 and BLG 2)**

Cracks in roof slab and in beam observed in Building 1

| Item No. | Observation | Recommended Action Plan | Recommended Timeline |
|---|---|---|---|
| 9 | Cracking on some beams and slabs (BLG 1 and BLG 2); | Portions of floor finish to be removed to investigate if cracks penetrate the building slab structure. Building Engineer to review further if cracks are found to penetrate into building structure. | 6-weeks |
| 10 | Cracking on some beams and slabs (BLG 1 and BLG 2); | Carry out repair remedial works as required. | 6-weeks |
| 11 | Cracking on some beams and slabs (BLG 1 and BLG 2); | Continue to monitor for cracking on an on-going basis | 6-months |

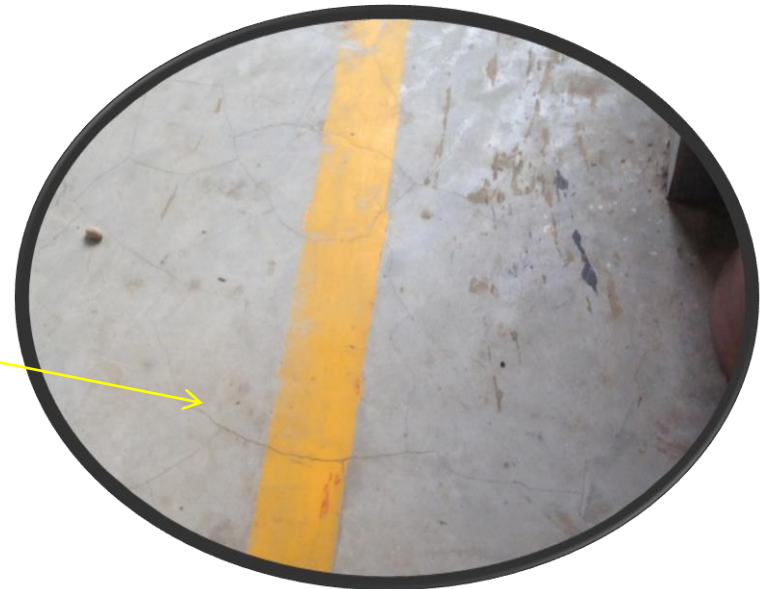
Observed cracks in floor slabs in Building 2

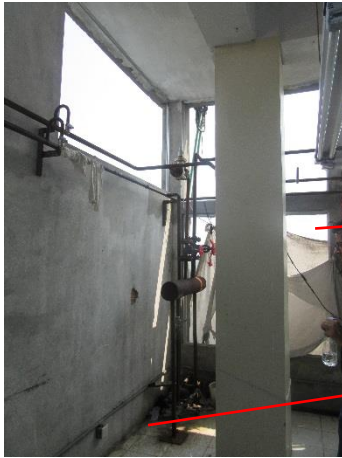
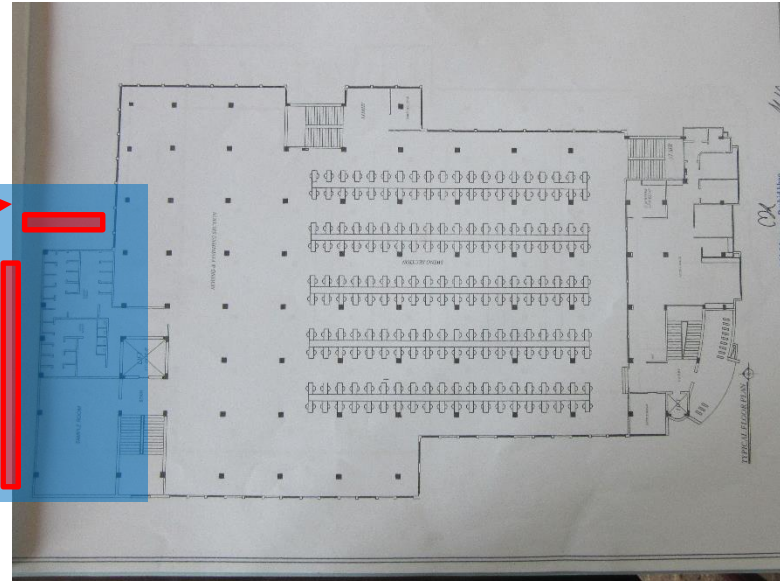
# Discrepancies between site observations and information on drawings

Building 1 – cantilevers not included in the drawings (area highlighted)

| Item No. | Observation | Recommended Action Plan | Recommended Timeline |
|---|---|---|---|
| 12 | Discrepancies between site observations and information on drawings | Update the drawings | 6-months |

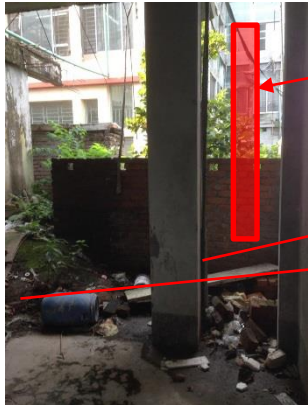
Column missing

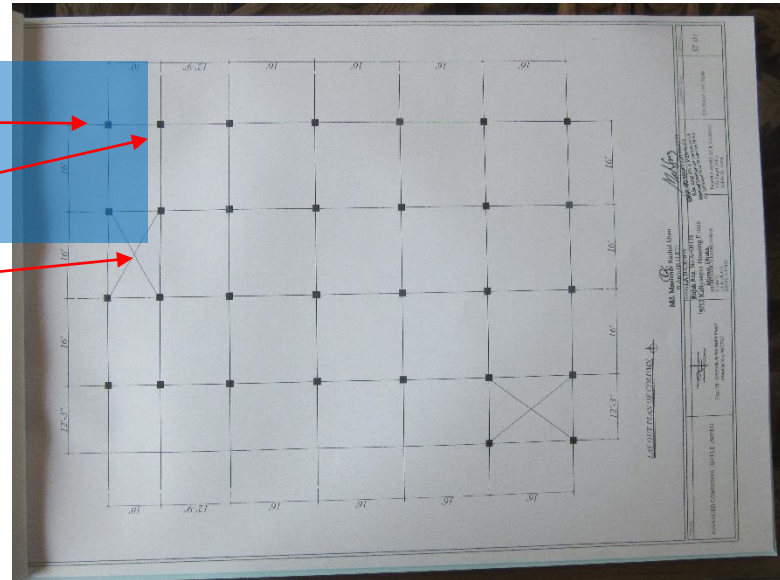
Building 2 – the area highlighted observed on site seems different from what is included in the drawings

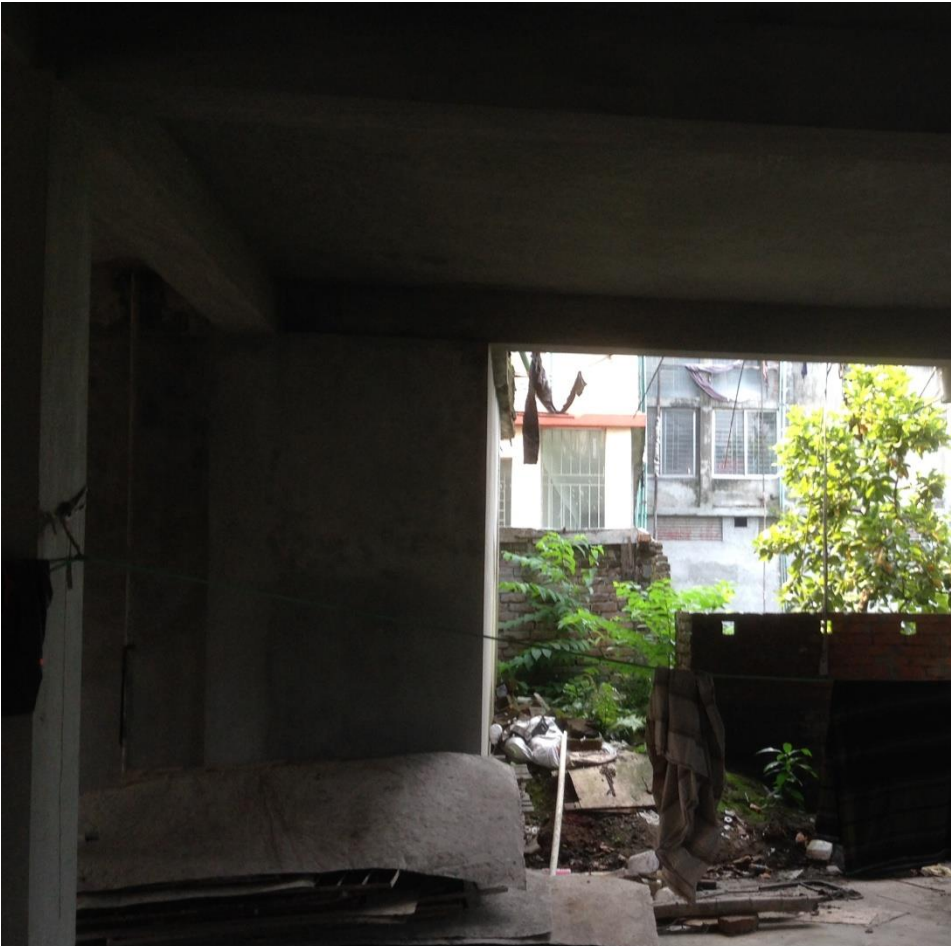
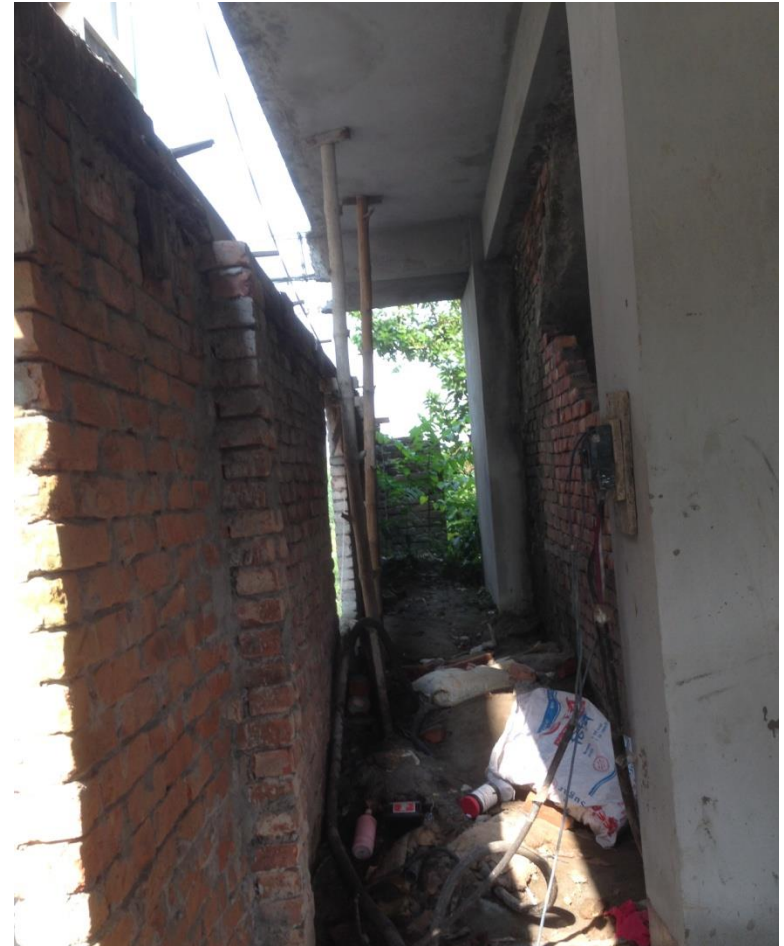
# **Presence of almost 1m soil in some cantilevers of BLG2**

Observed heavy accumulation of soils and rubbishes on the cantilever of the 2<sup>nd</sup> floor in Building 2

| Item No. | Observation | Recommended Action Plan | Recommended Timeline |
|---|---|---|---|
| 13 | Presence of almost 1m soil in some cantilevers of BLG2; | Remove soil from the cantilever; | 6-weeks |
| 14 | Presence of almost 1m soil in some cantilevers of BLG2; | Carry out any remedial work as directed by the Factory Engineer. | 6-months |

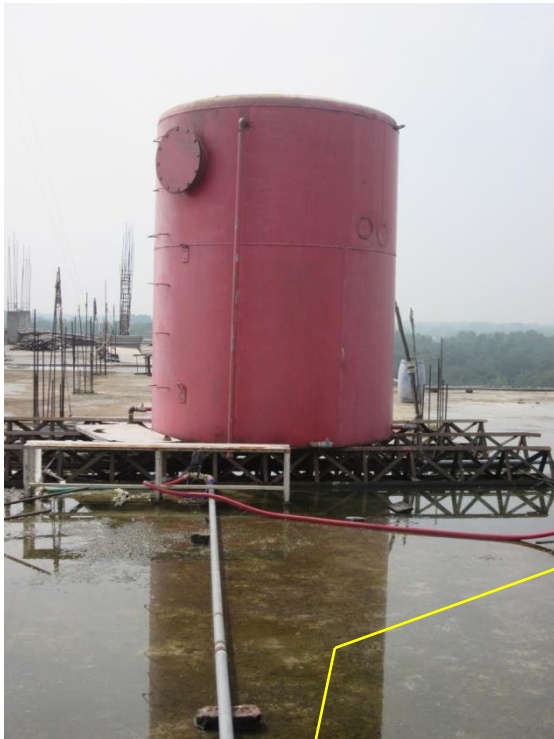
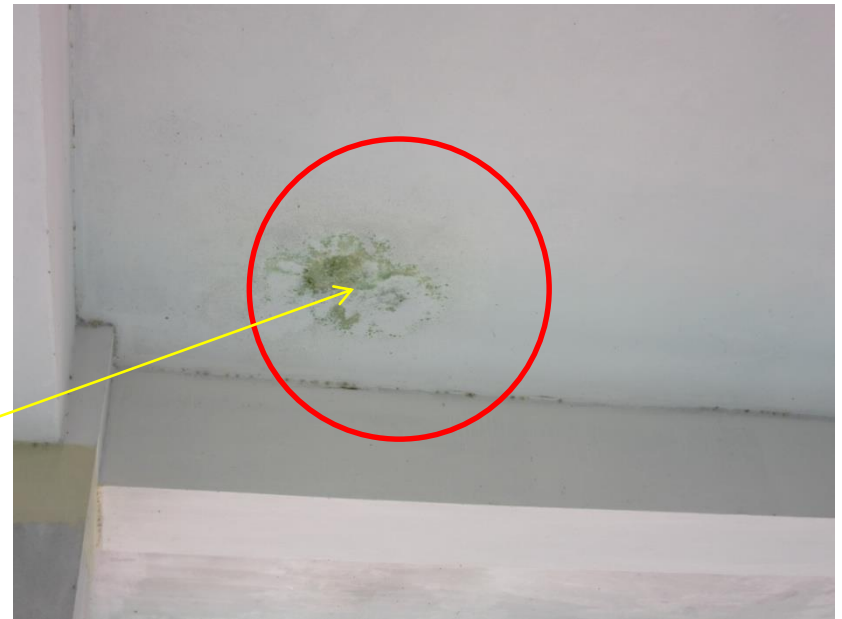
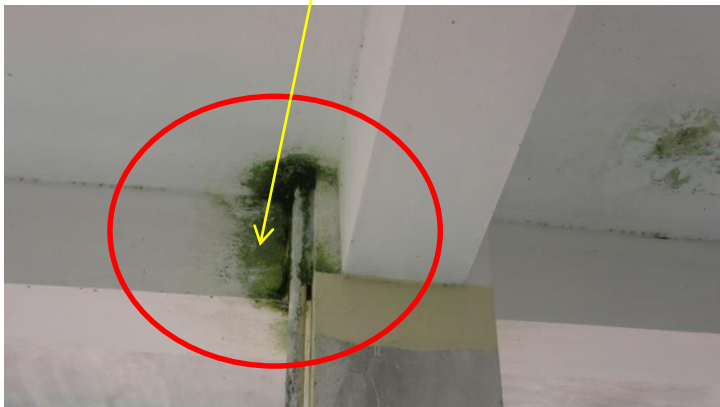
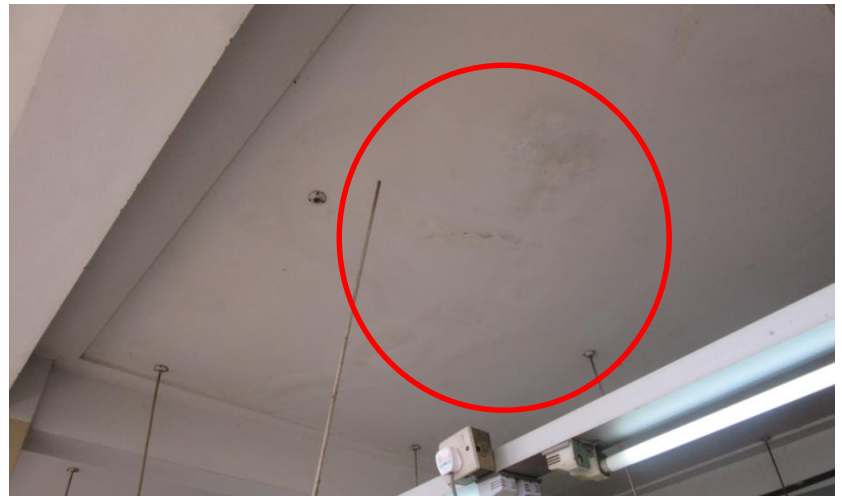
**Dampness in some areas (BLG 1 and BLG 2)**

Logged water on the roof created some damp areas on the roof slab of the following floor in Building 1

| Item No. | Observation | Recommended Action Plan | Recommended Timeline |
|---|---|---|---|
| 15 | Dampness in some areas; | Carry out repair remedial works as required. | 6-months |
