# Genesis Fashions Ltd.

126/1 Kadda Nandun, Kadda Bazar, Gazipur Sadar, Gazipur  
(23.985952, 90.356677)

24<sup>th</sup> October 2015

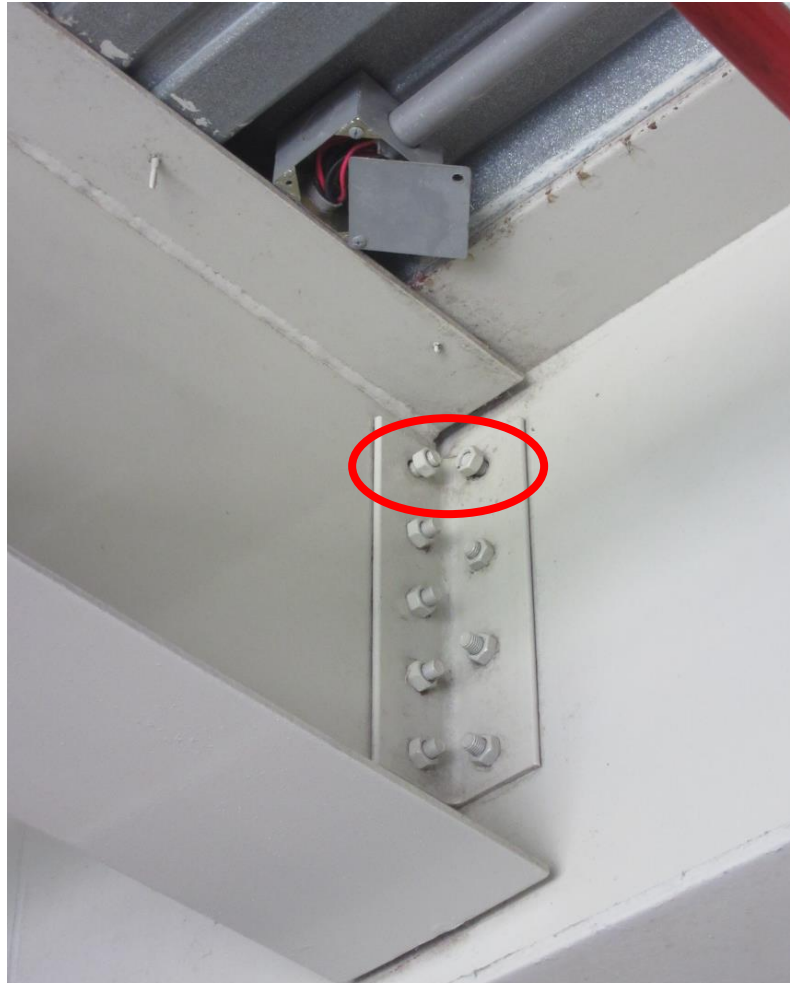
# Loose bolts

Bolted connections are found  
loosened

**ITEM 1:** Loosened bolts needs to be tightened.

| Item No. | Observation | Recommended Action Plan | Recommended Timeline |
|---|---|---|---|
| 1 | Tighten loose bolts. | Check the connections and tighten loose bolts. | 6-months |

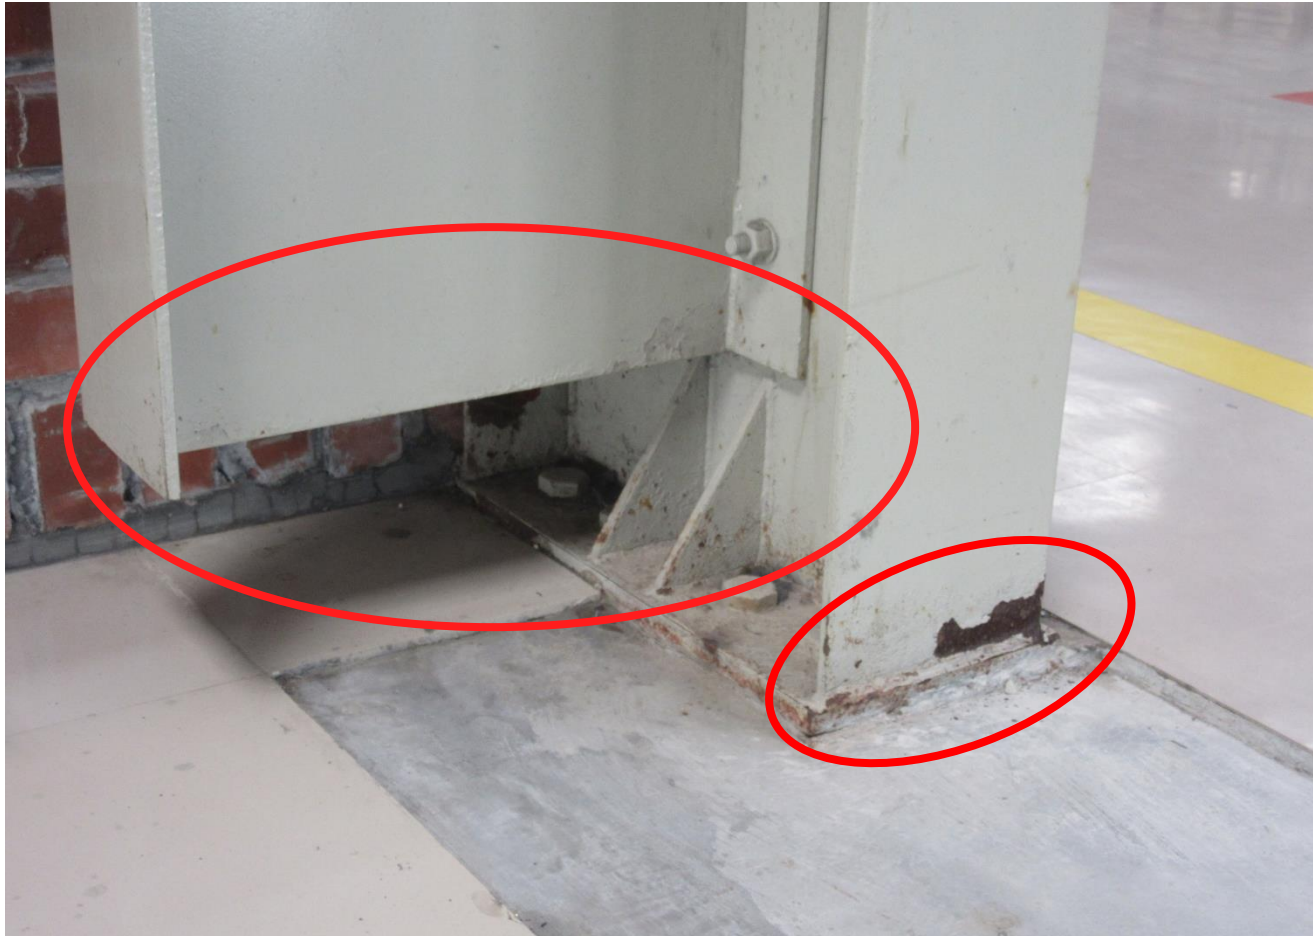
# Discontinuity and Corrosion

Discontinuity and Corrosion found in the portal frame bracing at column F-17

**ITEM 2:** Repair of the corrosion protection paint.

| Item No. | Observation | Recommended Action Plan | Recommended Timeline |
|---|---|---|---|
| 2 | Repair corrosion protection paint. | Check structural elements paints and repair corrosion protection paint. | 6-months |

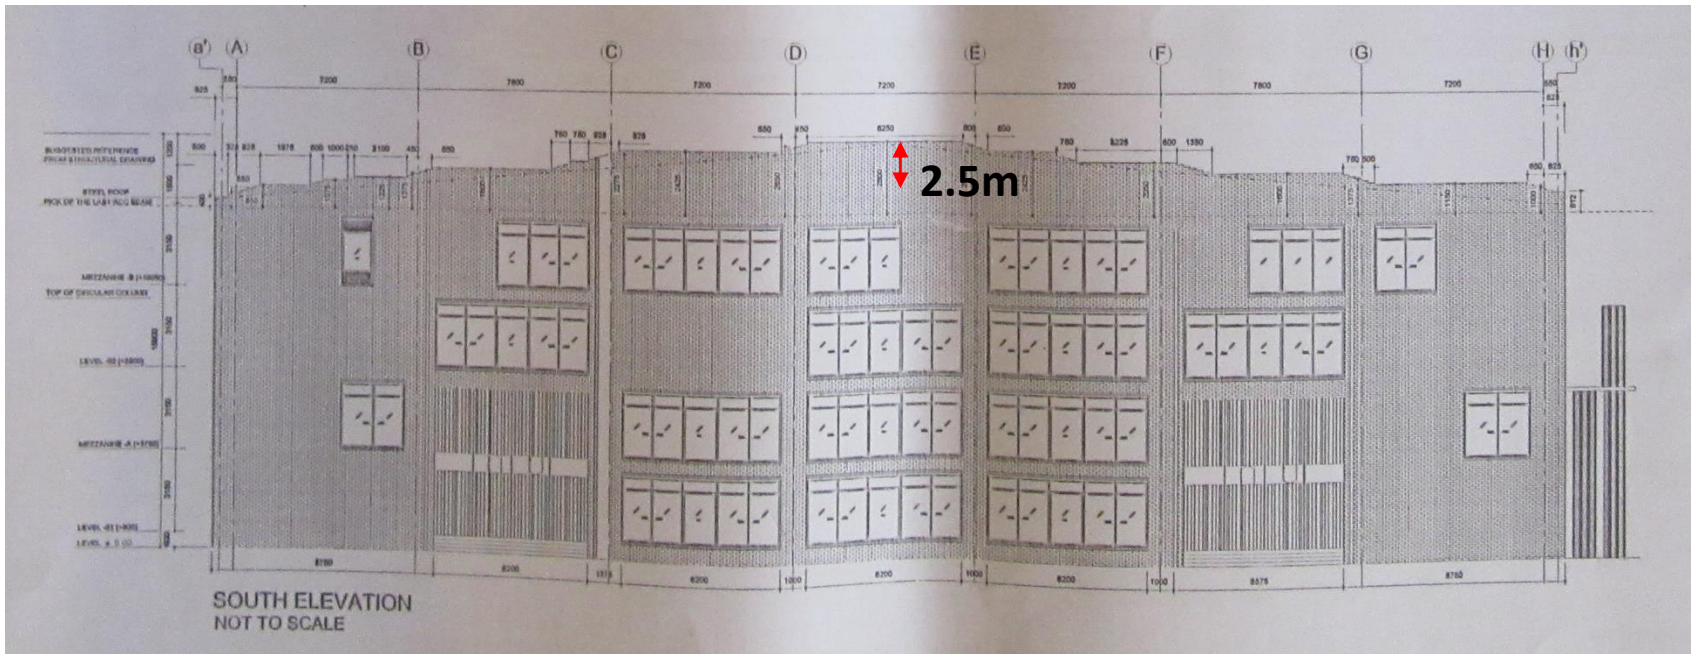
# High Parapet wall

High parapet wall over the roof may fall if it subjects to the horizontal (wind) force

**ITEM 3:** Verify lateral stability of the parapet wall.

| Item No. | Observation | Recommended Action Plan | Recommended Timeline |
|---|---|---|---|
| 3 | Verify lateral stability of the parapet wall. | Building Engineer should check parapet wall stability. | 6-months |

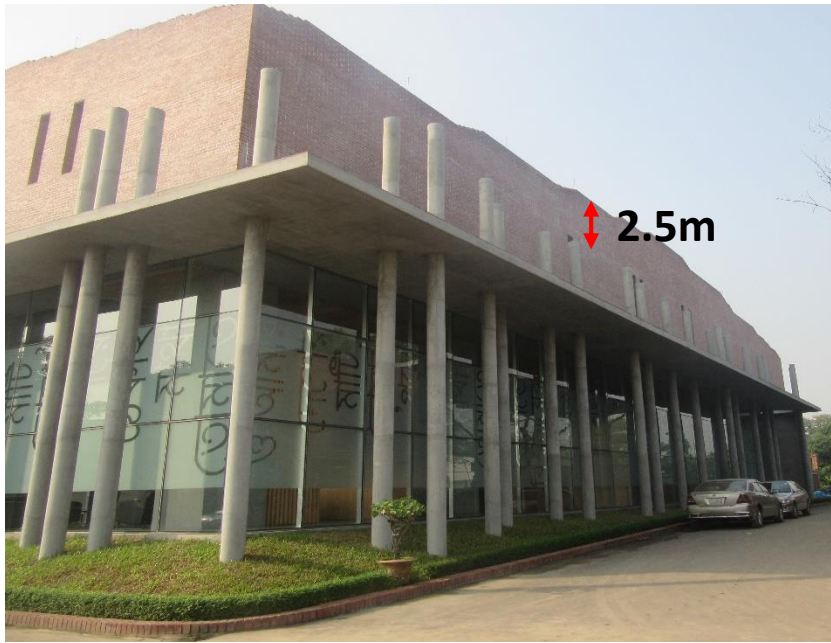
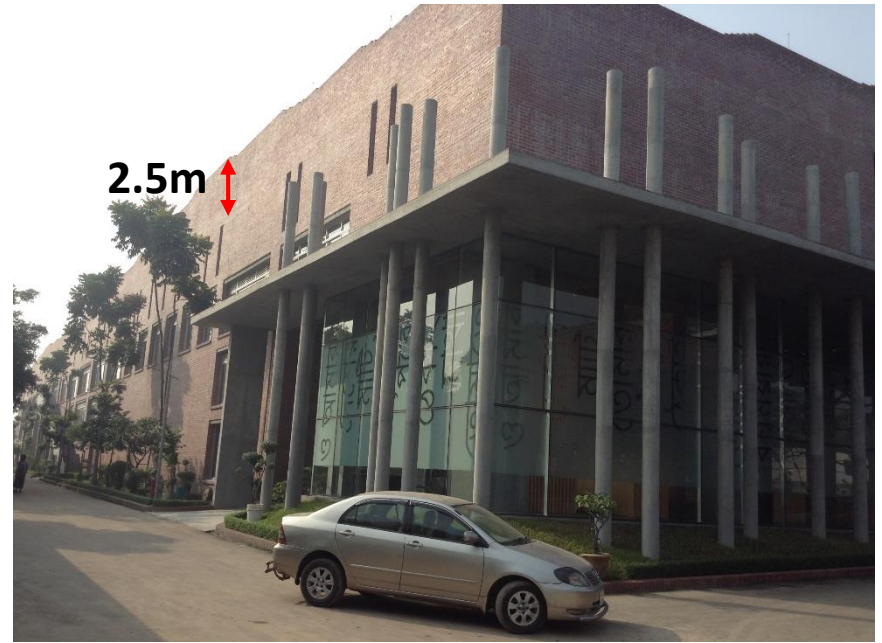
High parapet wall over the roof may fall if it subjects to the horizontal (wind) force
