PROSTAR APPARELS LTD.

Potka, Kapasia Road, Gosingga, Sreepur; Gazipur
(24.183998 N, 90.487563 E)

25th October 2015

Observations

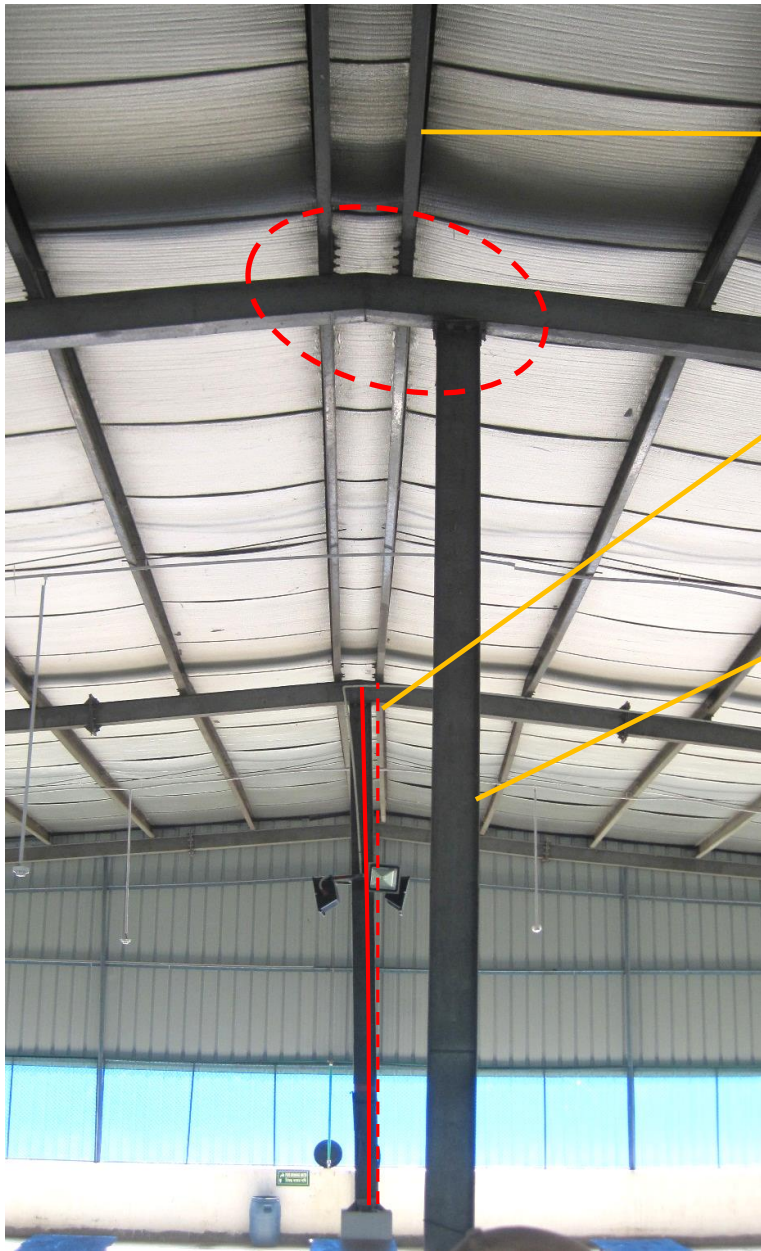
Poorly designed and constructed structural steel framing above first floor of Emroidery and Generator Building

Steel column not aligned with the centerline of portal frame

Steel column tilted out of plumb.

No lateral bracing to frame in any direction.
No bracing at roof level

Pin connected columns at both ends.

Lateral buckling at mid rafter

Item No.	Observation	Recommended Action Plan	Recommended Timeline
1	Poorly designed and constructed structural steel framing above first floor of Embroidery and Generator Building	As-built drawings to be prepared by Building Engineer. Stability analysis to be performed on steel frame. Install adequate bracing and steelwork connections to provide stability.	6-months
2	Poor lateral stability of the Main Factory steel moment framing (Building 1)	Lateral stability of the moment frame system to be checked by the Building Engineer. Suitable lateral stability to be provided as required.	6-months
3	Poorly constructed steelwork connections at several locations (Buildings 1, 3 & 6)	Visually inspect all connections in all steel frame buildings and rectify connections as appropriate.	6-months

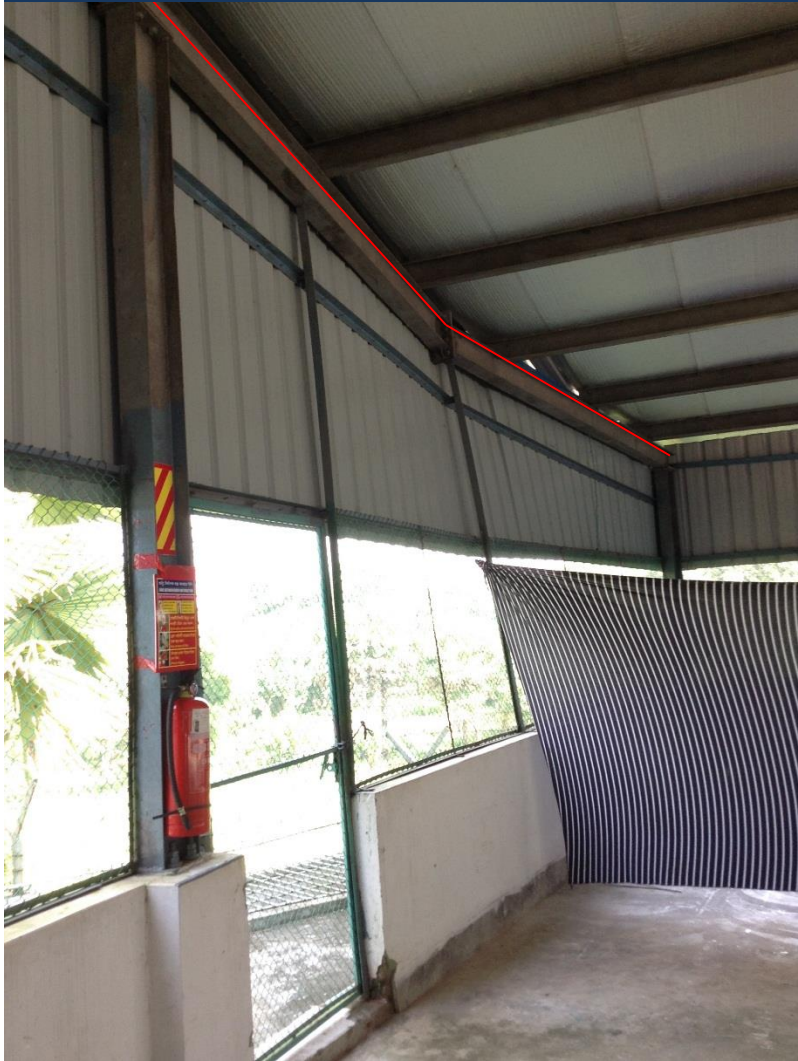
Gaps in bolted connections

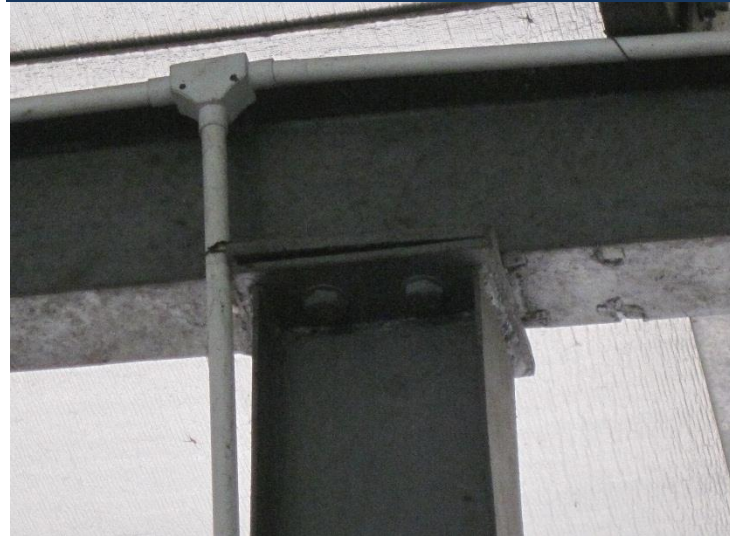
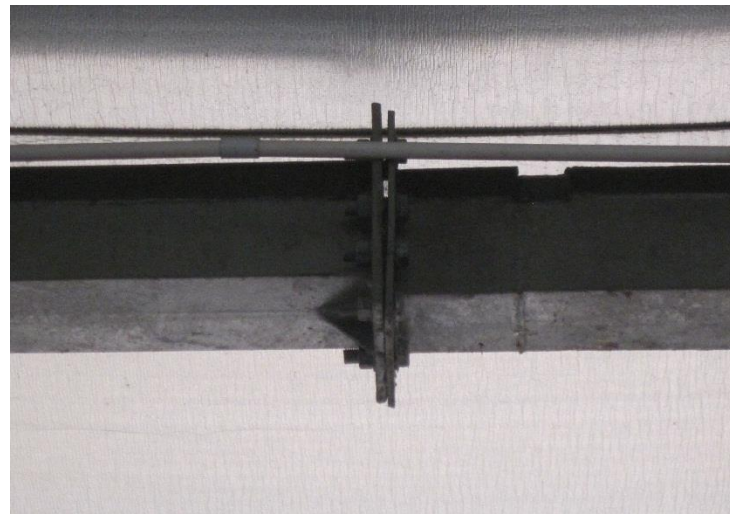
Poor lateral stability of the Main Factory steel moment framing

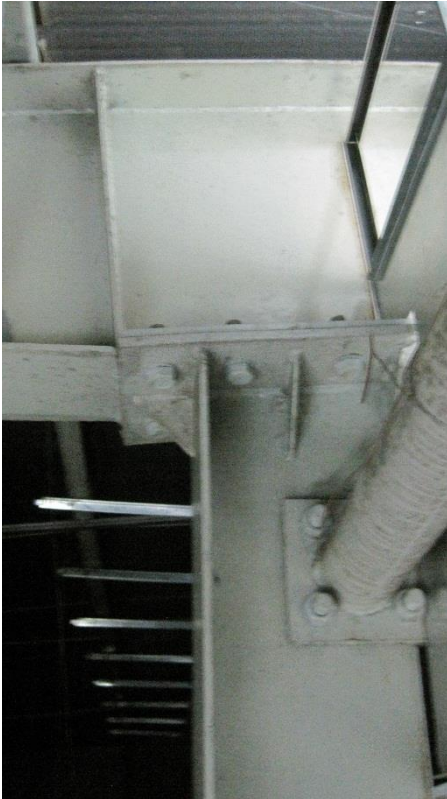
Top plate detail – semi rigid flexible connection

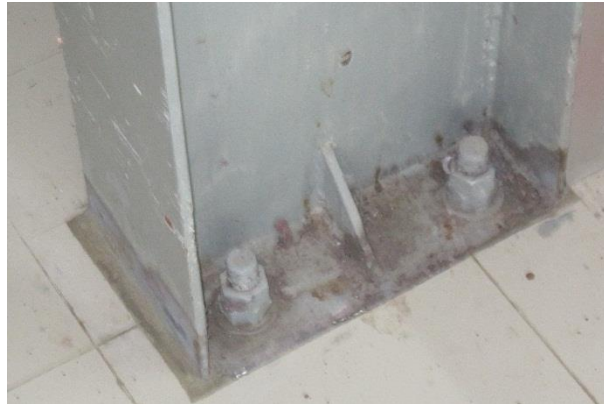
Typical end plate detail of internal column

Poorly constructed steelwork connections in several locations

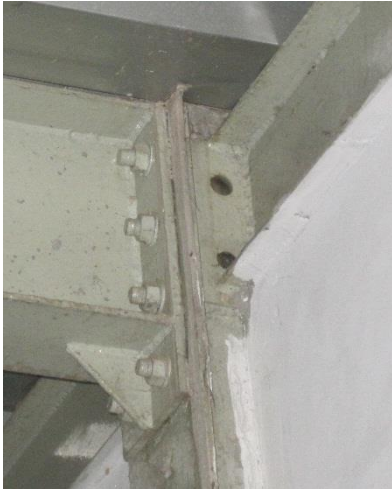
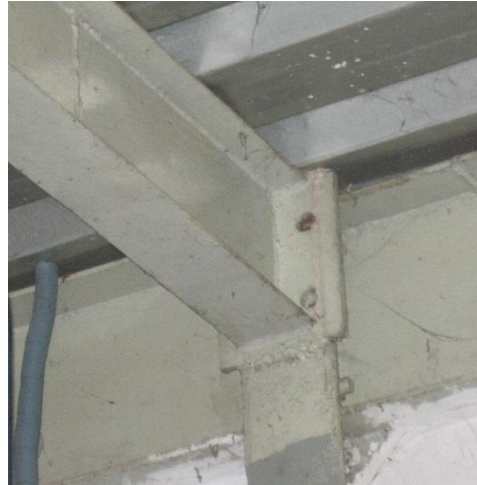
Missing bolts under mezzanine floor of main factory (finished good ceiling)

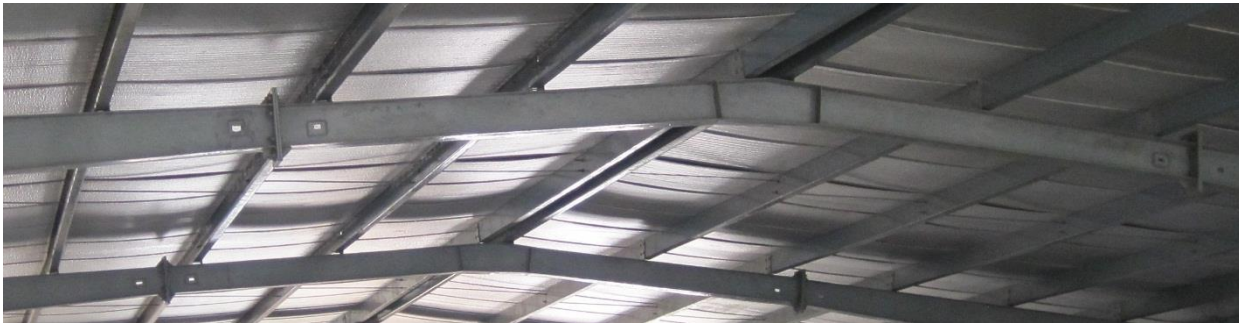
Lack of lateral braces in warehouse roof
