# AFIYA KNITWEAR LTD.

Holding 10/2, Block C, Road 3, Ward 2, Durgapur Ashulia, Savar, Dhaka  
(24.1839128 N, 90.4877295 E)

27<sup>th</sup> October 2015

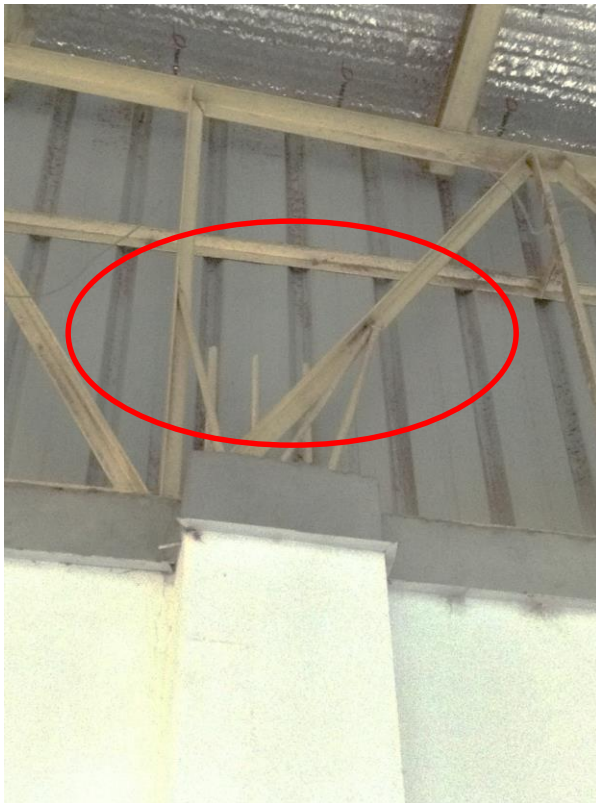
# **Poorly designed and constructed structural steel framing and connections**

Truss resting on top of the RC columns welded to column rebars

| Item No. | Observation | Recommended Action Plan | Recommended Timeline |
|---|---|---|---|
| 1 | Poorly designed and constructed structural steel framing and connections | Engage a Building engineer to inspect the connections of the steel truss to the steel posts and the RC column. | 6-weeks |
| 2 | Poorly designed and constructed structural steel framing and connections | Provide adequate steel detailing and additional welding where required. | 6-months |

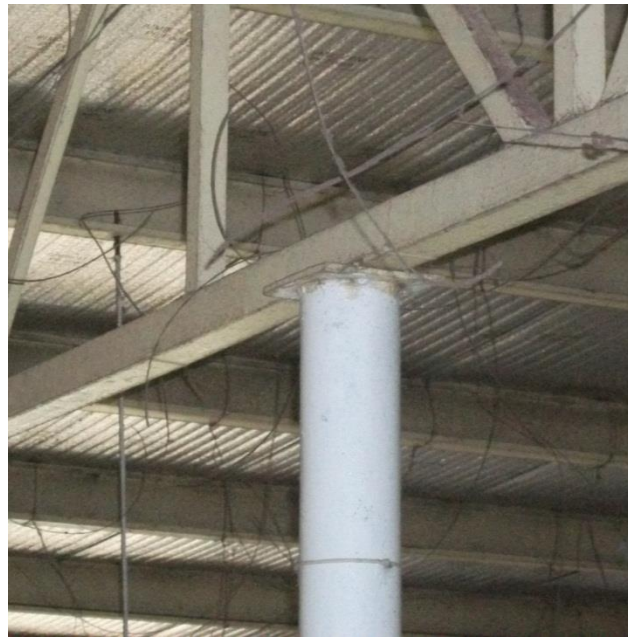
Poor welding between Steel Post to Truss bottom flange

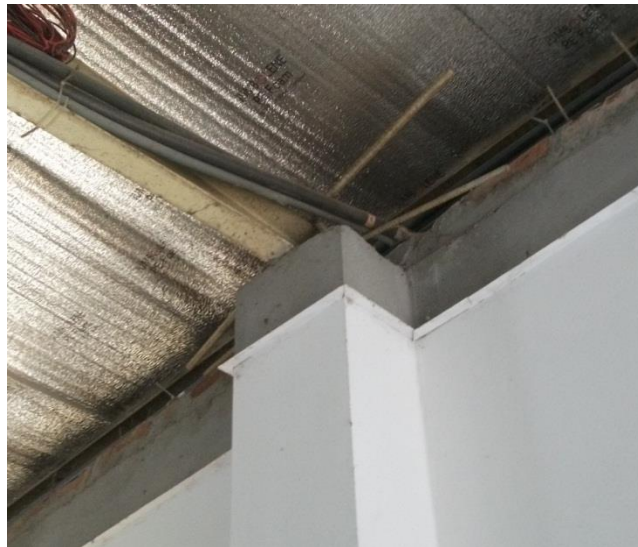
Steel truss resting on top of the RC column at edge. Proper connection was not observed. Exposed rebars are tied and welded to steel profiles.

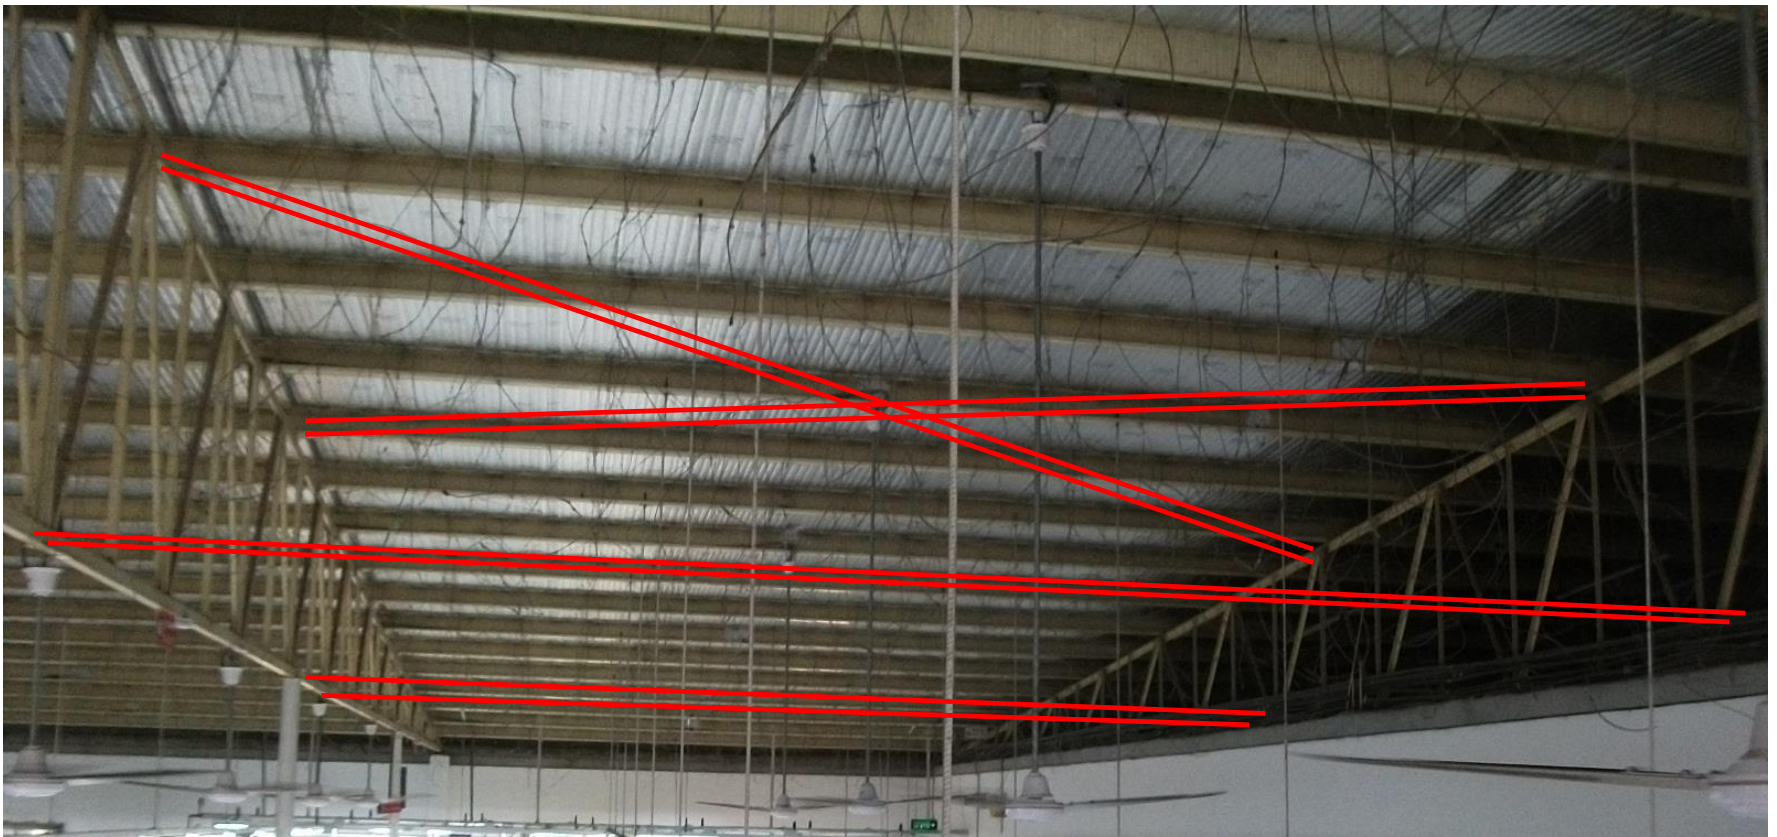
# **Lack of lateral stability elements**

**Stability elements are missing at bottom flange of truss**  
**Lack of diagonal bracing at roof level**

| Item No. | Observation | Recommended Action Plan | Recommended Timeline |
|---|---|---|---|
| 3 | Lack of lateral stability elements | Lateral stability of the moment frame system to be checked by the assigned Building Engineer | 6-weeks |
| 4 | Lack of lateral stability elements | Provide proper lateral bracing | 6-months |
