# Arrival Fashion Limited (Bhaluka)

Holding-18, Mamarishpur, Mallikabari, Bhaluka, Mymensingh-2240

20 December 2023

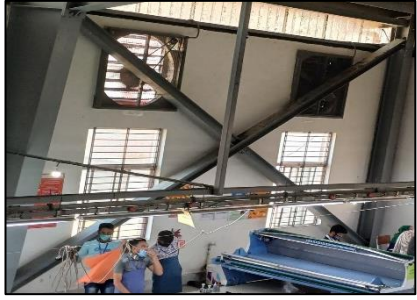
ASD design code has been used with ASD load combination.

In FEA model, rod section has been assigned as vertical bracing instead of I-section.

| Observation | Action Plan | Timeline |
|---|---|---|
| Inconsistency in design report and FEA model (Garments Shed). | The building engineer is required to revise the design report considering the effect of compression member and proper design code. | within 6 weeks |

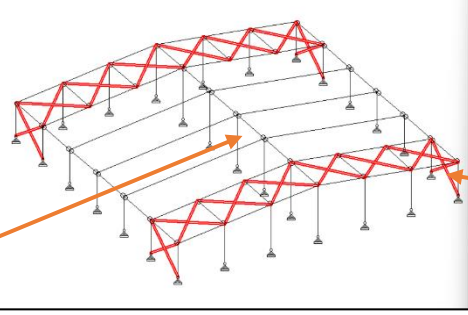
AISC LRFD design code is used in design report.

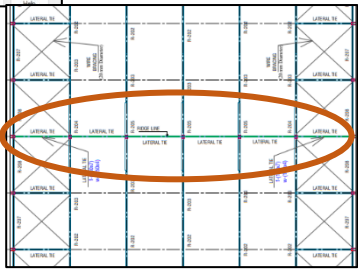
These compression members are missing in FEA model.

**Description:** The Garments shed has been designed in accordance with AISC LRFD as per design report. However, ASD design code with ASD load combinations was observed in FEA model. Also, inconsistency was found in horizontal compression member and vertical bracing assignment. The building engineer is required to revise the design report considering the effect of compression member and proper design code.

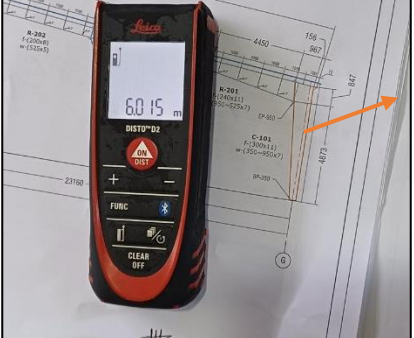
Eave height was found 6.01m instead of 4.87m.

| Observation | Action Plan | Timeline |
|---|---|---|
| Mismatch in as built drawings (Garments Shed). | The building engineer is required to survey the full structure and produce accurate as-built drawings. | within 6 weeks |

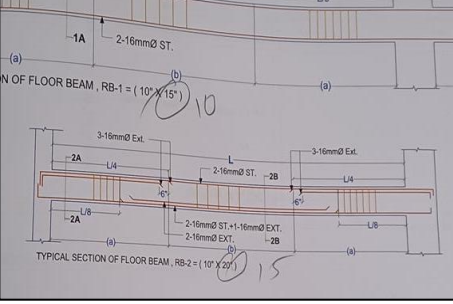
Mezzanine floor beam depth was found 250 mm instead of 375 mm.

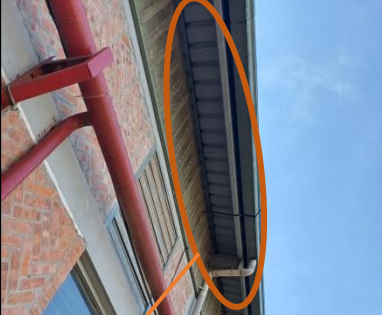
Extended portion of the rafter has not shown in drawing.

**Description:** During inspection, mismatches were found between onsite condition and as-built drawing of garment shed. Extended part of the rafter was not shown in the drawing. Also, mismatches were observed in mezzanine floor beam size and eave height of the shed. The building engineer is required to survey the full structure and produce accurate as-built drawings.

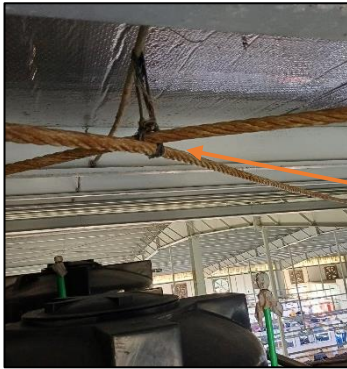
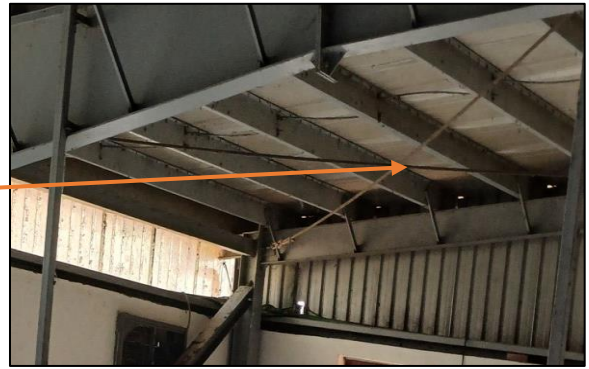
Loose cable bracing  
were observed.

**Description:** During inspection, loose cable bracings were observed on the roof of garment shed. Factory engineer is required to tighten the loose cable bracings.

| Observation | Action Plan | Timeline |
|---|---|---|
| Loose Cable bracing (Garments Shed). | Factory engineer is required to tighten the loose cable bracings. | within 6 weeks |

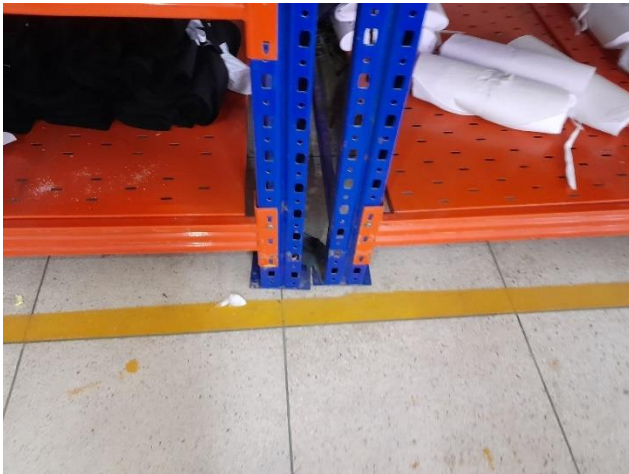
Storage Rack – not anchored

| Observation | Action Plan | Timeline |
|---|---|---|
| Non-structural element found not anchored. (Garments Shed). | Factory engineer is required to anchor/brace all non-structural elements. | within 6 weeks |

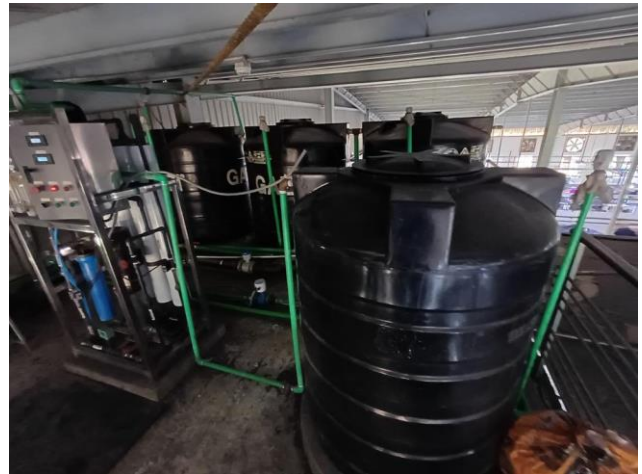
Plastic Water Tank on mezzanine roof  
not braced

**Description:** During inspection non-structural elements were found unbraced and without anchoring. Factory engineers are required to anchor all non-structural elements.

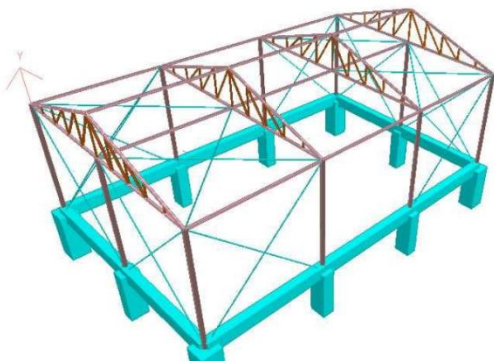
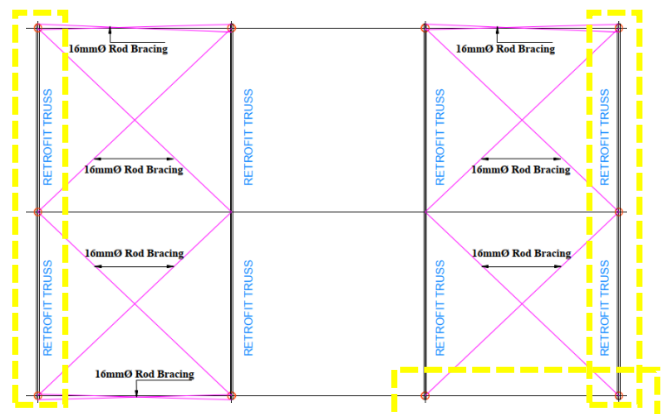
Wall Bracing in FEA model

Wall Bracing not shown in marked position in Retrofitting drawing

| Observation | Action Plan | Timeline |
|---|---|---|
| Lack of Lateral Stability (Dining Shed-01) | Building engineer is required to check the lateral stability of the shed considering the as built condition and submit to the RSC for review. | within 6 weeks |

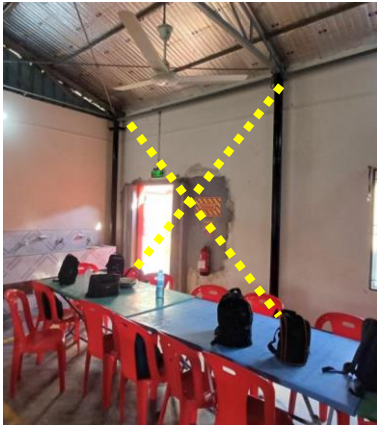
Bracing Missing in side wall

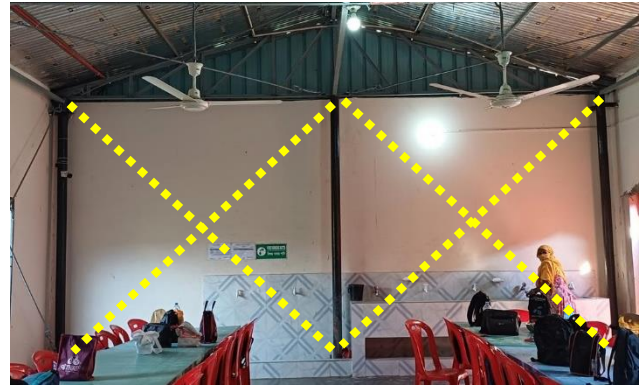
Bracing Missing in end frame

**Description:** Wall bracings were not shown in retrofitting drawings and not found in as built condition which are necessary for lateral stability of the frame. Building engineer is required to check the lateral stability of the shed considering the as built condition and submit to the RSC for review.

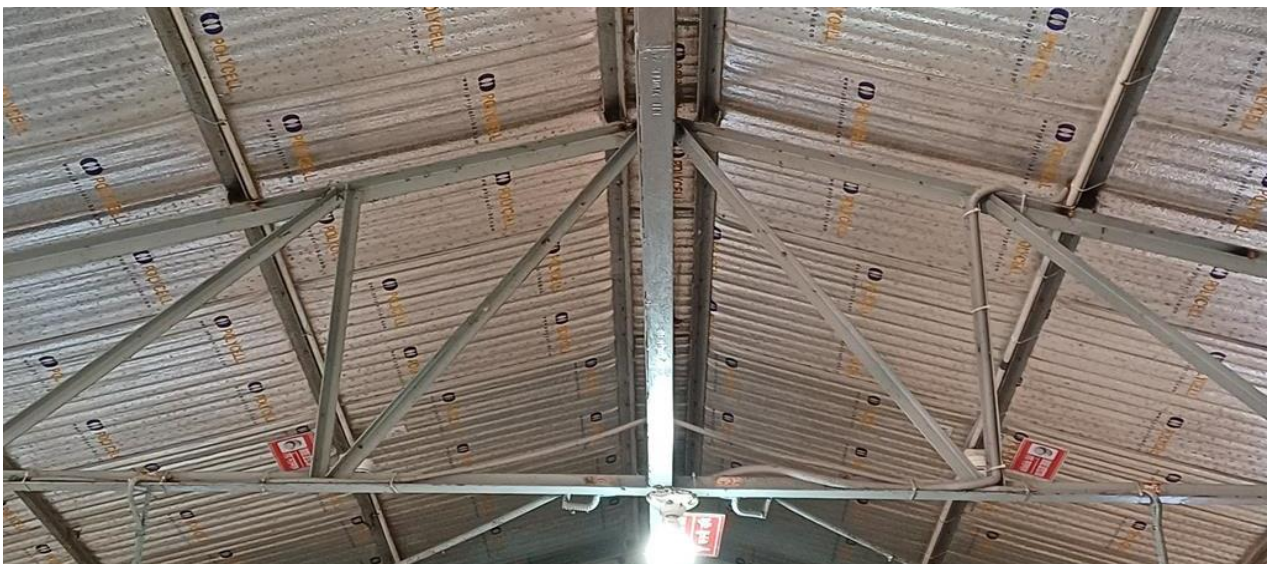
Top & Bottom Chord found L 50x50x5 instead of steel tube (50x50x5)

**Description:** During inspection, top & bottom chords were found L 50x50x5 instead of steel tube (50x50x5). Building engineer is required to complete the remediation works as per retrofitting drawings.

| Observation | Action Plan | Timeline |
|---|---|---|
| Incomplete retrofitting works (Dining Shed-01) | Building engineer is required to complete the remediation works as per retrofitting drawings. | within 6 months |

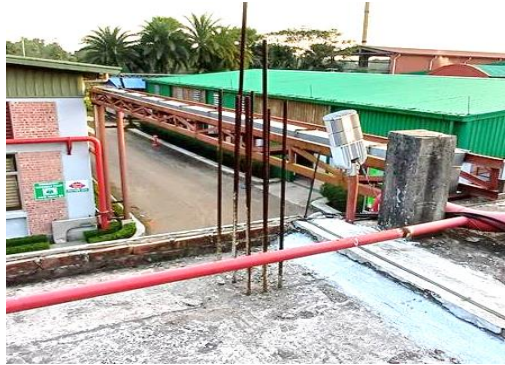
**Description:** During inspection, corrosion was observed on exposed rebar at roof level. Factory is required to repair the corrosion and apply anti-corrosive coating on exposed rebar.

| Observation | Action Plan | Timeline |
|---|---|---|
| Corrosion found on exposed rebar (Generator Building). | Factory is required to remove corrosion and apply rust proof paint on exposed rebar. | within 6 weeks |

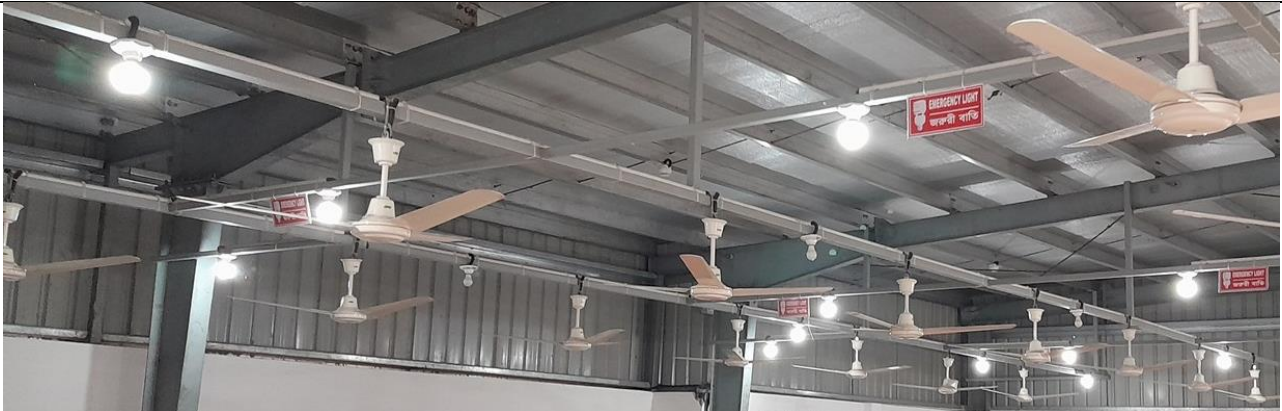
**Description:** Portal frame action was observed in the short direction. No compression strut or load transfer media was observed in long direction. Building engineer is required to check the lateral stability of shed and submit to the RSC review.

| Observation | Action Plan | Timeline |
|---|---|---|
| Lack of lateral stability system (Dining Shed-02). | Building engineer is required to check the lateral stability of shed and submit to the RSC review. | within 6 weeks |

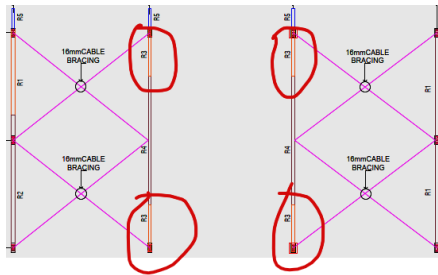
**Description:** During inspection, the web depth of Rafter-3 was found 440 mm instead of 540 mm. Building engineer is required to survey the whole structure and update as-built drawing as per site condition.

| Observation | Action Plan | Timeline |
|---|---|---|
| Discrepancies in as built drawings. (Dining Shed-02) | The building engineer is required to survey the full structure and produce accurate as-built drawings. | within 6 weeks |

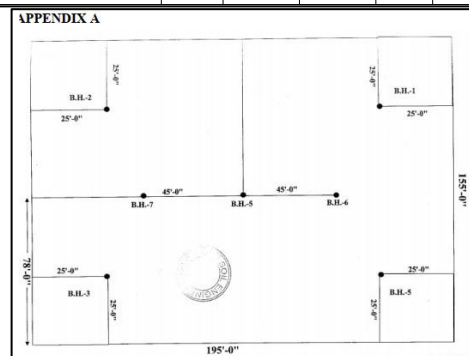
Pile capacity has been calculated from the average capacity of 5 bore hole data.

7 Bore Hole as per Bore hole layout.

**Description:** Garments building has been designed as per BNBC 2020 and Response modification factor 'R' value was taken for DUAL system (IMRF and Special RC Shear wall). However, no calculation of 'R' or check for dual system has been provided in design report. Also, load bearing capacity of pile has been calculated from the average value of 5 Bore Hole data where 7 Bore holes were investigated. The building engineer is required to revise the design documents considering the requirements for framing system as per BNBC 2020 and appropriate calculation for pile load bearing capacity.

| Observation | Action Plan | Timeline |
|---|---|---|
| Design report needs to be updated (Garments Building). | The building engineer is required to revise the design documents considering the requirements for framing system as per BNBC 2020 and appropriate calculation for pile load bearing capacity | within 6 months |

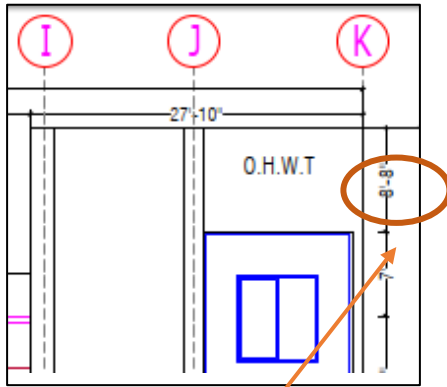
Possible overloading from  
higher capacity O.H.W.T.

Equivalent Water  
height of 200 psf live  
load is 0.975 m which  
is lower than existing  
capacity (2.34m) of  
O.H.W.T.

| Observation | Action Plan | Timeline |
|---|---|---|
| Load plans need to be revised (Garments Building). | The building engineer is required to update the load plan for actual capacity of water tank and incorporate it in design report. | within 6 weeks |

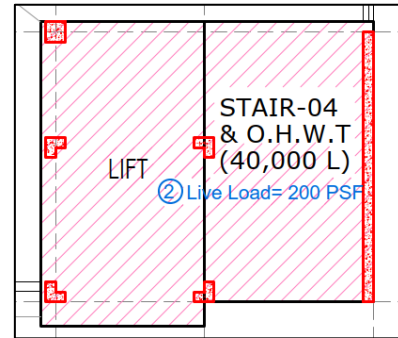
200 psf was considered on bottom  
slab of O.H.W.T. as per load plan.

**Description:** Garments building has been designed with a live load of 200psf for overhead water tank. However, the size of the water tanks has 475psf (2.34m of water height) which can cause overloading on the structures. The building engineer is required to update the load plan for actual capacity of water tank and incorporate it in design report.

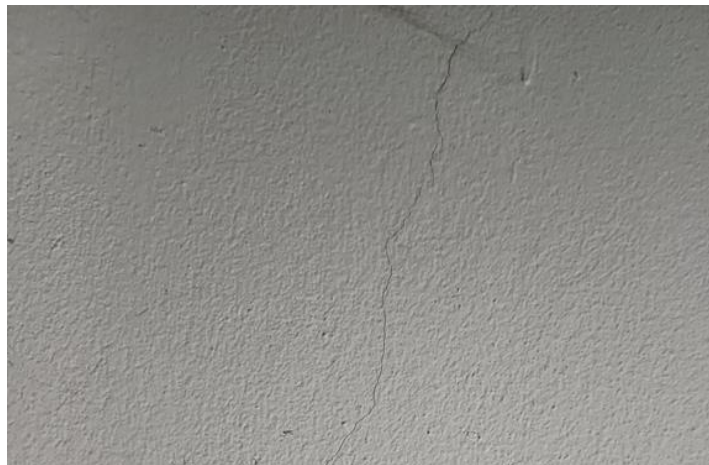
**Description:** During inspection, hairline cracks were observed on basement retaining wall at several locations. Factory is required to identify the reason of crack, take necessary remedial measure to repair the wall accordingly.

| Hairline crack on basement retaining wall (Garments Building). | Building engineer is required to investigate the reason of the crack, extend of the cracks and suggest necessary remedial measure to repair the crack accordingly. | within 6 weeks |

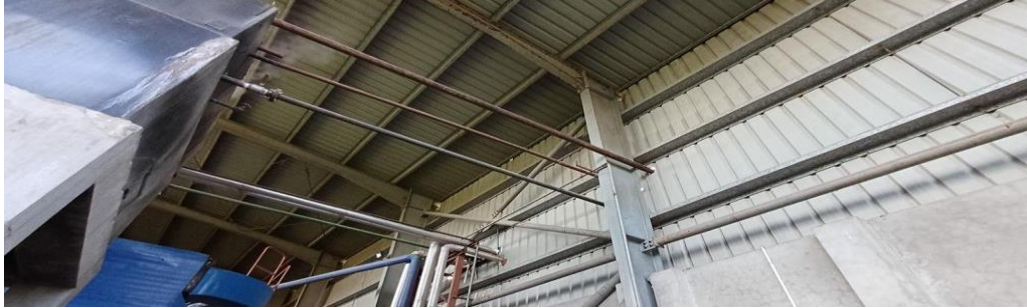
**Description:** Portal frame action was observed in the short direction. No compression strut or load transfer media was observed in long direction. Building engineer is required to check the lateral stability of shed and submit to the RSC review.

| Lack of lateral stability system (Boiler Shed). | Building engineer is required to check the lateral stability of shed and submit to the RSC review. | within 6 weeks |

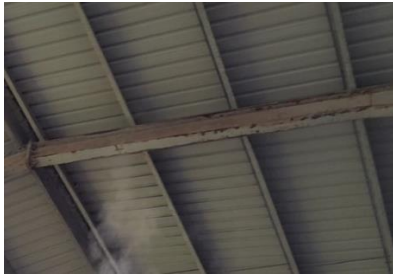
Rafter

**Description:** During inspection, corrosion was observed on several steel columns and rafters. Building engineer is required to repair the corrosion and apply anti-corrosive coating on steel members.

| Corrosion on steel member (Boiler Shed). | Building engineer is required to repair the corrosion and apply anti-corrosive coating on steel members. | within 6 weeks |

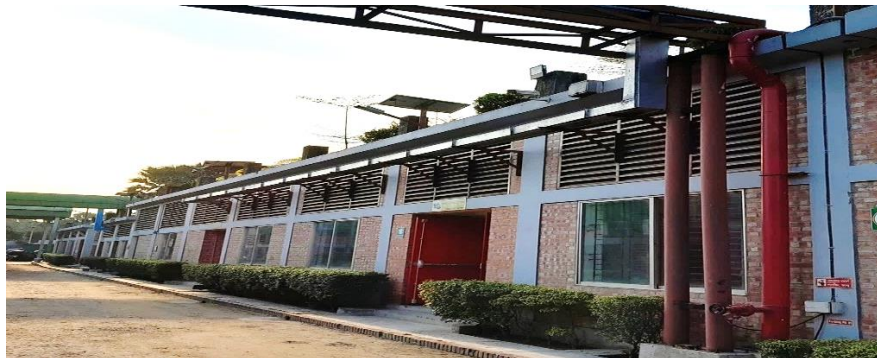
**Description:** As per BNBC, every building or structure designed shall have its design documents prepared in accordance with the provision of Section 1.9.1. During the inspection, the design report and as built structural drawing were not available on site.

The building engineer is required to prepare a set of design documents including as built drawings, live load plan at roof and a design report based on in-situ material strength and software-based analysis which shall be prepared in compliance with section 1.9.1, part-6 of BNBC.

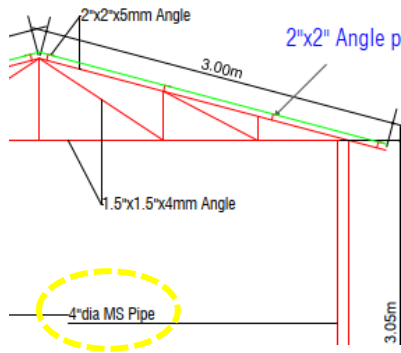
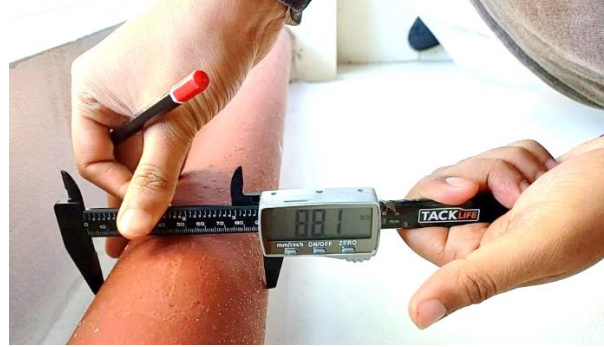
**Description:** During inspection, diameter of steel pipe columns was found 88 mm instead of 100 mm. Building engineer is required to survey the whole structure and update as-built drawing as per site condition.

| Discrepancies in as built drawings. (Fire Control Room) | The building engineer is required to survey the full structure and produce accurate as-built drawings. | within 6 weeks |

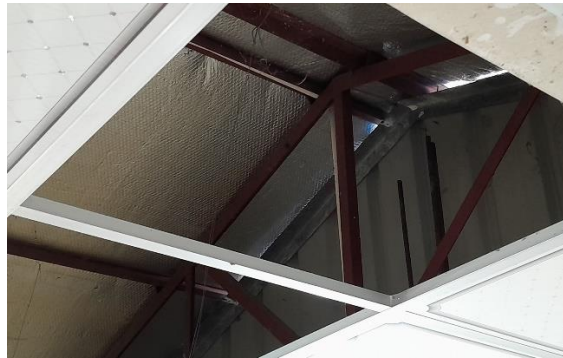
**Description:** Truss action was observed in the short direction. No compression strut or load transfer media was observed in long direction. Building engineer is required to check the lateral stability of shed and submit to the RSC review.

| Lack of lateral stability system (Fire Control Room). | Building engineer is required to check the lateral stability of shed and submit to the RSC review. | within 6 weeks |

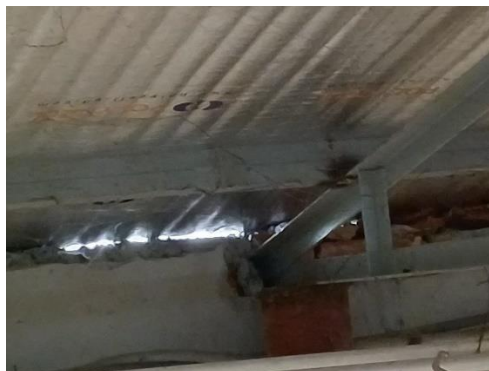
**Description:** Truss action was observed in the short direction. No compression strut or load transfer media was observed in long direction. Building engineer is required to check the lateral stability of shed and submit to the RSC review.

| Lack of lateral stability system (Childcare & Medical Room). | Building engineer is required to check the lateral stability of shed and submit to the RSC review. | within 6 weeks |
